# 2022 Periodic Review Report

(Reporting Period: May 15, 2021 to May 15, 2022)

Bern Metal Corporation  
22 Bender Avenue, City of Buffalo, New York  
NYSDEC Site No. 915135

LaBella Project No. 2223105

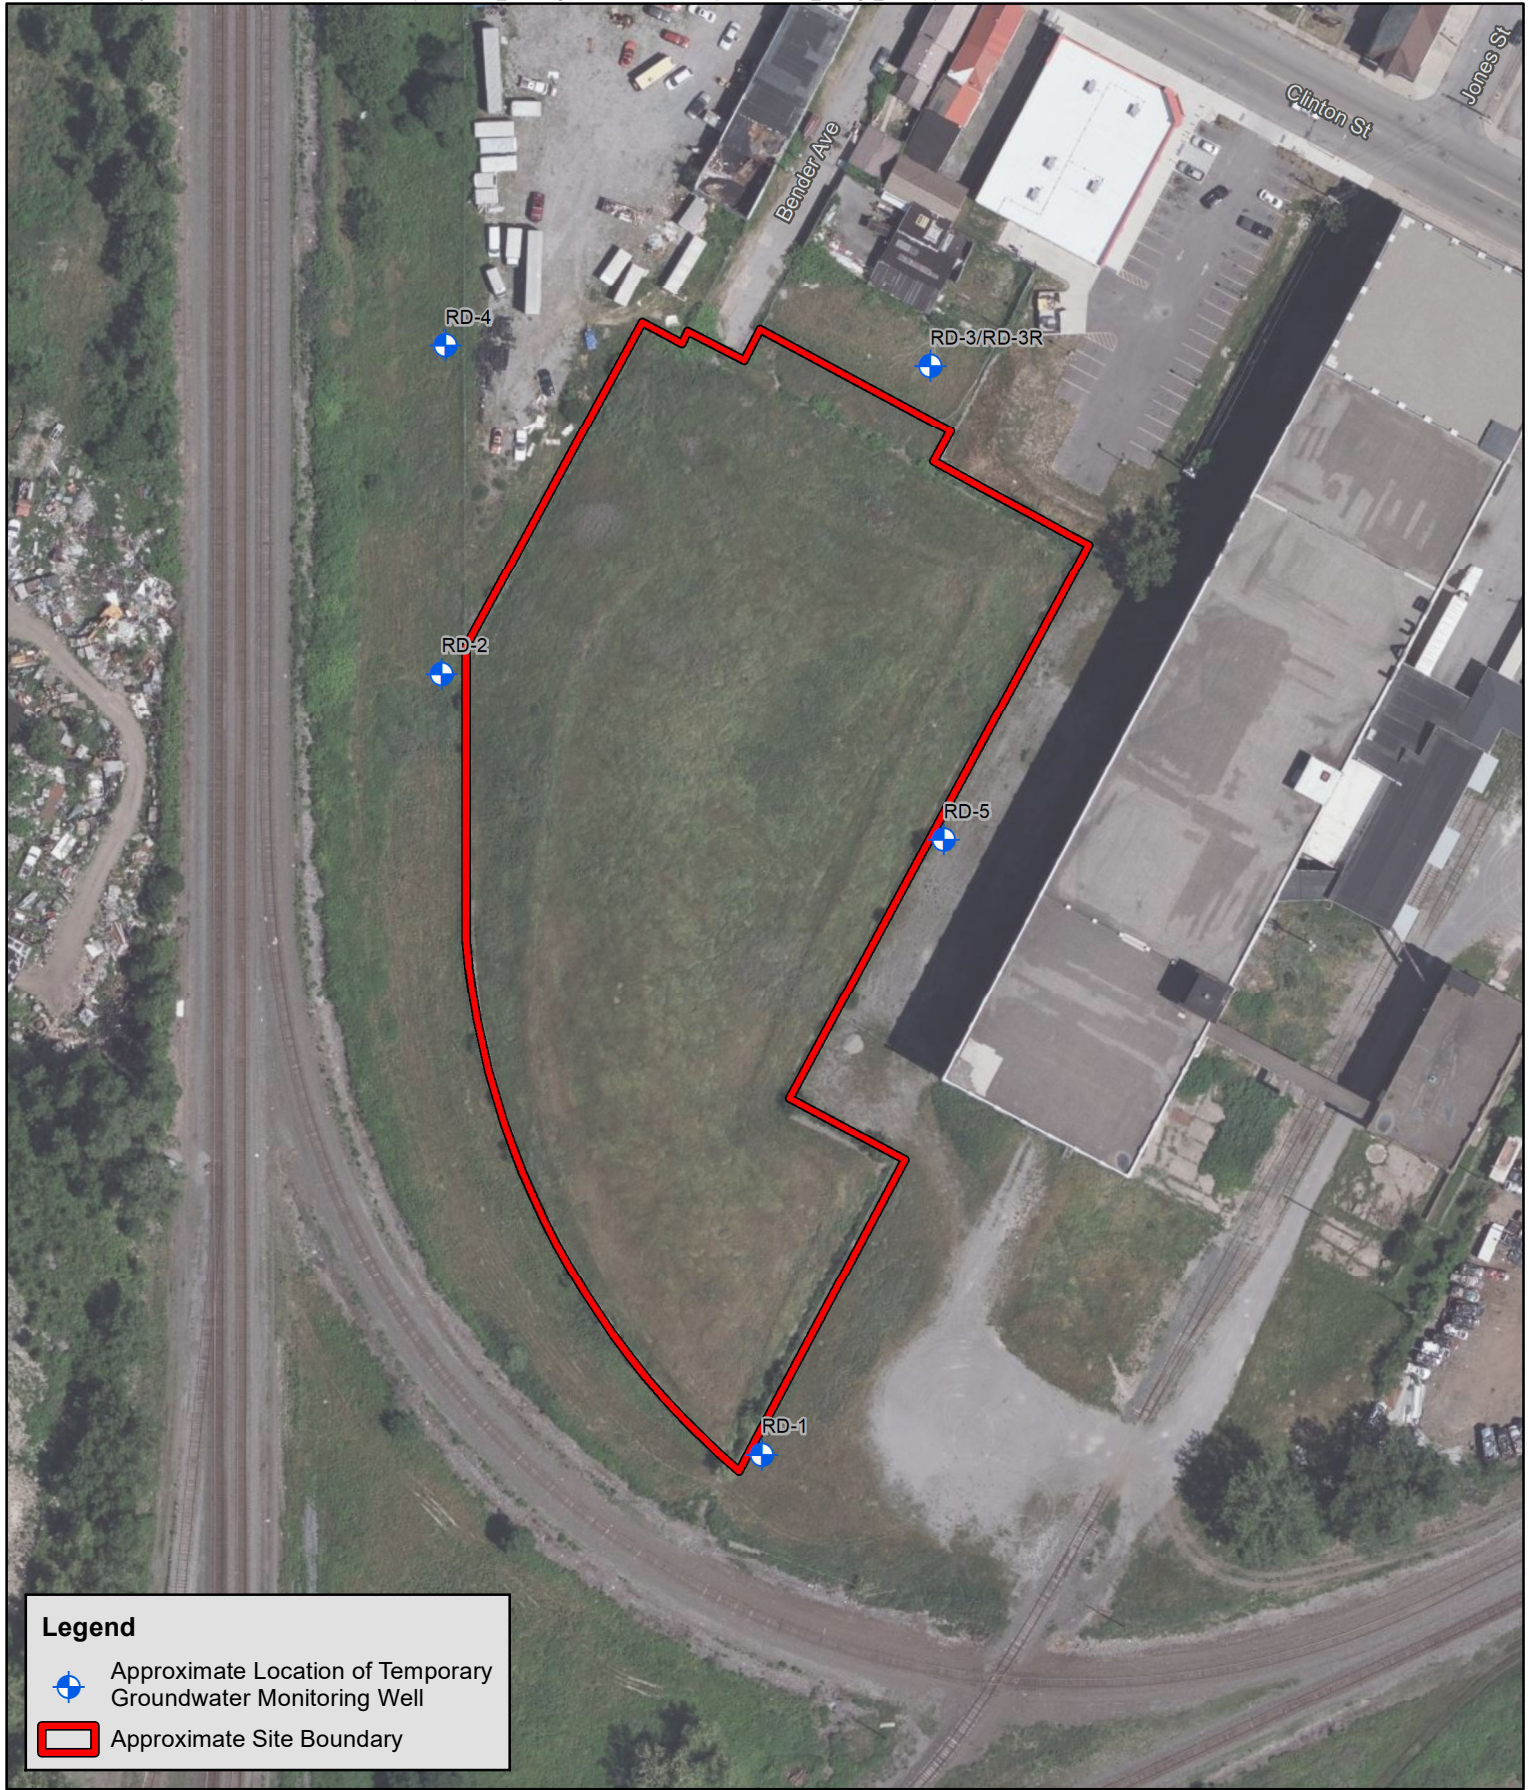
The Site encompasses approximately 3.049 acres and is located at 22 and 23 Bender Street in the City of Buffalo, Erie County, New York (see Figure 1). As shown in Figure 2, the Site is bounded by Norfolk Southern railroad tracks to the west and south, Laub International to the east, and commercial, residential and vacant properties to the north. The Site is currently a vacant grass covered landfill. Figure 2 depicts the Site boundaries overlain on a current aerial image.

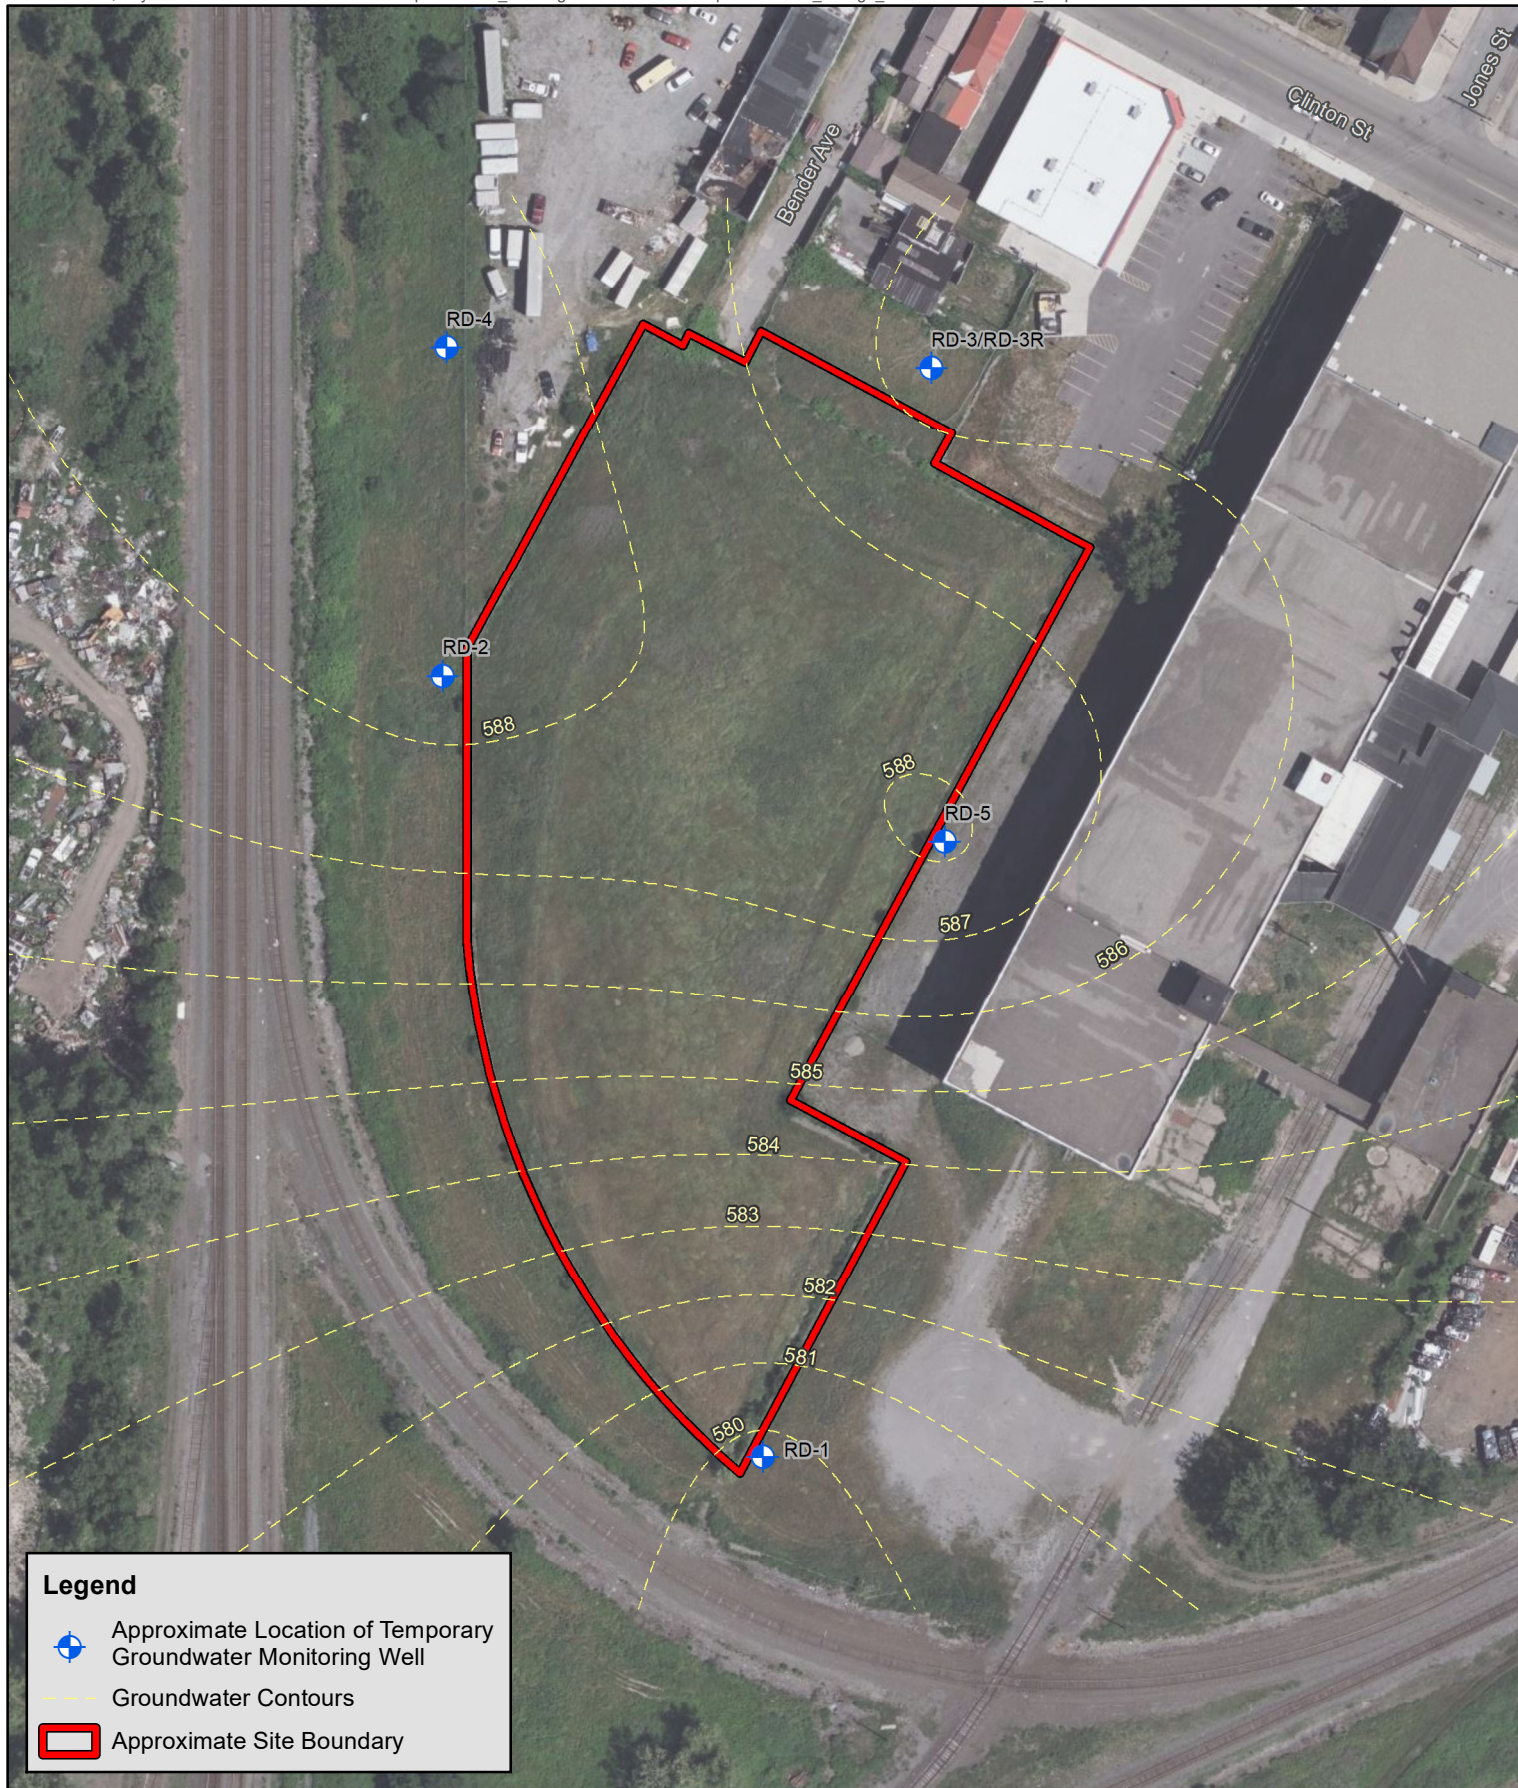
2223105  
**Figure 3**  
8/1/2022

Groundwater elevations at each monitoring well at the Site are summarized in Table 1. Groundwater contours are depicted on Figure 3. Field parameters collected at the time of sampling are provided in Table 2. Monitoring well sampling logs are included in Appendix 4.
