Site Management Periodic Review Report (2024) Site No. 915141B

NFG - Iroquois Gas/Westwood Pharmaceutical Riparian Site,
Buffalo, New York

January 2025, Rev. September 2025
Project No. 1403480-1000

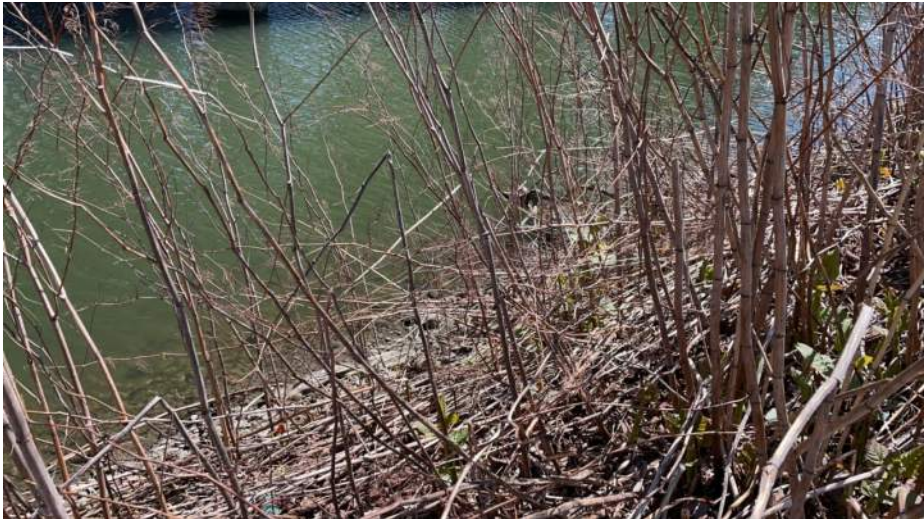
PHOTO BY: RICK FRAPPA, P.G.			
PHOTOGRAPH No: 06	DATE: April 22, 2024	LATITUDE: 42.9310030423532	LONGITUDE: -78.8946990990309
DIRECTION: Southwest	SITE LOCATION: SCAJAQUADA CREEK SITE - BUFFALO, NEW YORK		
DESCRIPTION: Exposed area of geotextile about 30 ft north of the prior area approximately 12 ft in length.

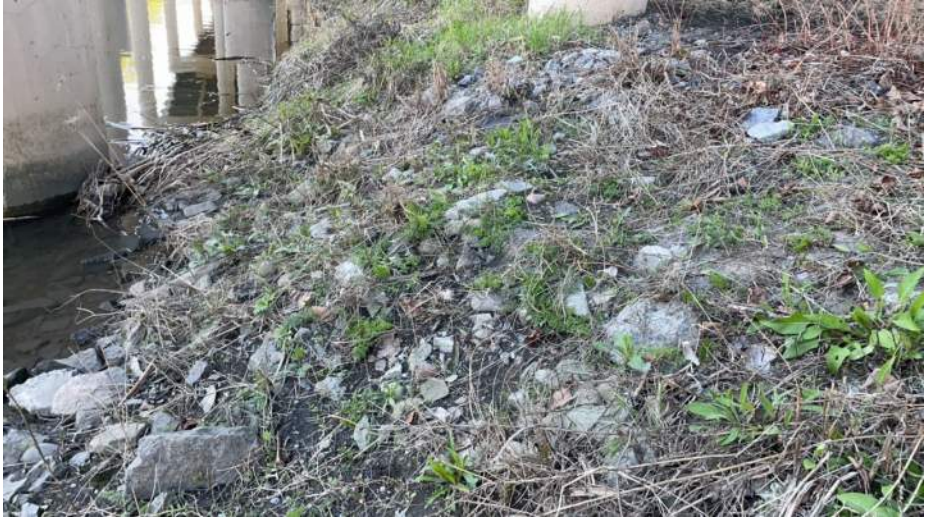
PHOTO BY: RICK FRAPPA, P.G.			
PHOTOGRAPH No: 10	DATE: April 22, 2024	LATITUDE: 42.931702282989	LONGITUDE: -78.8933235041041
DIRECTION: Southwest	SITE LOCATION: SCAJAQUADA CREEK SITE - BUFFALO, NEW YORK		
DESCRIPTION: South view of sheetpile. Good condition, no seeps or sheen visible.

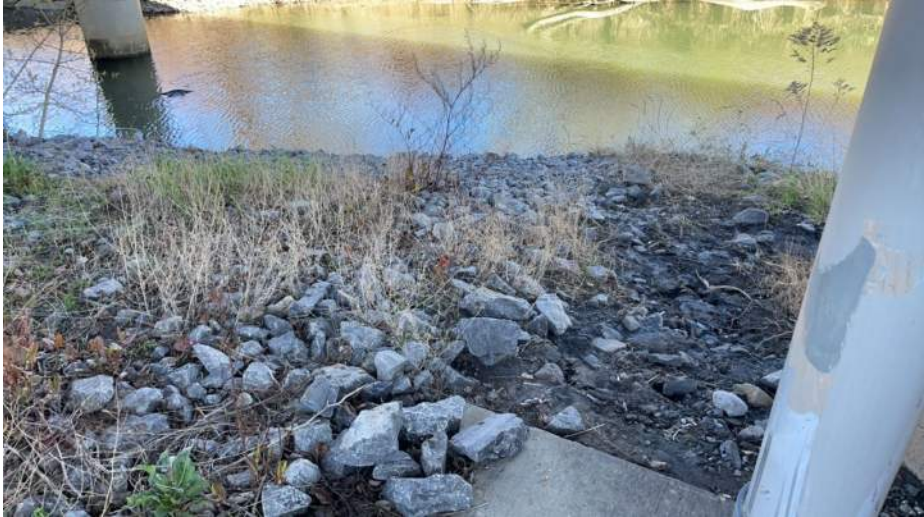
PHOTO BY: RICK FRAPPA, P.G.			
PHOTOGRAPH No: 12	DATE: April 22, 2024	LATITUDE: 42.9325125989378	LONGITUDE: -78.8934231952304
DIRECTION: South	SITE LOCATION: SCAJAQUADA CREEK SITE - BUFFALO, NEW YORK		
DESCRIPTION: South view from RR bridge. No sheens.

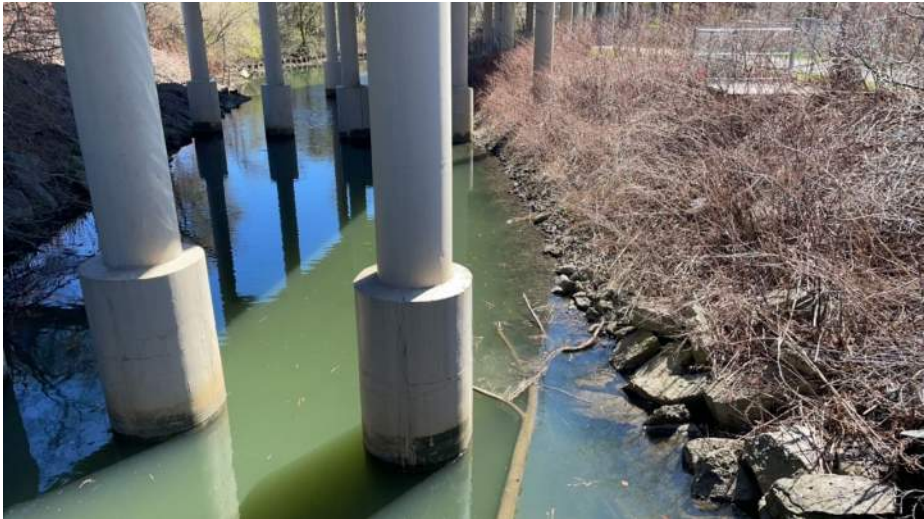
PHOTOGRAPH No: 13	DATE: April 22, 2024	LATITUDE: 42.9326645266368	LONGITUDE: -78.8931843869026
DIRECTION: Northwest	SITE LOCATION: SCAJAQUADA CREEK SITE - BUFFALO, NEW YORK		
DESCRIPTION: 2015 Maintenance Area is in good condition.

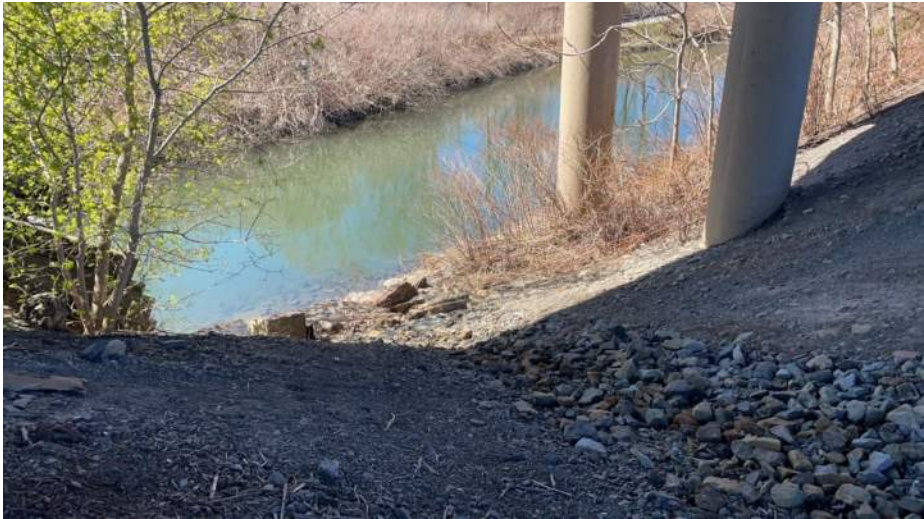
PHOTO BY: RICK FRAPPA, P.G.			
PHOTOGRAPH No: 14	DATE: April 22, 2024	LATITUDE: 42.9311195680296	LONGITUDE: -78.8936448539984
DIRECTION: Northeast	SITE LOCATION: SCAJAQUADA CREEK SITE - BUFFALO, NEW YORK		
DESCRIPTION: Flowing outfall with gabions. No sheens observed. Gabions in good condition.

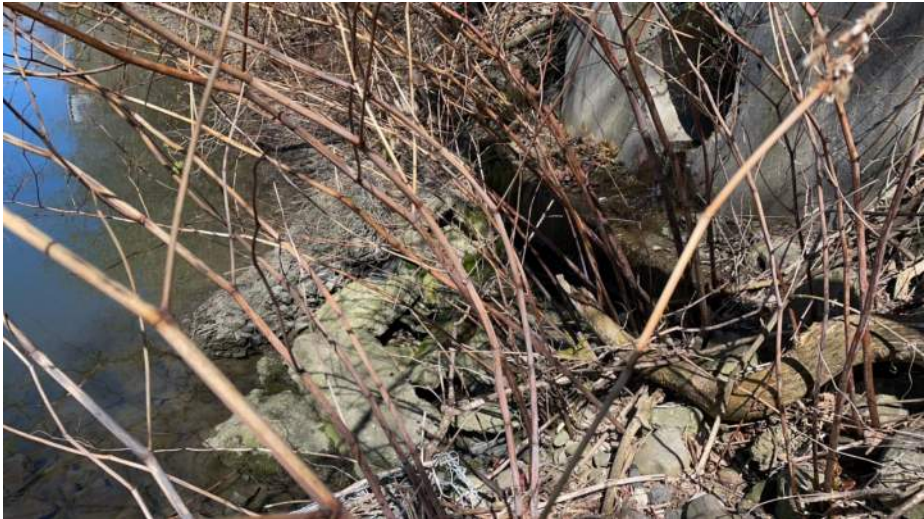
PHOTOGRAPH No: 15	DATE: April 22, 2024	LATITUDE: 42.9308550528024	LONGITUDE: -78.8940623495782
DIRECTION: West	SITE LOCATION: SCAJAQUADA CREEK SITE - BUFFALO, NEW YORK		
DESCRIPTION: 2015 Maintenance Area 2. Area is in good condition.

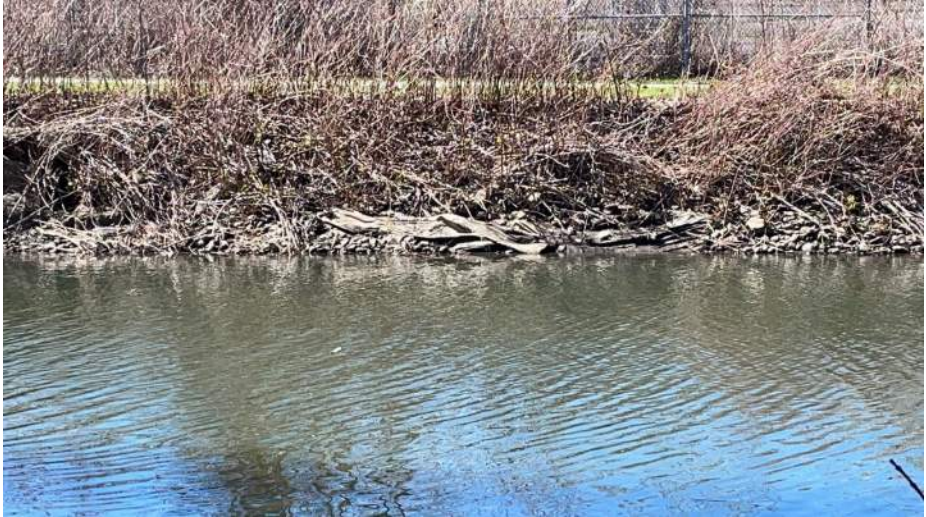
PHOTO BY: RICK FRAPPA, P.G.			
PHOTOGRAPH No: 18	DATE: April 22, 2024	LATITUDE: 42.9305911044902	LONGITUDE: -78.8948762065872
DIRECTION: West	SITE LOCATION: SCAJAQUADA CREEK SITE - BUFFALO, NEW YORK		
DESCRIPTION: Exposed geotextile downslope of splash pad from downspout. Need to add armor stone to prevent erosion into creek bank soil. Photo shows a reflection from the Expressway and trees above. No sheens are present on the surface water.

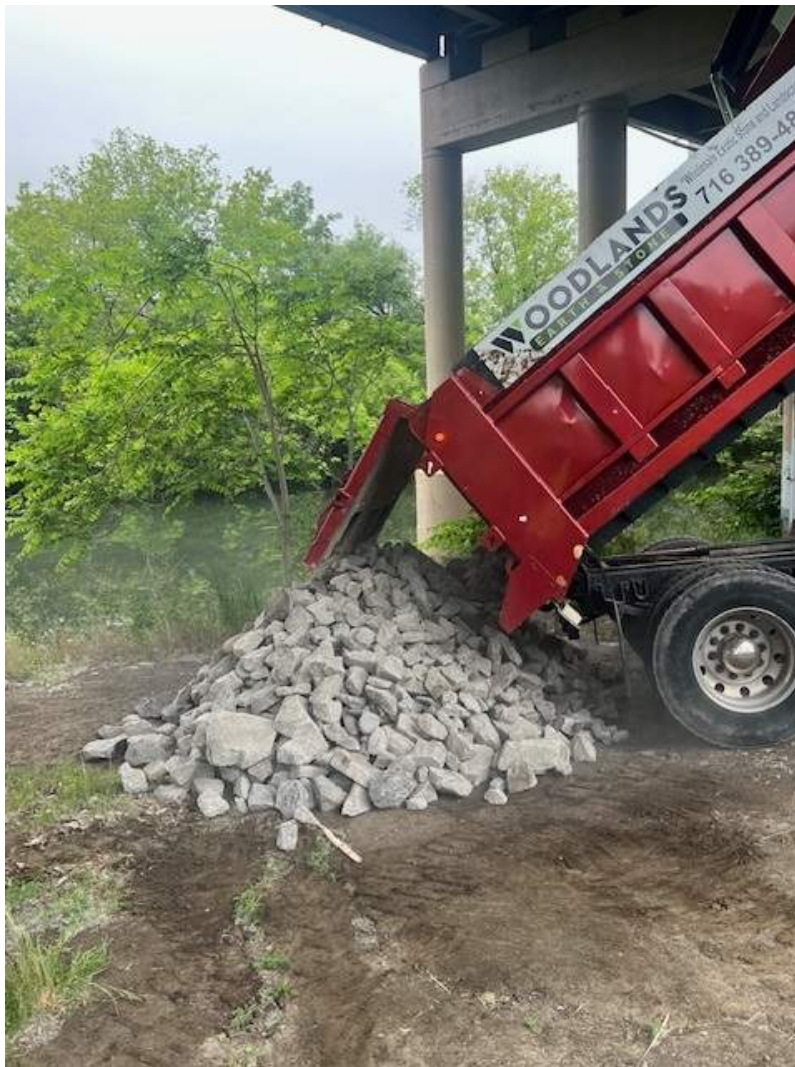
Photograph 1: Light Stone Fill being delivered to Site (Looking south).

- Sun placed Light Stone Fill (Item #620.03) material on the 2024 Cap Maintenance Areas identified during a 2024 site inspection (see Figure 1). The material was placed using a tracked skid steer machine (see Photographs 1 through 4). Approximately 40-tons of material was used to complete the Cap repairs.

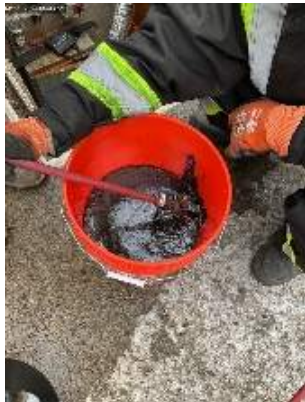
<p>Photograph 2: Discharge from north vault.</p>

09:04 AM	Pumping ~2 GPM. Consistency changed to ~20% DNAPL and ~80% water.

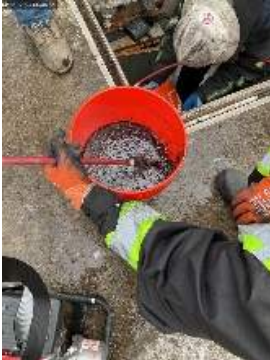
<p>Photograph 3: Discharge from north vault.</p>
09:09 AM	Pumping ~3 GPM, discharge silty, light brown with moderate sheen present.

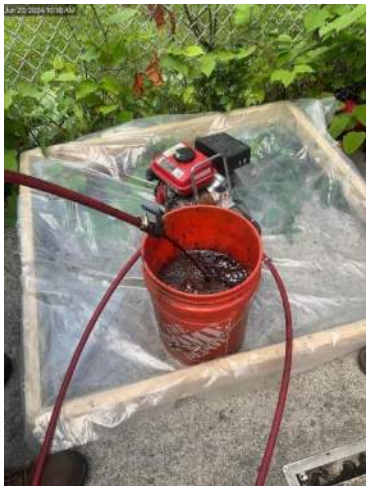
<p>Photograph 5: Discharge from North vault.</p>

<p>10:23 AM</p>	<p>Flow rate check: 3 gallons/min. Strong coal tar odor, less DNAPL present approximately ~5 % Estimate a total of approximately 3 gallons DNAPL removed during enhanced recovery testing.</p>

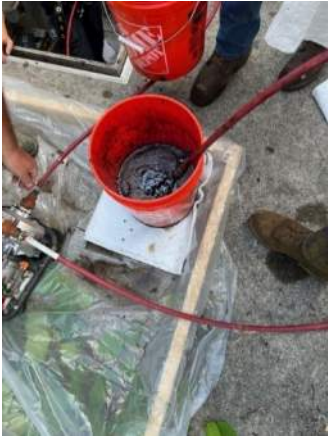
<p>Photograph 5: Discharge from north vault.</p>
0950	<p>Pumping Rate Check:</p> <p>Pumping rate of ~3 GPM, Silty, brown, heavy sheen, strong coal tar odor present, ~<5% DNAPL.</p>	
1000	<p>Pumping Rate Check:</p> <p>Pumping rate of ~3 GPM, silty, brown, heavy sheen, strong coal tar odor present, ~<5% DNAPL.</p>

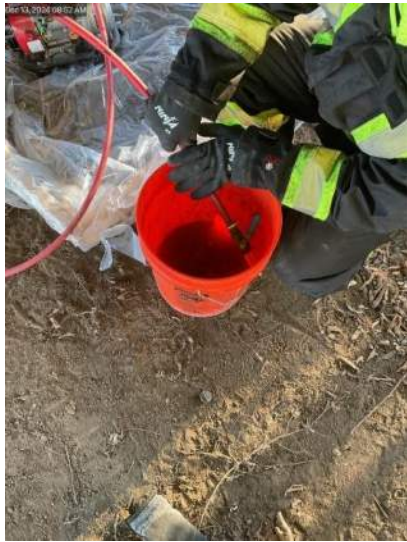
<p>Photograph 2: Discharge at South Vault</p>
0856	Flow rate test: ~3 gallons/min. Silty, clear water with no NAPL blebs. Hydrogen sulfide odor and light coal tar odor.	
0925	Flow rate test: ~3 gallons/minute. Light sheen, clear no NAPL blebs. Hydrogen sulfide odor and light coal tar odor.	
0939	Flow rate test: ~2.5 gallons/minute. Light sheen, clear no NAPL blebs. Hydrogen sulfide odor and light coal tar odor.

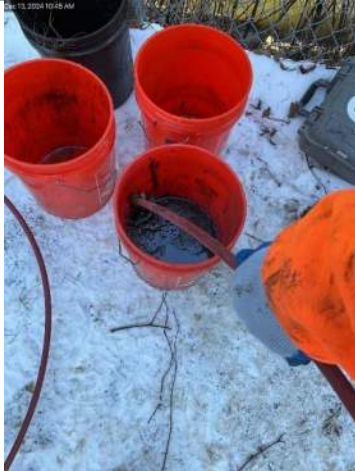
1042	Begin purging with trash pump at North Vault. Black, heavy sheen, strong coal tar odor. Approximately half DNAPL and half water.

<p>Photograph 3: Discharge from north vault.</p>

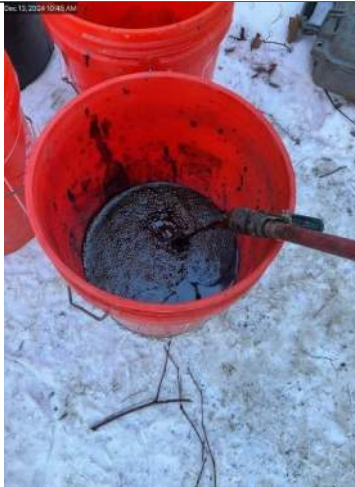
<p>Photograph 4: Discharge from north vault.</p>
1049	Flow rate test: ~3.25 gallons/ minute. Black, heavy sheen, strong coal tar odor. Amount of DNAPL steadily decreasing.	
1113	Flow rate test: 3.5 gallons/minutes. Clear, heavy sheen, strong coal tar odor. DNAPL no longer present in the purge water.

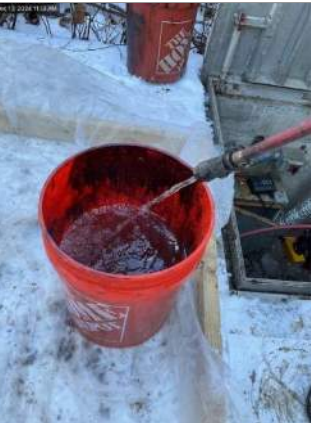
<p>Photograph 4: Discharge from north vault.</p>
