## **Site Management Periodic Review Report (2025) Site No. 915141B**

NFG - Iroquois Gas/Westwood Pharmaceutical Riparian Site,  
Buffalo, New York

January 2026

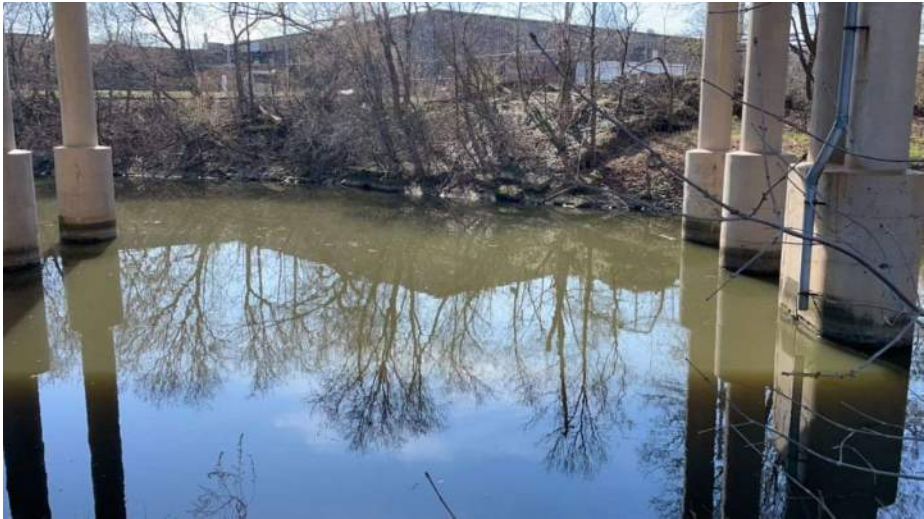
| <b>PHOTOGRAPH No: 7</b> | <b>DATE:</b><br>April 24, 2025 | <b>LATITUDE:</b><br>42.93124498513206 | <b>LONGITUDE:</b><br>-78.89435073210217 |

| <b>DESCRIPTION:</b><br><br>East bank view | | | |

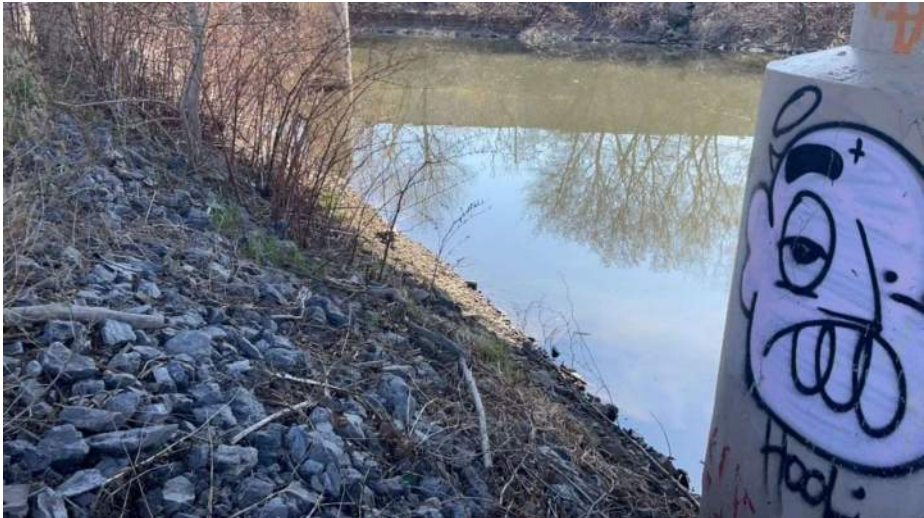
| <b>PHOTOGRAPH No: 8</b> | <b>DATE:</b><br>April 24, 2025 | <b>LATITUDE:</b><br>42.93131701869014 | <b>LONGITUDE:</b><br>-78.89425540905096 |

| <b>DESCRIPTION:</b><br><br>West Bank | | | |

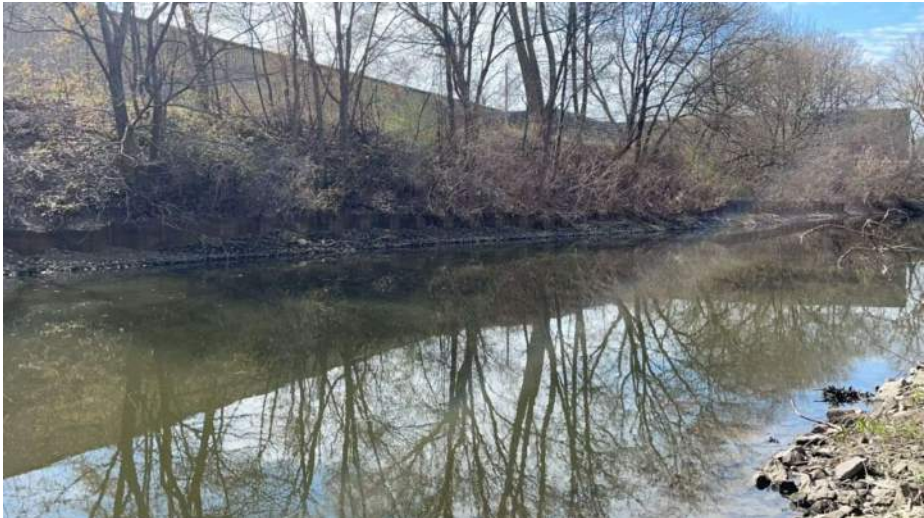
| <b>PHOTOGRAPH No: 12</b> | <b>DATE:</b><br>April 24, 2025 | <b>LATITUDE:</b><br>42.93180788779919 | <b>LONGITUDE:</b><br>-78.89316354754241 |

| <b>DESCRIPTION:</b><br><br>Shherpile | | | |

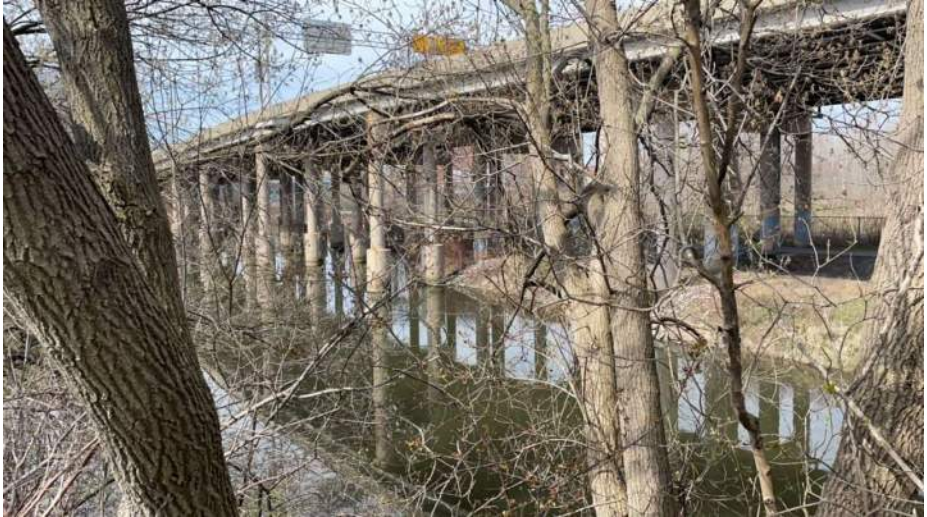
| <b>PHOTOGRAPH No: 17</b> | <b>DATE:</b><br>April 24, 2025 | <b>LATITUDE:</b><br>42.93140716421917 | <b>LONGITUDE:</b><br>-78.8933042473397 |

| <b>DESCRIPTION:</b><br><br>Creek viewed | | | |

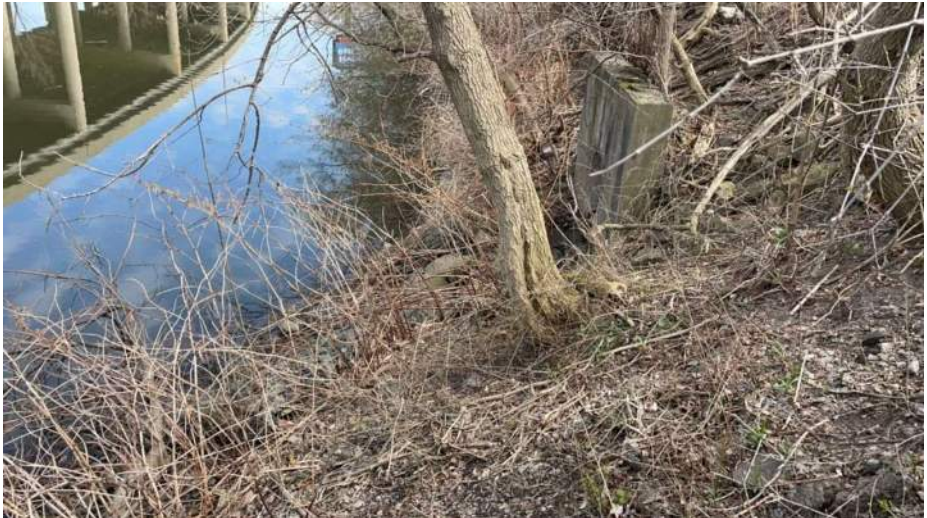
| <b>PHOTOGRAPH No: OUTFALL</b> | <b>DATE:</b><br>April 24, 2025 | <b>LATITUDE:</b><br>42.9310633569585 | <b>LONGITUDE:</b><br>-78.89359558972006 |

| <b>DESCRIPTION:</b><br><br>Outfall | | | |
