NYSDEC SITE NUMBER: 9-15-151
FORMER GE APPARATUS SERVICE CENTER
318 URBAN STREET
BUFFALO, NEW YORK

FINAL CONSTRUCTION CERTIFICATION REPORT

MAY 2012

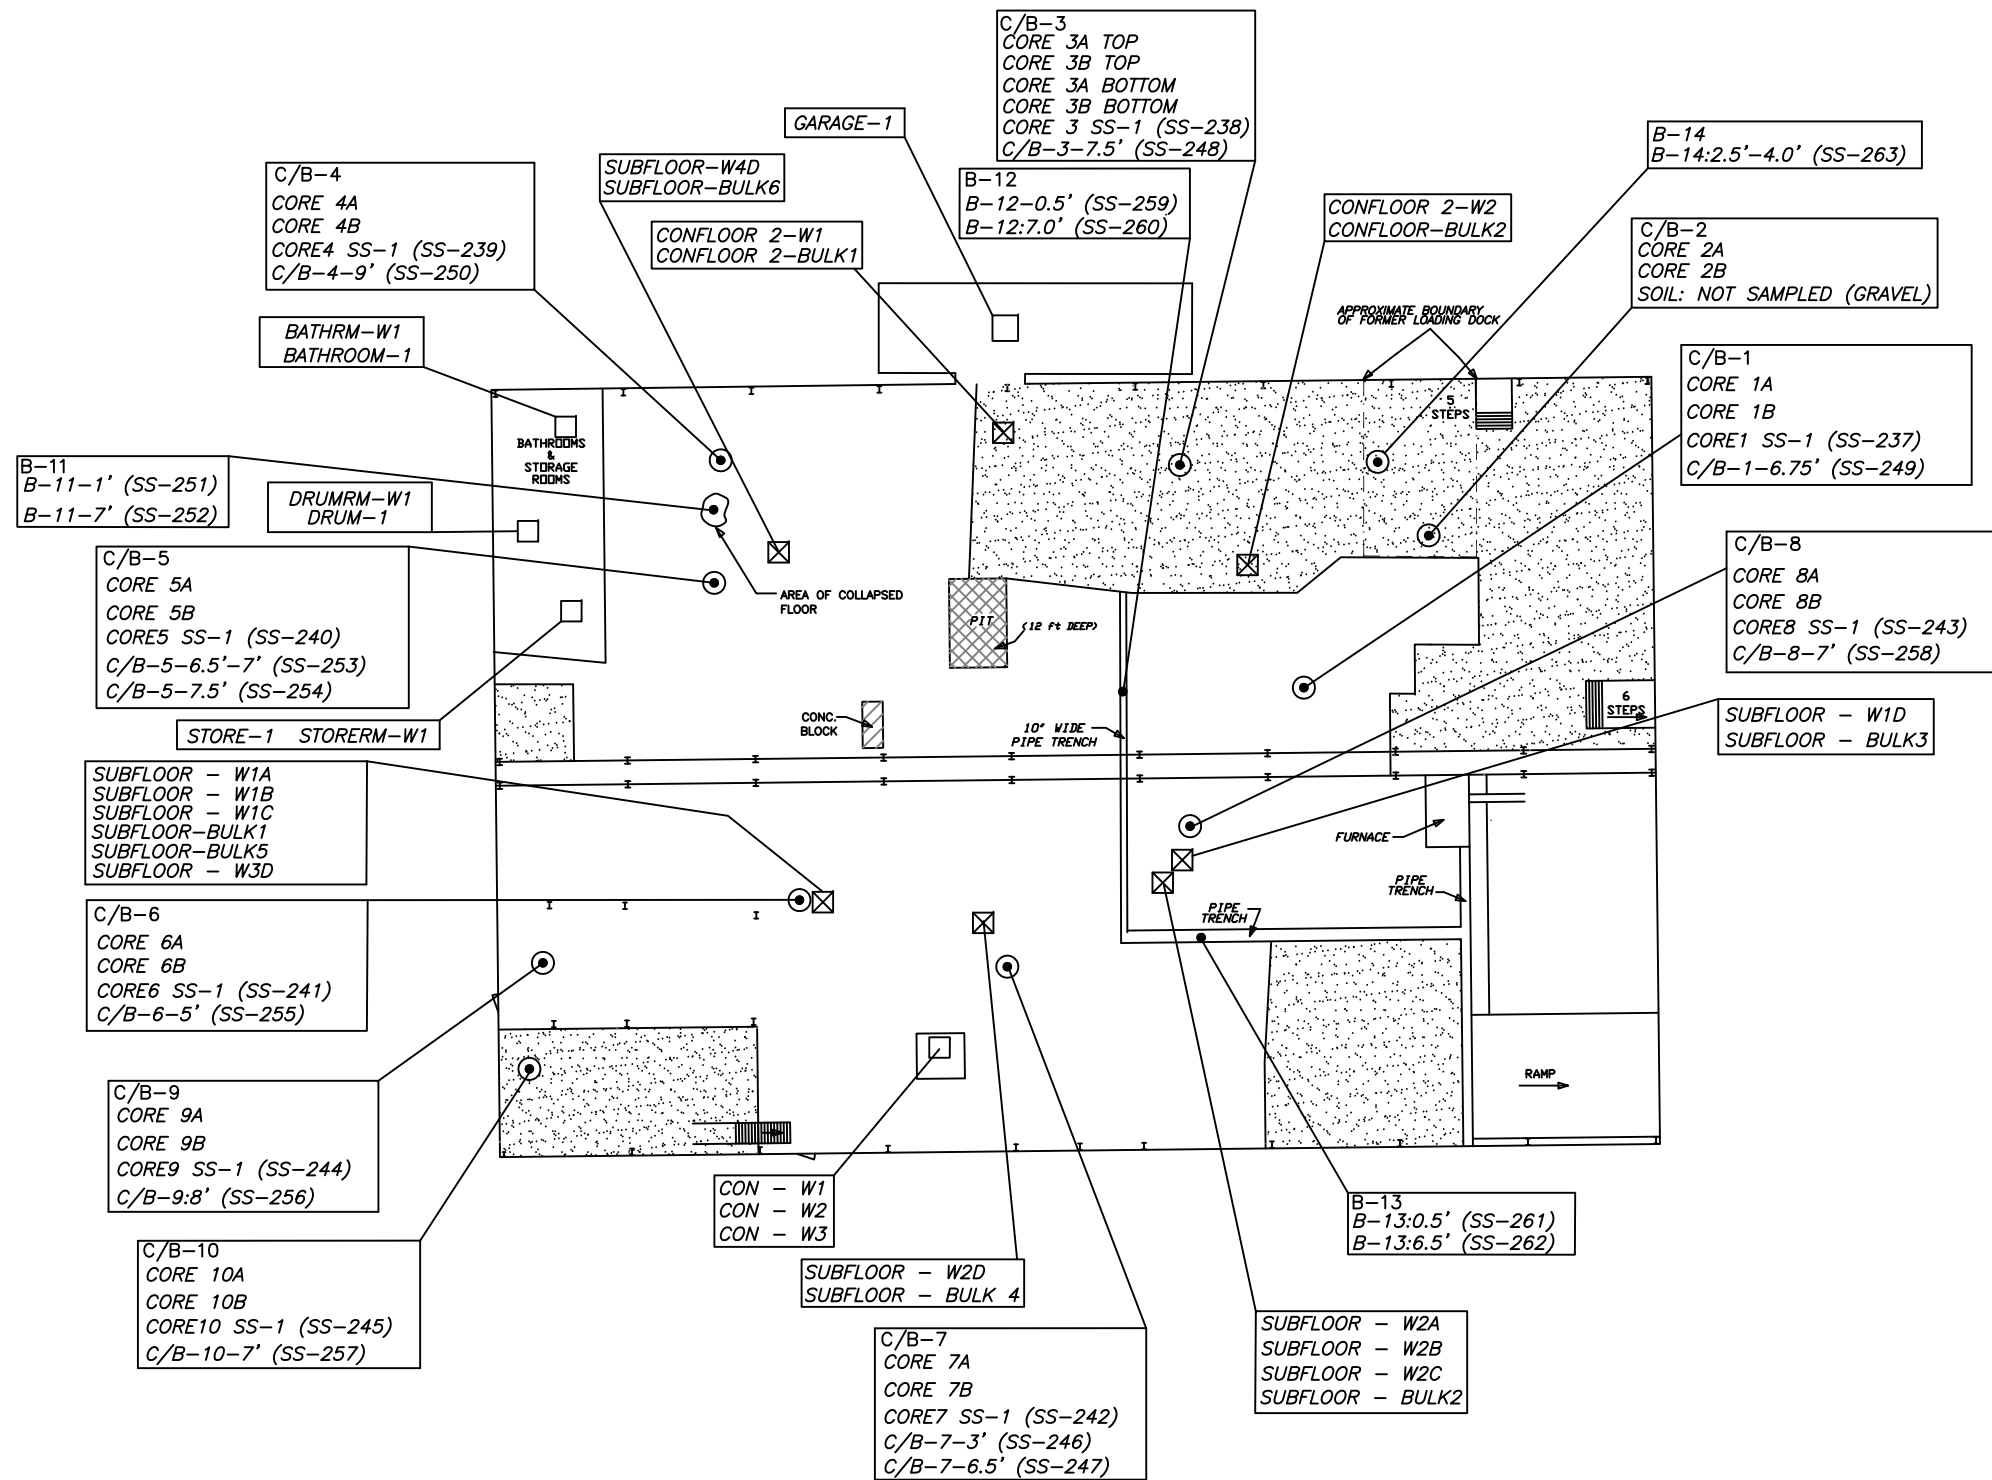
FIGURE 5

Note: Subfloor and core sample locations are shown on Figure 5.
Wall sample location is not shown on figures.
All samples analyzed by EPA Method 8080.
Depth measured from surface of concrete floor or subfloor.
Cleanup standard for PCBs in concrete chip samples is 50 mg/kg.

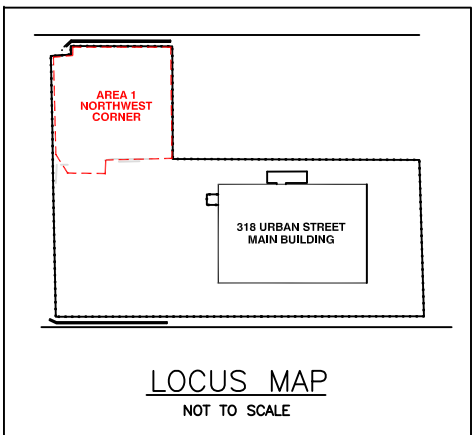
Title: AREA 1 PLAN - FINAL PCB CONFIRMATION SAMPLES	
Location: 318 URBAN STREET BUFFALO, NEW YORK	
Client: 	GENERAL ELECTRIC COMPANY
	Drafter: KP
URS Corporation 3 Corporate Drive, Suite 203 Clifton Park, New York 12065	Date: April 2012
Drg. Size: 11 x 17	Job No.: 38394784.30000
FIGURE 8

Notes: Sample locations that document remedial objectives were achieved are shown on Figure 8. Soils represented by samples that failed to meet the remedial objectives were removed via additional excavation, thus those sample locations are not shown on the figure.

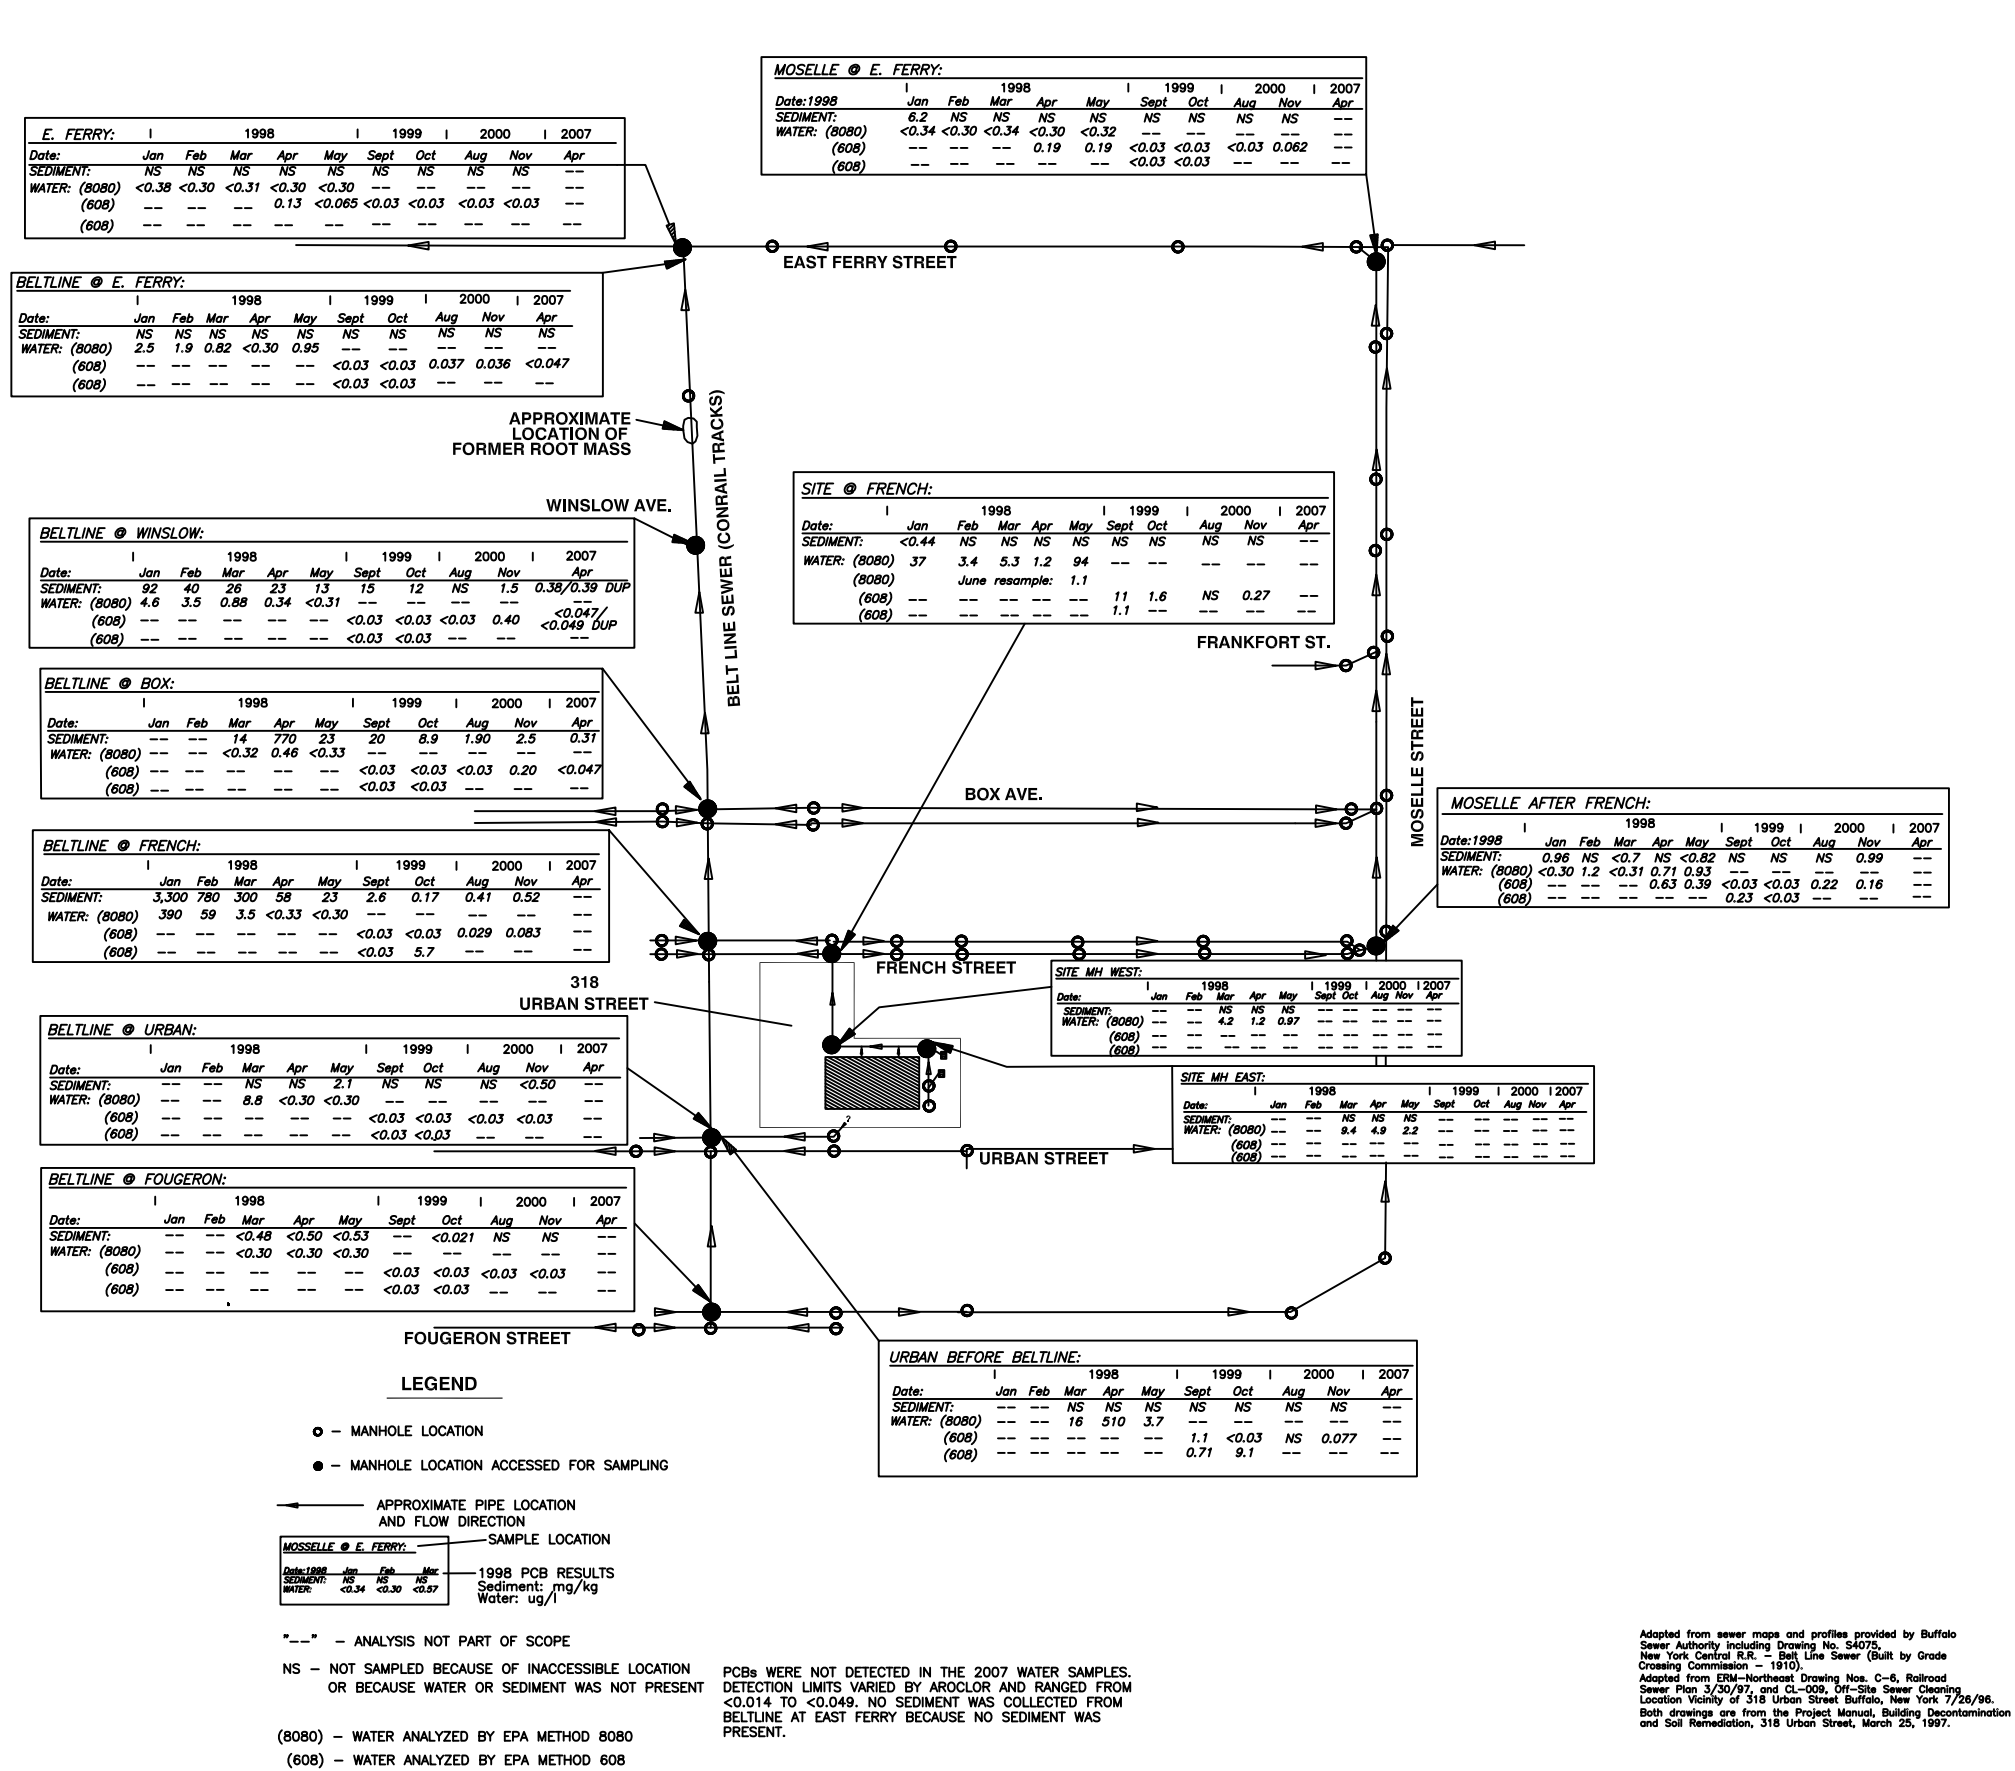
FIGURE 13

Figure 13 presents a summary of the analytical results for PCB analyses of the water and sediment samples collected during the seven sampling events (January through May 1998 and September and October 1999). As of the last monitoring event in October 1999, PCB concentrations in the water at all monitoring locations were less than the Buffalo Sewer Authority (BSA) 2 µg/L slug discharge limit.

Figure 13 presents a summary of the analytical results for PCB analyses of the water and sediment samples collected during nine sampling events conducted between January 1998 and November 2000. Based on discussions with the NYSDEC and BSA, the BSA sewer discharge limit of 0.3 µg/L was used as a comparison value for PCBs in water. Based on the August 2000 monitoring event, PCB concentrations in the water at all monitoring locations were less than the Buffalo Sewer Authority (BSA) 0.3 µg/L sewer discharge limit. For the November 2000 monitoring event, only one sample (Beltline @ Windslow) was found to contain a PCB concentration (0.40 µg/L) that slightly exceeded the BSA's sewer discharge limit.

Figure 13 presents a summary of the analytical results for PCB analyses of the water and sediment samples collected between January 1998 and April 2007. The analytical results for the water samples collected in April 2007 indicated that PCBs were not present at concentrations above the laboratory detection limits. The laboratory detection limits varied by aroclor, and ranged from 0.014 to 0.049 µg/L. Based on the results of the April 2007 sediment samples, low concentrations of PCBs (0.31 and 0.39 mg/kg) were detected. However, the concentrations were below 1 mg/kg, which is generally considered to be protective of human health and the environment.
