Re: Periodic Review Report and IC/EC Certification Submittal
318 Urban Street Site
Buffalo, New York
NYSDEC Site Number: 915151

318 Urban Street Site

Periodic Review Report For November 2013 through October 2015

NYSDEC Site Number: 9-15-151

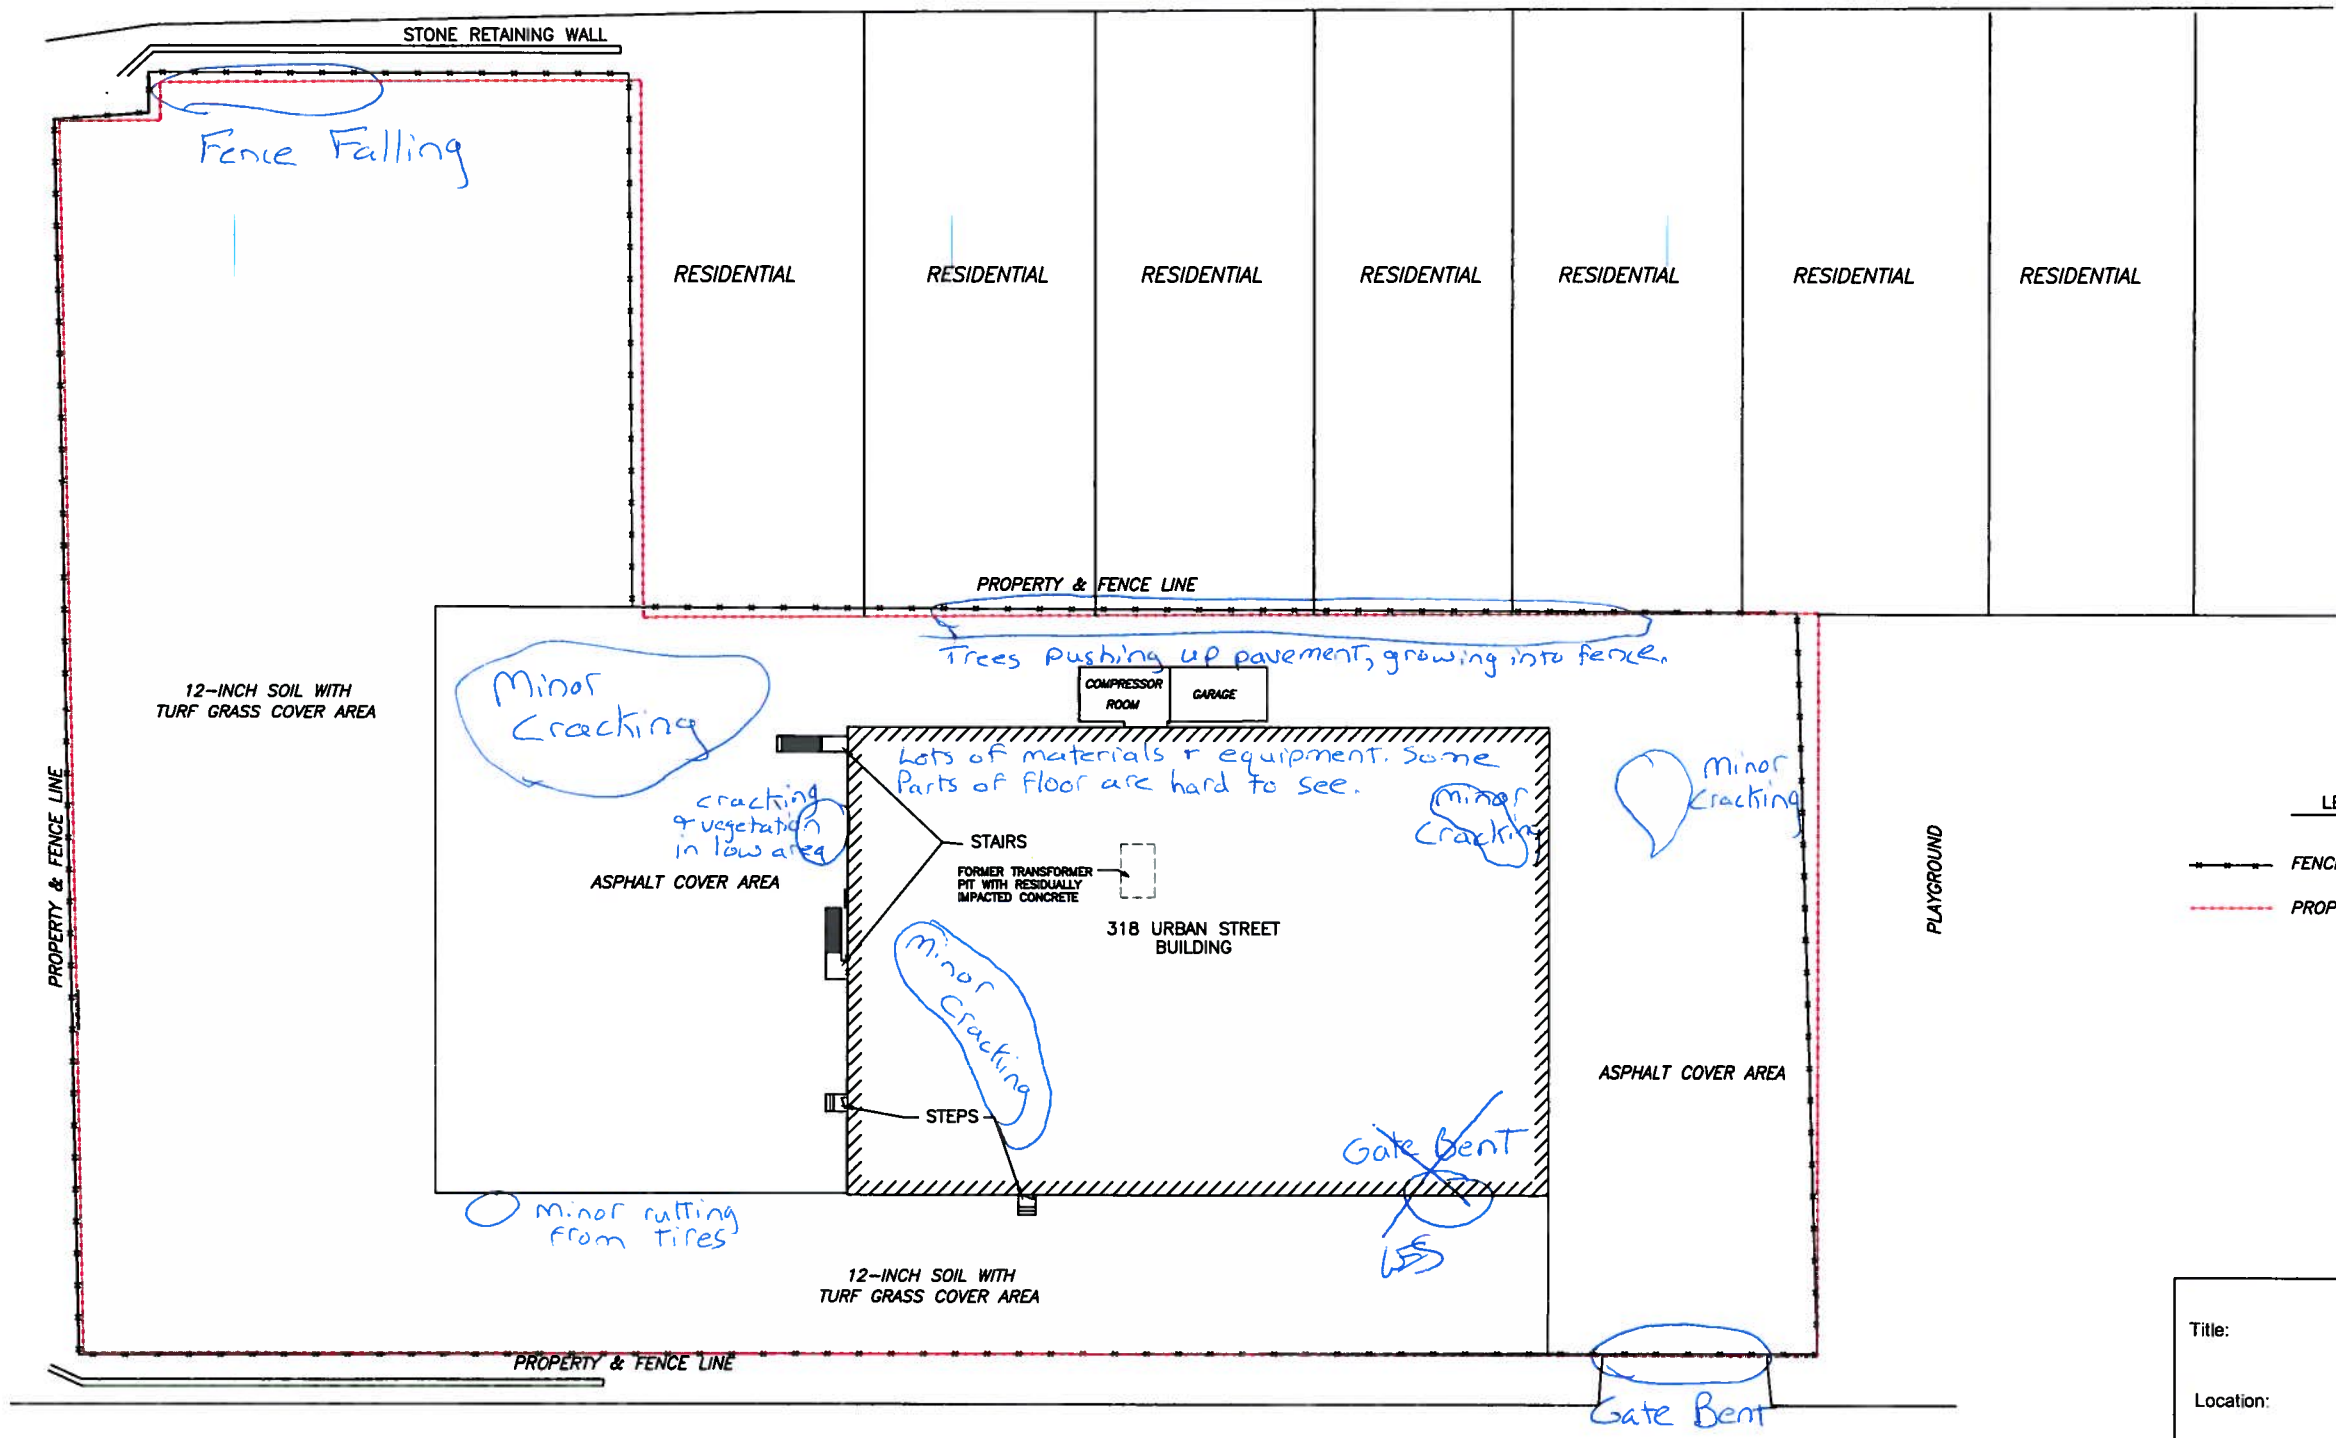
Title: SITE MAP

- Minor cracks + heaving in exterior pavement. Mr. Sweeney says they may put a sealing coat on next summer.
- Fence and gate intact, but could use some maintenance. Some sections bent and/or leaning.

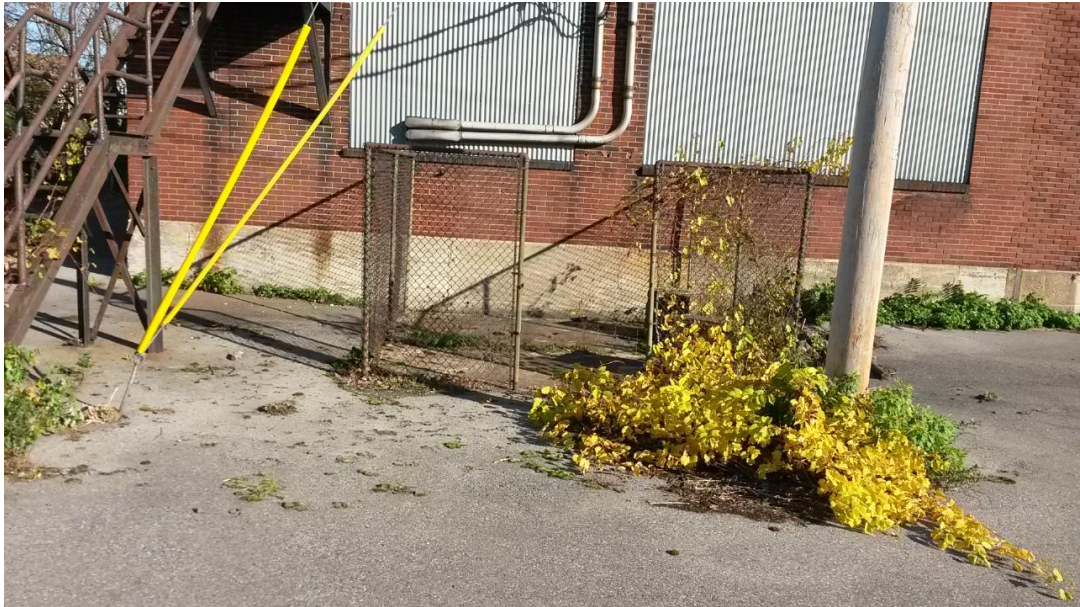
PHOTO NO: 11 Date: 10/30/15 Direction: North Description: View of pavement on the western side of building.	 
PHOTO NO: 12 Date: 10/30/15 Direction: East Description: View of the pavement condition near the northwest building corner. Minor cracking with vegetation growth.
