**Evaluation of the Former GM – Saginaw Facility Investigations**

**Niagara Mohawk Power Corporation  
300 Erie Boulevard West  
Syracuse, New York 13202  
Kensington Terminal Station, Buffalo, New York**

**Geomatrix Consultants Inc.  
336 Harris Hill Road, Ste. 100  
Williamsville, NY 14221  
(716) 565-0624**

**Project B4295  
December 22, 1997**

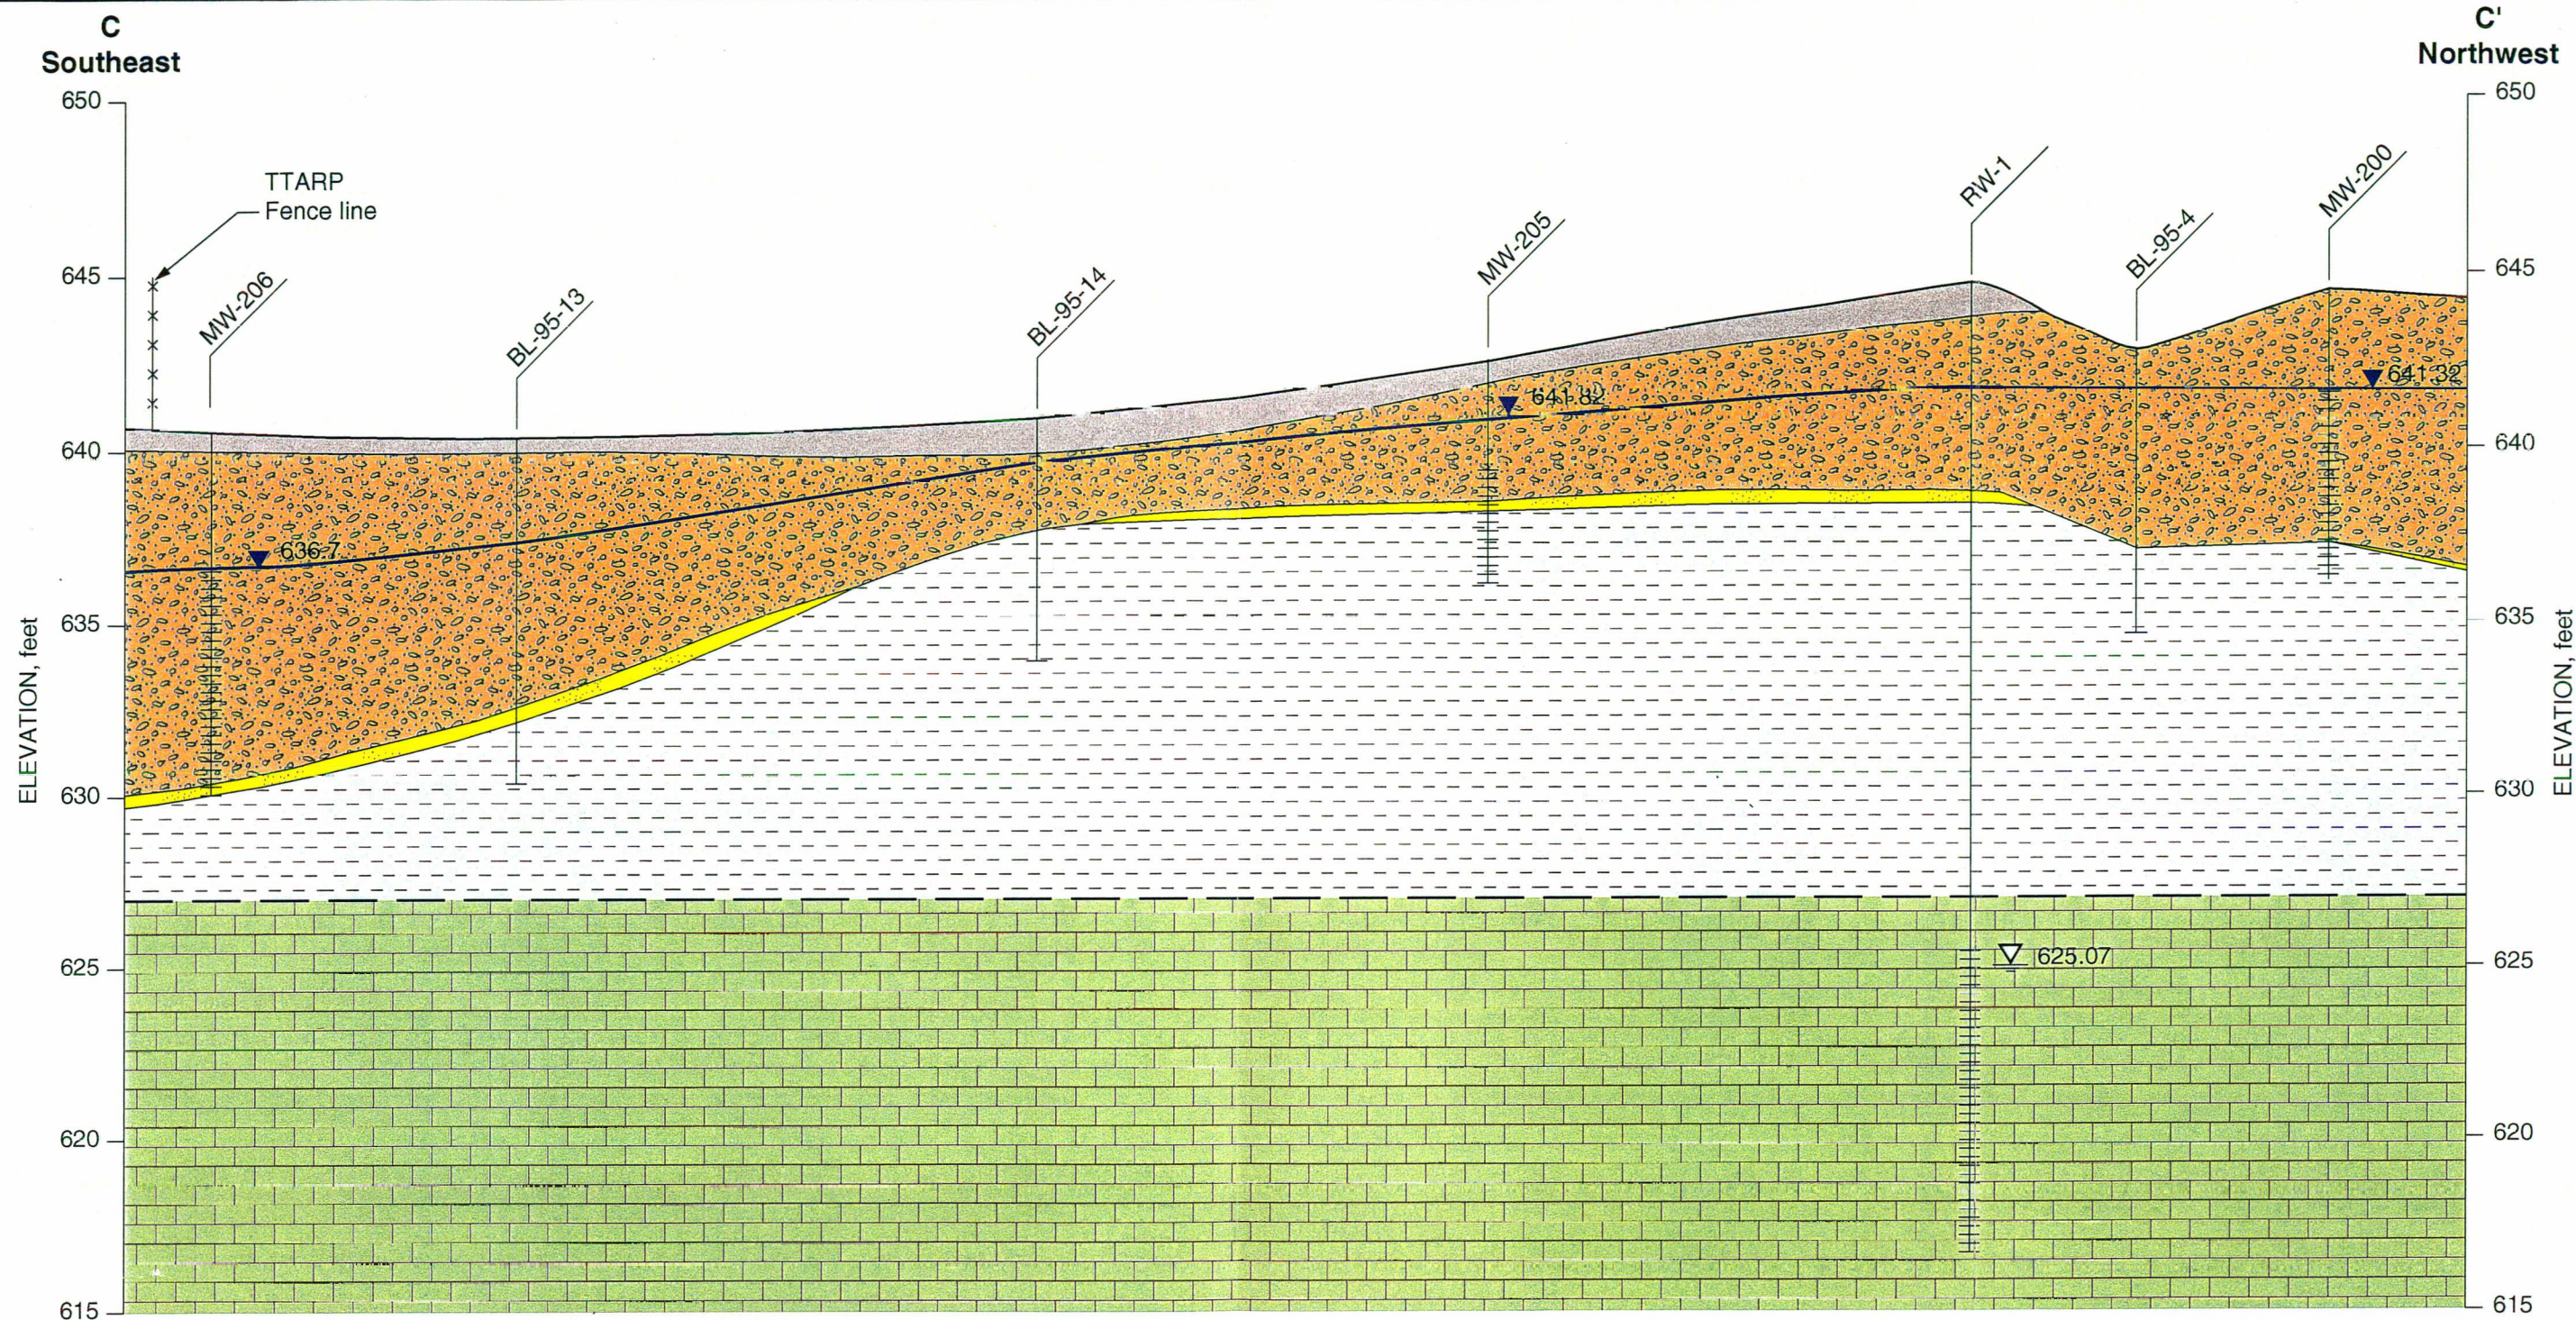
Cross-sectional groundwater flow modeling is presented in Figure 5 along section line C-C' (from the source area to the southeast in the direction of NMPC property). The cross-sectional flow model presents groundwater flow directions and time of travel estimates in saturated soil and bedrock. As shown in Figure 5, groundwater flow velocities (approximately 50 to 60 ft/yr) are moderate through the fill in the direction of the Niagara Mohawk Property. Groundwater from the PCB source area could have reached the vicinity of the Niagara Mohawk property in less than 10 years. Spillage of PCBs occurred during the early 1970's (EMCON Site Investigation Report, 1997), more than 25 years ago.

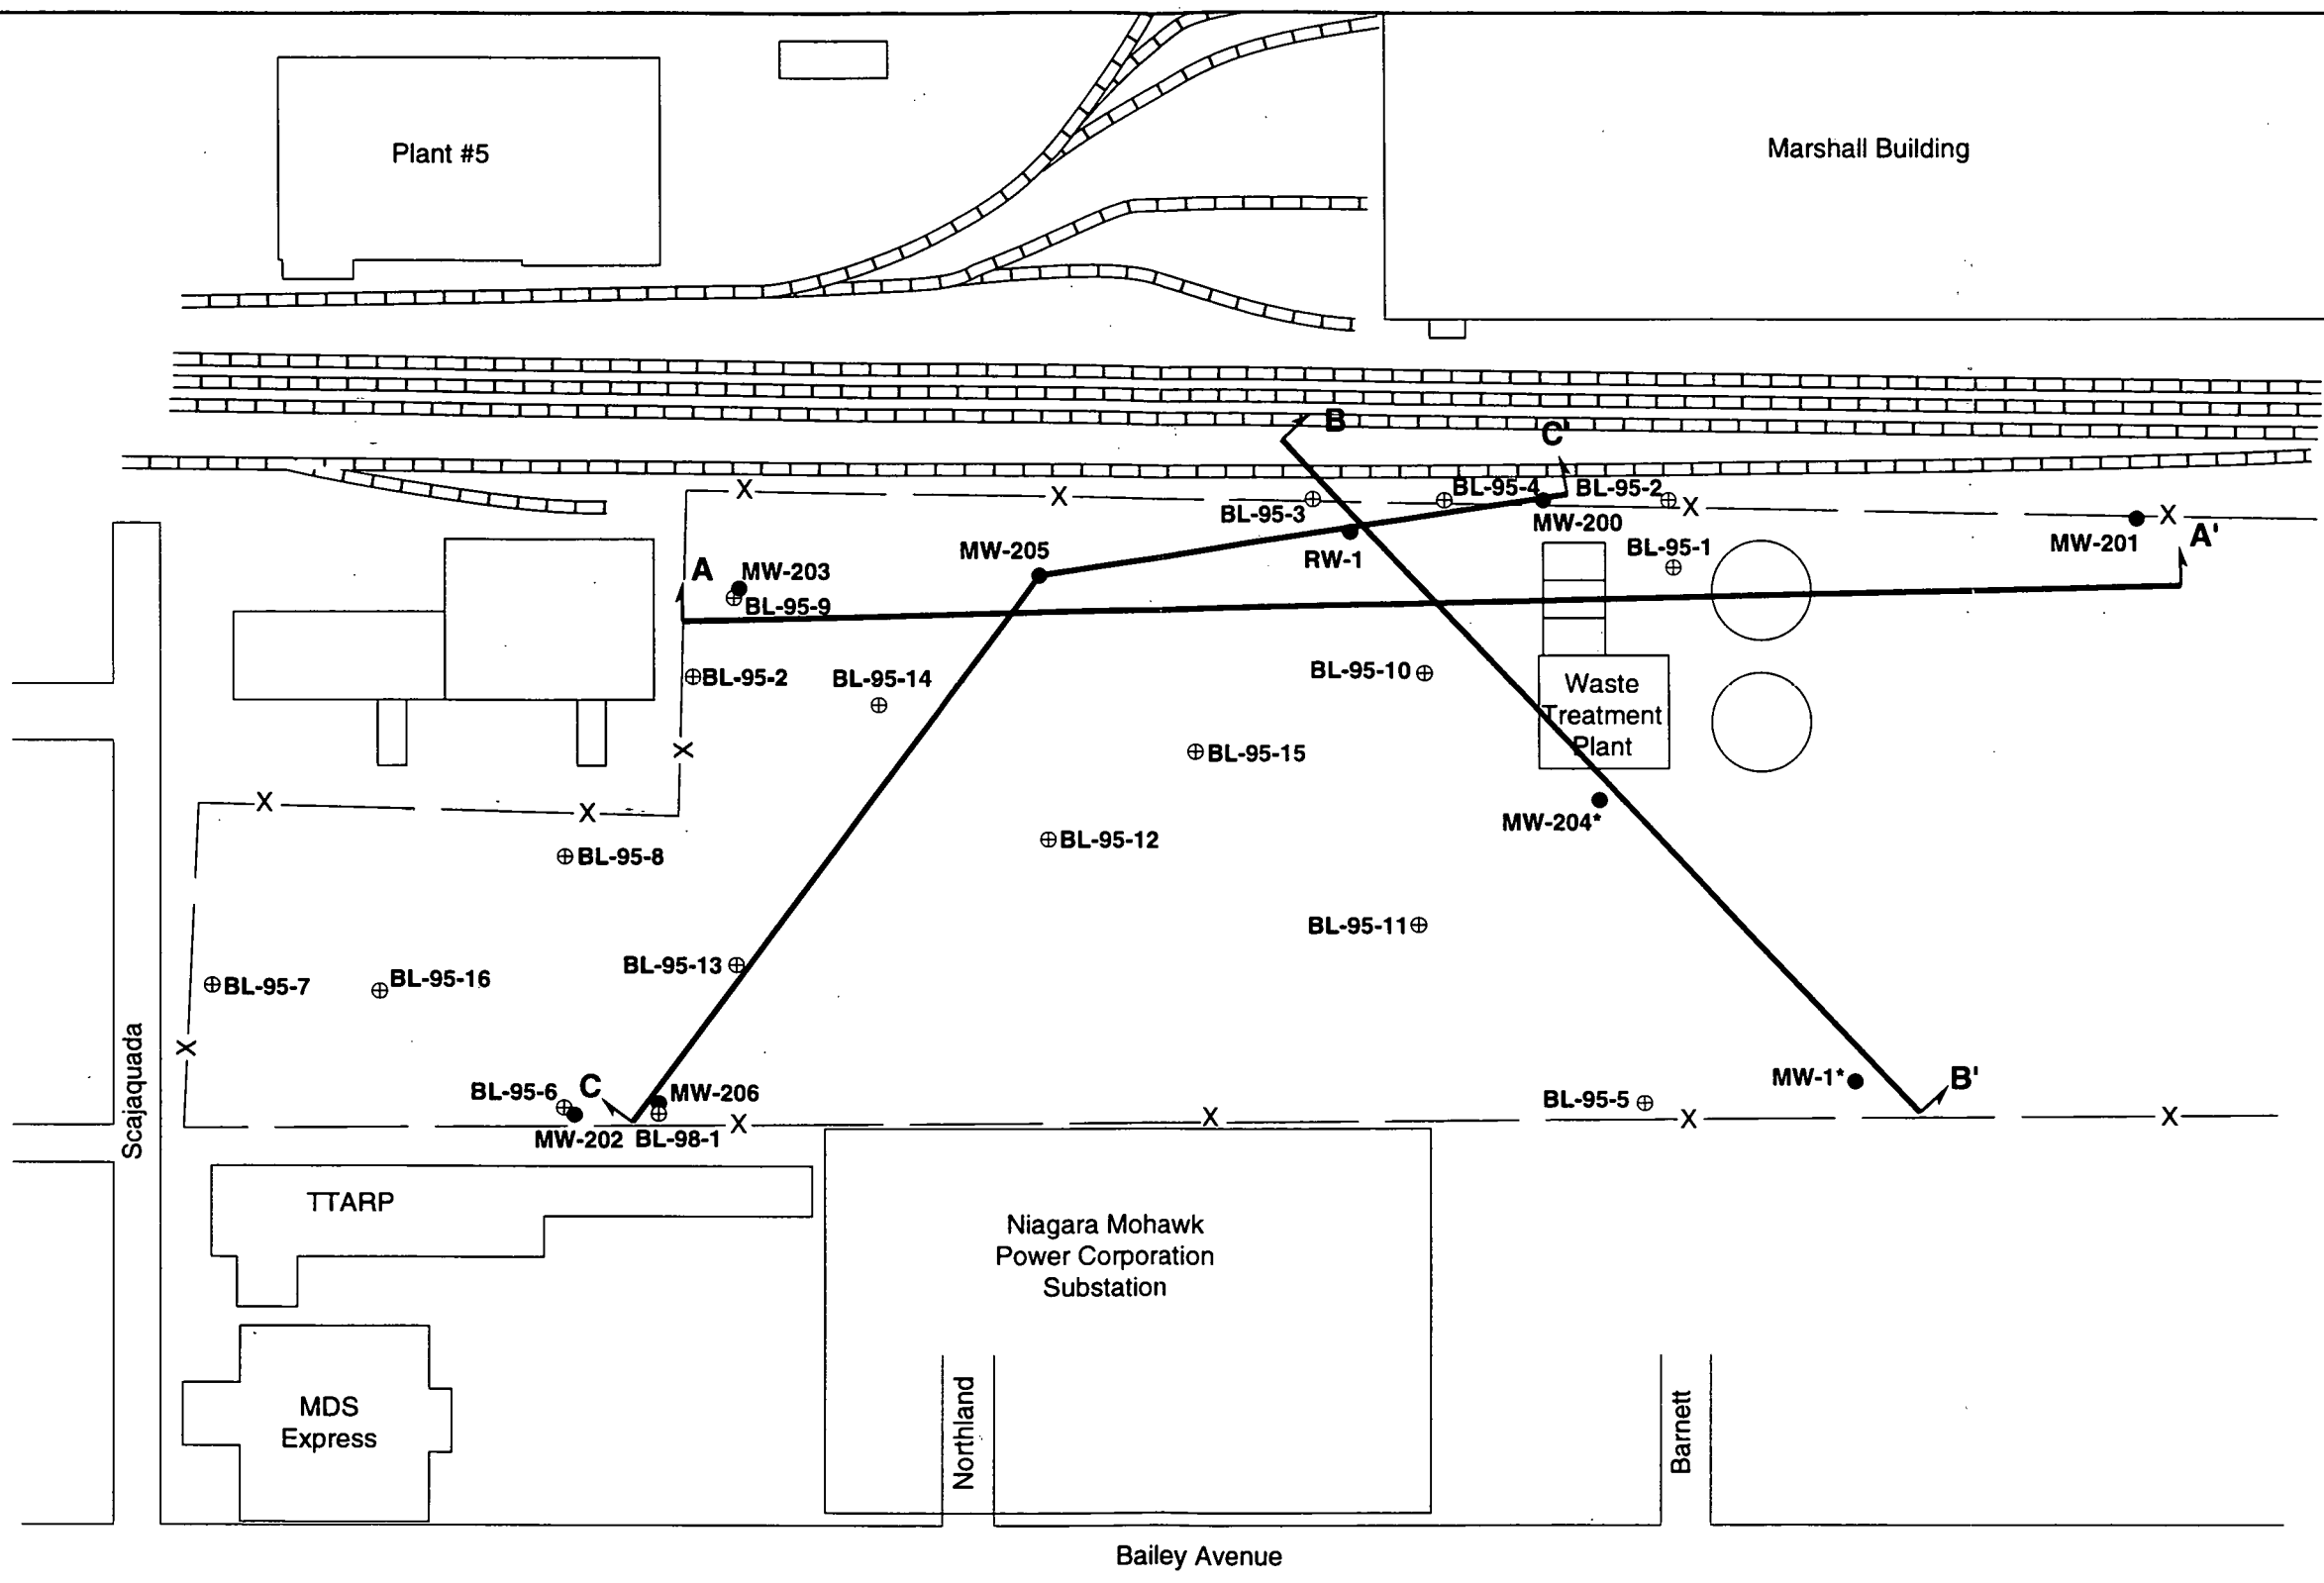
Figure  
2

These stratigraphic units are presented in cross-section using the same section lines drawn by EMCON (Drawings 4 and 5 of the Site Investigation Report) on Figures 2 and 3. However, several corrections to the EMCON-prepared cross-sections were necessary to match monitoring well construction diagrams (i.e. well screen positions) and location of geologic contacts to depths reported in the borehole logs. An additional cross-section was prepared using EMCON data along section line C-C', oriented with the general direction of groundwater flow (see Figure 4). Since storm sewer depths are not presented in the EMCON report, sewers are not shown on the cross-sections. The cross-section in Figure 4 shows a clay confining unit sloping from the source area to the southeast toward the southwest corner of NMPC property.
