Re: Remedial Construction Certification Report
Saginaw-Buffalo Site, Buffalo, NY
NYSDEC Site No. 915152

**REMEDIAL CONSTRUCTION CERTIFICATION
REPORT**

SAGINAW-BUFFALO SITE

NYSDEC SITE NO. 915152

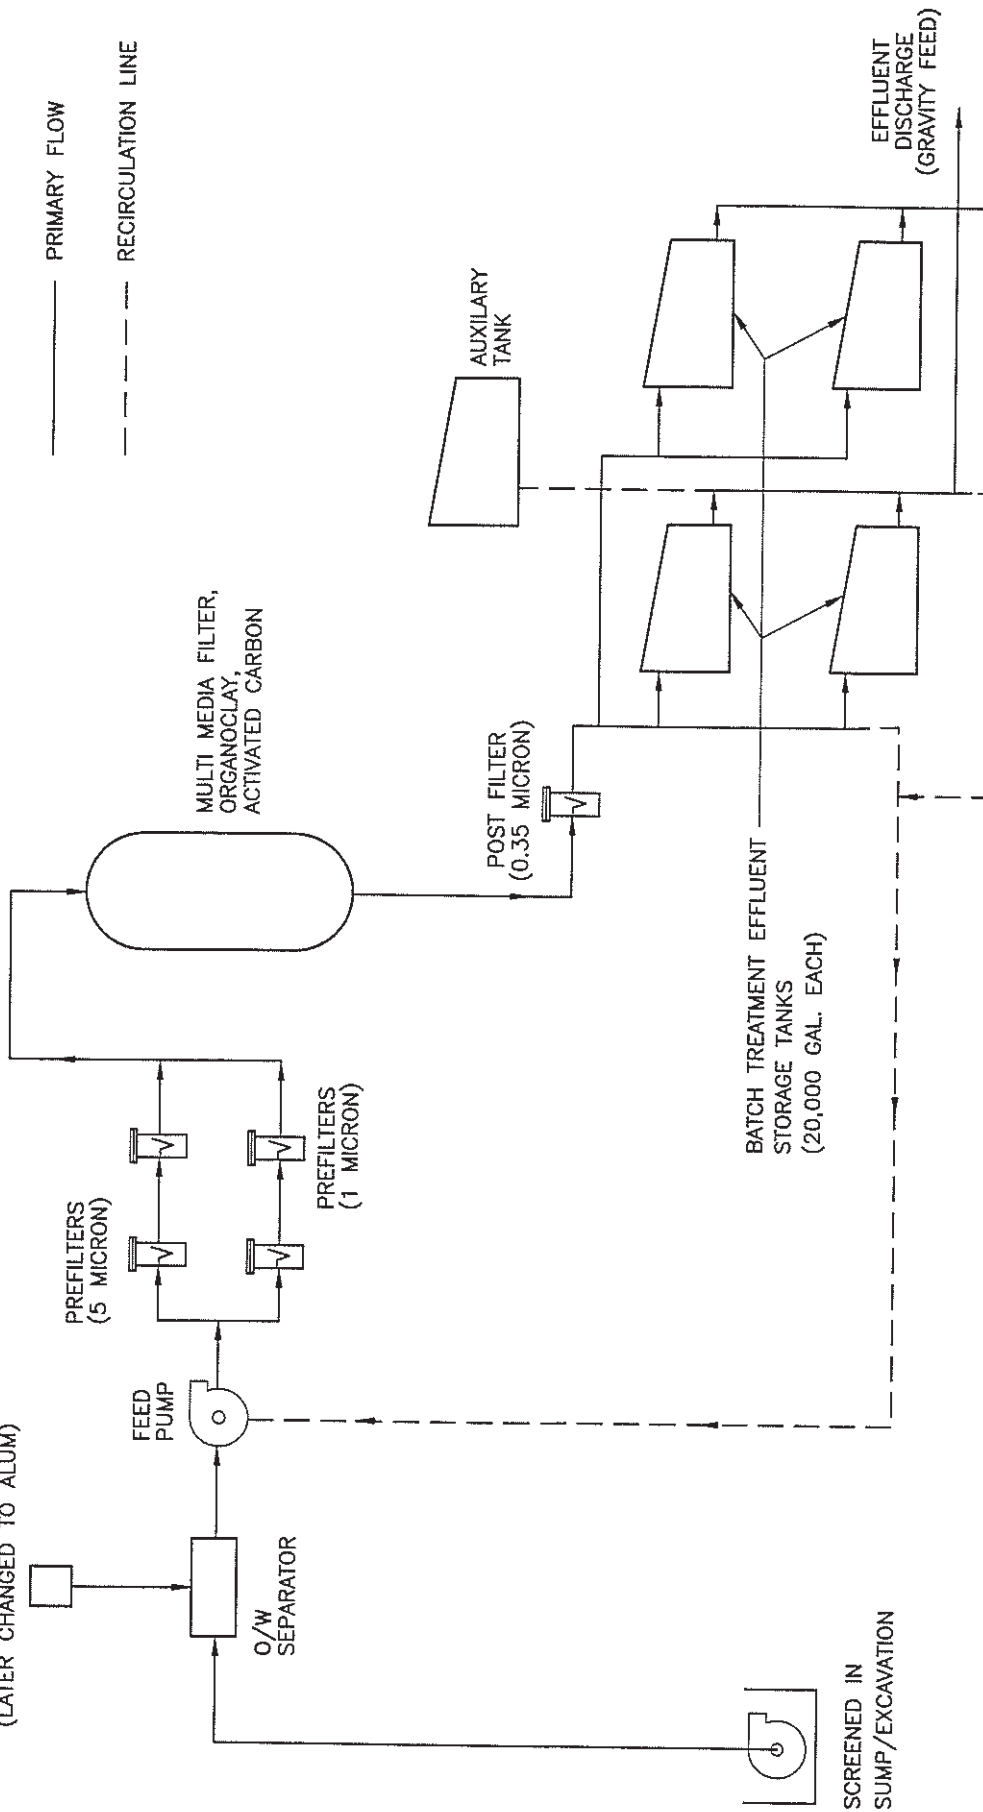
FIGURE 2
 GM CORP. SAGINAW-BUFFALO SITE
 PCB AND LEAD REMEDIATION
 BUFFALO, ERIE COUNTY, NEW YORK
 WATER TREATMENT SYSTEM FLOW DIAGRAM

The water treatment system consisted of one 20,000-gallon influent tank used for oil/water separation and precipitation of suspended solids through the addition of polyaluminum chloride solution; four bag filter housings in dual in-line configuration (two 5-micron/1-micron combinations); multi-media filter consisting of 4,000 pounds of filter sand, 2,000 pounds of modified organoclay for removal of emulsified and organic oils, and 2,000 pounds of Calgon Filtrasorb 300 carbon; and two 0.35 micron cartridge filters for removal of small particulates. Treated water was stored in one of four effluent frac tanks pending analytical results prior to discharge to the BSA sanitary sewer system. Figure 2 shows a layout of the treatment system. Replacement of the filter media and carbon was necessary once during the project due to fouling of the carbon with oil. The contractor then began using alum rather than the polyaluminum chloride to remove solids.

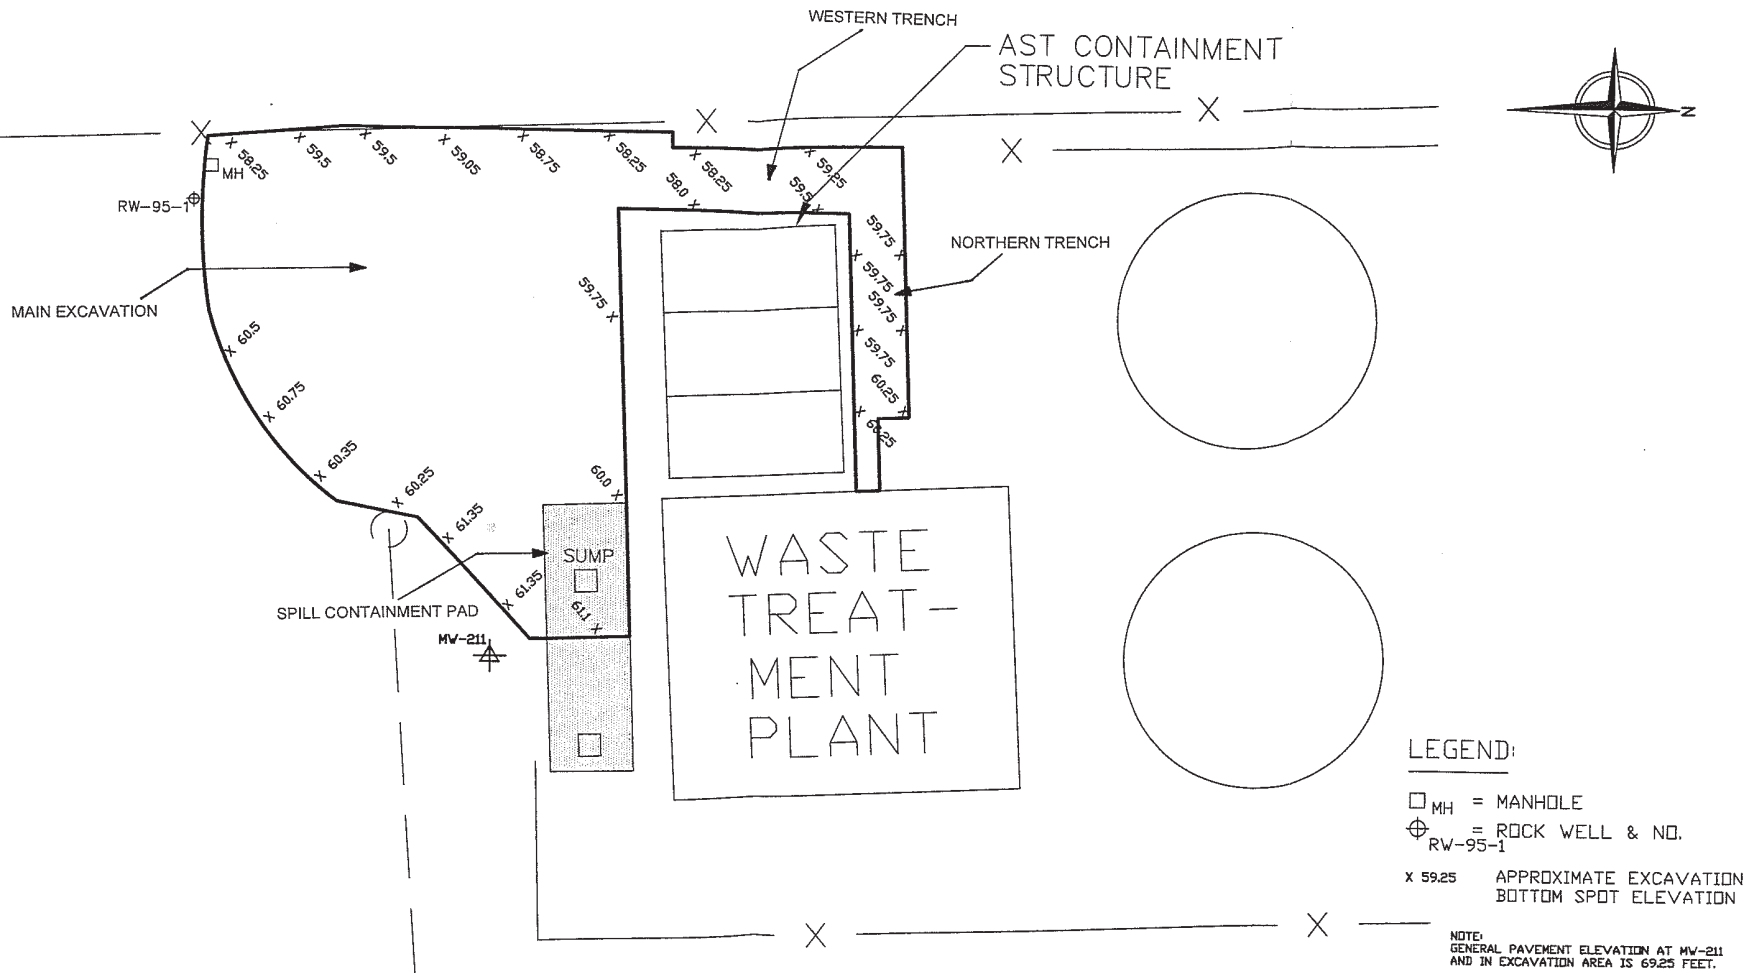
DRAWING I
GM CORP. SAGINAW-BUFFALO SITE
PCB AND LEAD REMEDIATION
BUFFALO, ERIE COUNTY, NEW YORK
LIMIT OF EXCAVATION
RECORD DRAWING

lines and concerns for undermining the foundation of the AST containment structure. Photographs of the excavation activities are provided in Appendix E.

A hard layer of slag material was encountered around the perimeter of the AST containment structure at approximately 1.5 to 2 feet below ground surface. It took repeated tries with the backhoe bucket to break through this material. There was a concern that vibrations caused by the repeated pounding would damage the walls of the AST containment structure. As a result, at several points around the perimeter of the AST containment structure, excavation was terminated 4 to 5 feet away from the containment structure walls.

Excavation activities were completed on August 20, 1998. When complete, the excavation covered approximately 11,000 square feet in area. A volume of approximately 3,388 cubic yards of impacted soils (4,012.67 tons) was removed. The material was manifested as a RCRA/TSCA waste (due to the presence of both lead and PCBs) and transported to Chemical Waste Management in Model City, New York for lead stabilization and land disposal. Table 3-2 provides a summary of the waste shipments. Copies of the hazardous waste manifests, land ban paperwork, and certificates of disposal are provided in Appendix F.

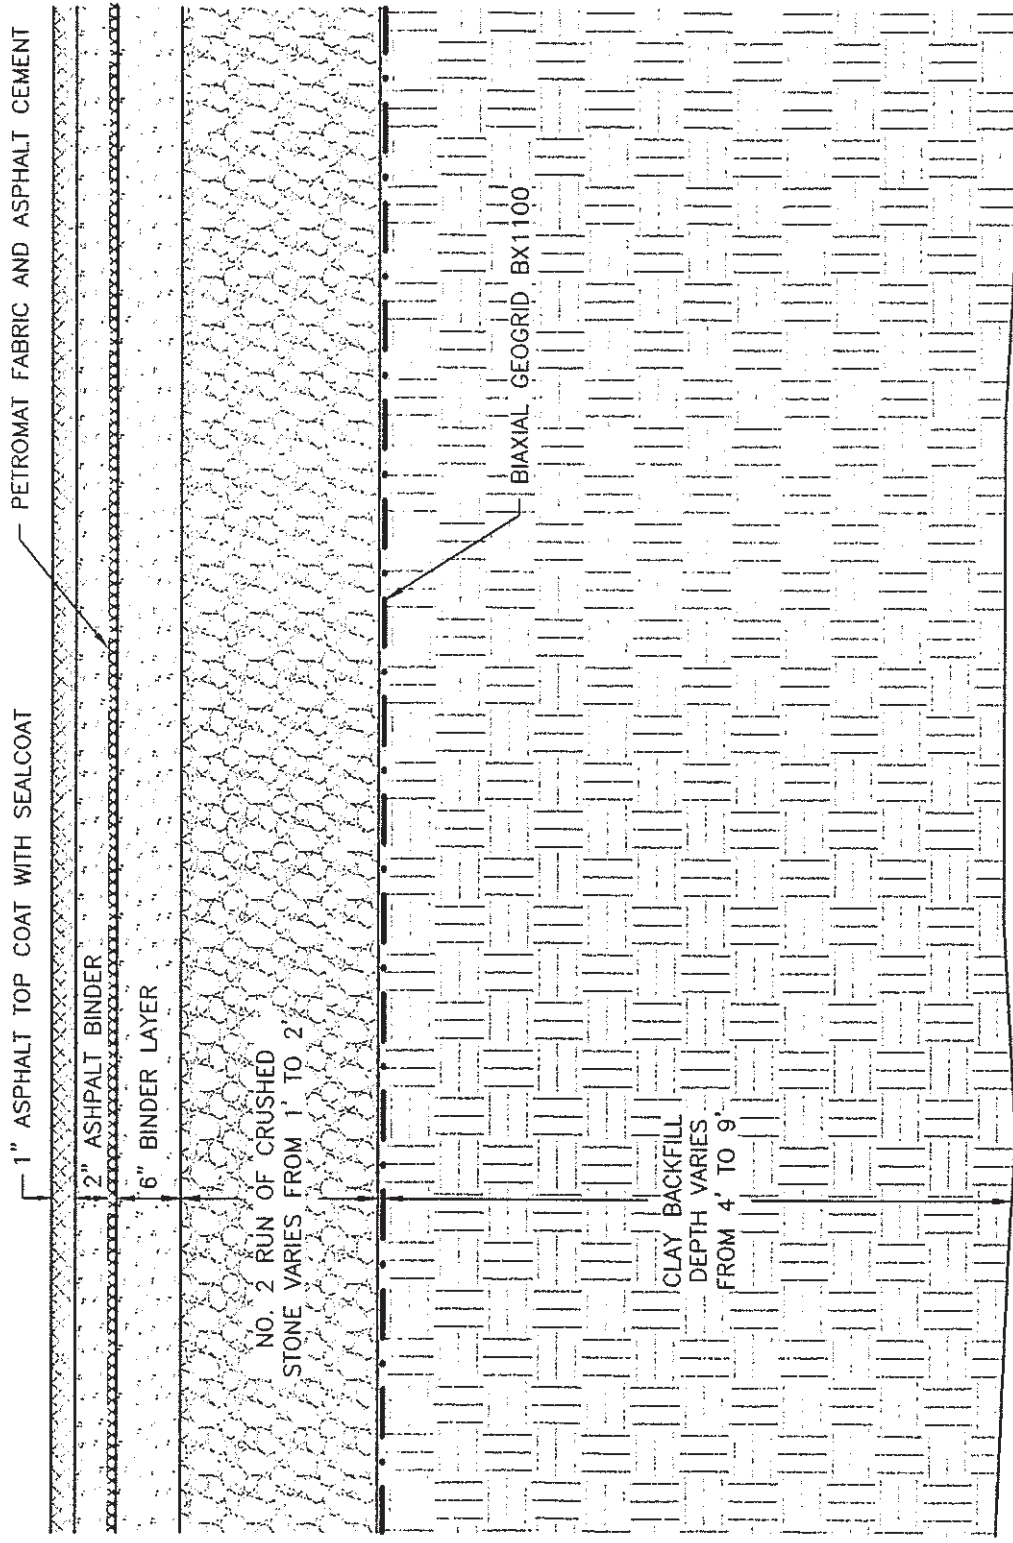
DRAWING 5
GM CORP. SAGINAW-BUFFALO SITE
PCB AND LEAD REMEDIATION
BUFFALO, ERIE COUNTY, NEW YORK
TYPICAL BACKFILL CROSS-SECTION
RECORD DRAWING

Backfill was placed in two-foot lifts and compacted to approximately 12-inches in thickness. Backfill was compacted by means of a sheep's-foot roller and large, single-drum vibratory roller to a minimum density of 85 percent of maximum dry density. A total of nine lifts were placed. Due to excessive moisture (greater than 20%), several loads of backfill were refused by Severson and returned to the supplier.

Backfill was compacted to a minimum density of 85 percent, as opposed to the target 95 percent as requested by AAM in the preconstruction meeting. This change was due to the moisture content of the clay. Efforts to reduce the water content in the backfill material brought on site were only moderately successful. Due to the lower minimum clay density, it was determined that a geogrid would be placed above the clay, followed by approximately 1.5 feet of compacted stone. This approach sufficiently stabilized the material to provide a suitable base for the parking lot.

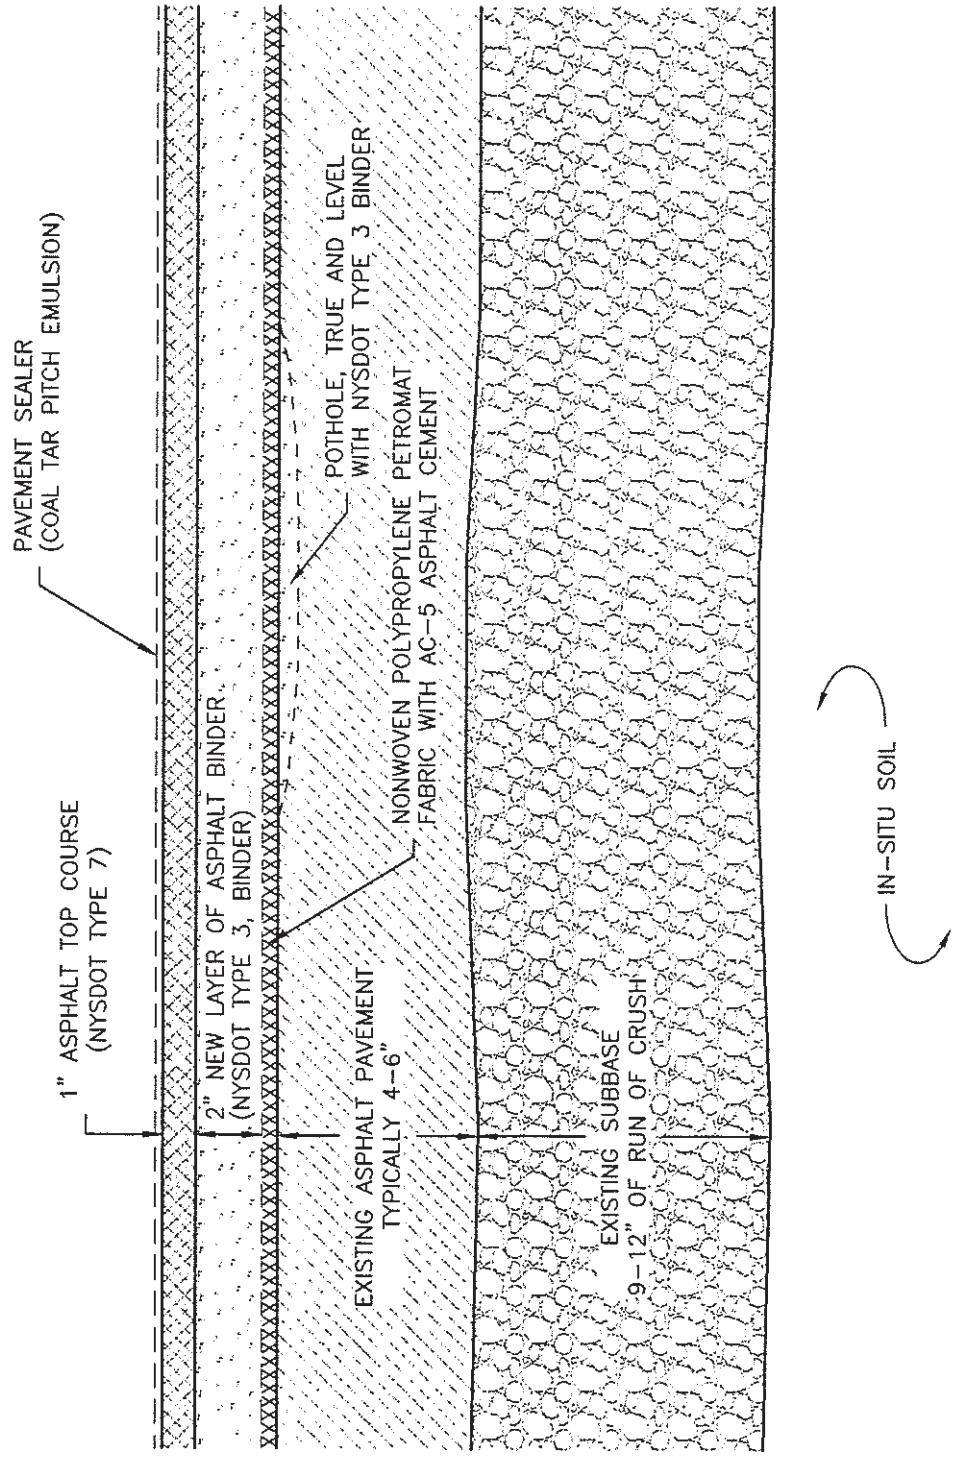
DRAWING 8
GM CORP. SAGINAW-BUFFALO SITE
PCB AND LEAD REMEDIATION
BUFFALO, ERIE COUNTY, NEW YORK
TYPICAL PAVEMENT CROSS-SECTION
RECORD DRAWING

Core samples to evaluate the thickness of the asphalt and subbase were not completed. Alternatively, the contractor removed asphalt in damaged areas and did localized inspections of the subbase in those areas. It was determined that asphalt was degrading due to inadequate thickness of the asphalt binder material and not as a result of inadequate subbase.

Phase I of the paving was conducted between October 5, 1998 and October 25, 1998. The Phase I area consisted of the excavation area, remaining northern third of the parking lot, motorcycle parking area, and eastern aisle. Paving activities consisted of rolling the stone backfill area to compact the new material, placement of a minimum of two inches of binder material over the compacted stone, reconstruction of two damaged manholes, filling low areas in previously paved sections of the Phase I area to level the surface, removal of 1,007 square feet of damaged asphalt, placement of petromat fabric, placement of a minimum of two inches of binder material over the petromat, placement of one inch of topcoat binder, and striping of the newly laid asphalt. Guard rails and fence posts were also installed.

Phase II of the paving was conducted between October 26, 1998 and November 1, 1998. The Phase II area consisted of the parking area between the eastern and western entrance aisles. Activities included reconstruction of two damaged manholes, filling low areas with binder to level the surface, removal of 445 square feet of damaged asphalt, placement of petromat fabric, placement of a minimum of two inches of binder material over the petromat, placement of one inch of topcoat binder, and striping of the newly laid asphalt. New guardrails were also installed.

Phase III paving was completed between November 2, 1998 and November 16, 1998. The Phase III area consisted of the western entrance aisle and the area south of the Phase I area. Activities in the Phase III area included removal of 24,761 square feet of damaged asphalt and replacement with four inches of binder. Additional activities included reconstruction of one damaged manhole, filling low areas with binder to level the surface,
