Soil Vapor Intrusion Evaluation

CMS ASSOCIATES REMEDIATION SITE 210 French Road Building

Site no. 915168

September 2014

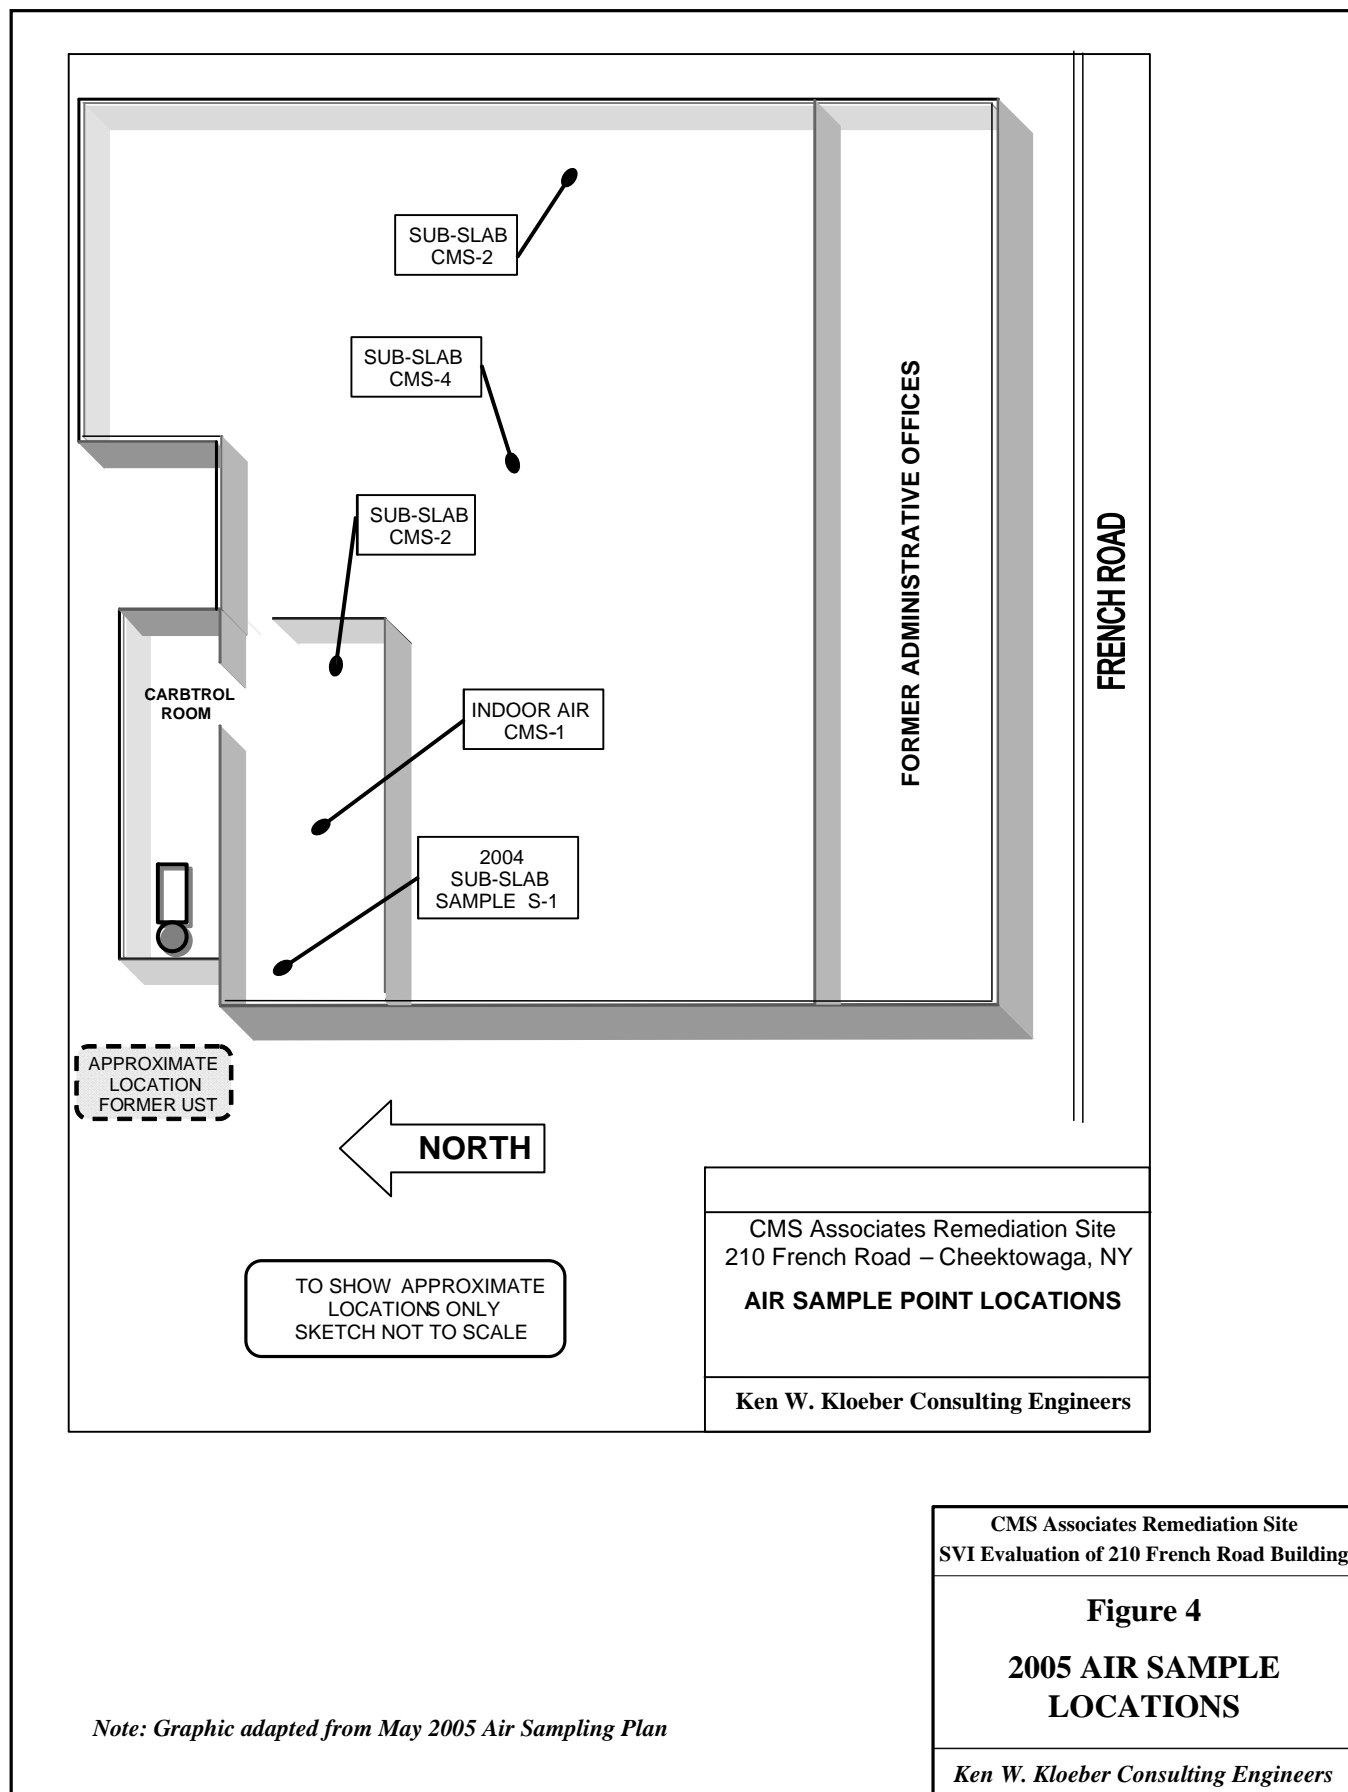
The highest sub-slab VOCs were observed at sample locations 189-S1, CMS-3, and CMS-2 (see *Figure 4*.) Sample CMS-4 exhibited lower VOCs, yet it was virtually mid-point between two of the highest readings. That indicated a potential discontinuity of the sub-slab media, or something present to block the free movement of the vapor.

VOCs present under the slab indicate that the groundwater contaminant plume extended beneath the building footprint. According to CMS, a 5-inch unreinforced-concrete slab was poured atop 4-inches of crushed stone so—barring a significant anomaly in the composition or compaction of the underlying base material—there was an opportunity for good vapor communication below the slab. The lower VOCs in sample CMS-4 may indicate such an inconsistency.

No sub-slab or indoor-air testing was performed in the former office area at the south end of the building (see *Figure 4*) because (1) it was unsure if Cugini Ventures would conclude the purchase; (2) those areas were not to be occupied; (3) use of the space was uncertain; and (4) the structure might be reconstructed or even demolished in the future.

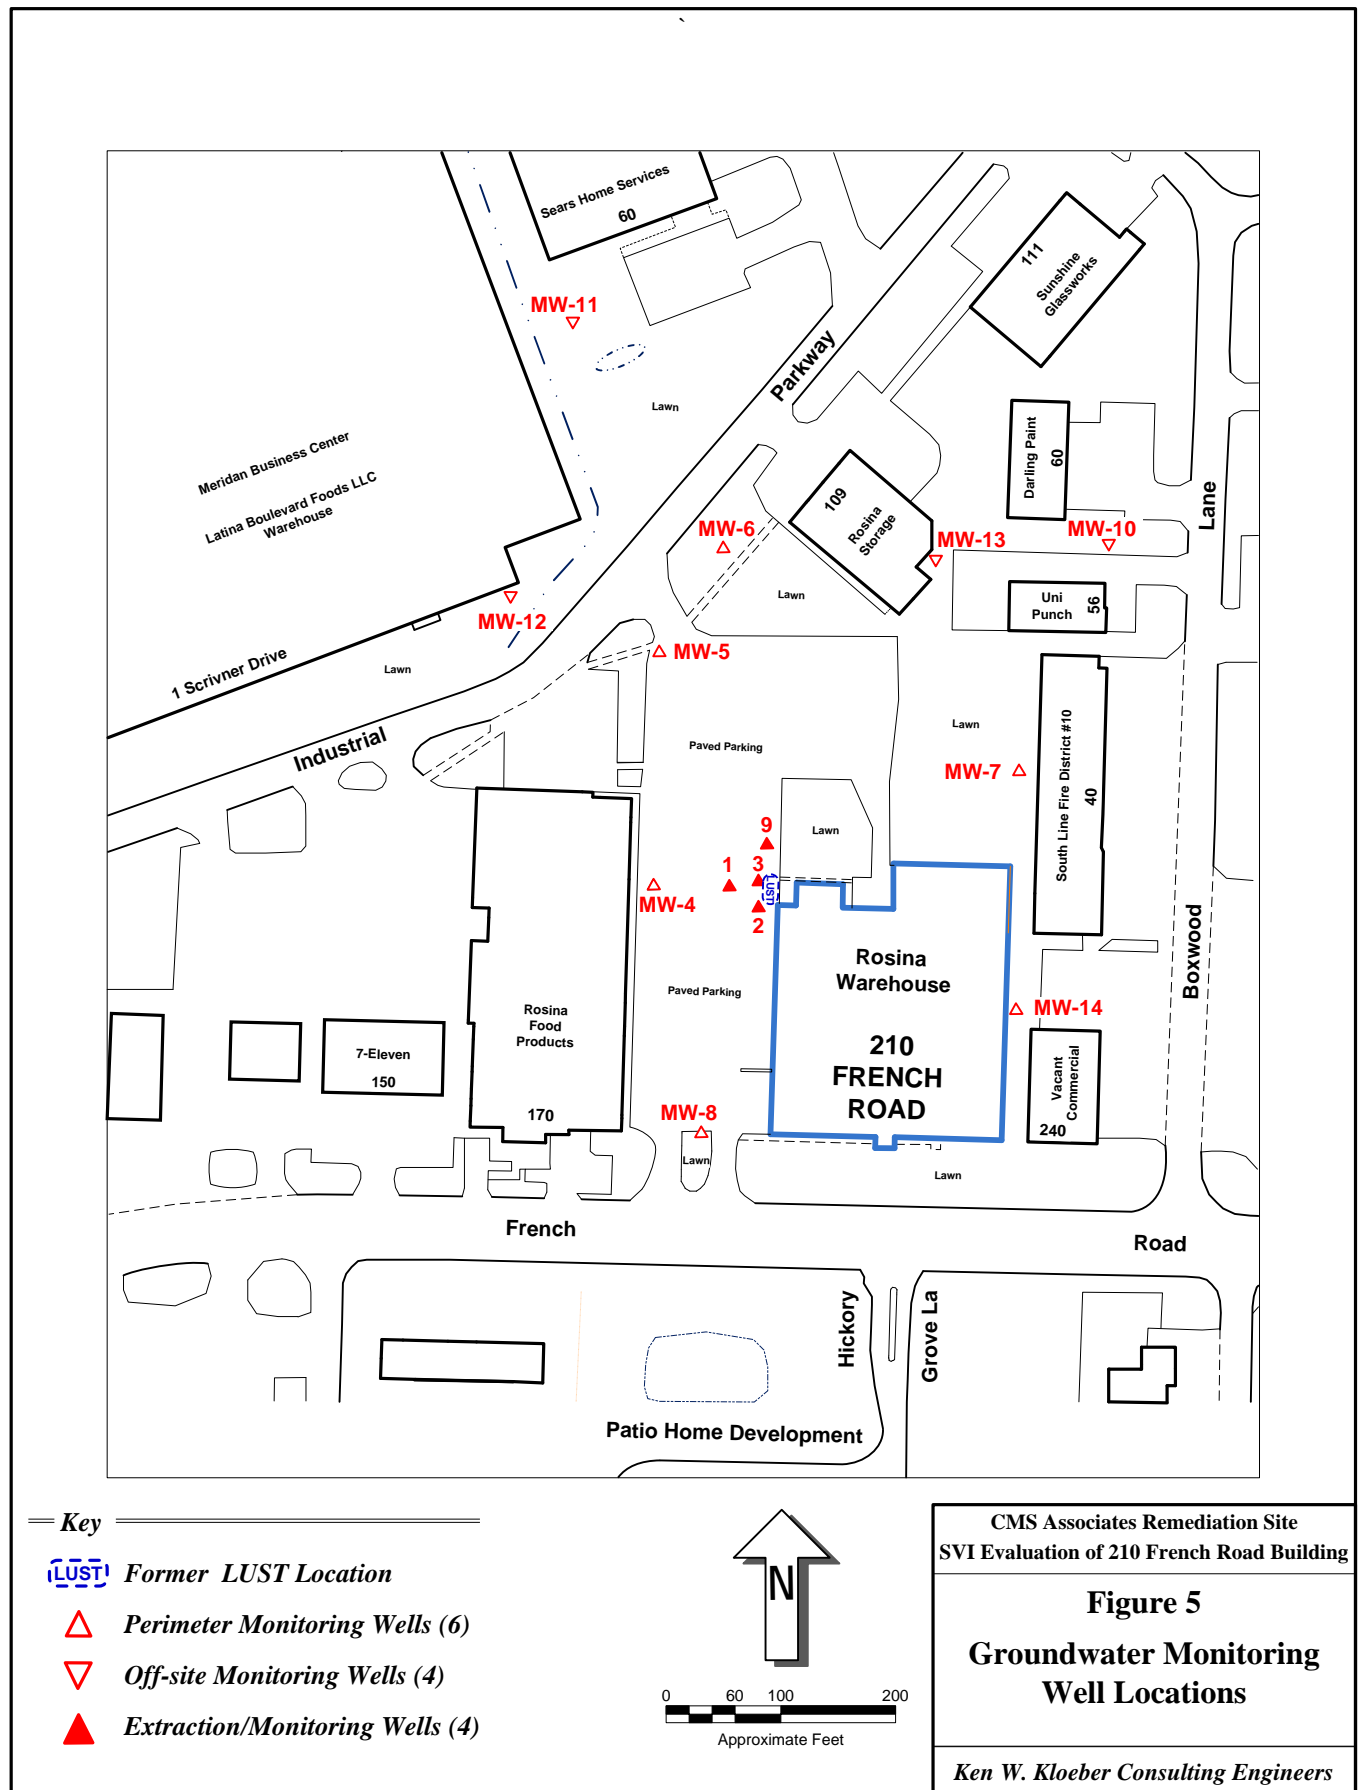
The new perimeter well MW-14 also helped further define the groundwater VOC plume and yielded data to evaluate the potential for SVI impact on the 210 building (see *Figure 2* for the estimated extent of the VOC plume.)
