# PHOTOLOG 2/26/09 Site Investigation Test Pits by TVGA

ABC Paving Site, NYSDEC Site No. 915179

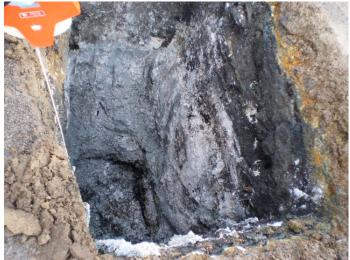
TP-1 profile: Upper layer contains slag/foundry sand like fill followed by a lime waste fill stained by MGP purifier waste
