Annual Hyde Park Gorge Walk, August 11, 2004

Notes by Will Welling and Brian Sadowski

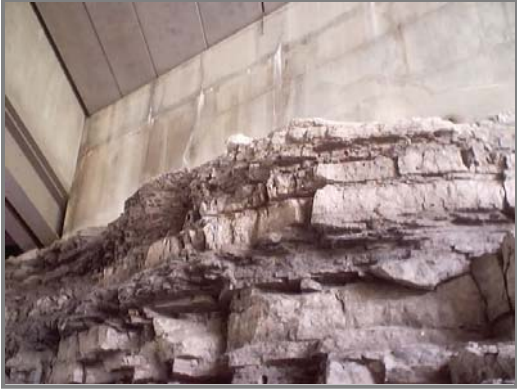
Photo 1, left. Rocks beneath the Robert Moses Overpass.	Beginning with Photo 3, this column contains the field report descriptions from Jim Thornton, CRA, e-mailed on 8/12/04 to the participants. GF-S(number), corresponds to Seep (number). "GF-S(number)" format is used on the field map.

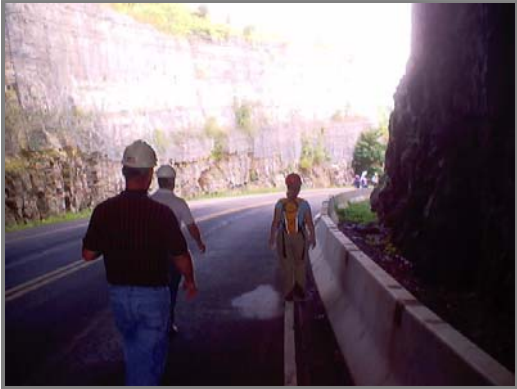
Photo 2, left. Proceeding to the first seep. The seeps are not numbered in the visiting sequence but are named in the order in which they were discovered. Jim Thornton took charge of the walk. He had a collection of previous years' observations. At each stop he compared our present observations	to what was seen last year. Most seeps appeared to be very similar to last year.
