ENGINEERING INVESTIGATIONS AT INACTIVE HAZARDOUS WASTE SITES IN THE STATE OF NEW YORK

PRELIMINARY SITE ASSESSMENT Volume 1

Roblin Steel Site
Site Number 932059
City of North Tonawanda, Niagara County

February 1995

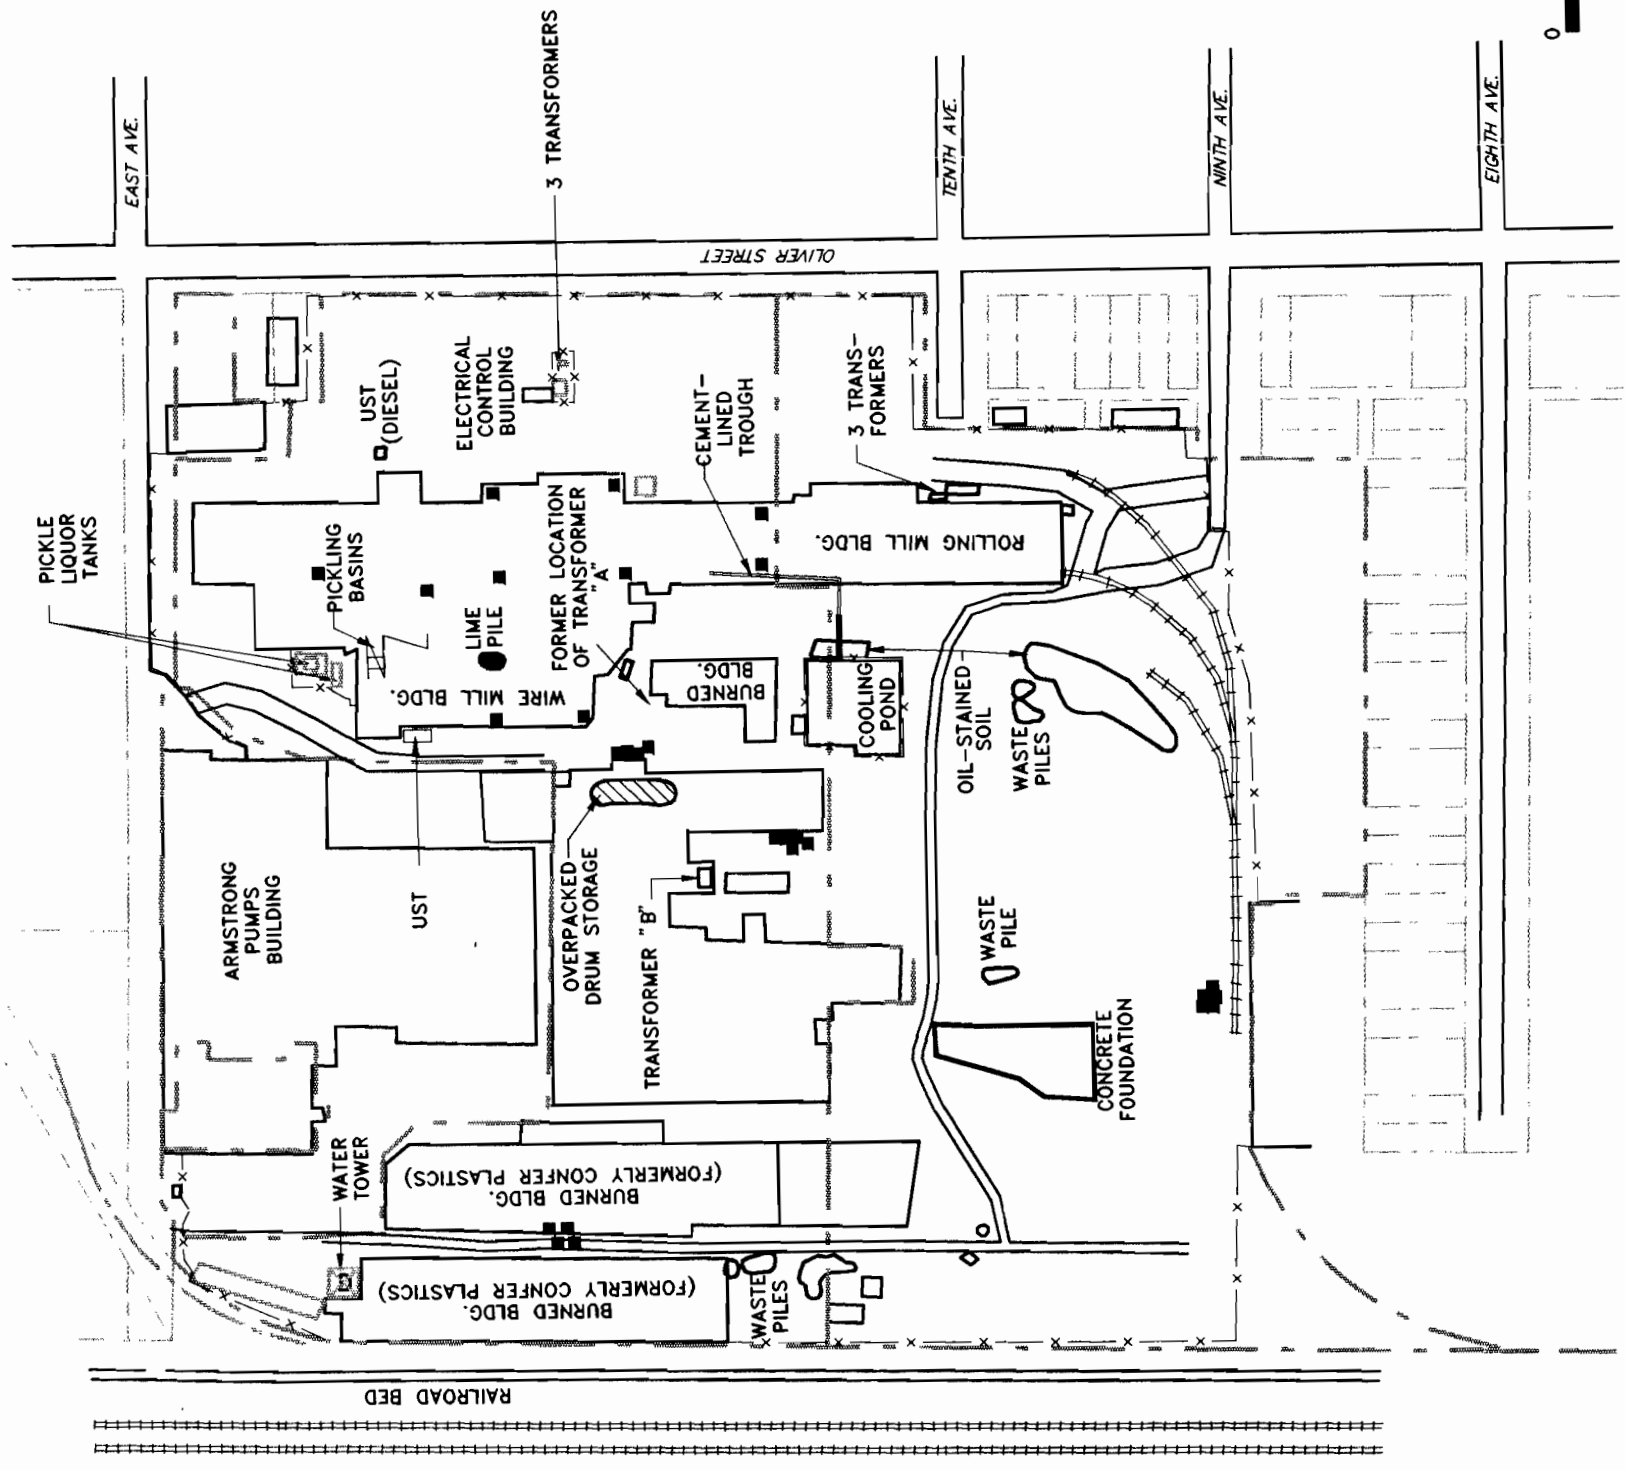
Figure 3-1 SAMPLE LOCATION MAP ROBLIN STEEL

Surface water, sediment, surface soil, waste, subsurface soil, and groundwater samples were collected at and around the site by E & E between July 15 and November 11, 1993 (see Figure 3-1). Sample locations were chosen with the concurrence of the NYSDEC field representative and were based on information provided in NYSDEC's abbreviated work plan for the site. All sample collection, shipping, handling, and analytical procedures were performed in accordance with the QAPjP (E & E 1993c). Additionally, field and sampling procedures were performed in accordance with the work plan (E & E 1993a), and HASP (E & E 1993b). Sample analysis was performed by E & E's ASC in accordance with NYSDEC's 1991 Analytical Services Protocol. All analytical data pertaining to the Roblin Steel site have been third-party validated by ChemWorld Environmental, Inc. Table 3-3 summarizes the samples collected and analyses performed.

Three samples of liquid media were collected at the site on July 15, 1993. The sample locations are shown on Figure 3-1. Sample SW-1 consisted of water from the surface of the cooling pond. Sample SW-3 consisted of water from a cement-lined pickling basin located in the wire mill building. This elongated basin extended through a wall at a right angle to three smaller pickling basins at the north end of the wire mill building. Samples

SW-1 and SW-3 were submitted for Target Compound List (TCL) organic and inorganic analyses. Sample SW-2 consisted of oil and sludge from a cement-lined trough in the rolling mill building (see Figure 3-1). The trough contained trash and debris, including engine and machine parts, and less than 1 foot of water. The sample was collected from an approximately 3-inch-thick layer of oil and sludge that was floating on the water. Sample SW-2 was analyzed for hazardous waste characteristics, including reactivity (total sulfide and cyanide), corrosivity (pH), and ignitability (flash point); PCBs in liquid; petroleum products; and toxicity characteristic leaching procedure (TCLP) volatile and semivolatile compounds and metals. One matrix spike/matrix spike duplicate (MS/MSD) sample set and one trip blank were analyzed with these samples for QA/QC purposes.

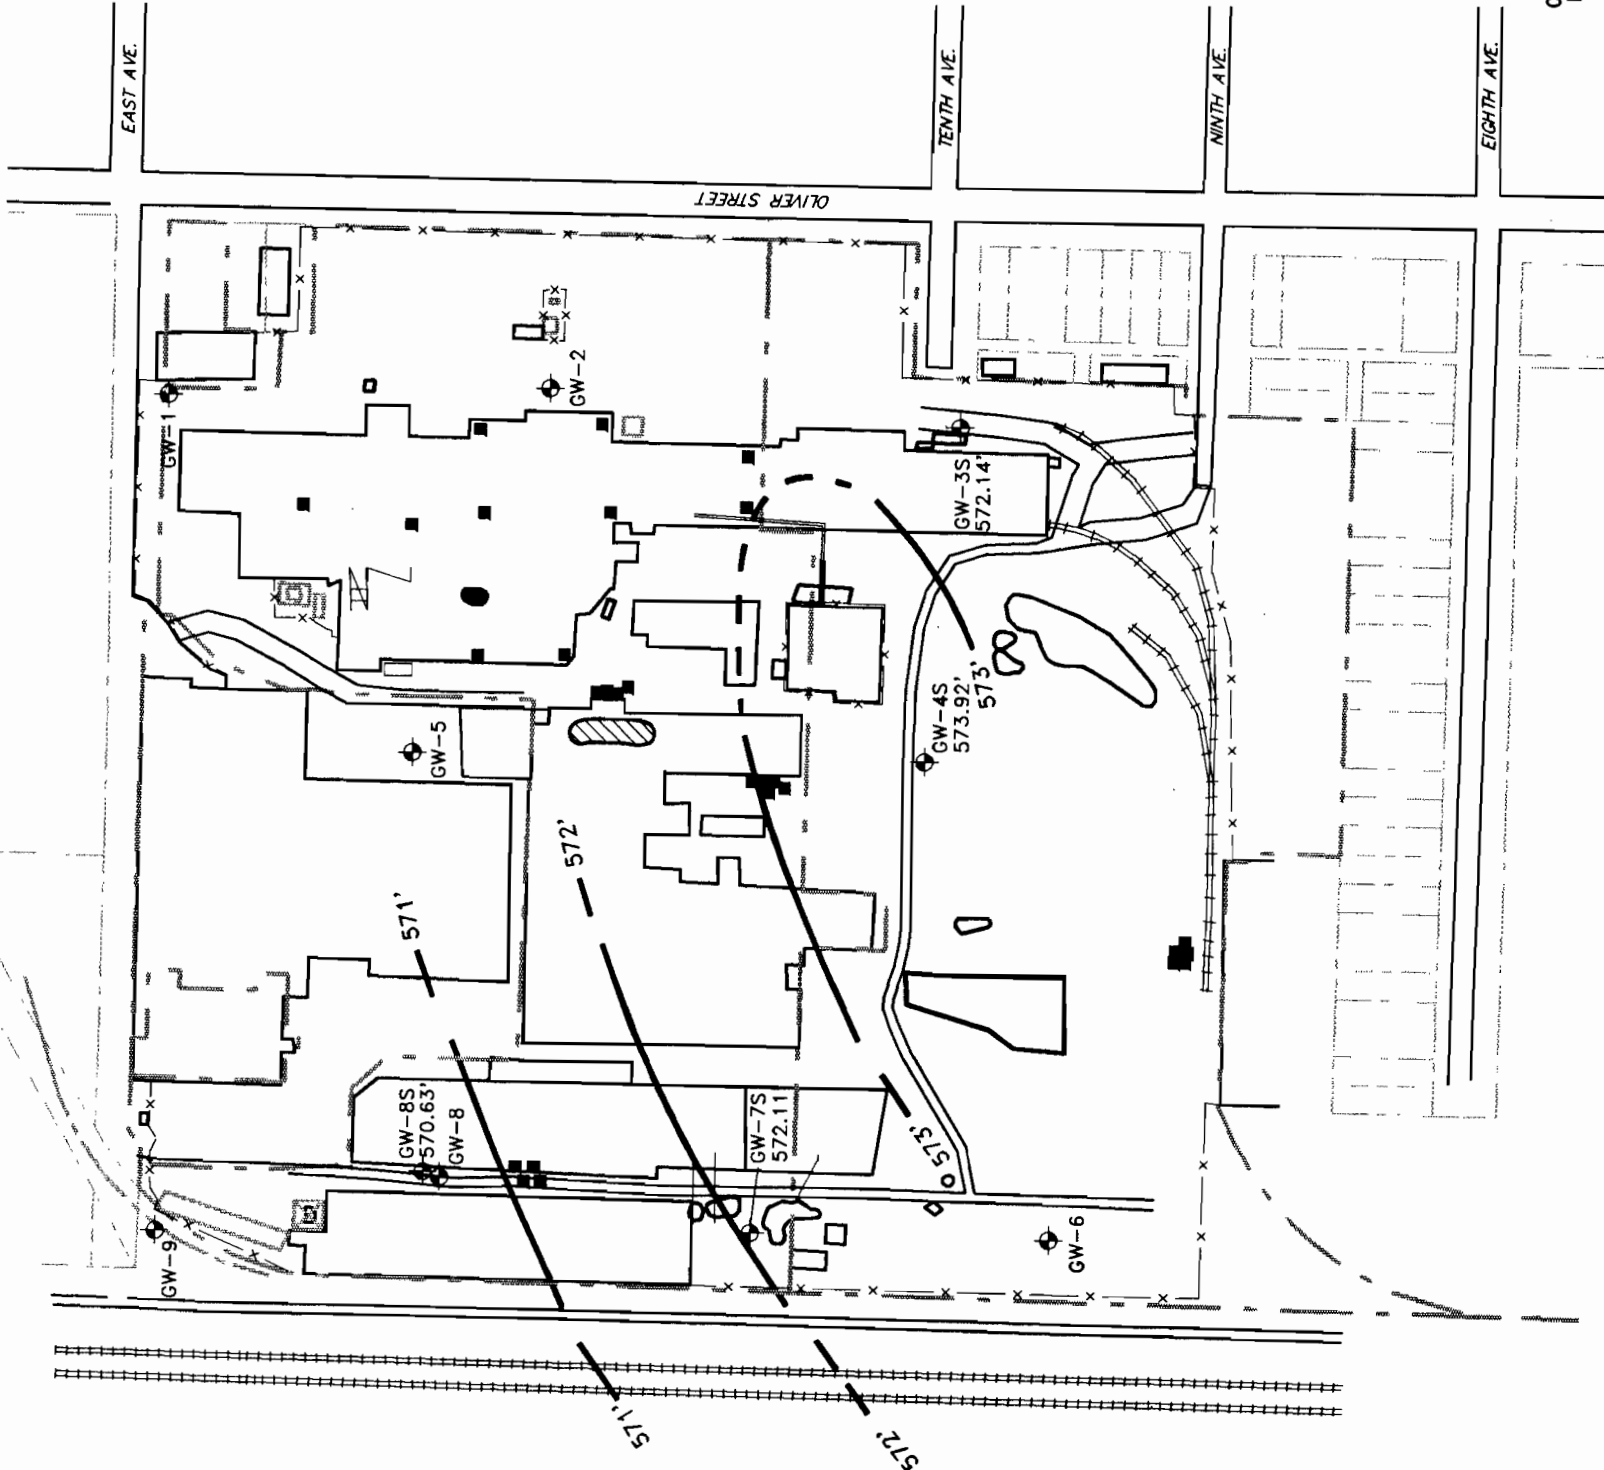
Figure 3-4 POTENTIOMETRIC SURFACE CONTOUR MAP
 SHALLOW OVERBURDEN WELLS
 FEBRUARY 28, 1994
 ROBLIN STEEL SITE

As shown on Figure 3-4, groundwater flow in the shallow overburden is primarily to the northwest, but with a northeast/southwest trending divide present near GW-4S. As on November 9, 1993, GW-4S had the highest water level, with a component of flow to the northwest and to the east toward GW-3S. The data indicate that the cooling pond is hydraulically connected to the groundwater and is recharging the shallow overburden. Groundwater flow emanates radially from this recharge area, but the ultimate flow direction should be to the northwest toward the Niagara River.

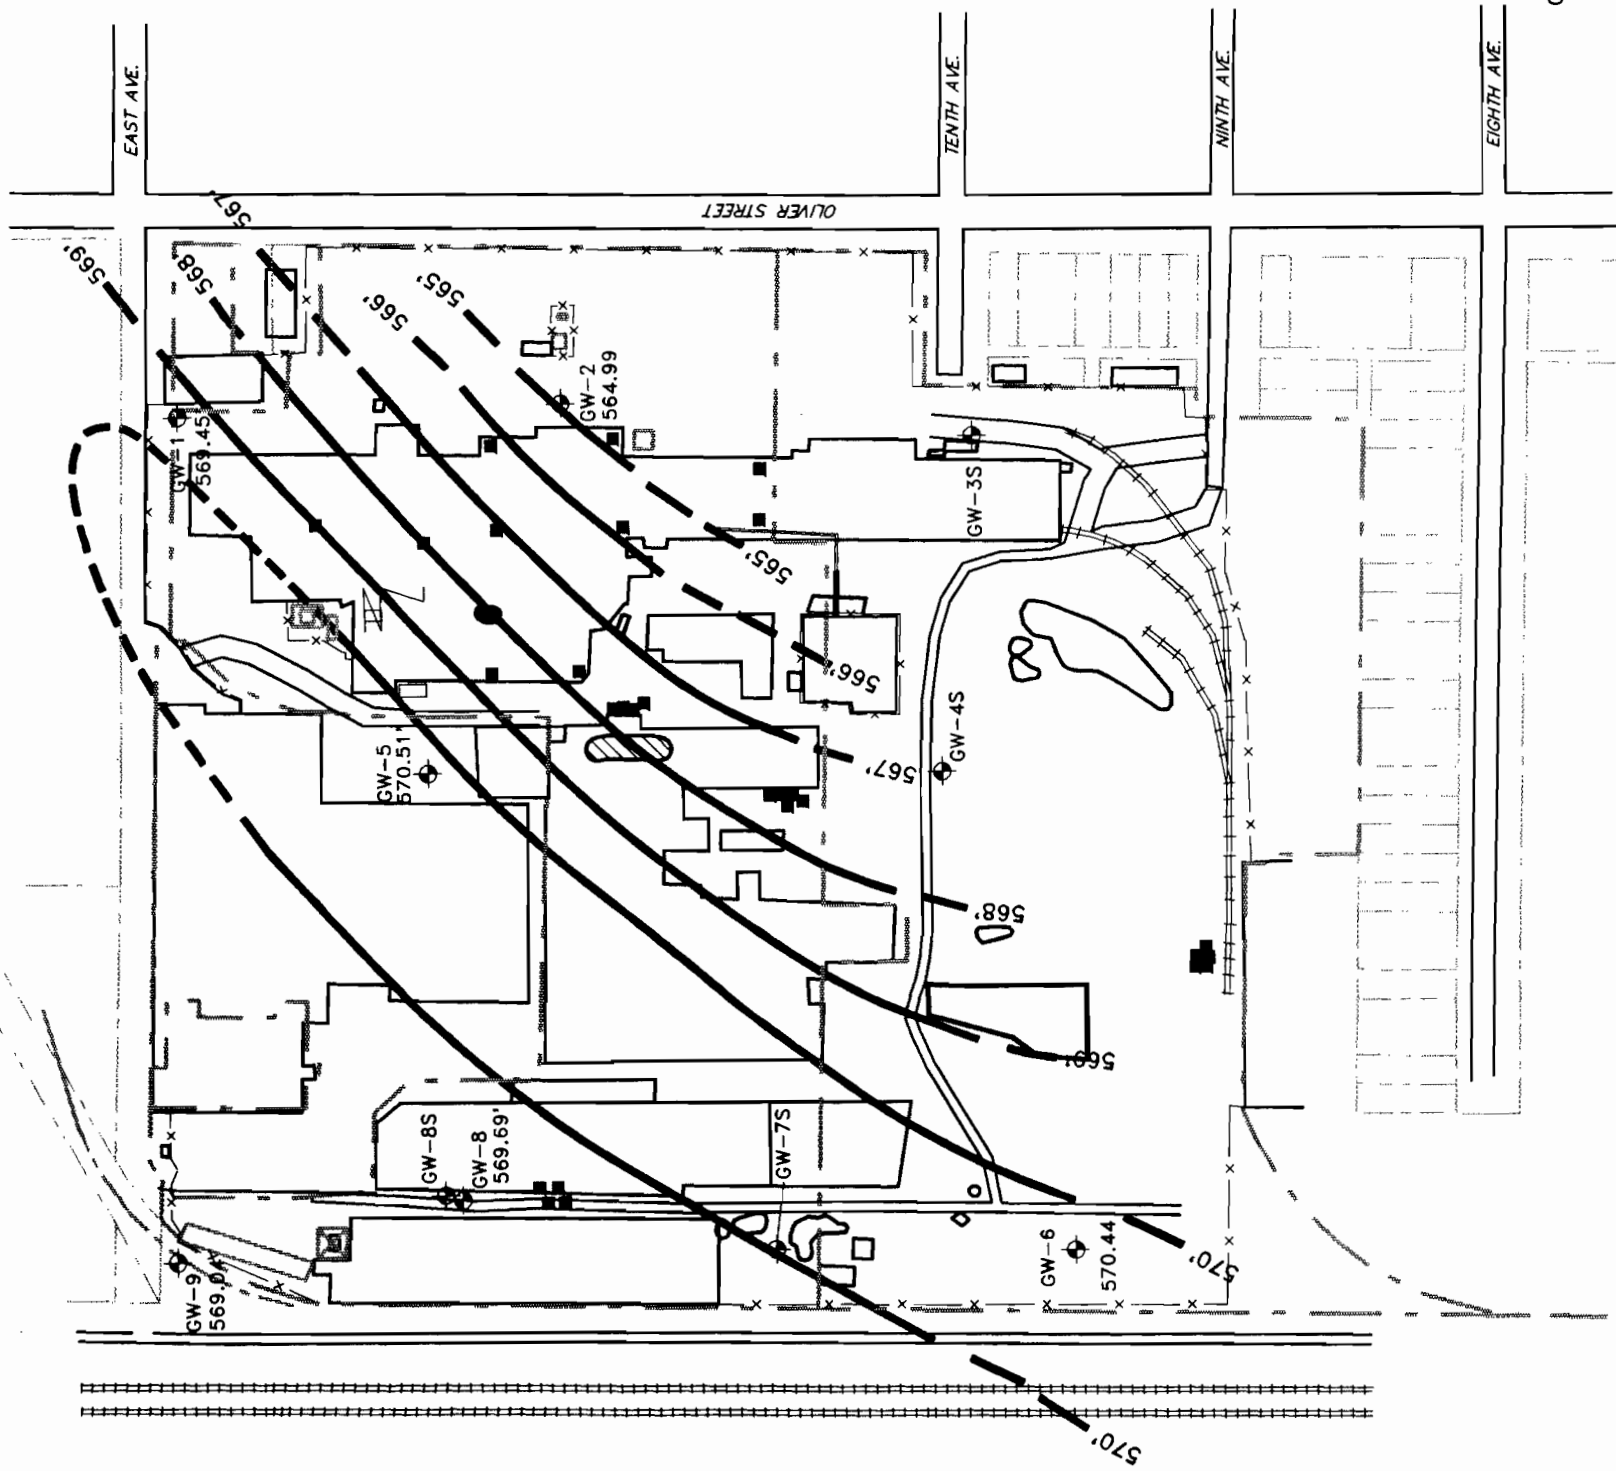
Figure 3-5 POTENTIOMETRIC SURFACE CONTOUR MAP
 DEEP OVERBURDEN WELLS
 FEBRUARY 28, 1994
 ROBLIN STEEL

Potentiometric surface contours for the deep overburden wells on February 28, 1994, indicate the presence of a north-northeast/south-southwest trending flow divide near GW-5 and GW-6 (see Figure 3-5). Groundwater flow from this divide is both to the west-northwest and east-southeast. The horizontal hydraulic gradient between wells GW-6 and GW-2 was very similar to that on November 9, 1993.
