May 8, 2006

RE: **Investigation of Storm Water at the Metaullics Facility**  
Former Carborundum Site, Sanborn, NY

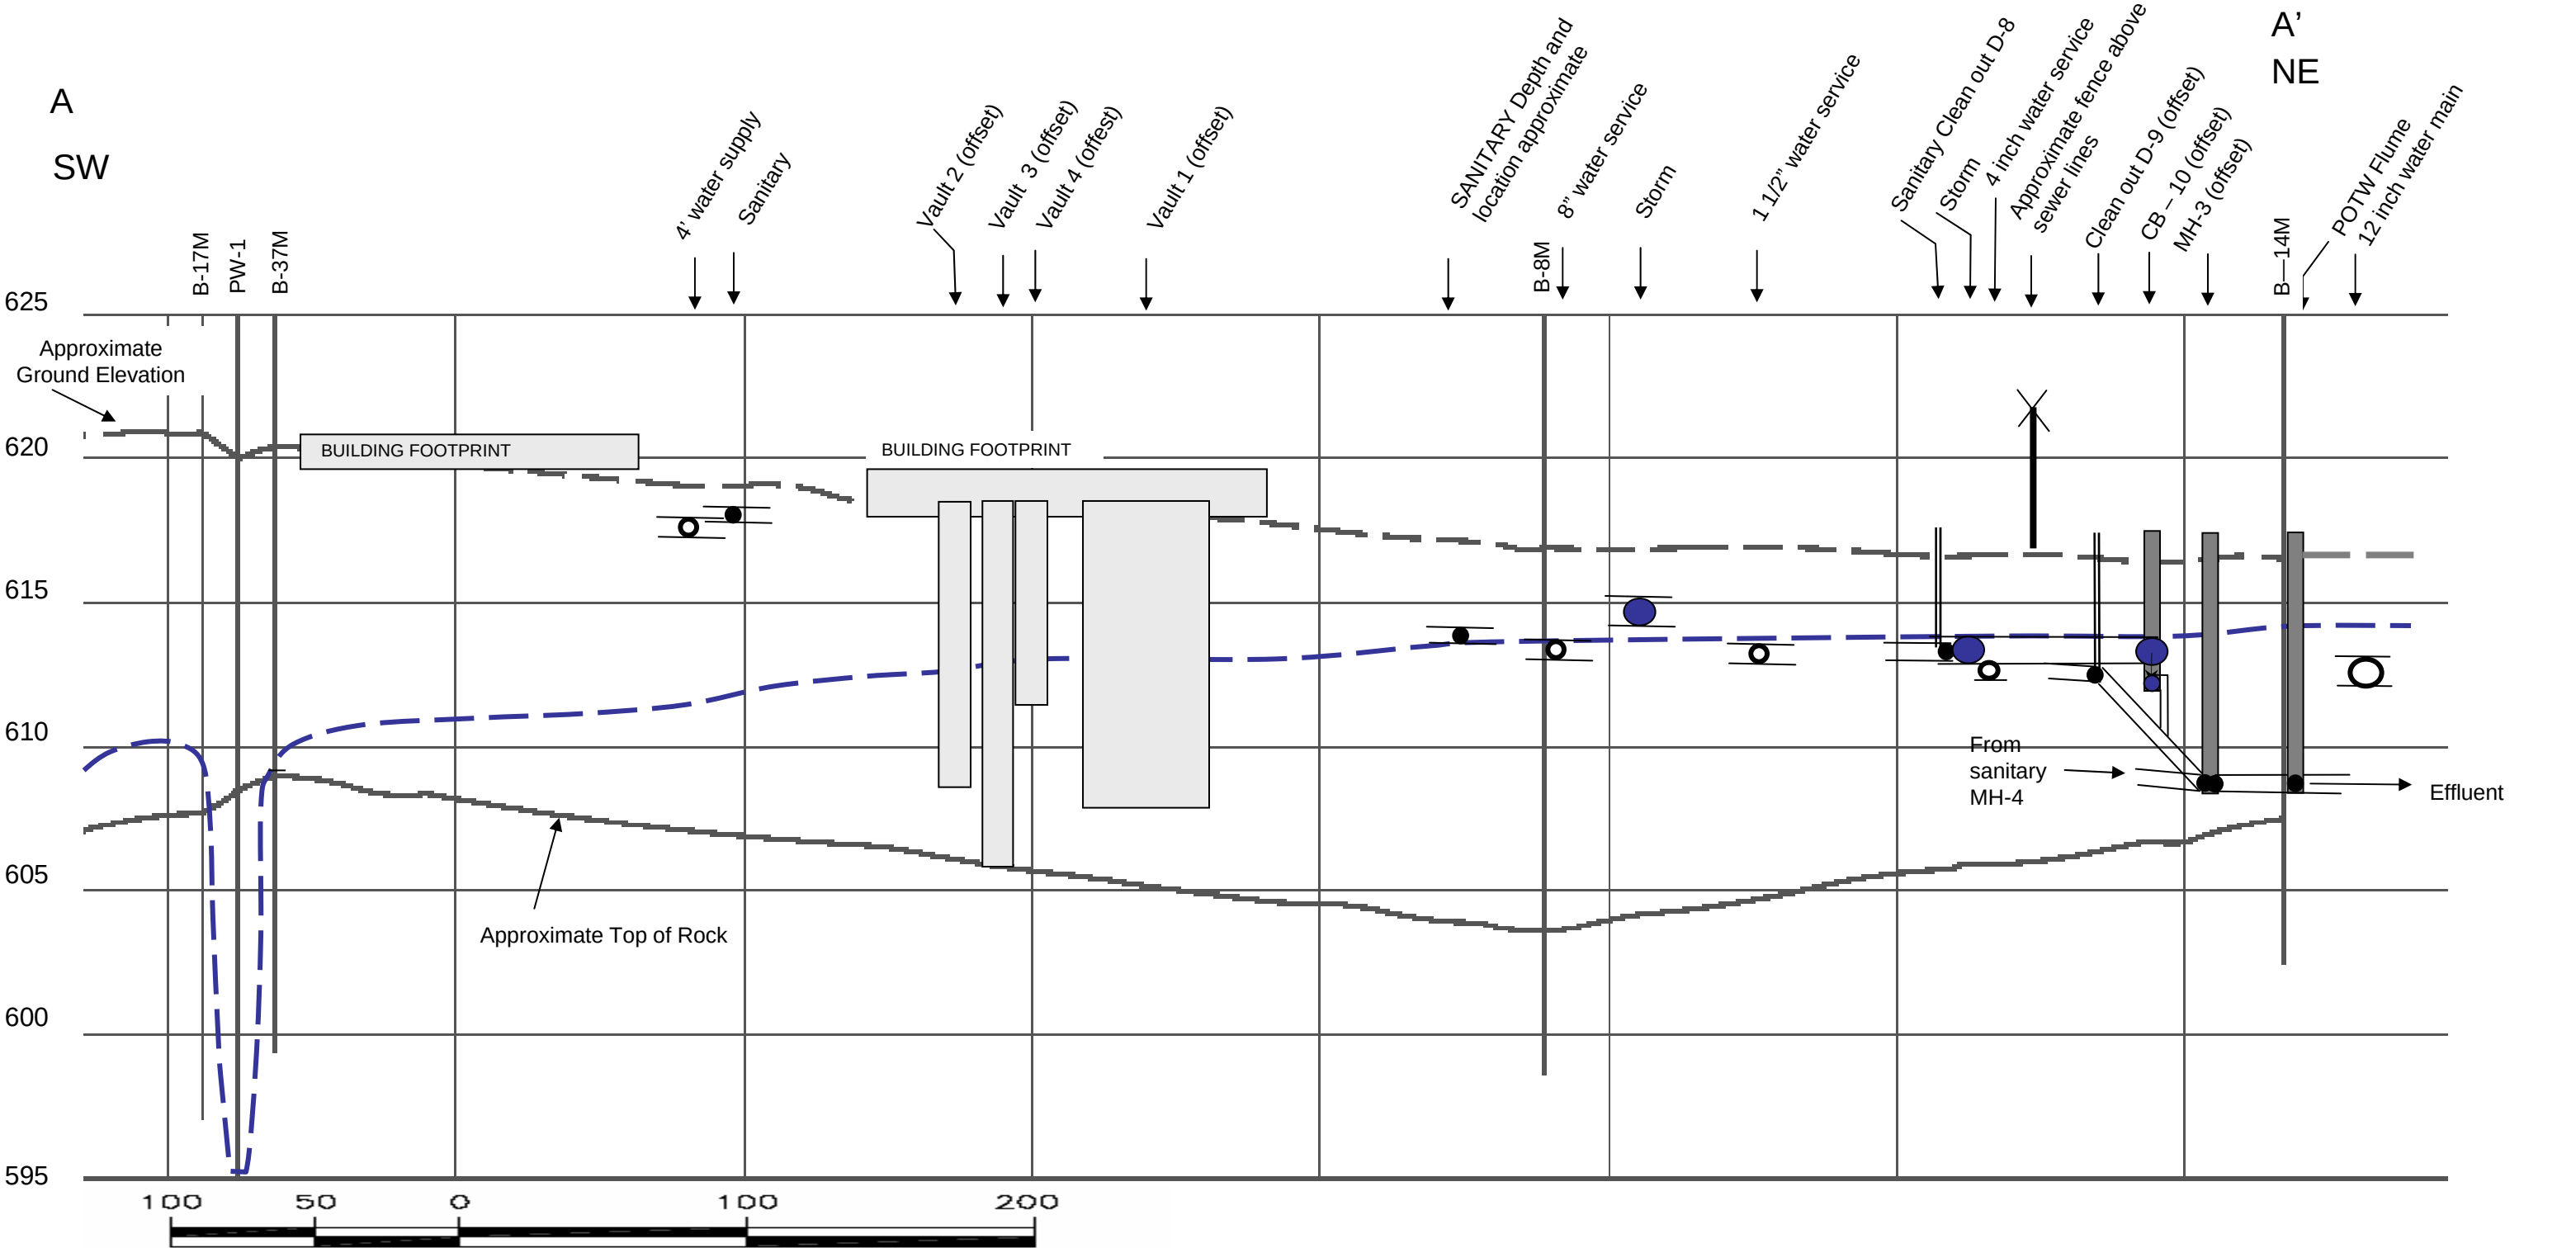
FIGURE 1

The sewer field investigation was conducted on March, 7<sup>th</sup>, 10<sup>th</sup>, and 30<sup>th</sup>, 2006. During the sewer investigation, depth to inverts and piping sizes were measured. Flow pattern and condition of the system were also inspected. Figure 1 shows a plan view of site sewers, including the storm and sanitary sewers. Figure 2 is a cross-section schematic summarizing the observations and measurements. Figure 2 shows in plan view, the approximate locations of site water supply utilities. Table 1 is a map key detailing specific observations and measurements made during the investigation. A photographic log is provided in Appendix A. Results from the 2006 investigation indicate that the storm and sanitary sewer systems are separate systems upstream of the tie-in near the POTW discharge. This tie-in is located between CB-10 and MH-3. Each system has various types of piping and various invert elevations.

During the investigation, it was noted that the storm sewer was constructed of various materials, including corrugated steel, PVC, and concrete. A majority of the storm water piping is corrugated steel, of unknown integrity. In February 2006, Metaullics replaced a section of the 18-inch corrugated steel storm sewer with PVC pipe (east of location D-9 on Figure 1). Based on observations of the removed piping, the original section of sewer, located south of CB-10, was in poor condition.

The sanitary sewer is an aggregation of newer and older construction. The older system shows several separate sewer systems, each with a septic tank and leach field. The system was upgraded (date unknown) to the present configuration, but included some of the existing infrastructure. For example, the sanitary line south of the manufacturing building previously extended to a leach field east of the present-day property line. Currently, there is a lift station (G on Figure 1) that pumps water northerly into the newer sanitary system.

- Four sumps from the manufacturing building discharge to the sanitary sewer;
- Process cooling water discharges with water from Sumps 2 and 3 to the sanitary system at location D-1 (Figure 1). Based on visual observation only, there was a constant flow of approximately 5 to 10 gallons per minute (GPM) at location D-1.
- From the north side of the Metaullics building to the POTW shed, most of the sanitary sewer is near or below the March 8 hydraulic head;
- The section of sanitary sewer after the tie-in with the storm sewer (near CB-10), based on depth to inverts and historic water level measurements, may be up to five feet lower than the hydraulic head, at times; and
- Reportedly due to root penetration, a portion of the clay sanitary sewer was replaced with PVC by Metaullics (D-2 on Figure 1).

As part of the Metaullics processing, below-grade vaults house manufacturing equipment. Four of these vaults have sump pits fitted with pumps to remove infiltrating water. The water from the sumps is discharged to the sanitary sewer. Figure 1 shows the plan view location of the vaults and the discharge location of the sumps. Three vaults are located in the building and one vault is outside, adjacent to the building. Figure 2 shows the approximate location and depth of the vaults as projected onto cross-section A-A'. Table 1 describes the specifics of each sump.

ATLANTIC RICHFIELD COMPANY  
FORMER CARBORUNDUM FACILITY  
SITE PLAN AND SEWER UTILITIES

| H – | Feb. 2006 storm line replacement, samples with fluoride and chlorine concentrations. |
| D-9 – | Sanitary clean out, depth to invert is 5.2 feet below grade, pipe is broken at grade. |
