RE: Former Carborundum Site, Sanborn, New York
Sanitary and Storm Sewer Infiltration Evaluation

SITE PLAN AND SEWER UTILITIES

**INVESTIGATION OF STORM WATER AT THE METAULLICS FACILITY
MAY 2006**

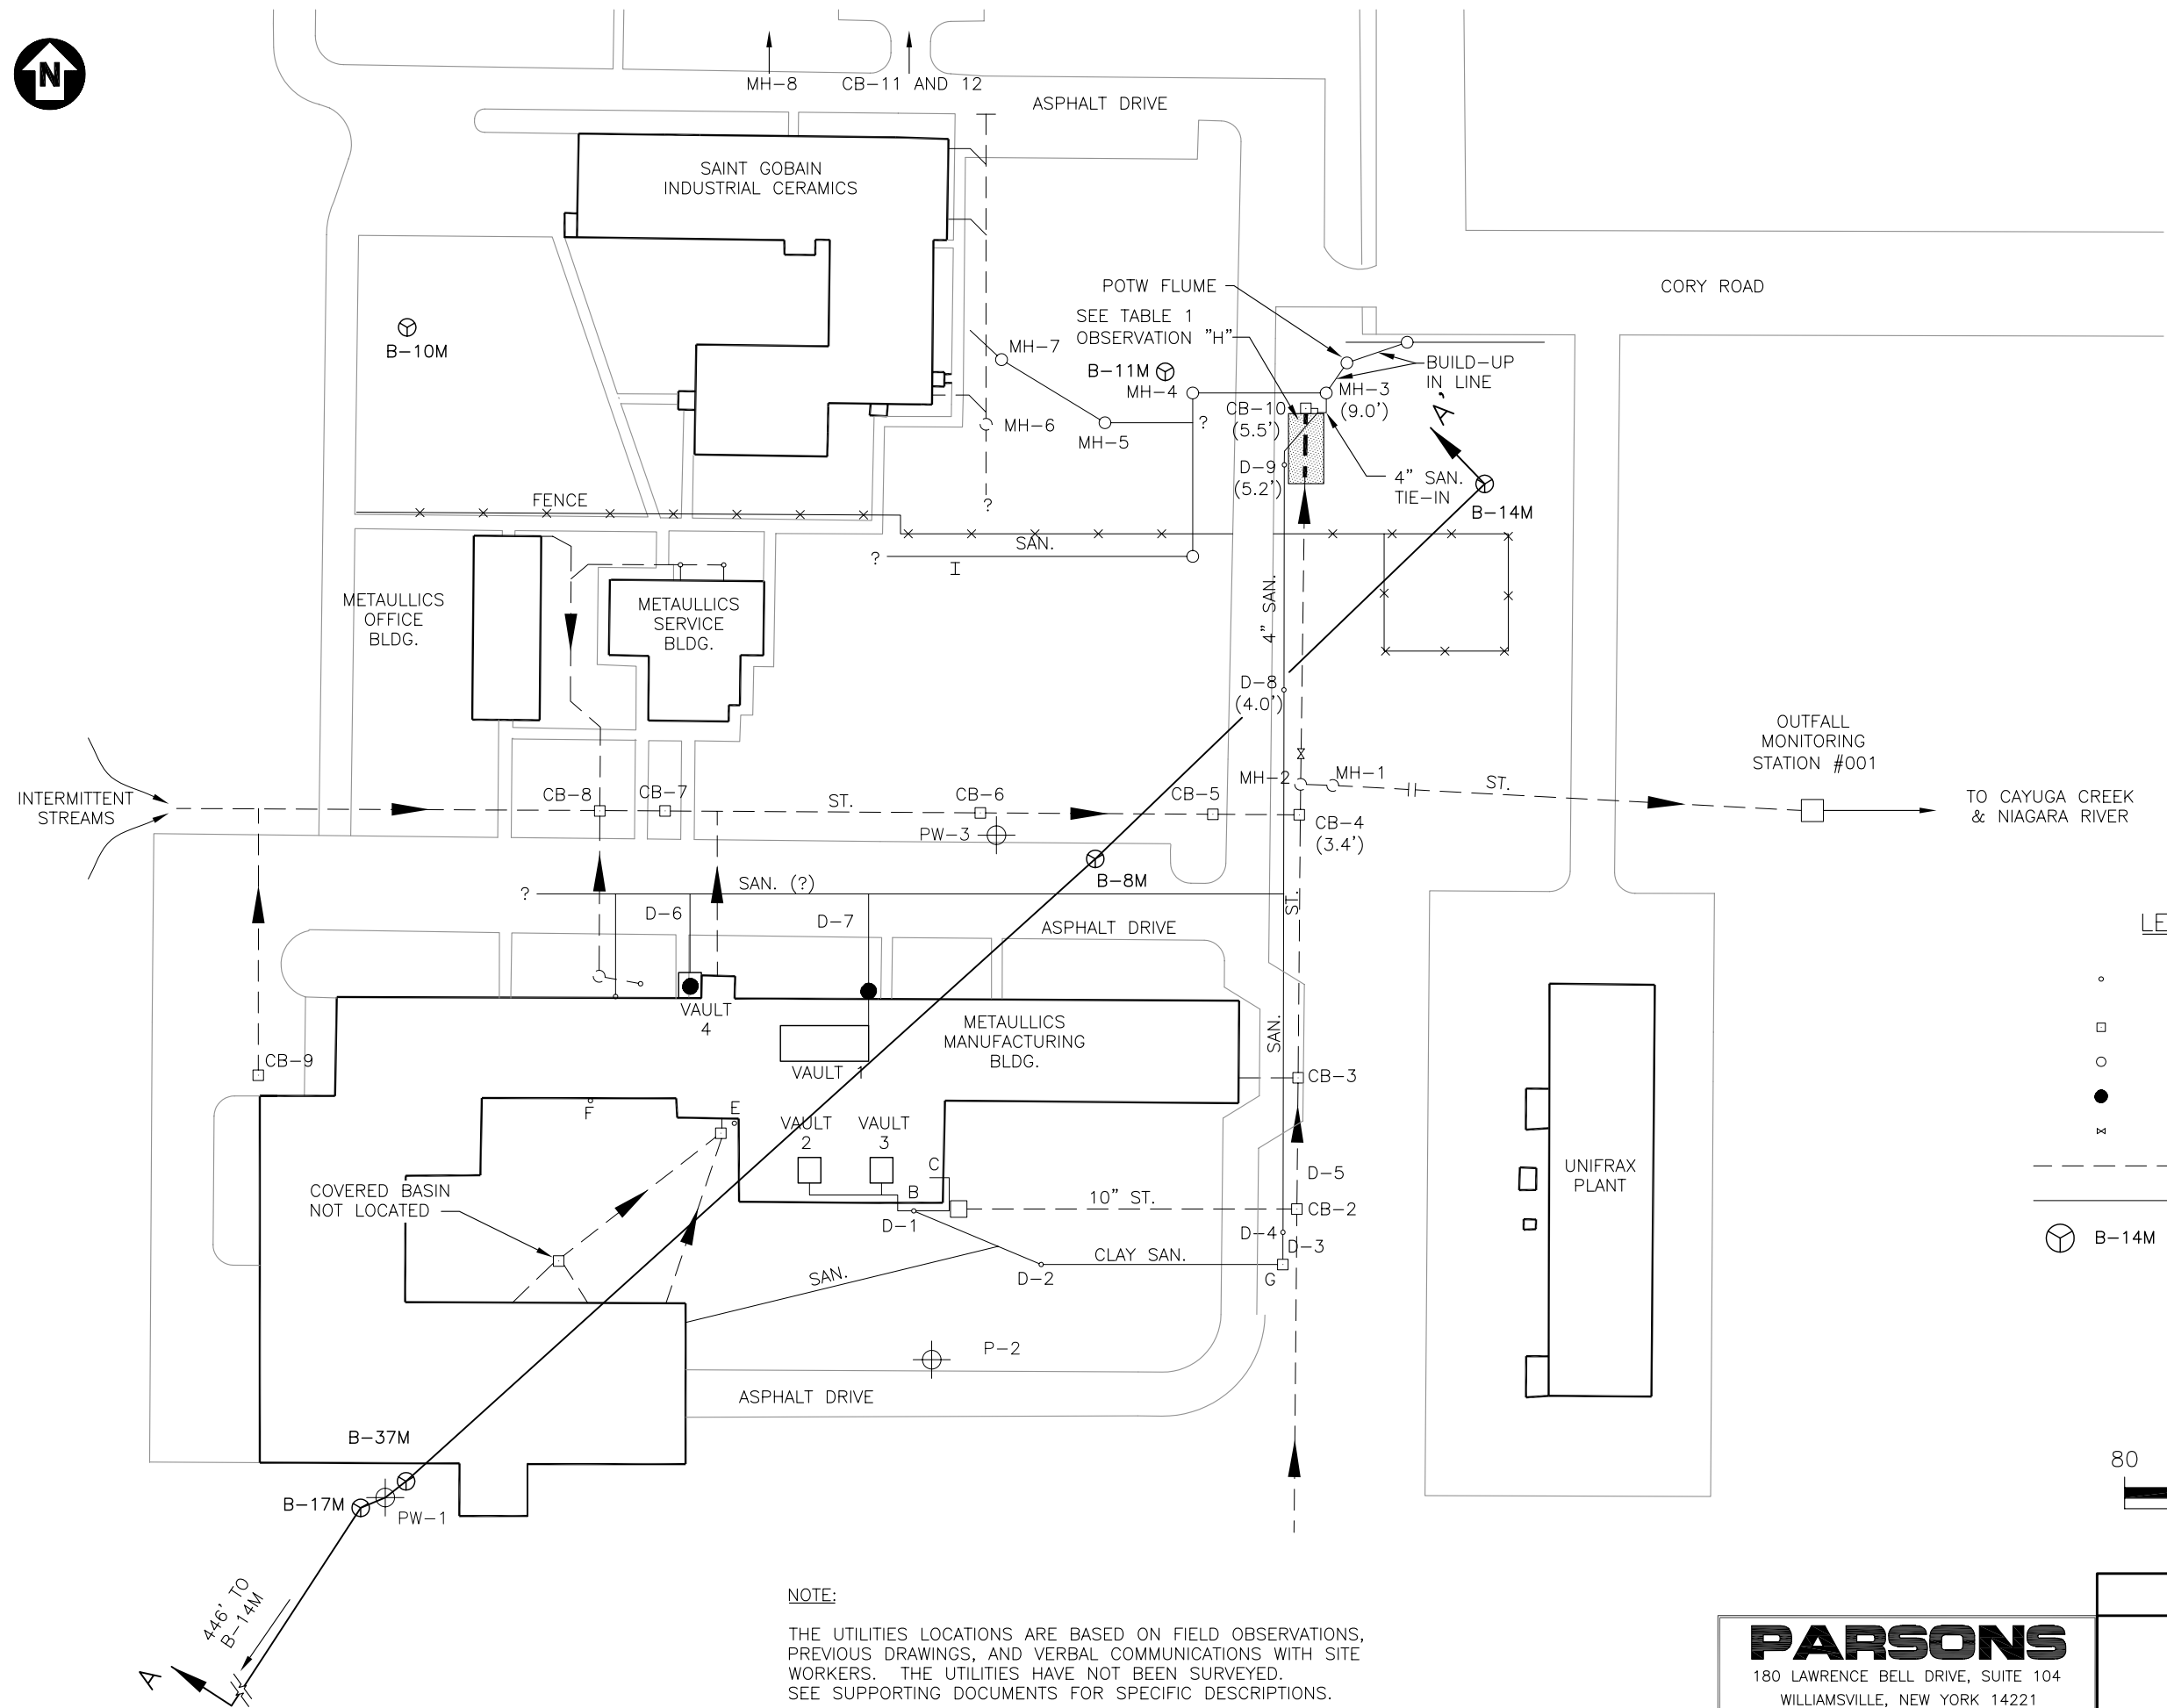
D-6 and 7 –	Line to sanitary from sump discharges.
D-8 –	Sanitary clean out. Depth to invert is 4.6 feet below top of pipe, 4.6 feet below grade.
D-9 –	Sanitary clean out, depth to invert is 5.2 feet below grade, pipe is broken at grade.
<u>Catch basins</u>	
CB-1 –	Receives flow from roof drain. 10-inch pipe, invert is 1.5 feet below grade. Discharges east to CB -2.
CB-2 –	Receives flow from CB – 1. Depth to invert is 3 feet below top of CB, CB is 1.5 feet above driveway. May receive flow from south.
CB-3 –	8-inch line from CB-2 (2.5 feet to invert), and 4-inch line from building (depth to invert is 1.5 feet). Discharges to the north. CB is at grade.
CB-4 –	Depth to invert is 3.9 feet.

CB-5 through CB-7 – 10-inch lines west to east, 2 feet below grade to invert. Corrugated steel pipe. Standing water.
CB-8 – Invert depths 4.8 feet, west to east, 15-inch corrugated pipe. Four inch PVC from the north, slight flow. Eight inch corrugated pipe from the south.
CB-9 – One foot to invert, 4-inch pipe.
CB-10 – 15-inch line (line that was replaced). Five foot depth to invert. Discharge pipe to east is 6-inch PVC, depth to invert is 5.5 feet. On 3/7/2006 there was no flow through CB, but sound of running water was heard.
CB-11 and 12 – In the northern parking lot. Pipe with sump to west. Connection to other system unknown.
<u>Manholes:</u>
MH-1 – Previous line to SPEDES discharge. Valves closed.
MH-2 – Depth to inverts 3.85 feet. 15-inch storm line.
MH-3 – After storm and sanitary sewers combine. Eight and 10-inch pipe influents, 10-inch effluent. Three to four inches of flow on 3/7/2006 (dry conditions). Depth to inverts is 9.3 feet. Manhole in good condition.

MH-4 – 8-inch PVC pipes. One inch of flow on 3/7/2006, 8.4 feet to inverts, leaks in frame.
MH-5 – Good condition 6-inch PVC pipes, ½-inch of flow. Seven feet to inverts.
MH-6 – North-south 10-inch corrugated piping, probably storm sewer. Brick cone and barrel, 6.5 feet to inverts. Mineralization on brick.
MH-7 – Shallow sanitary, three feet to inverts, debris in line. 6-inch PVC.

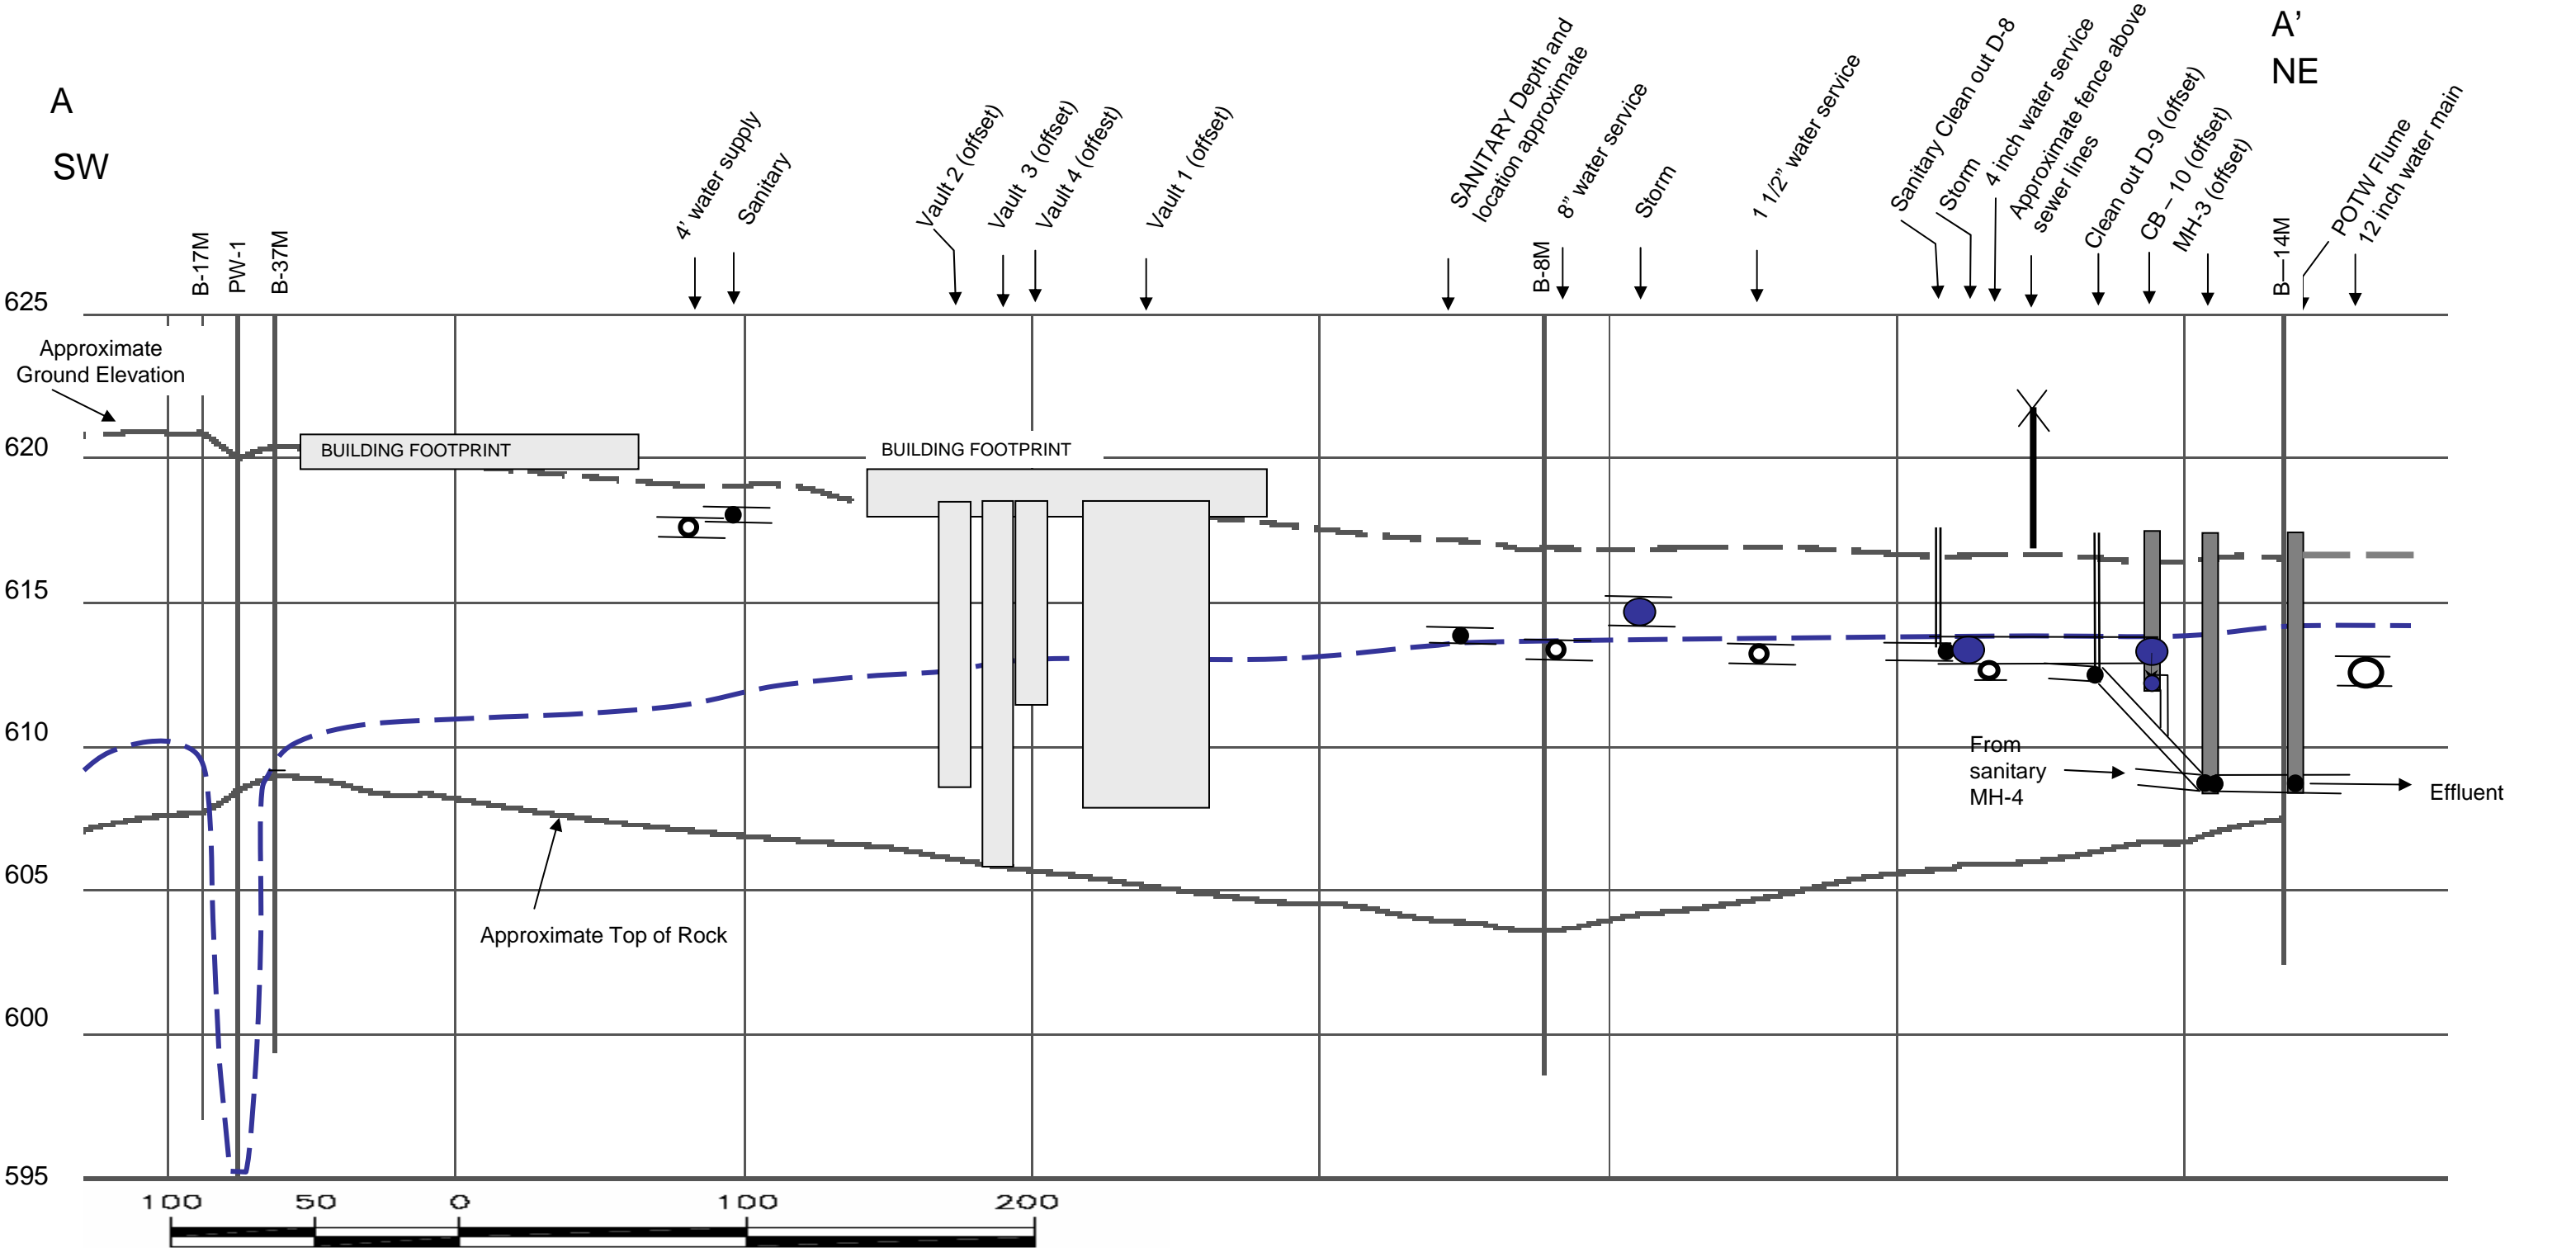
As part of the Metaullics processing, below-grade vaults house manufacturing equipment. Four of these vaults have sump pits fitted with pumps to remove infiltrating water. The water from the sumps is discharged to the sanitary sewer. Figure 1 shows the plan view location of the vaults and the discharge location of the sumps. Three vaults are located in the building and one vault is outside, adjacent to the building. Figure 2 shows the approximate location and depth of the vaults as projected onto cross-section A-A'. Table 1 describes the specifics of each sump.
