# Remedial Investigation Report

## **Eighteenmile Creek Corridor, Lockport, Niagara County, New York Site Number 932121**

September 2006

New York State Department of Environmental Conservation  
Region 9  
270 Michigan Avenue  
Buffalo, New York 14203-2999

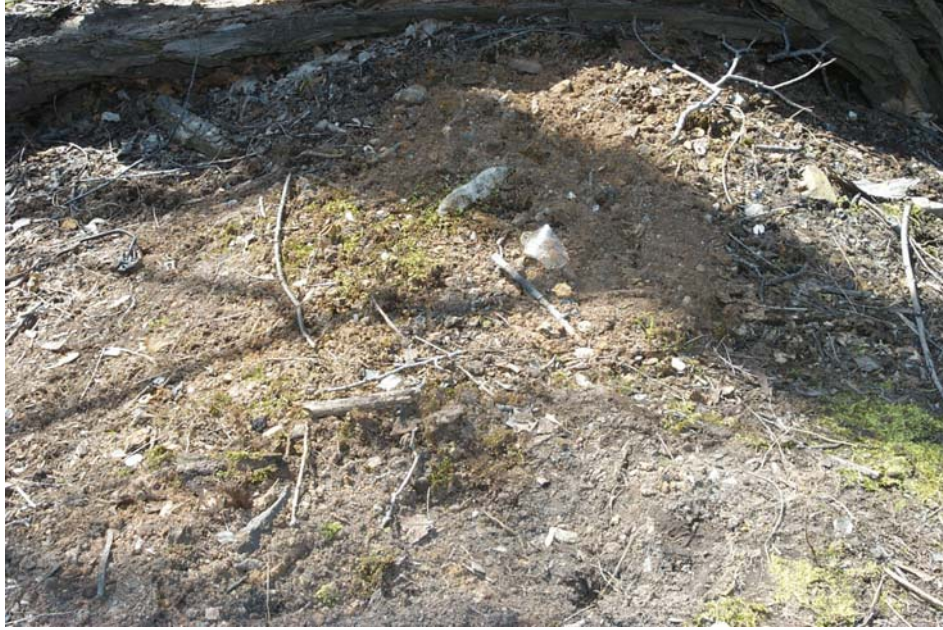
**Figure 5-1. Photograph of ash from a small ridge along Eighteenmile Creek. This area was the location of sample SS-3. Photograph taken by Paul Dicky on April 16, 2002.**

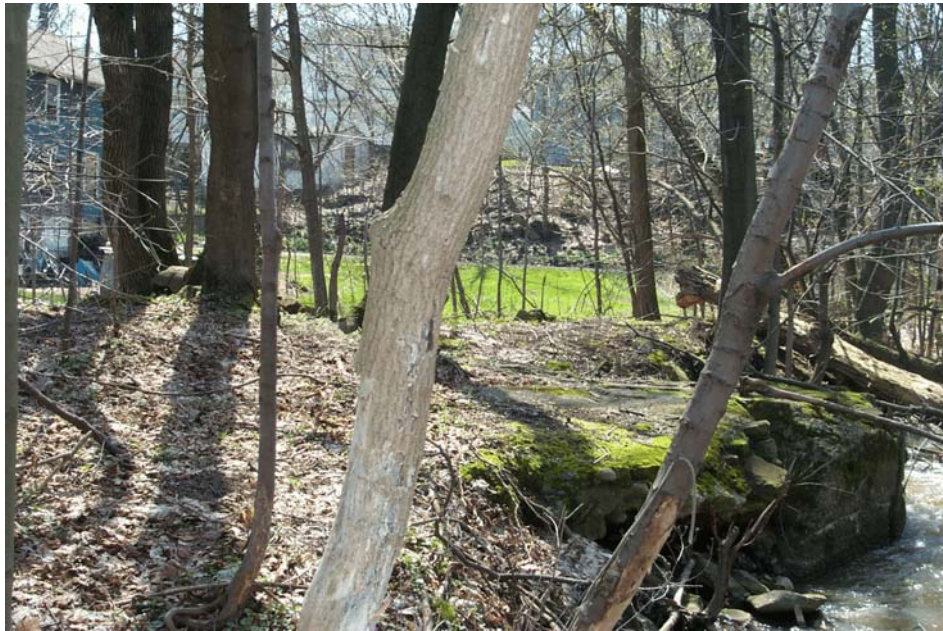
**Figure 5-2. Photograph of the small ridge of ash fill along Eighteenmile Creek. The grassy area in the background is the side yard of the property at 143 Water Street. Photograph taken by Paul Dicky on April 16, 2002.**

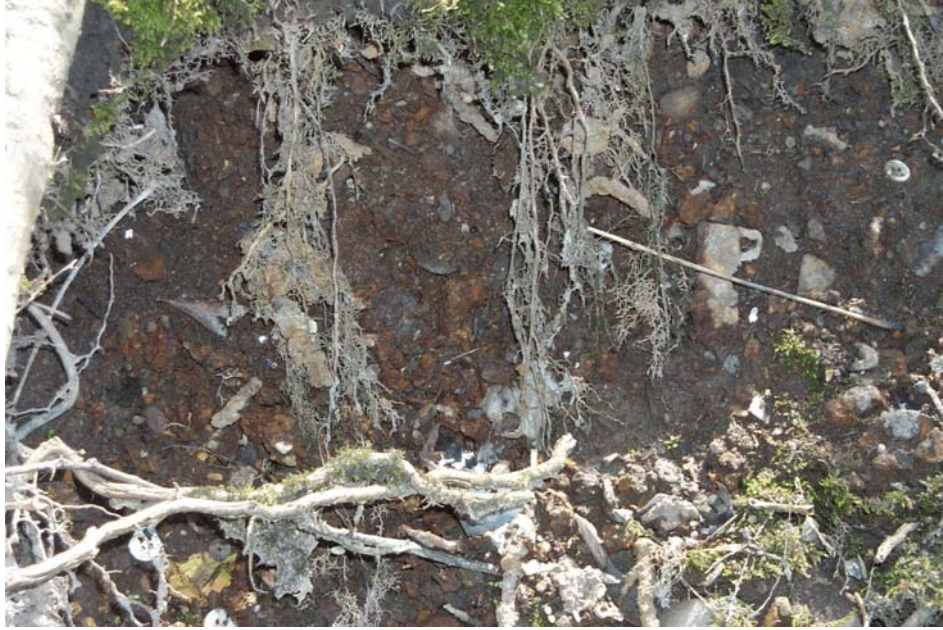
**Figure 5-3. Closeup photograph of ash fill in the creek bank along Eighteenmile Creek. Observe the buttons, which are characteristic of the ash fill on the island of the former Flintkote property. Photograph taken by Paul Dicky on April 16, 2002.**

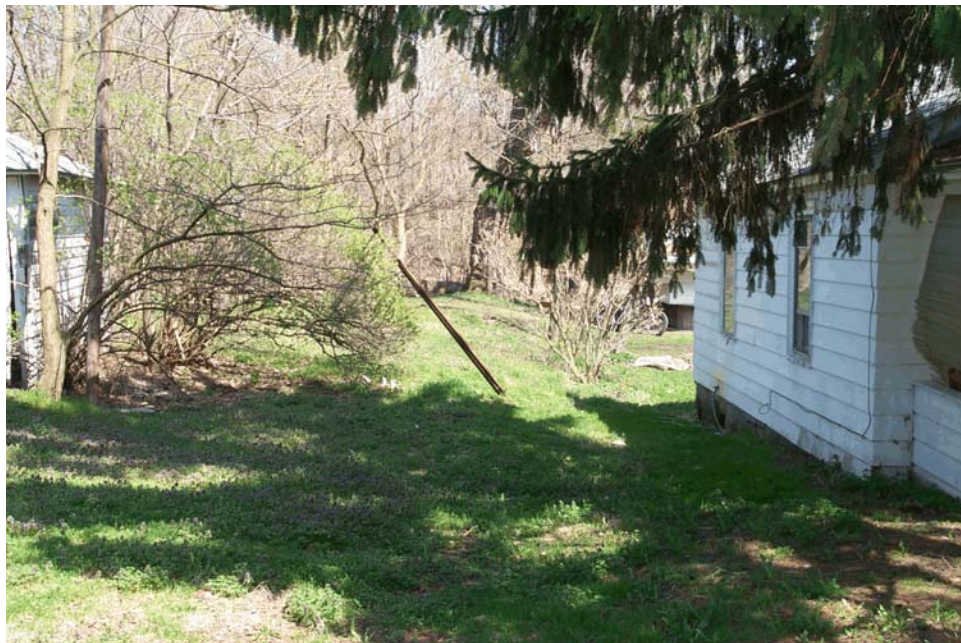
**Figure 5-4. Photograph of the property line between 131 and 127 Water Street. The elevation difference (about 3 feet) delineates the extent of ash-cinder fill at the 143 and 131 Water Street properties. Photograph taken by Paul Dicky on April 16, 2002.**

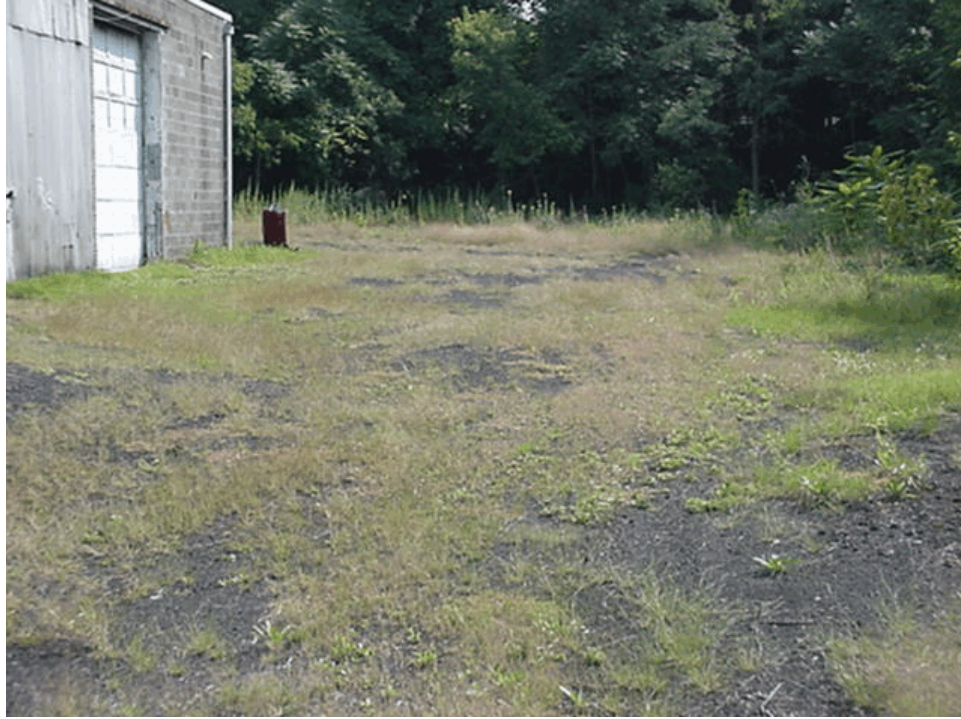
**Figure 5-5. Photograph of the slag and cinder fill on the White Transportation property. Photograph taken by Glenn May on September 22, 2005.**

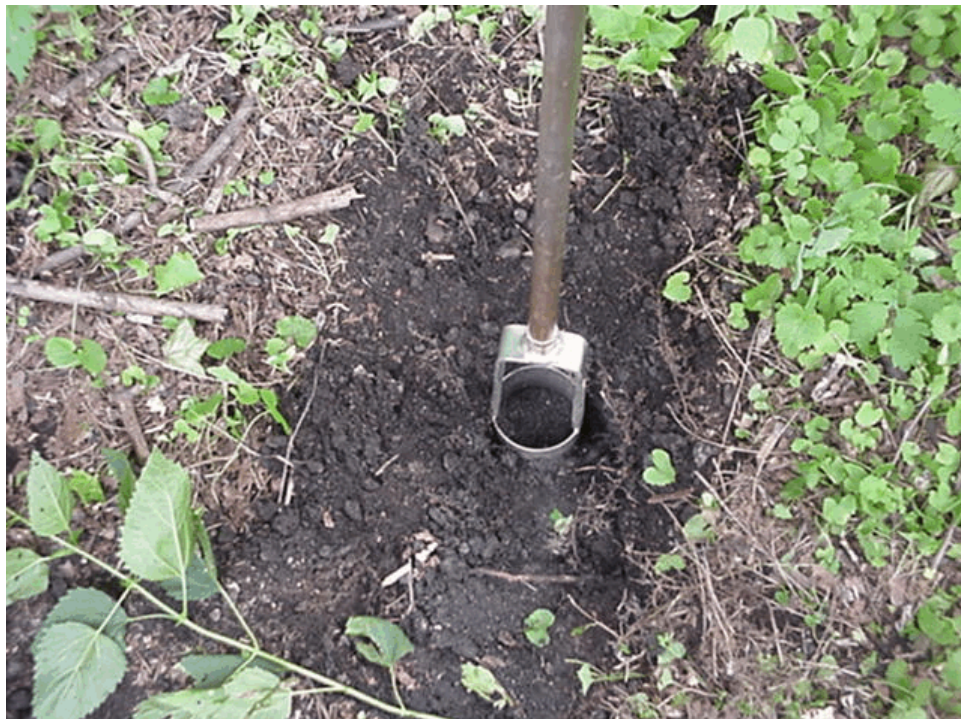
**Figure 5-6. Closeup photograph of the slag and cinder fill on the White Transportation property. Photograph taken by Glenn May on September 22, 2005.**

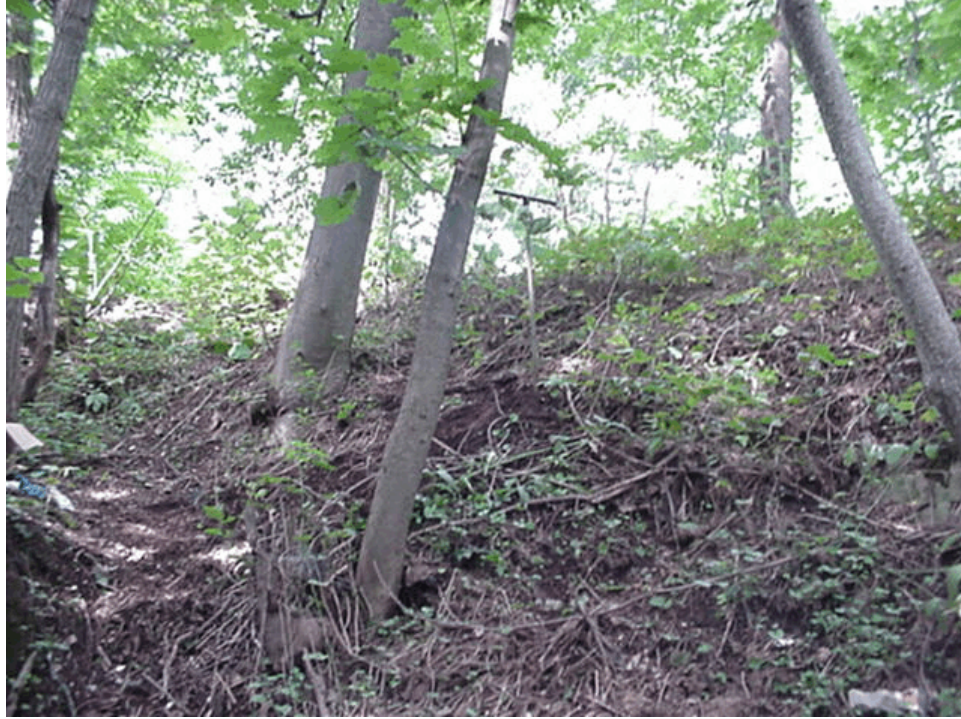
**Figure 5-7. Photograph of the ash-like fill along the north bank of Eighteenmile Creek in Upson Park. Photograph taken by Glenn May on September 22, 2005.**

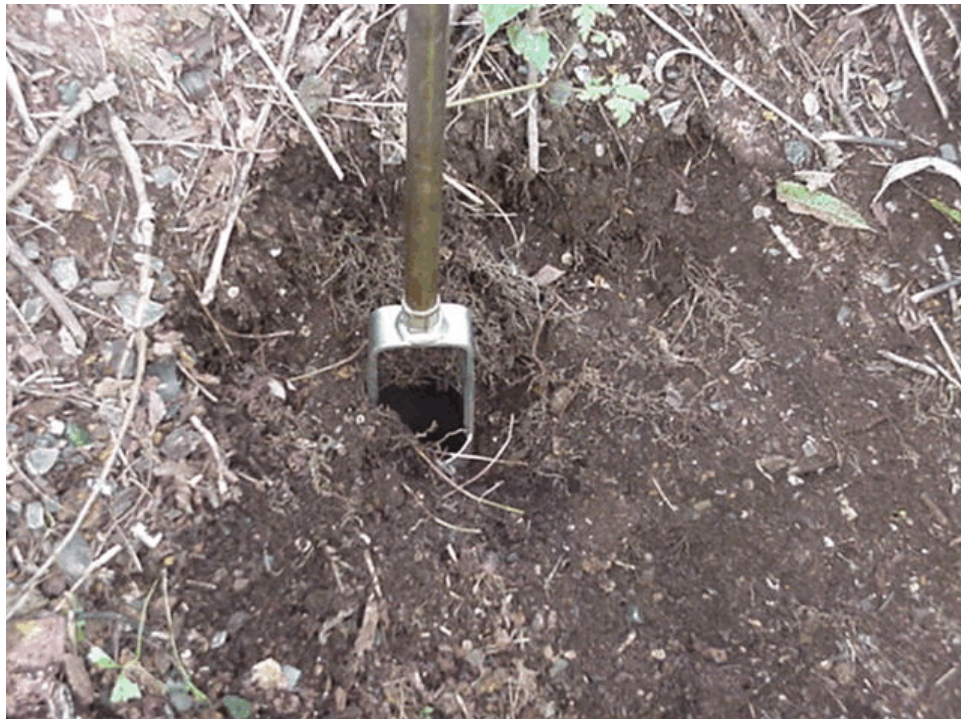
**Figure 5-8. Closeup photograph of the ash-like fill along the north bank of Eighteenmile Creek in Upson Park. Photograph taken by Glenn May on September 22, 2005.**

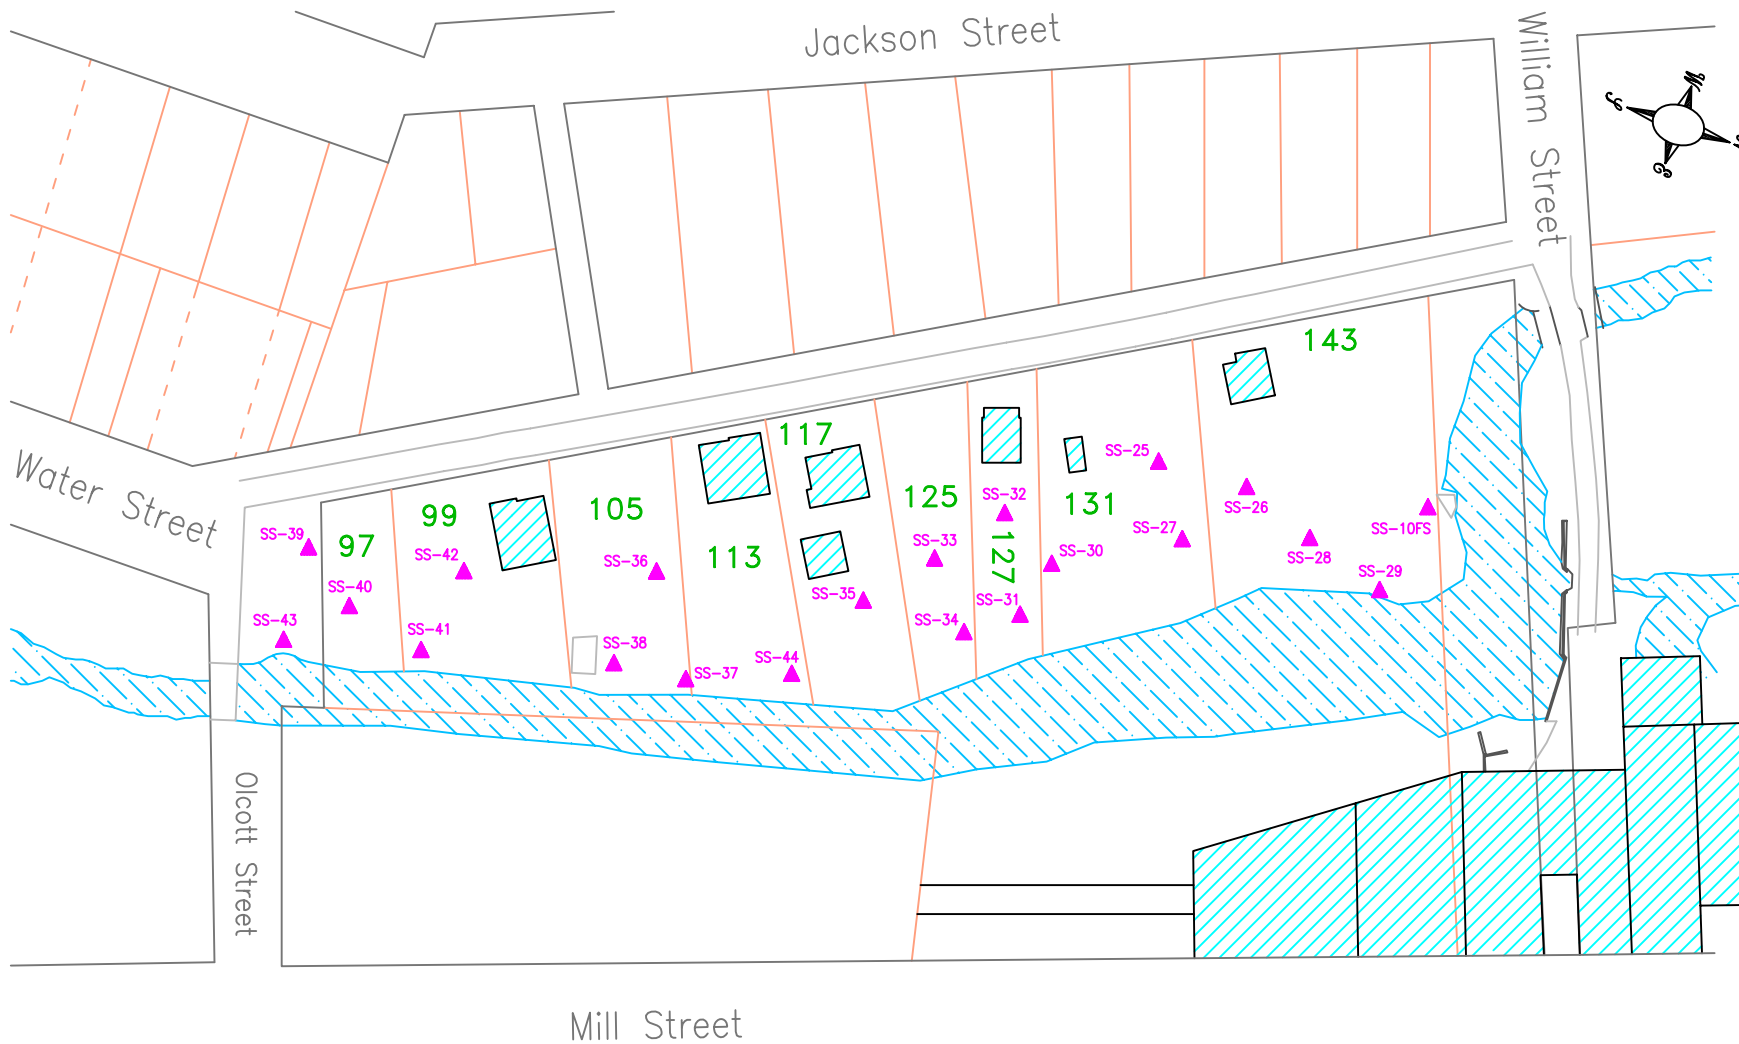
FIGURE 5-18

Figures 5-18 and 5-25 show that most residential soil and fill contains copper at concentrations that exceed the NYSDEC soil cleanup objective (25.0 mg/kg). The widespread occurrence of copper suggests that the fill material observed at these properties is the source of the copper contamination. The high copper concentration in sample SS-29 is likely related to creek flooding events as this sample was collected near the creek and contains copper at a concentration similar to those detected in Eighteenmile Creek sediment. Analytical results from an ash sample collected from the small ridge on the Water Street Section of the Former Flintkote Plant Site (Figure 5-2) contained copper at a concentration of 2,130 mg/kg. Surface water/solids runoff from this ridge to the 143 Water Street property likely explains the relatively high concentrations of copper in surface soil sample SS-10FS.

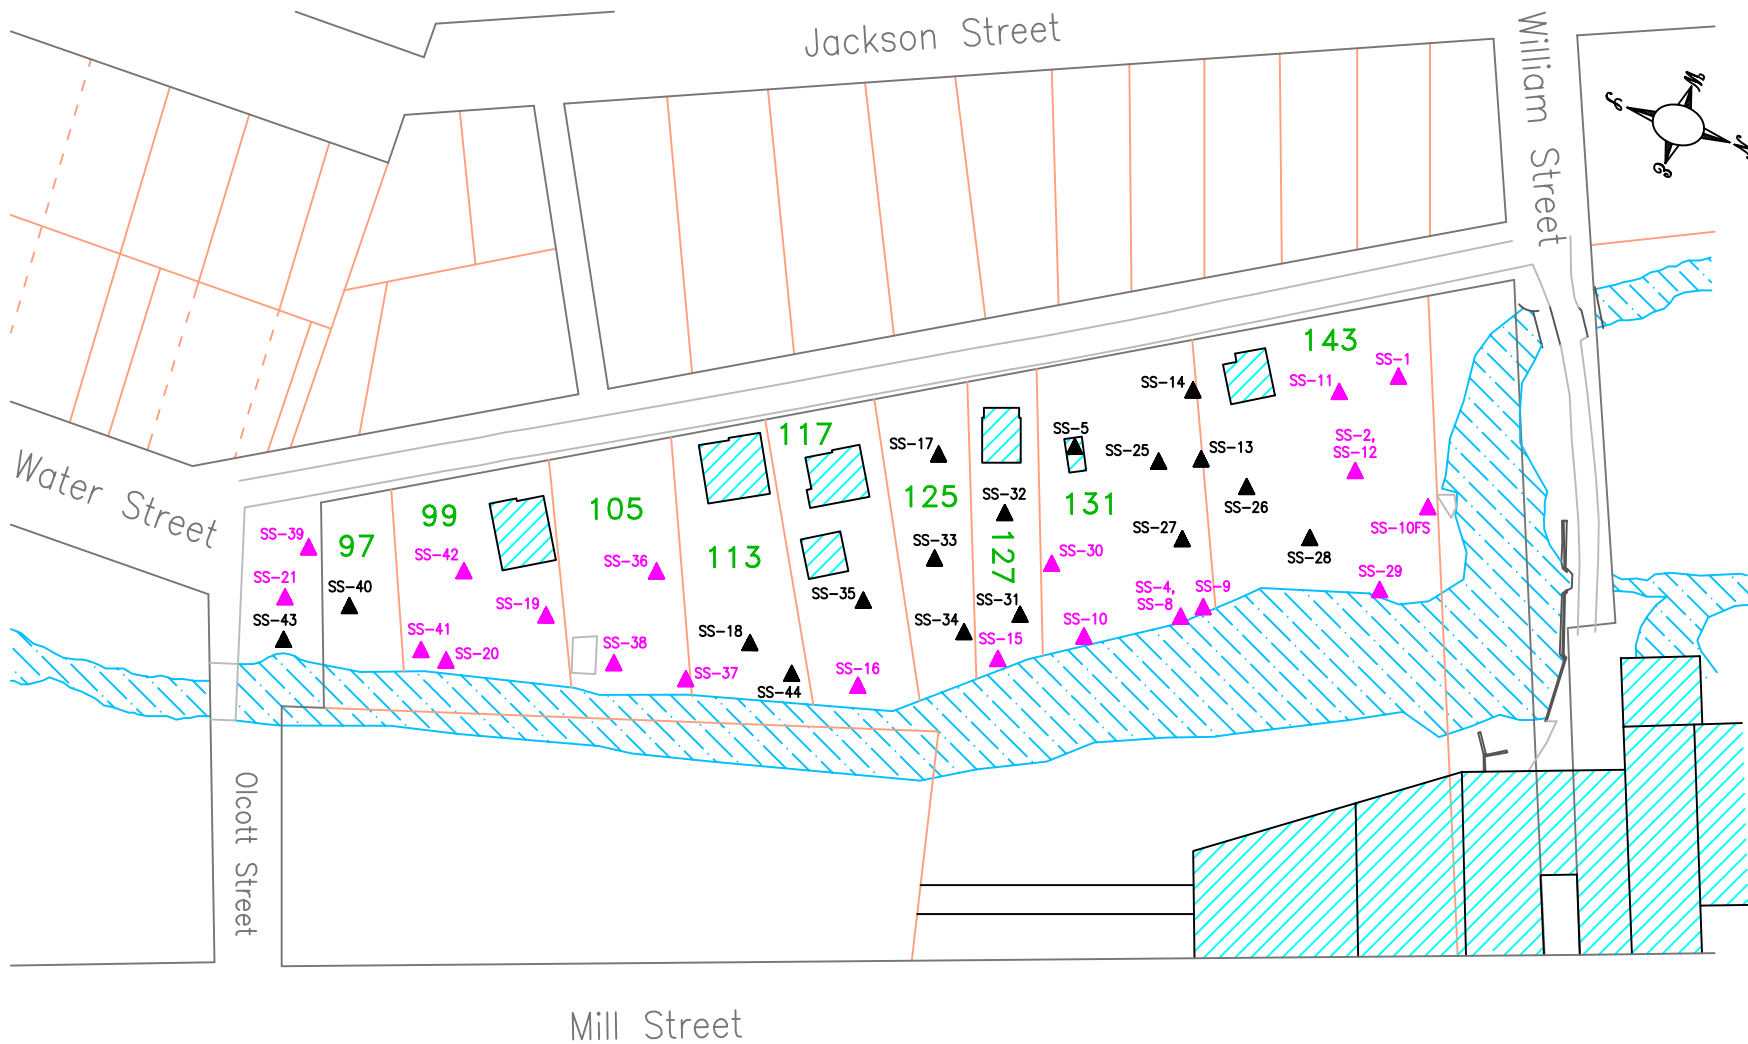
FIGURE 5-19

Lead was detected in all thirty-nine residential surface soil samples analyzed for lead at concentrations ranging from 29.8 to 4,630 mg/kg (Tables 5-2 thru 5-9). Figure 5-19 shows that twenty-two of these samples contained lead at concentrations that exceed the NYSDEC soil cleanup objective (400.0 mg/kg). In addition, eleven of these samples (SS-4, SS-8, SS-9, SS-10, SS-10FS, SS-12, SS-15, SS-21, SS-29, SS-30 and SS-41; Figure 3-2B) contained lead at concentrations above 1,000 mg/kg. The highest concentrations of lead (4,630 and 3,680 mg/kg) were detected in samples SS-10 and SS-21, respectively (Figure 3-2B).

The high lead concentrations in surface soil samples SS-4, SS-8, SS-9, SS-10, SS-15, SS-29 and SS-41 are likely related to creek flooding events as these samples were collected near the creek and contain lead at concentrations similar to those detected in Eighteenmile Creek sediment. Analytical results from an ash sample collected from the small ridge on the Water Street Section of the Former Flintkote Plant Site (Figure 5-2) contained lead at a concentration of 4,250 mg/kg. This sample also exceeded the TCLP Regulatory Limit for lead, indicating that this ash is a characteristic hazardous waste (D008). Surface water/solids runoff from this ridge to the 143 Water Street property likely explains the relatively high concentrations of lead in surface soil samples SS-10FS and SS-12. The reason for the high lead concentrations in samples SS-21, SS-30 and SB-11 is unknown as the concentrations in these samples are higher than those detected in residential fill. In addition, the two surface soil samples do not appear to be located in the flood plain.

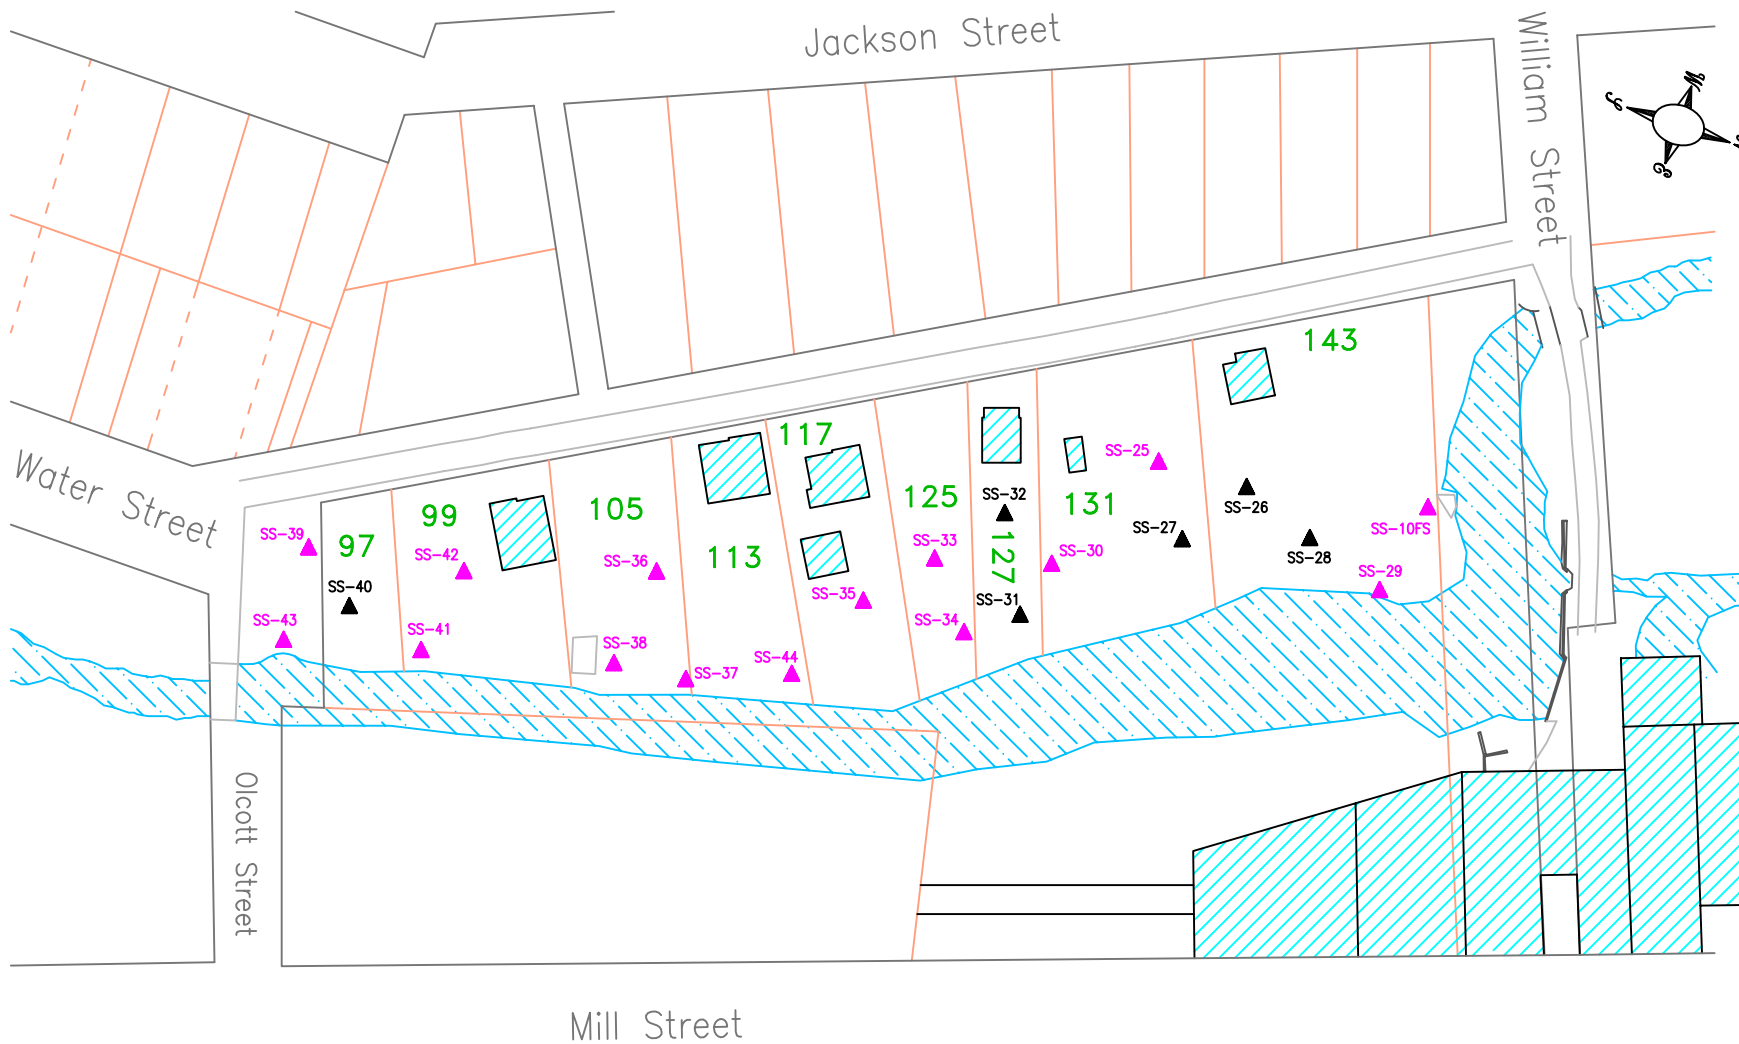
SITE NAME: EIGHTEENMILE CREEK CORRIDOR **FIGURE 5-20**

Zinc was detected in all twenty-one residential surface soil samples analyzed for zinc at concentrations ranging from 146 to 2,390 mg/kg (Tables 5-2 thru 5-9). Figure 5-20 shows that fifteen of these samples contain zinc at concentrations that exceed the NYSDEC soil cleanup objective (254.5 mg/kg). In addition, six of these samples (SS-10FS, SS-29, SS-30, SS-37, SS-41 and SS-44; Figure 3-2B) contained zinc at concentrations above 1,000 mg/kg. The highest concentrations of zinc (2,390 and 1,660 mg/kg) were detected in samples SS-10FS (143 Water Street) and SS-30 (131 Water Street), respectively.

The high zinc concentrations in surface soil samples SS-29, SS-37, SS-41 and SS-44 are likely related to creek flooding events as these samples were collected near the creek and contain zinc at concentrations similar to those detected in Eighteenmile Creek sediment. Analytical results from an ash sample collected from the small ridge on the Water Street Section of the Former Flintkote Plant Site (Figure 5-2) contained zinc at a concentration of 3,470 mg/kg. Surface water/solids runoff from this ridge to the 143 Water Street property likely explains the relatively high concentrations of zinc in surface soil sample SS-10FS. The reason for the high zinc concentration in sample SS-30 is unknown as the concentration in this sample is significantly higher than those detected in residential fill collected from the 131 Water Street property. In addition, this sample does not appear to be located in the flood plain.

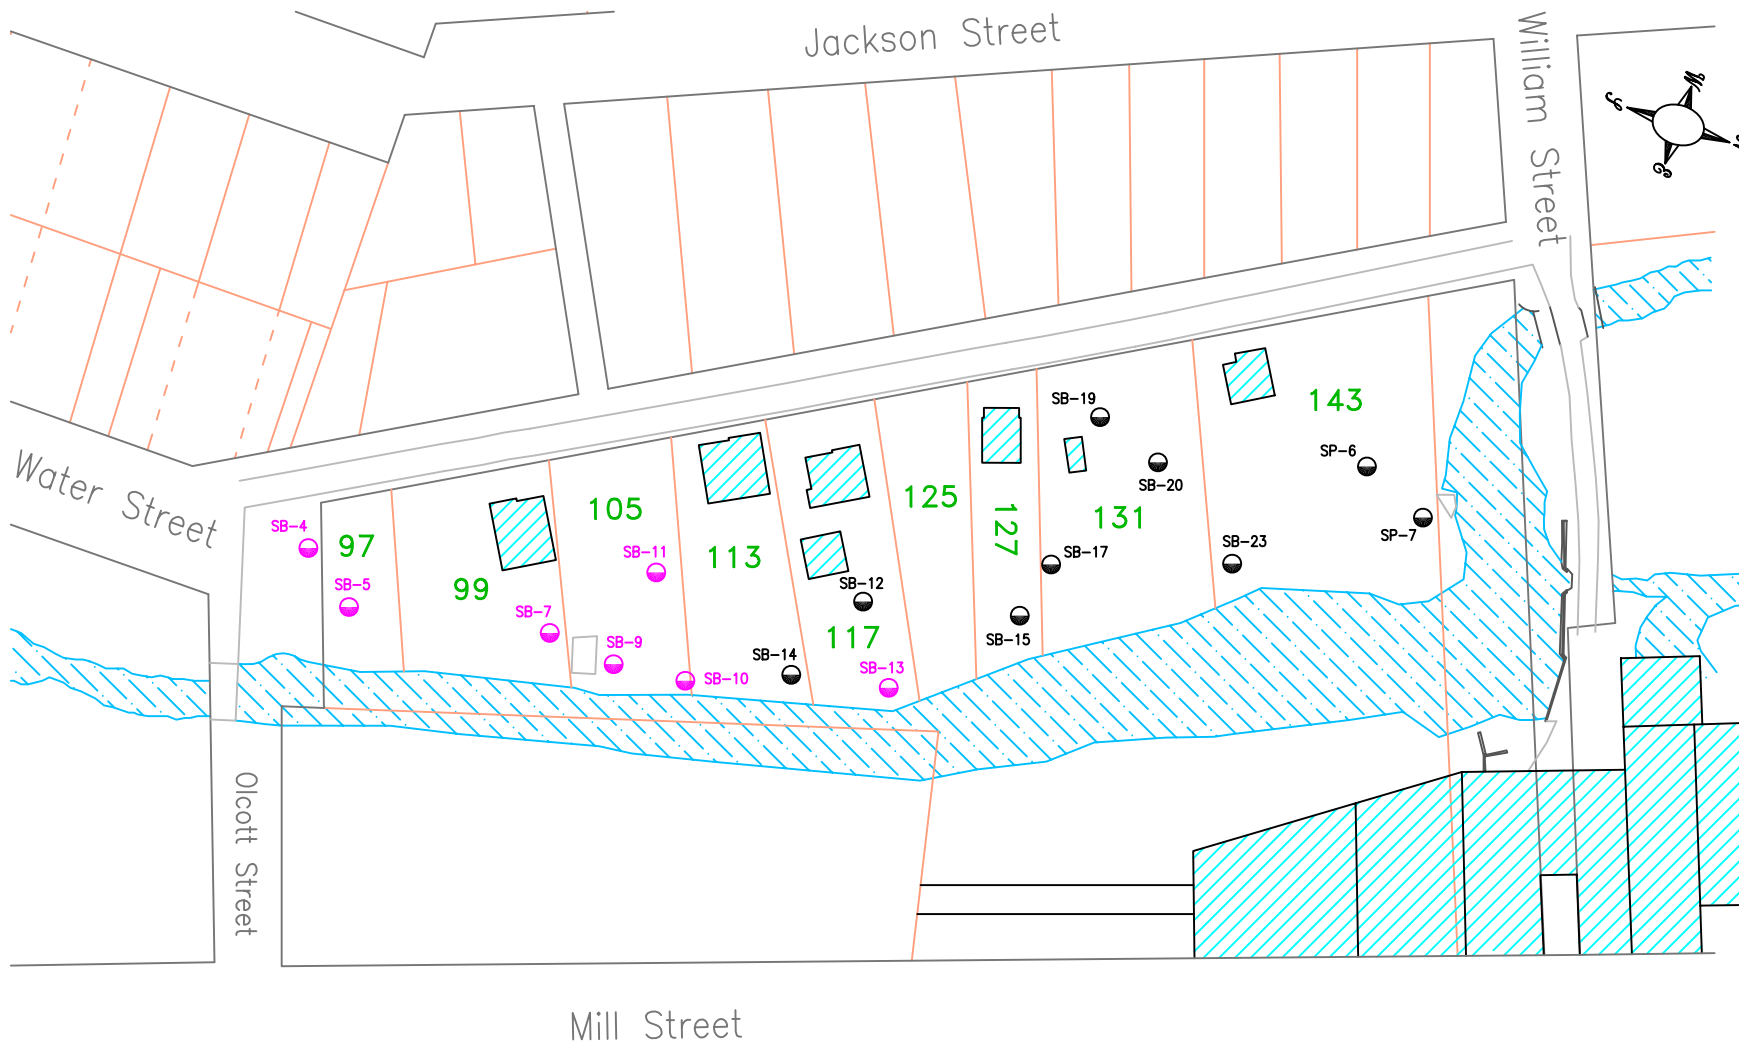
FIGURE 5-26

Lead was also detected in all nineteen residential subsurface samples at concentrations ranging from 5.4 to 1,030 mg/kg (Table 5-10). The highest concentrations of lead (1,030 mg/kg) was detected in sample SB-11, which was collected from the backyard of the 105 Water Street property (Figure 3-1). Figure 5-26 shows that every subsurface sample collected from the 97 to 117 Water Street properties, with the exception
