*Preliminary Site Assessment
Soil/Subsurface Structure
Investigation Report and Interim
Remedial Measures Plan*

Niagara Mohawk Power Corporation
Harper Substation
Niagara Falls, New York

December 2000

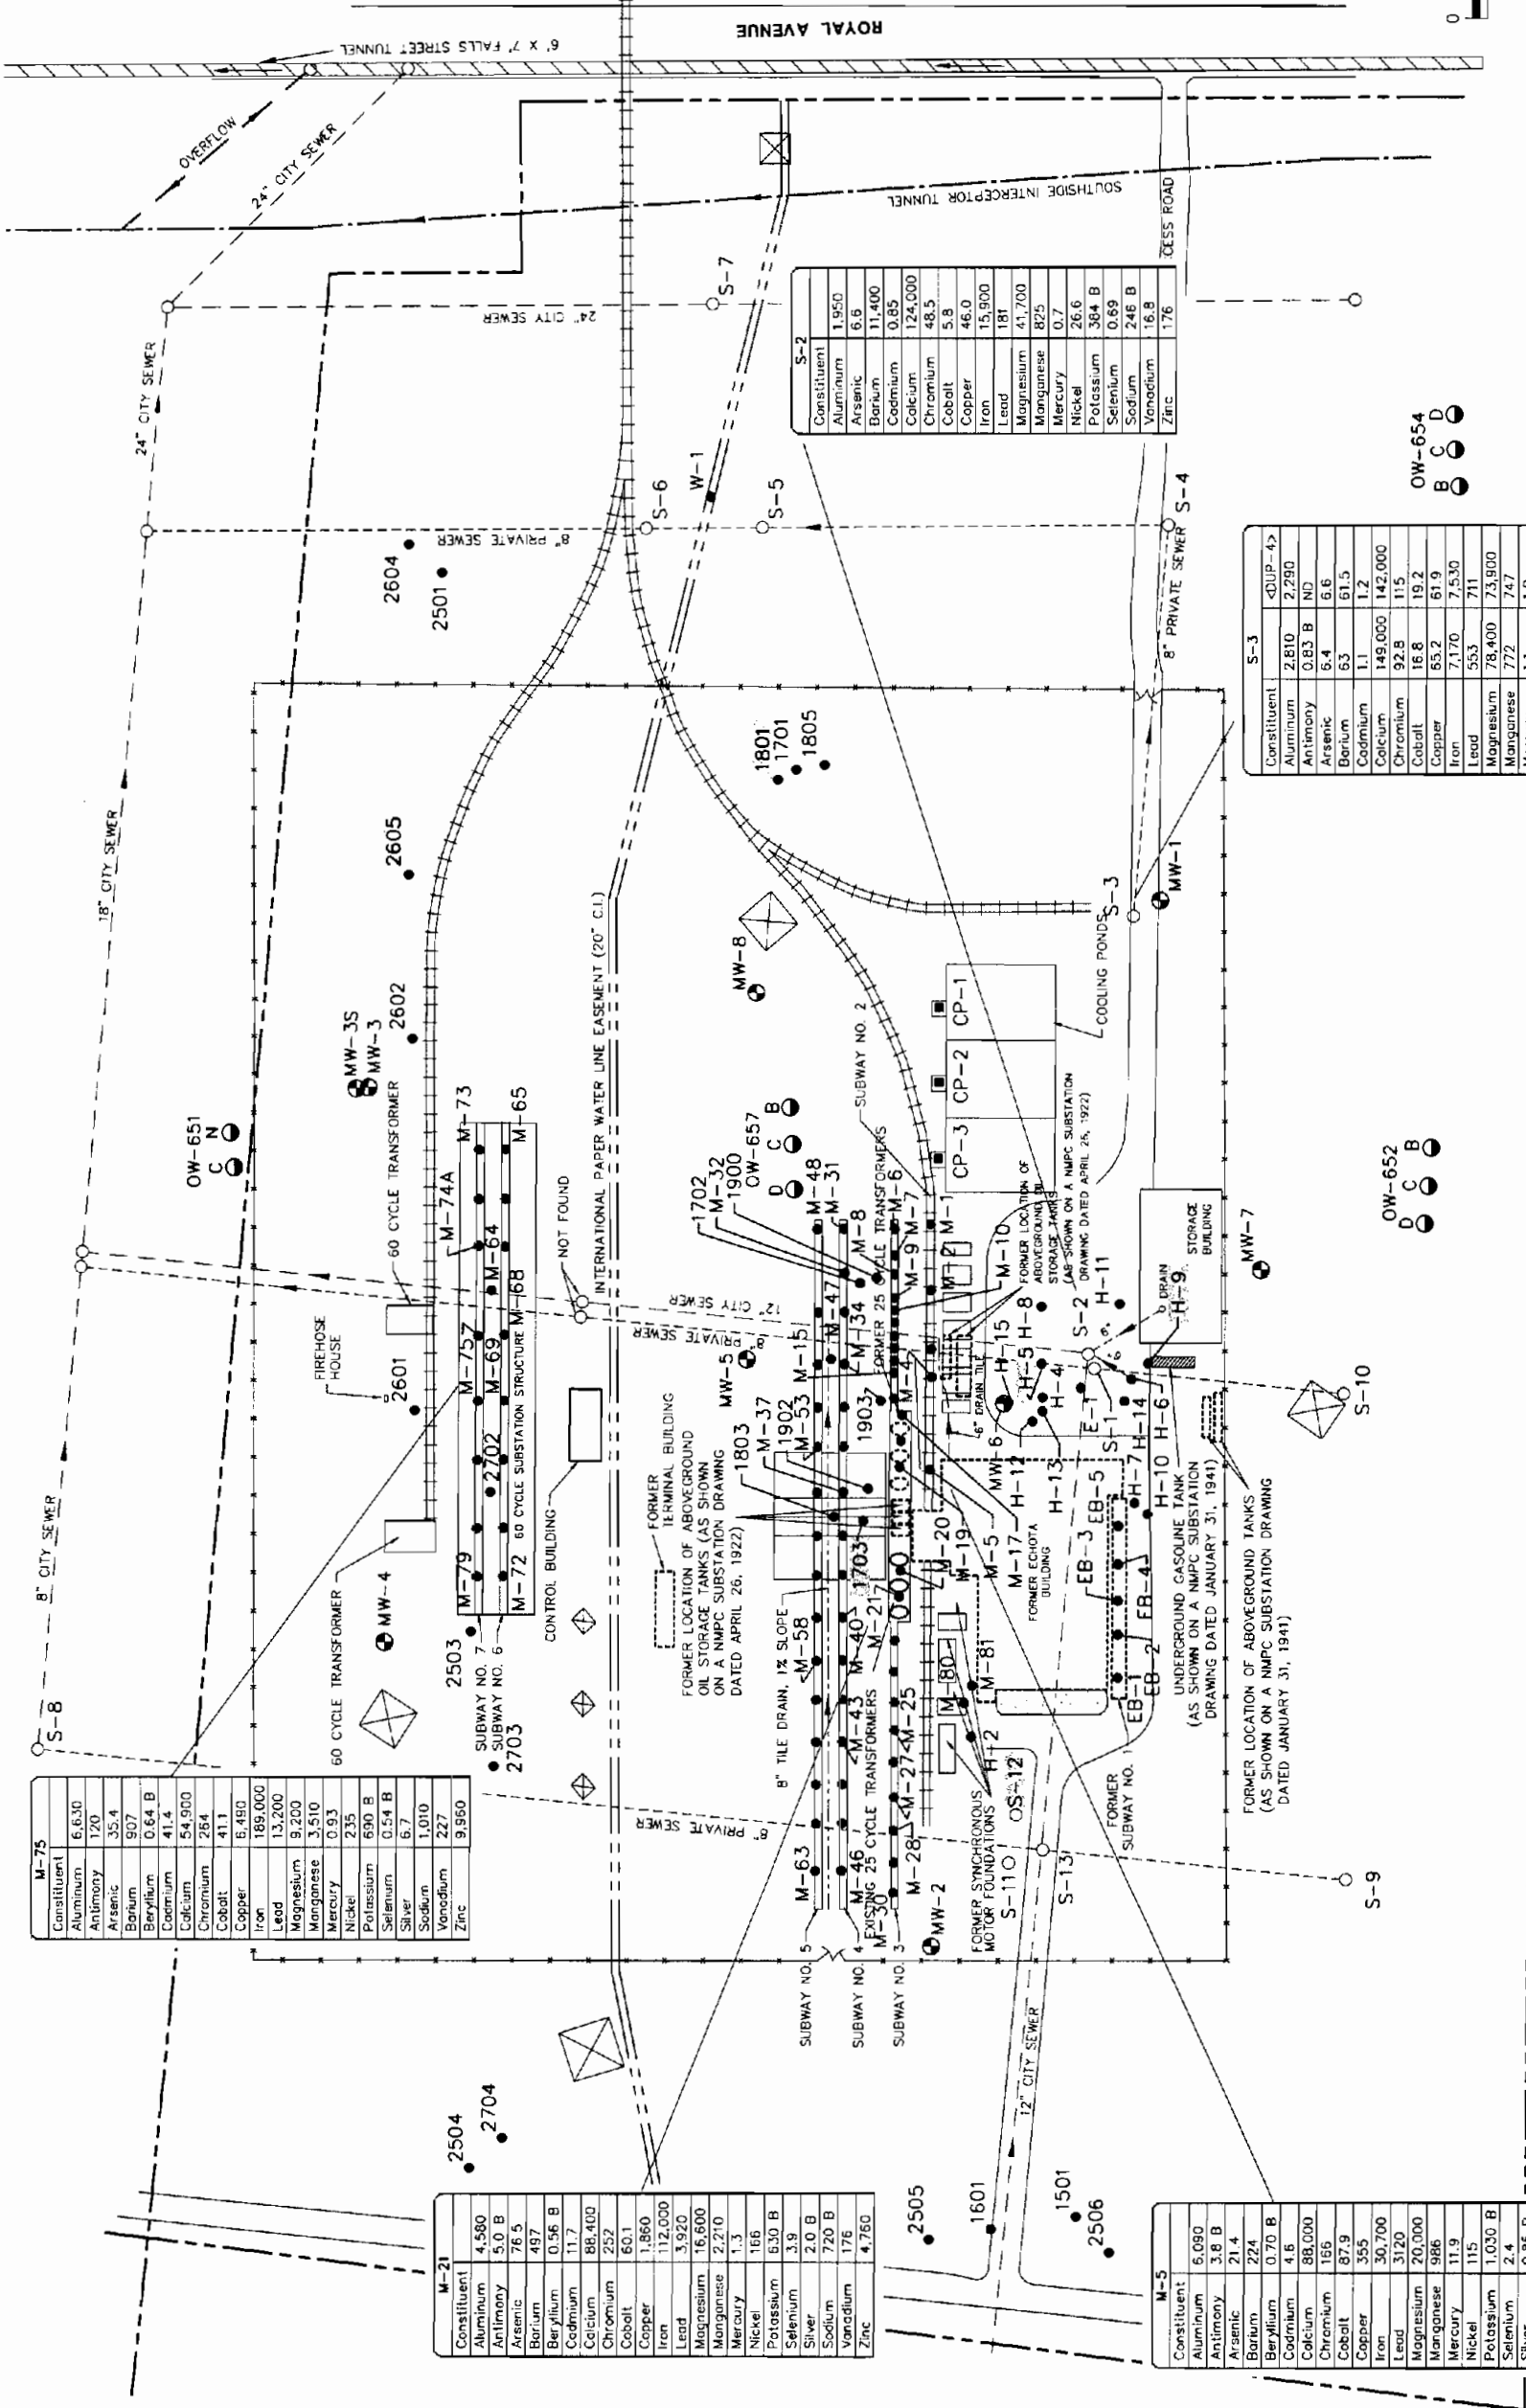
FIGURE
12

- Lead was detected in each of the subsurface structure debris samples at concentrations ranging from 181 ppm in sample S-2 to 13,200 ppm in sample M-75. Mercury was detected in each debris sample at concentrations ranging from 0.7 ppm in sample S-2 to 11.9 ppm in sample M-5. The analytical results obtained from the laboratory analysis of the subsurface structure debris samples for TAL inorganic constituents are listed in Table 12 and shown on Figure 12.

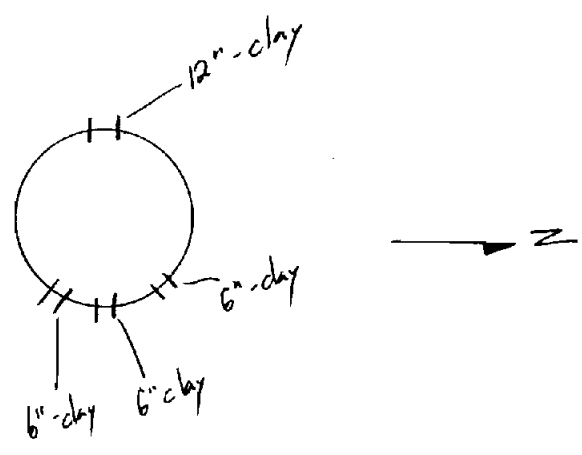
Overall Condition of Structure: Good
 Height of Riser Section: 10"
 Depth from Rim to Bottom of Structure: 15.5' Interior Dimensions of Structure: 24" - (0-7.5) - 36" (25')
 Depth of Water in Structure: 6" Sheen Present on Water (Y/N): No
 Depth of Debris in Structure: ND Description of Debris: Silt/Sand
 Debris Sample ID (if collected): S-2 Time Collected: 7/22/99 - 15:00

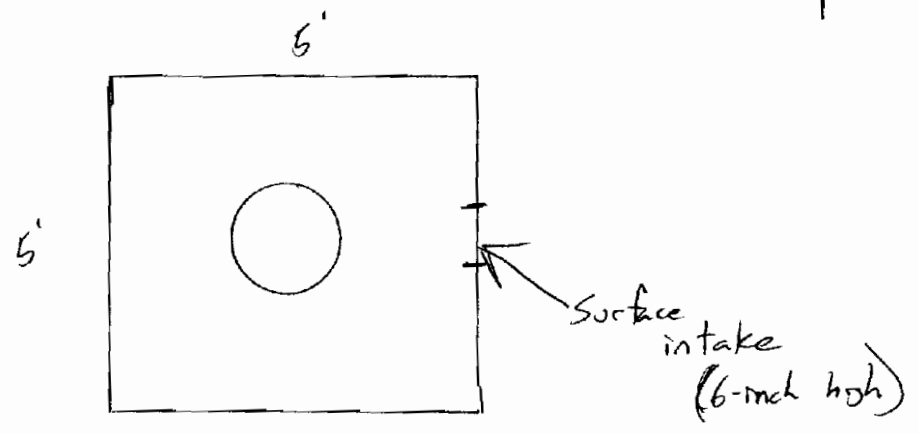
Overall Condition of Structure: Fair
 Height of Riser Section: 6"
 Depth from Rim to Bottom of Structure: 6.5' Interior Dimensions of Structure: 5' x 5'
 Depth of Water in Structure: 0" Sheen Present on Water (Y/N): NA
 Depth of Debris in Structure: 2.5' ± Description of Debris: Silt/Sand/Gravel
 Debris Sample ID (if collected): 5-3 Time Collected: 7/22/99 - 13:50

Other Information: • Inlet/outlet pipes cannot be observed
• Odor observed on debris sample collected
• Brick sidewall are dark

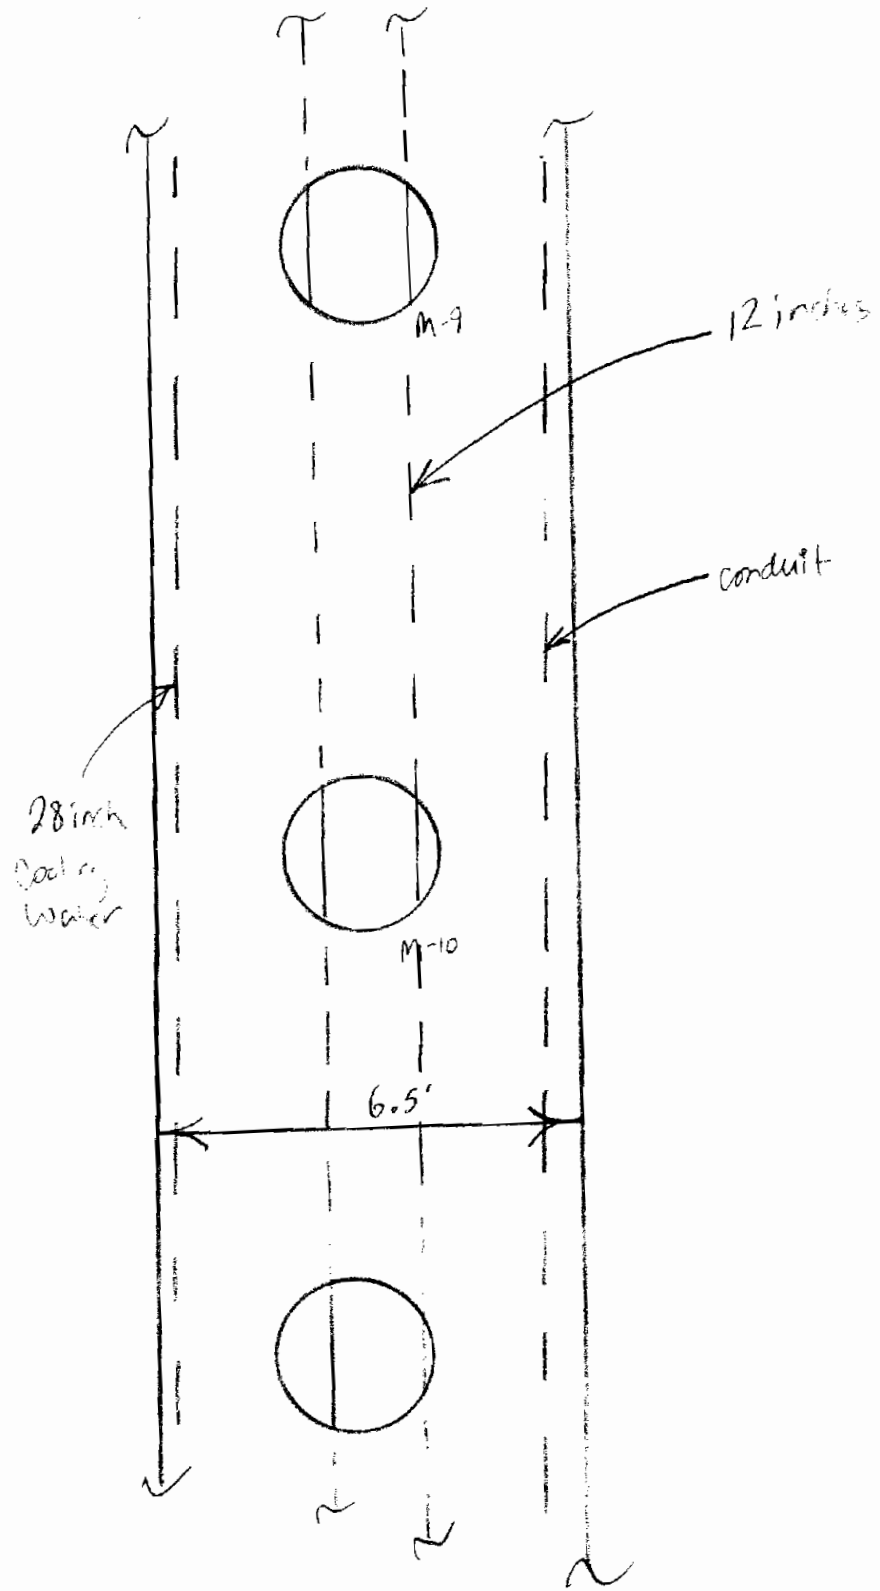
Overall Condition of Structure: good
 Height of Riser Section: 1 foot
 Depth from Rim to Bottom of Structure: 7.0 feet
 Depth of Water in Structure: 0
 Depth of Debris in Structure: 1 inch
 Debris Sample ID (if collected): _____
 Interior Dimensions of Structure: 6.5 feet wide
 Sheen Present on Water (Y/N): _____
 Description of Debris: Silt/sand/rusted metal
 Time Collected: _____

Other Information: M-13 could not be opened. Western side wall visually stained

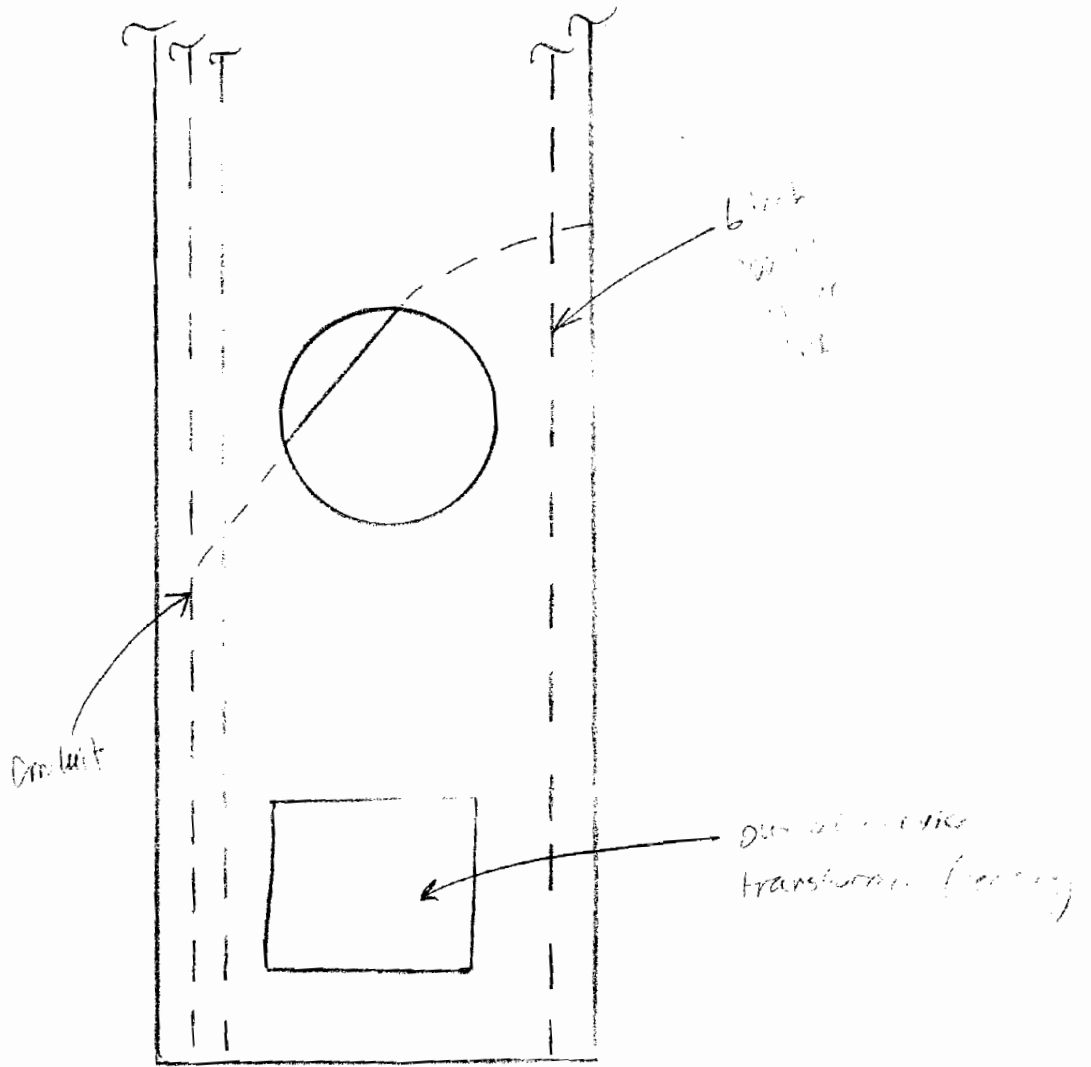
Type of Structure: Manhole / Catch Basin / Conduit Vault / Other: Concrete Subway
 Construction Materials:
 Riser Section: Brick&Mortar / Concrete / Other: Concrete / Steel (Circle One)
 Sidewalls: Brick&Mortar / Concrete Block / Concrete / Other: _____ (Circle One)
 Bottom: Brick&Mortar / Concrete Block / Concrete / Other: _____ (Circle One)
 Overall Condition of Structure: good
 Height of Riser Section: 1 foot
 Depth from Rim to Bottom of Structure: 7.0 feet
 Depth of Water in Structure: 6 inches
 Depth of Debris in Structure: 1 inch
 Debris Sample ID (if collected): _____
 Interior Dimensions of Structure: 6.5 feet wide
 Sheen Present on Water (Y/N): Y; slight sheen
 Description of Debris: Silt/Sand
 Time Collected: _____

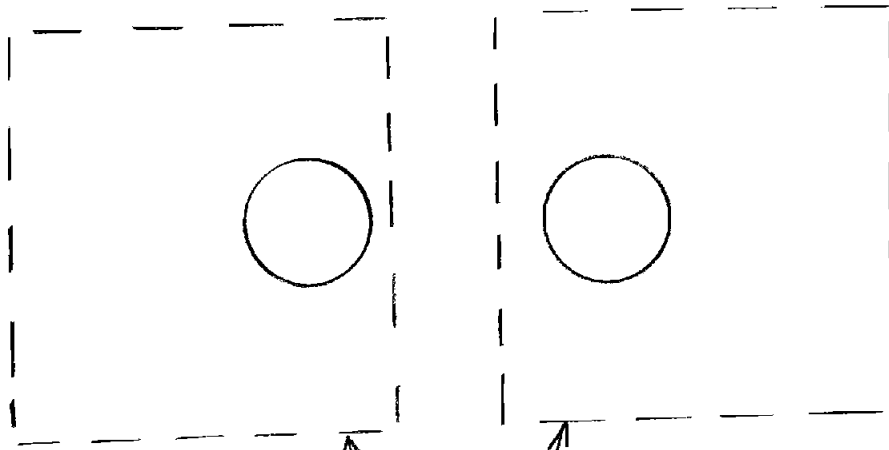
6' square
vaults

Overall Condition of Structure: good
Height of Riser Section: 1 foot
Depth from Rim to Bottom of Structure: 8 foot, 7.5 feet
Depth of Water in Structure: 2 feet, 1.5 feet
Depth of Debris in Structure: 6 inch
Debris Sample ID (if collected): _____

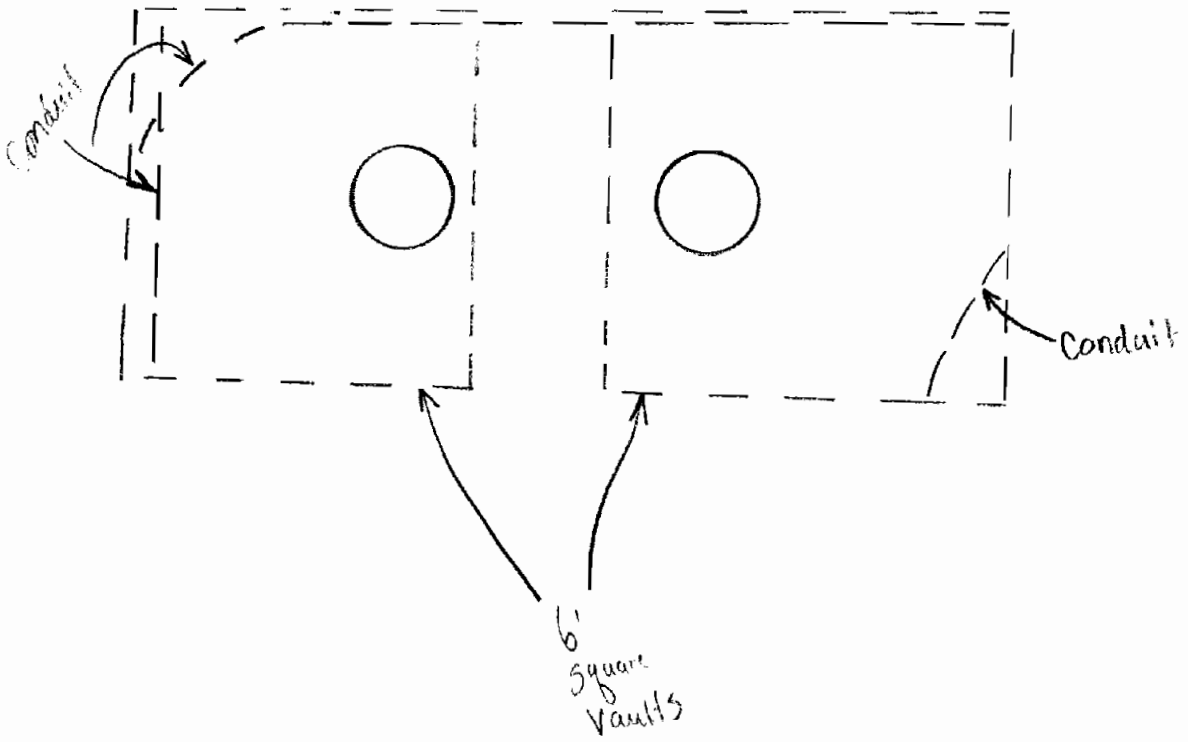
Overall Condition of Structure: Good
Height of Riser Section: 1.2'
Depth from Rim to Bottom of Structure: 7.5' **Interior Dimensions of Structure:** 5' x 5'
Depth of Water in Structure: 1.9' **Sheen Present on Water (Y/N):** Slight Sheen upon strong
Depth of Debris in Structure: ~2" **Description of Debris:** Silt Sand debris
Debris Sample ID (if collected): _____ **Time Collected:** _____

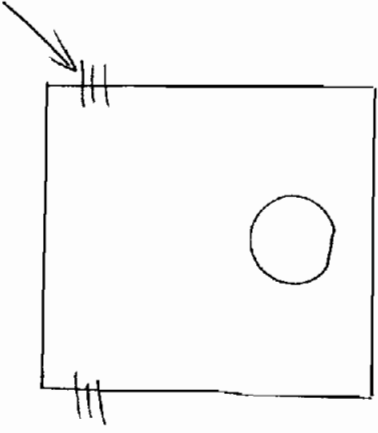
1701

Overall Condition of Structure: good
Height of Riser Section: 4.5 feet
Depth from Rim to Bottom of Structure: 10.8 feet **Interior Dimensions of Structure:** undetermined
Depth of Water in Structure: 2.3 feet **Sheen Present on Water (Y/N):** Y
Depth of Debris in Structure: 2 inches **Description of Debris:** silt/sand
Debris Sample ID (if collected): _____ **Time Collected:** _____

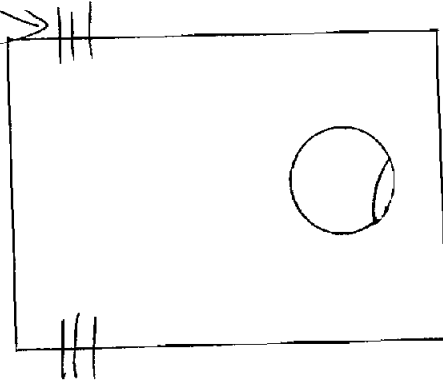
1805

Overall Condition of Structure: good
Height of Riser Section: 14.3 feet
Depth from Rim to Bottom of Structure: 11 feet
Depth of Water in Structure: 2.5 feet
Depth of Debris in Structure: 4 inch
Debris Sample ID (if collected): _____
Interior Dimensions of Structure: unknown
Sheen Present on Water (Y/N): slight sheen
Description of Debris: silt/sand
Time Collected: _____

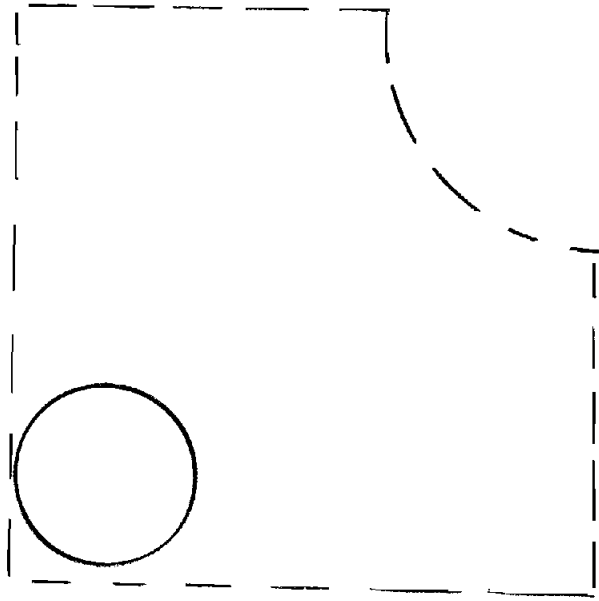
Overall Condition of Structure: good
Height of Riser Section: 2.5 feet
Depth from Rim to Bottom of Structure: 8.5 feet
Depth of Water in Structure: 0
Depth of Debris in Structure: 1-2 inches
Debris Sample ID (if collected): _____
Interior Dimensions of Structure: unknown
Sheen Present on Water (Y/N): _____
Description of Debris: rust/silt
Time Collected: _____

Other Information: Sidewalls are stained
