PHASE 1 RECONNAISSANCE SURVEY

Eighteenmile Creek Area of Concern

Niagara County, New York

Remedial Investigation/Feasibility Study

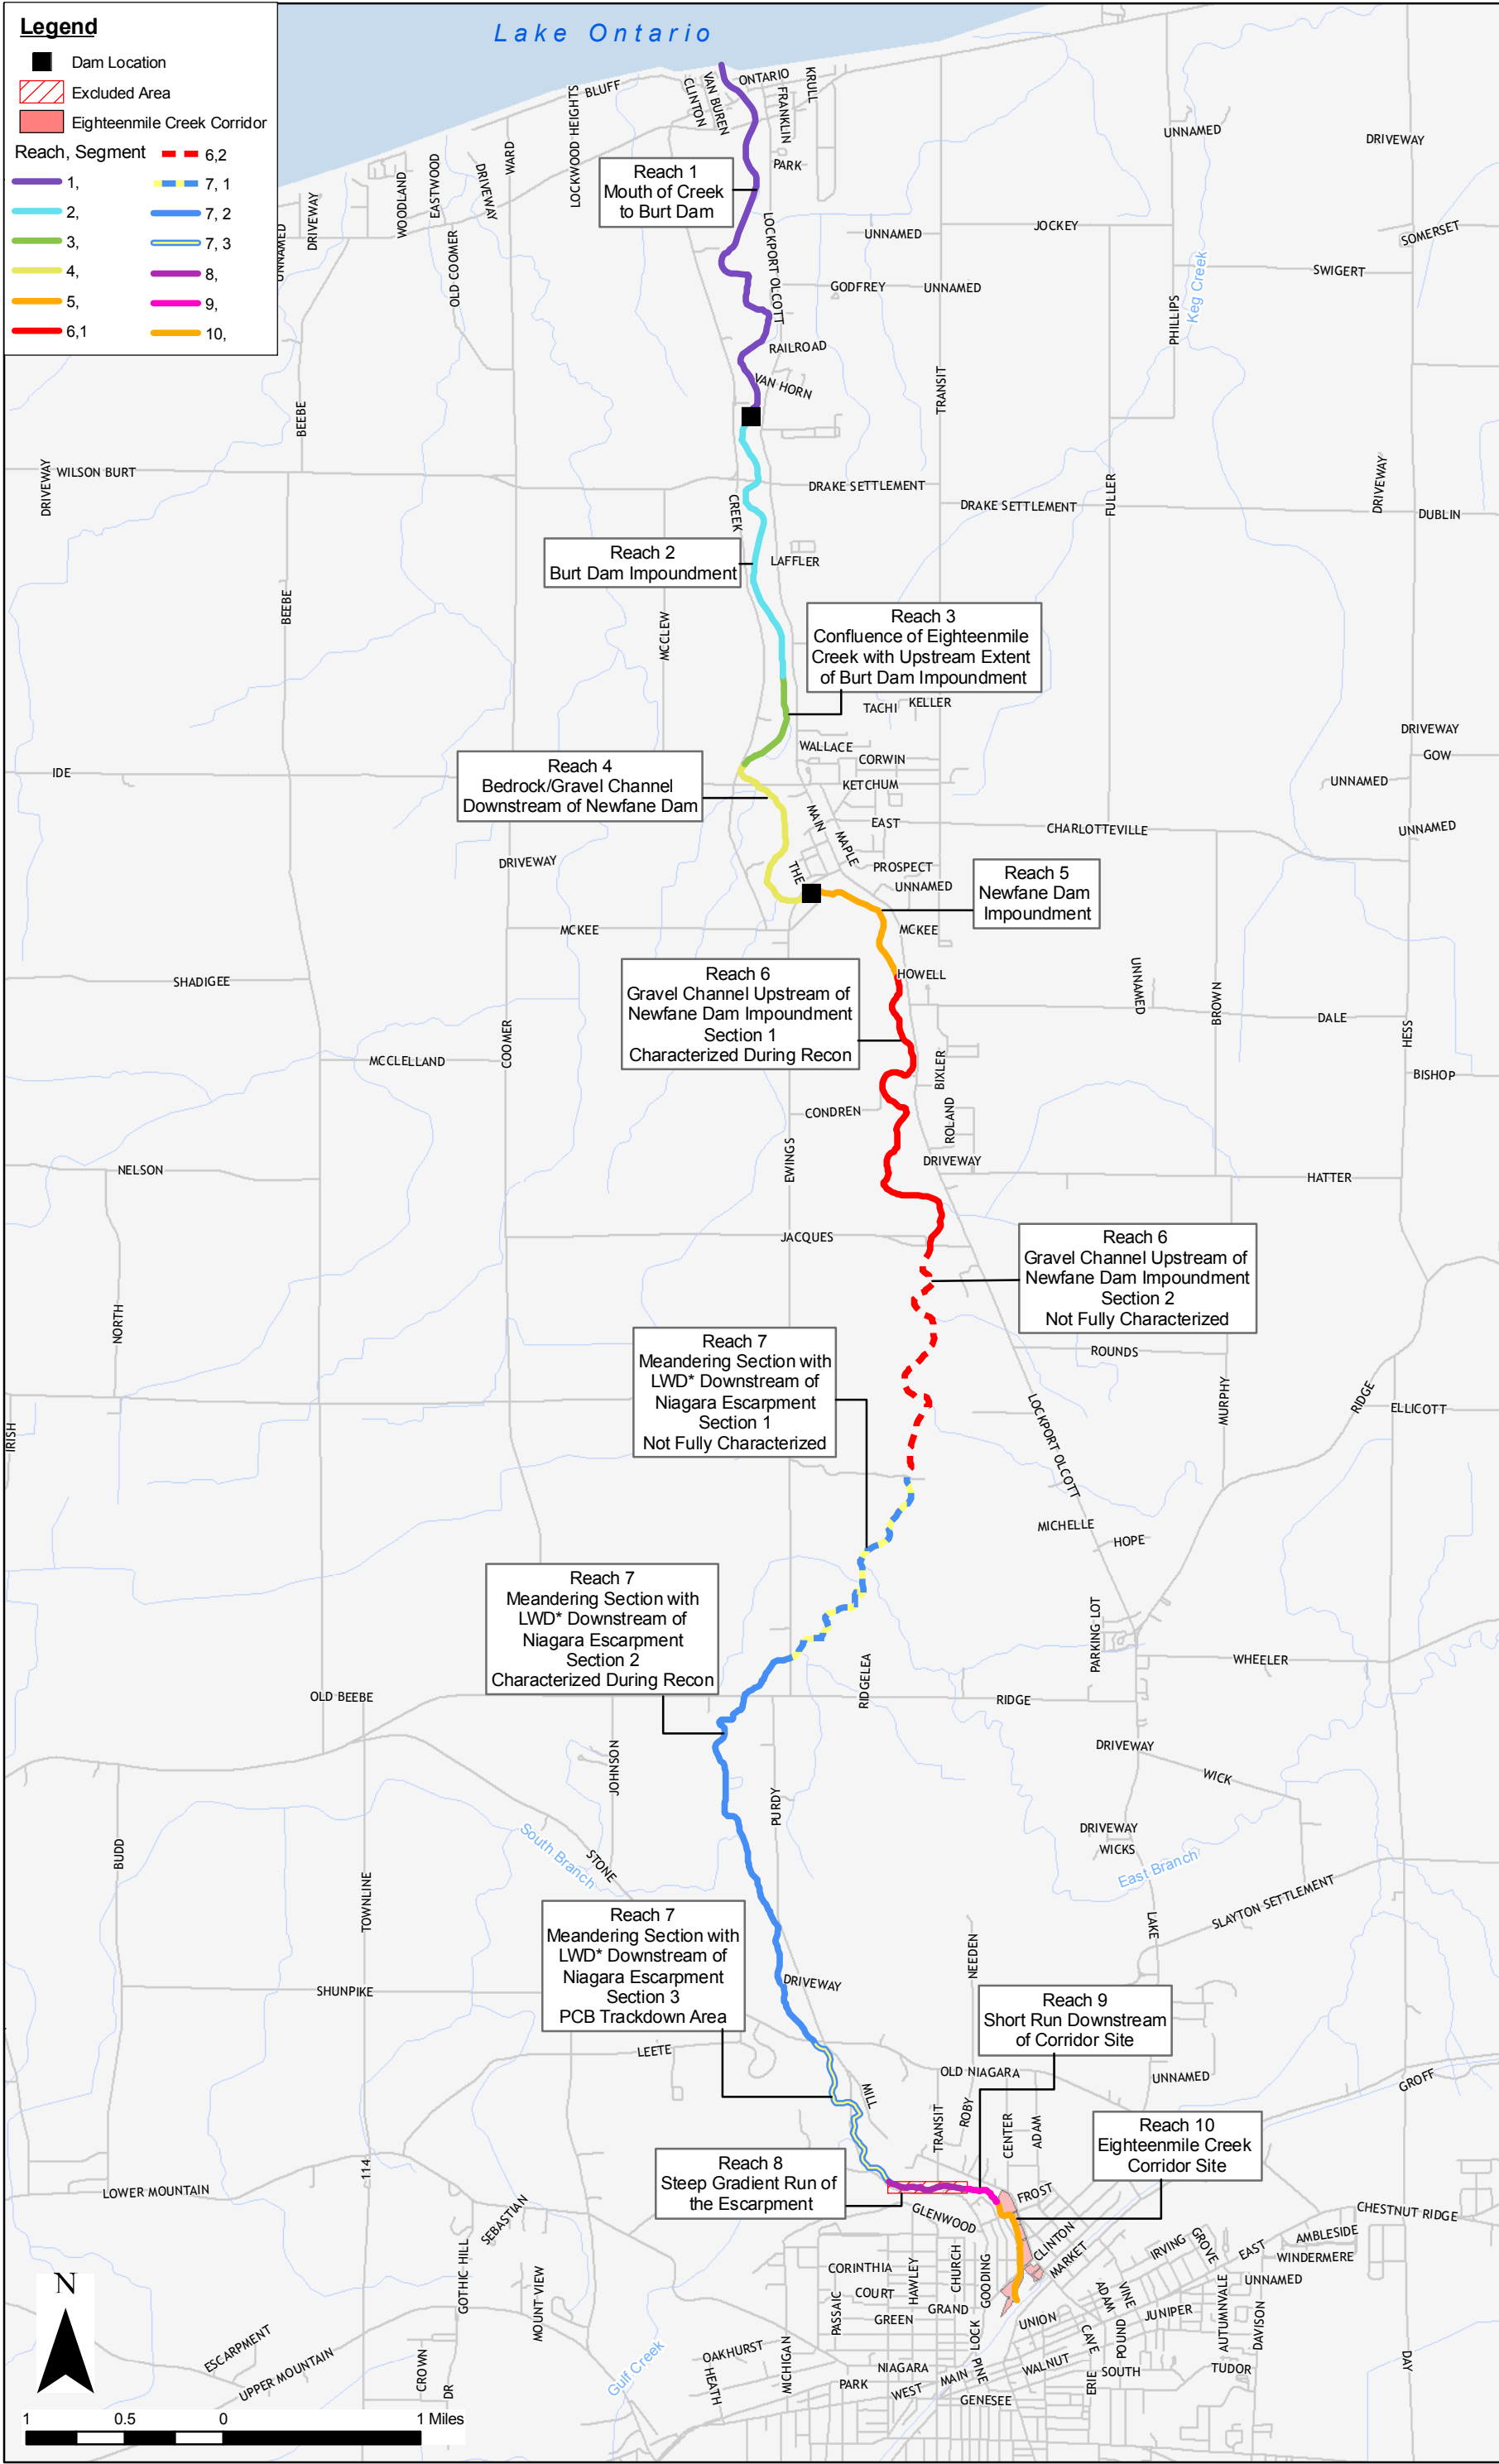
Figure 2-1 Eighteenmile Creek AOC and Investigation Areas

The results of the Phase 1 survey were used to define reaches of the creek based on the overall physical and channel substrate characteristics. These reaches are shown in Figure 2-1 and summarized on Table 2-1.

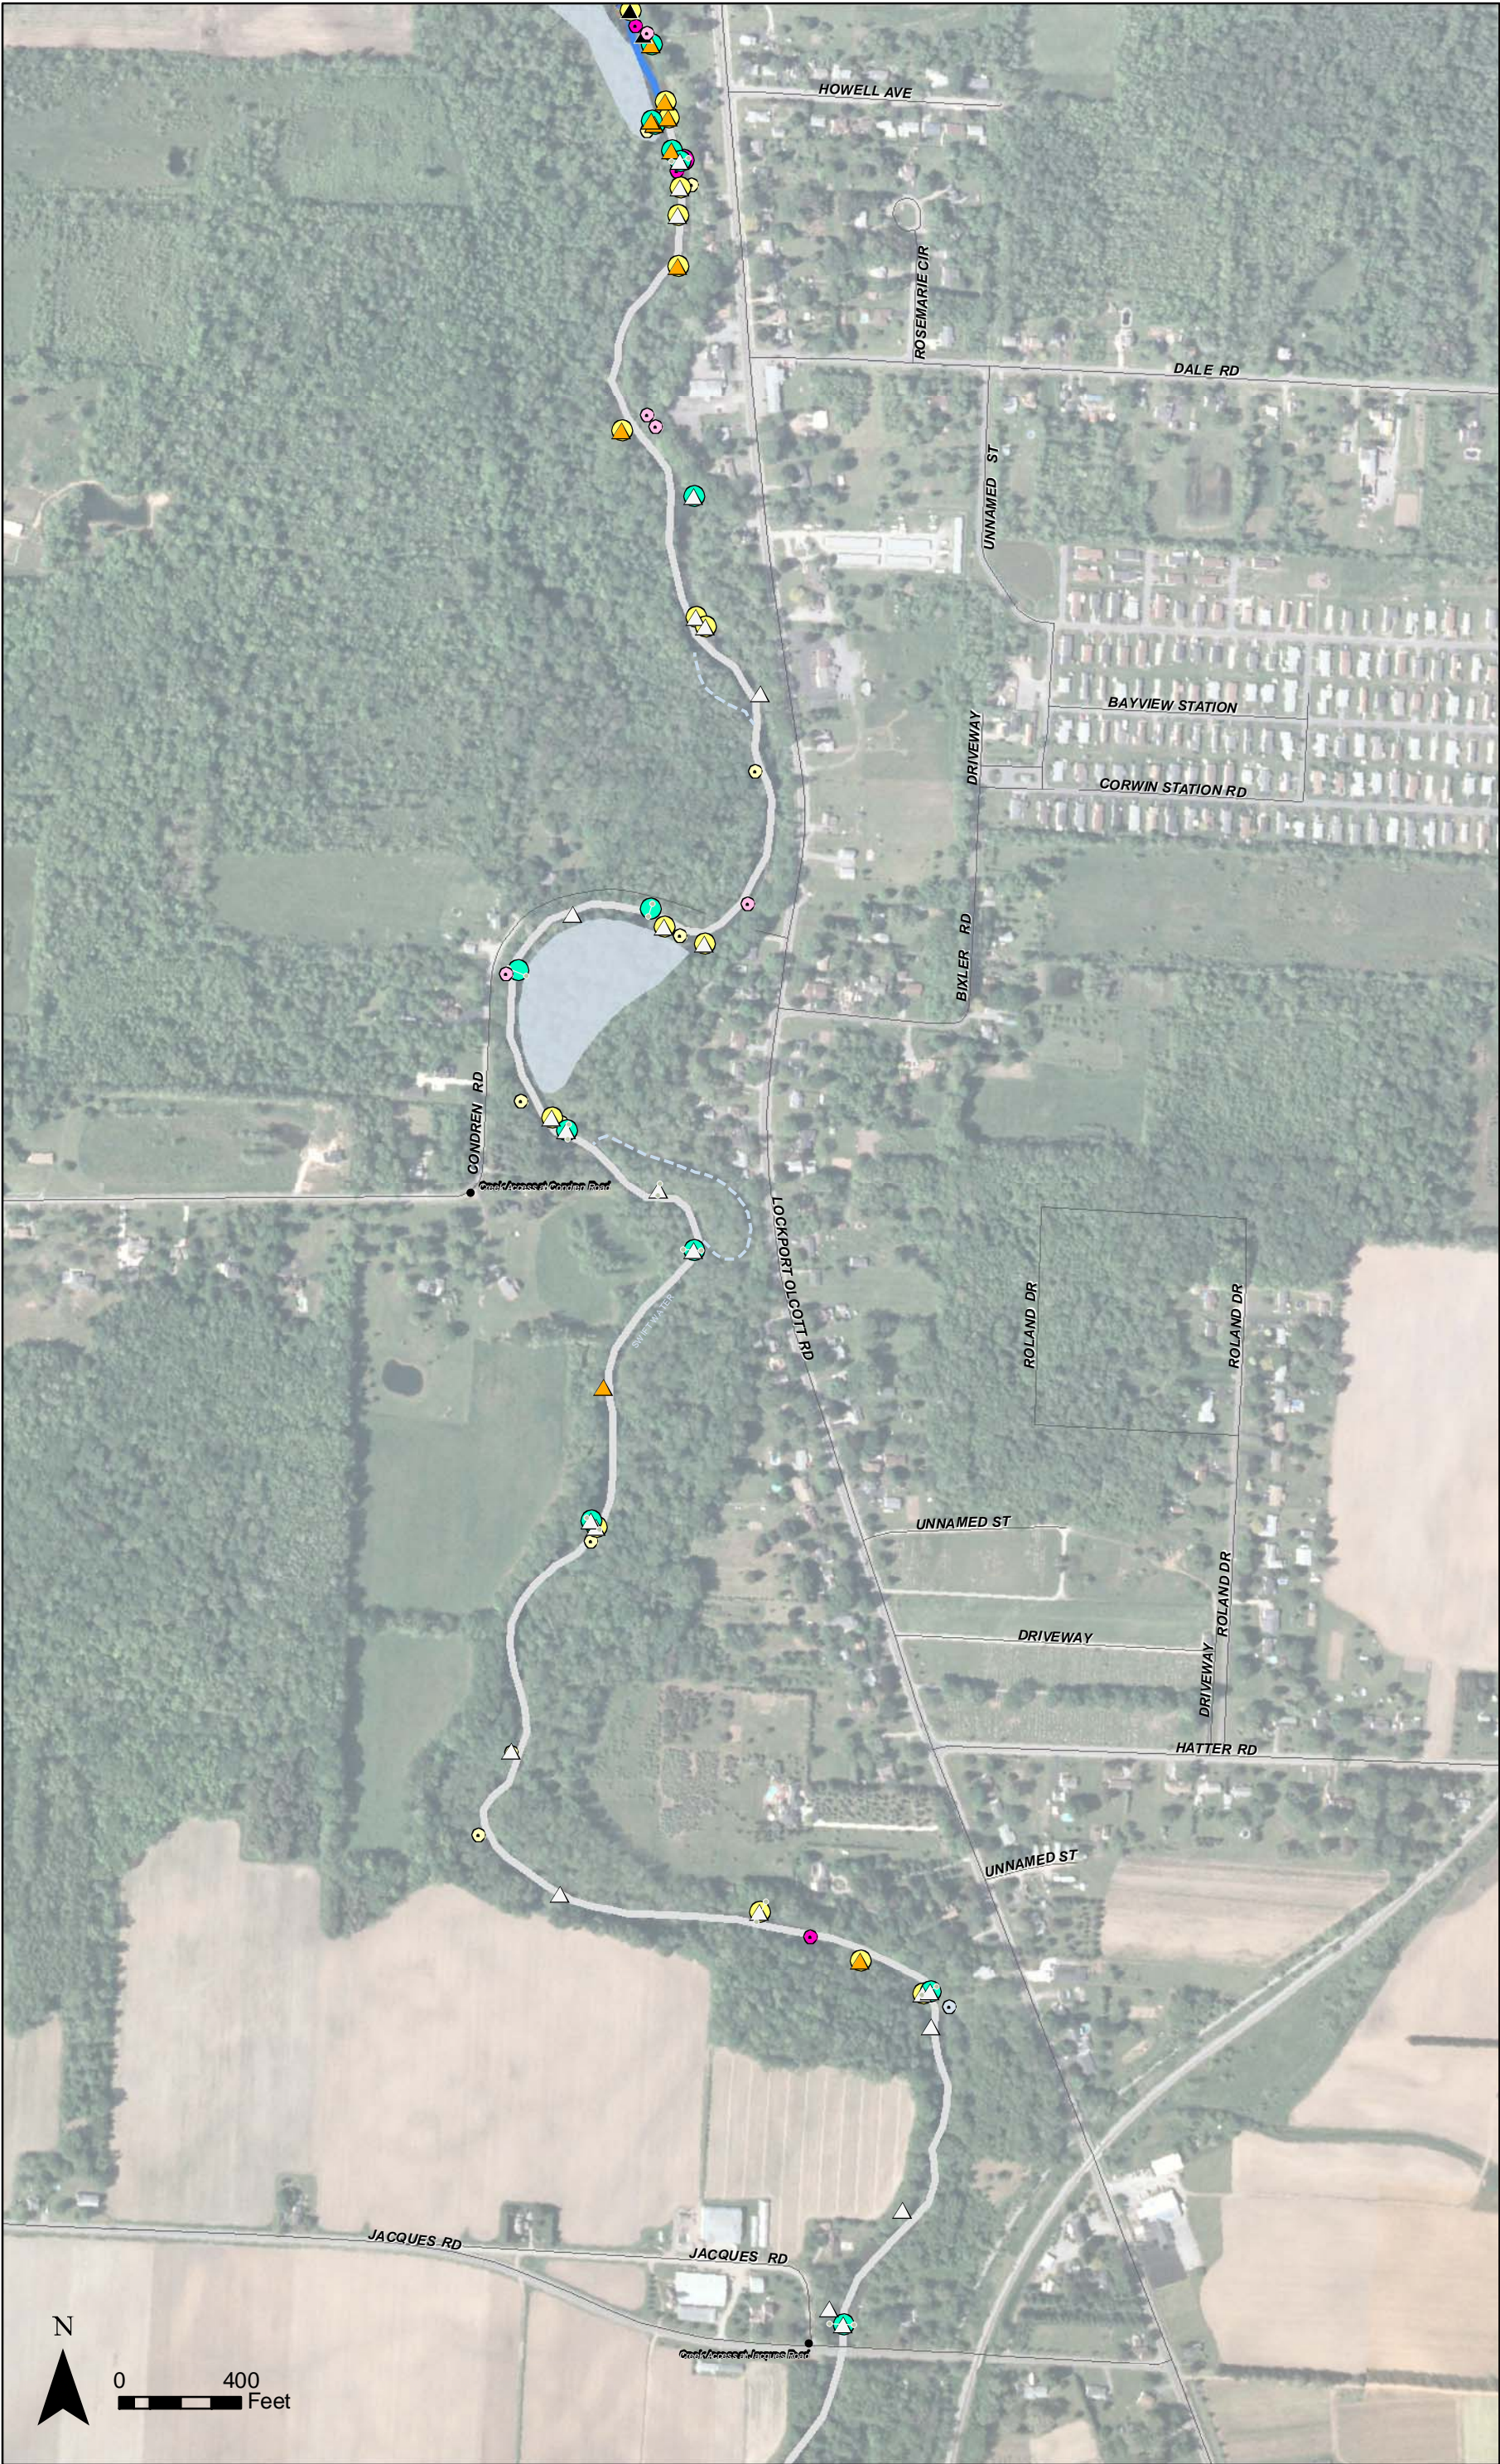
Figure 3-4 Reach 6, Segment 1
Eighteenmile Creek Field Reconnaissance,
Fall 2008 and Spring 2009, Niagara County, New York

Reach 6 is upstream of the Newfane Dam impoundment and is characterized by a gravel channel with scattered and shallow sediment deposition. The reach was divided into two sections based on the survey efforts. Section 1 was fully characterized during the Phase 1 survey and the results are summarized on Figure 3-4. Section 2 was part of the area from Ewings Road South to

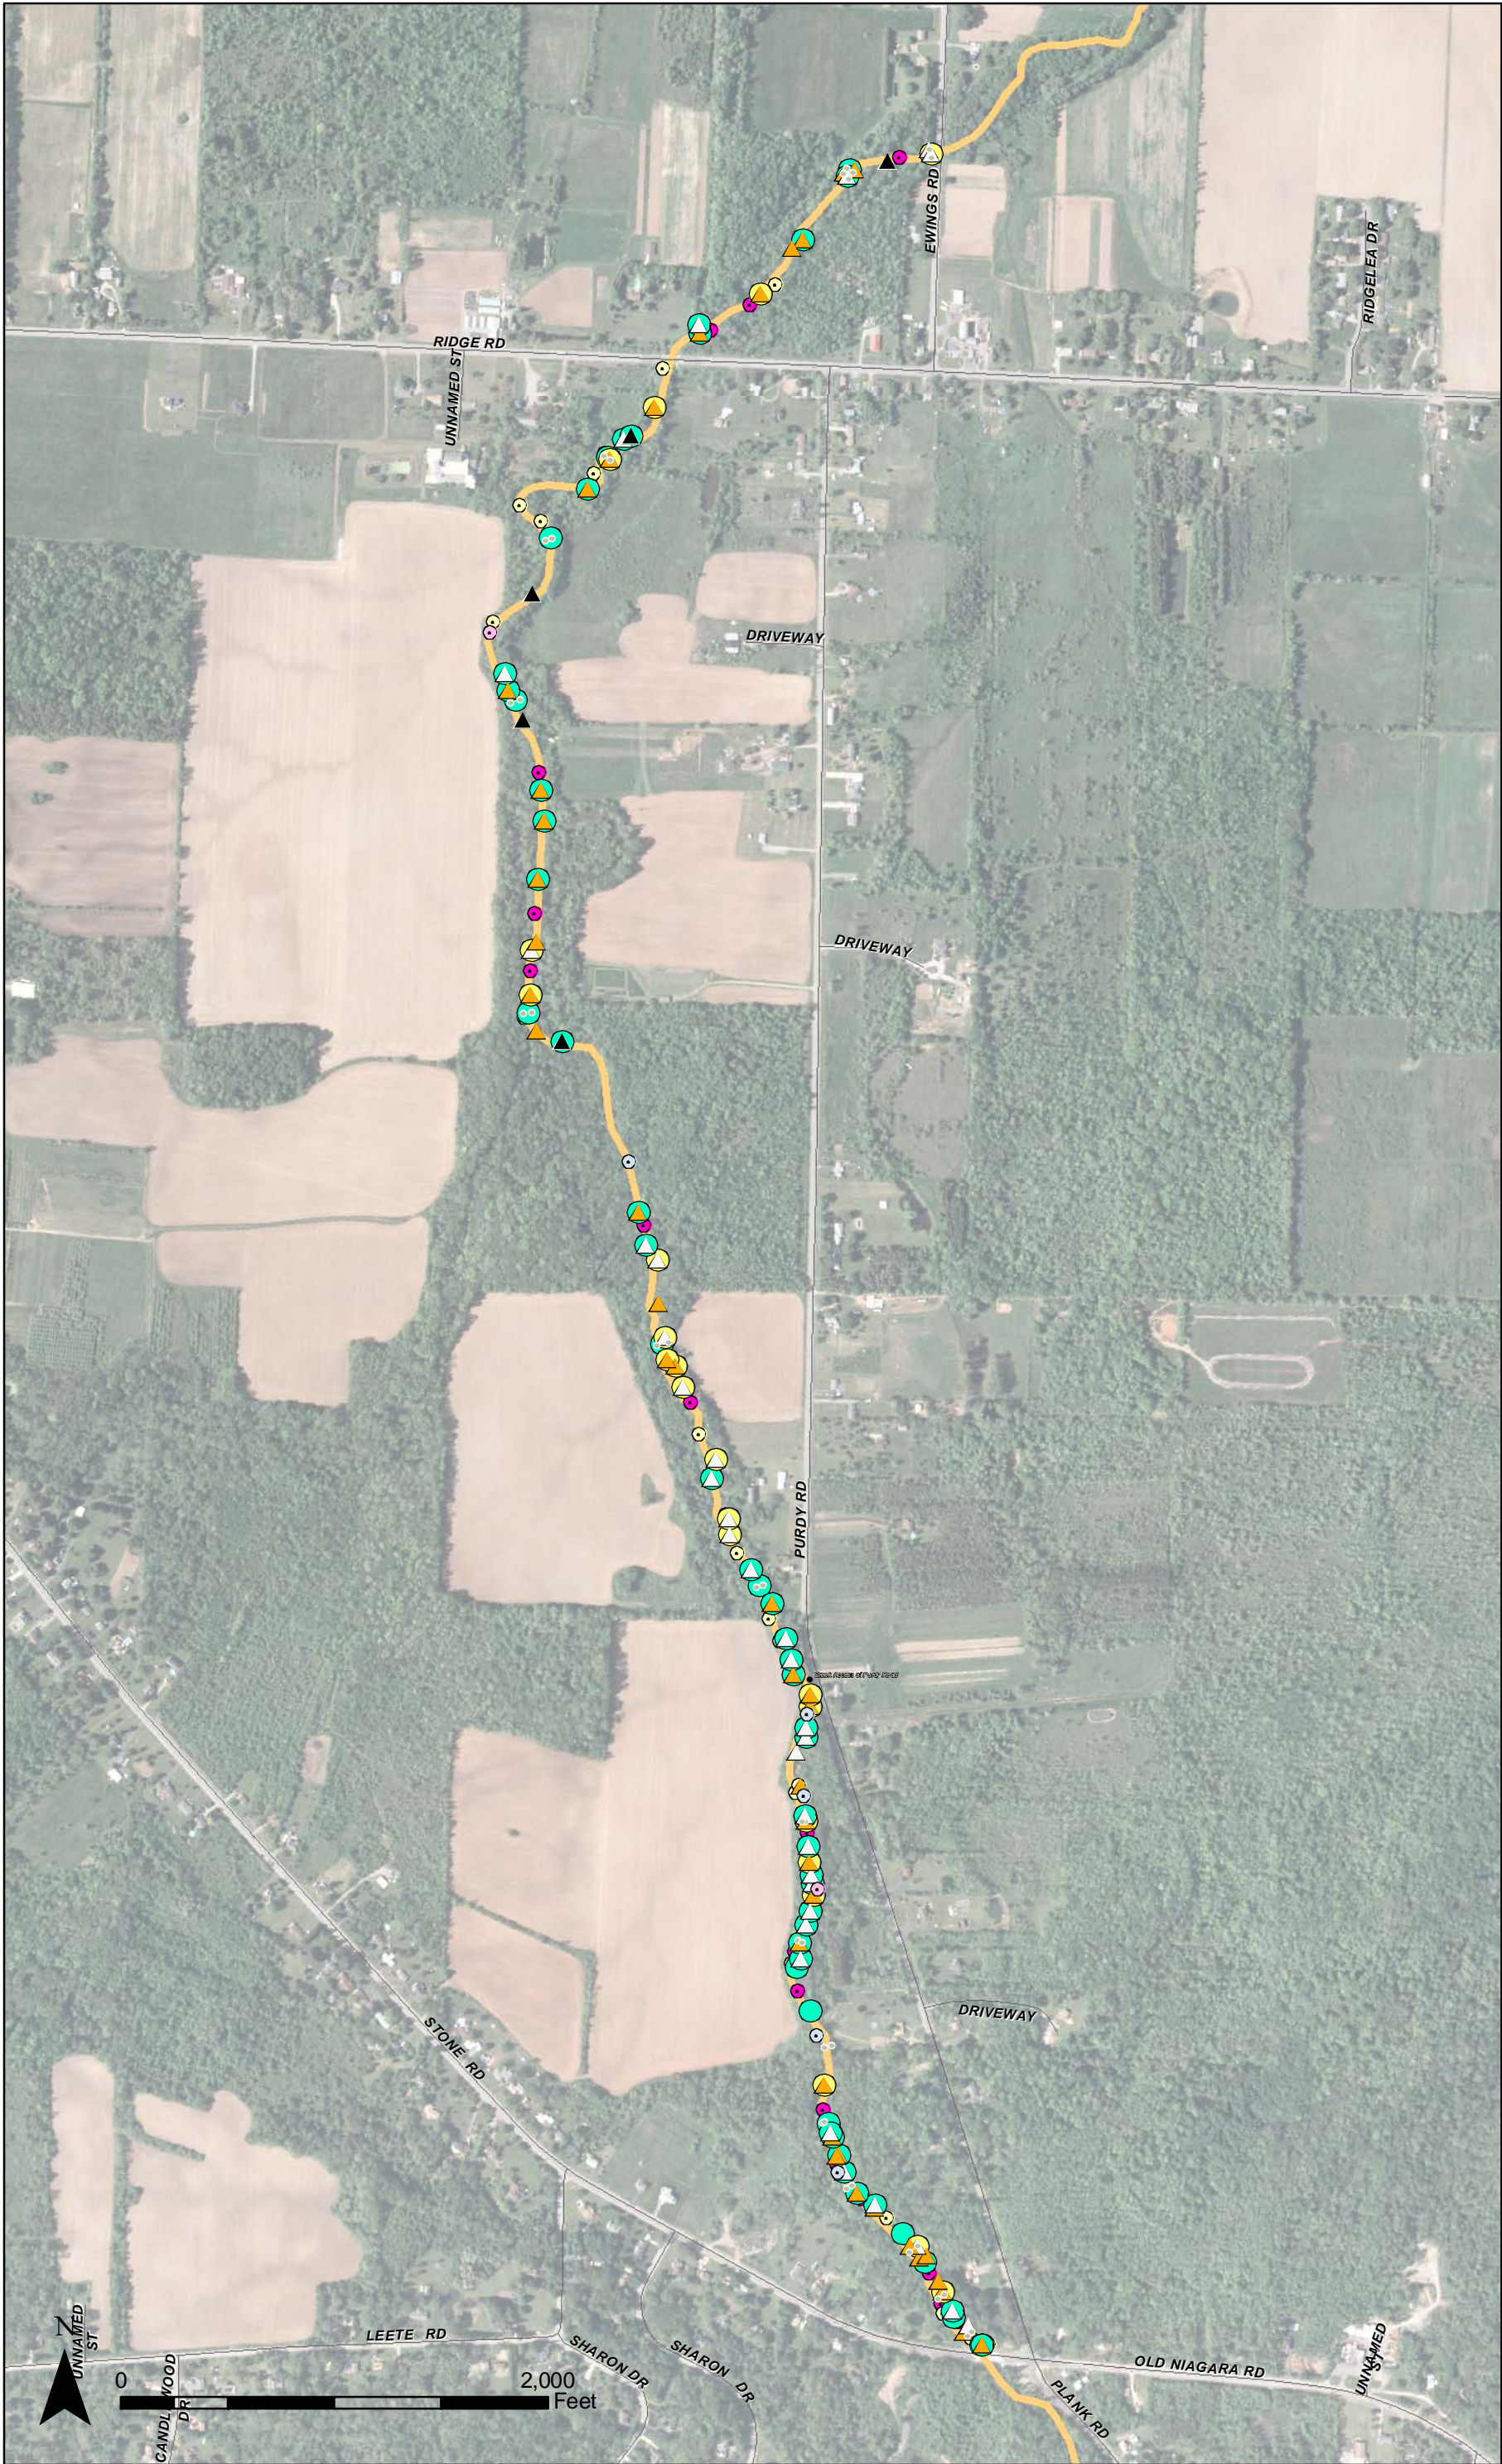
Figure 3-5 Reach 7, Segment 2
Eighteenmile Creek Field Reconnaissance,
Fall 2008 and Spring 2009, Niagara County, New York

Reach 7 begins at the bottom of the Niagara escarpment and continues upstream for almost 5 miles. The reach was divided into three sections based on the survey efforts. Section 1 (1.3 miles) was part of the area from Ewings Road South to Jacques Road that was not fully characterized due to limited access and a large number of log jams and woody debris. Section 2 (2.4 miles) was fully characterized during the Phase 1 survey and the results are summarized on Figure 3-5. Section 3 (1 mile) was characterized during the PCB trackdown study performed by EEEPC under contract to NCSWD (EEEPC 2007).
