# A

## Survey Figures

# B Survey Data Tables

**Table B-1 Sediment Thickness Points, Eighteenmile Creek, Niagara County, New York**

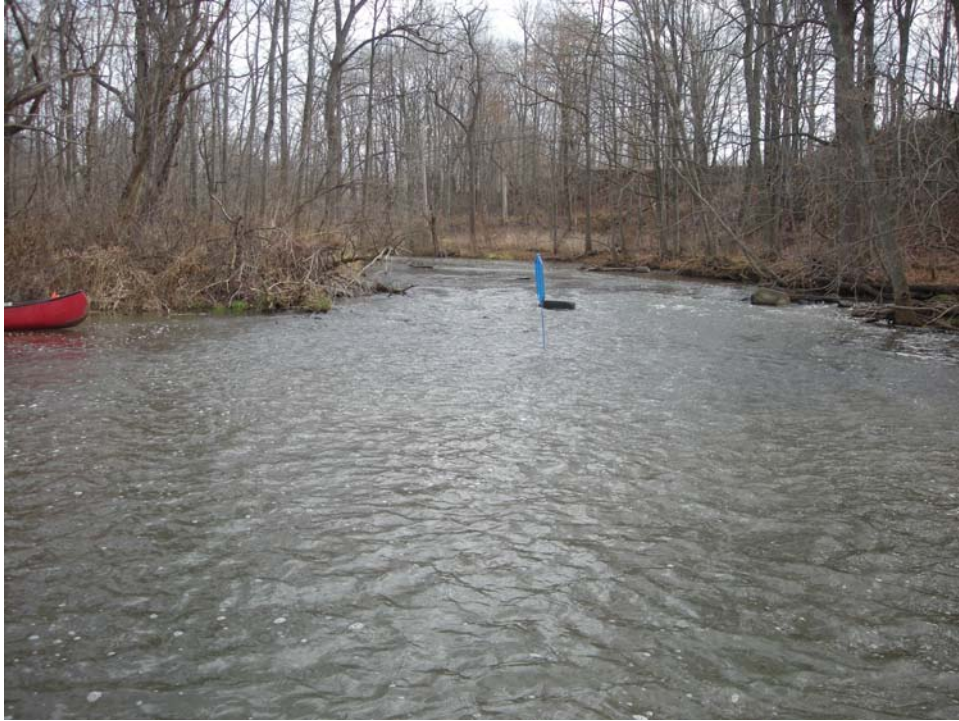
Photo: P30A  
Direction of view: S  
Description: Left channel, upstream view.

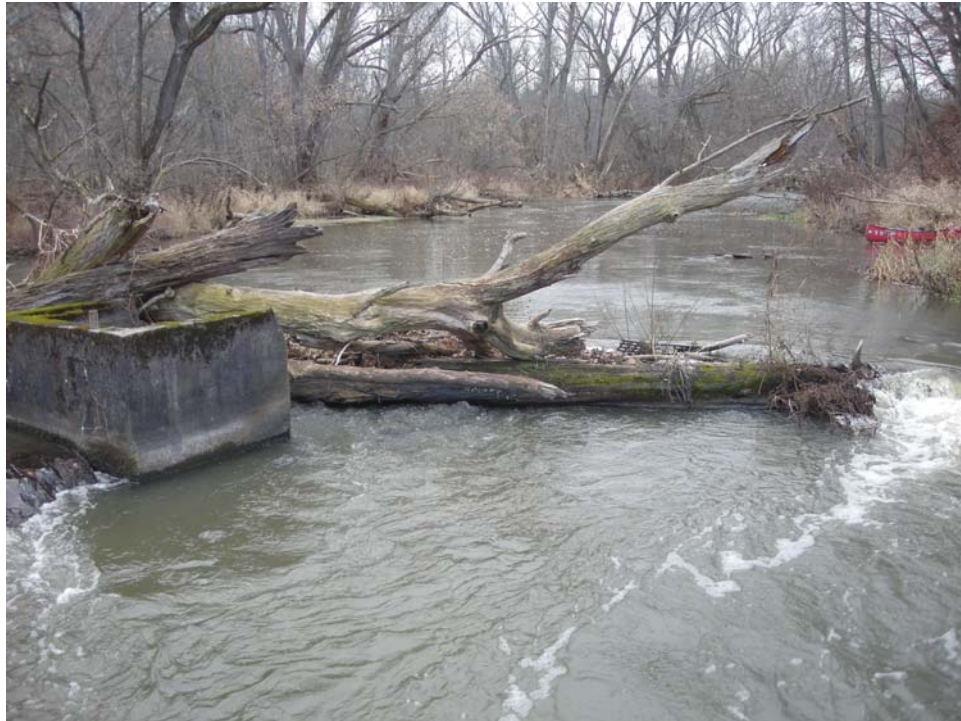
Photo: P53A  
Direction of view: S  
Description: Intake culvert in mid-channel.

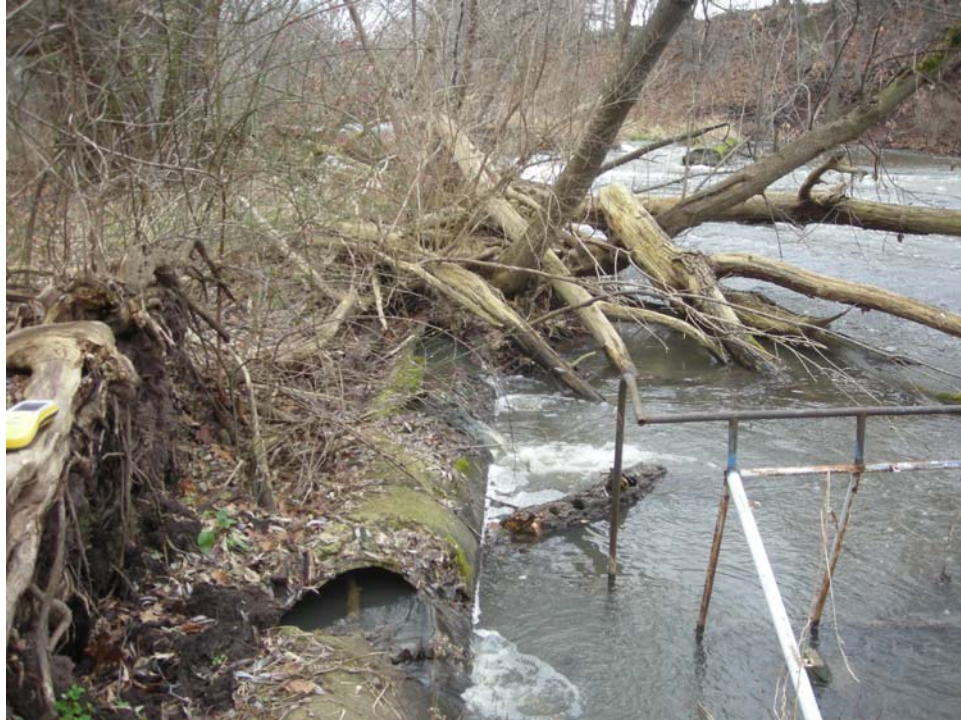
Photo: P54A  
Direction of view: SW  
Description: Intake culvert along RDB.

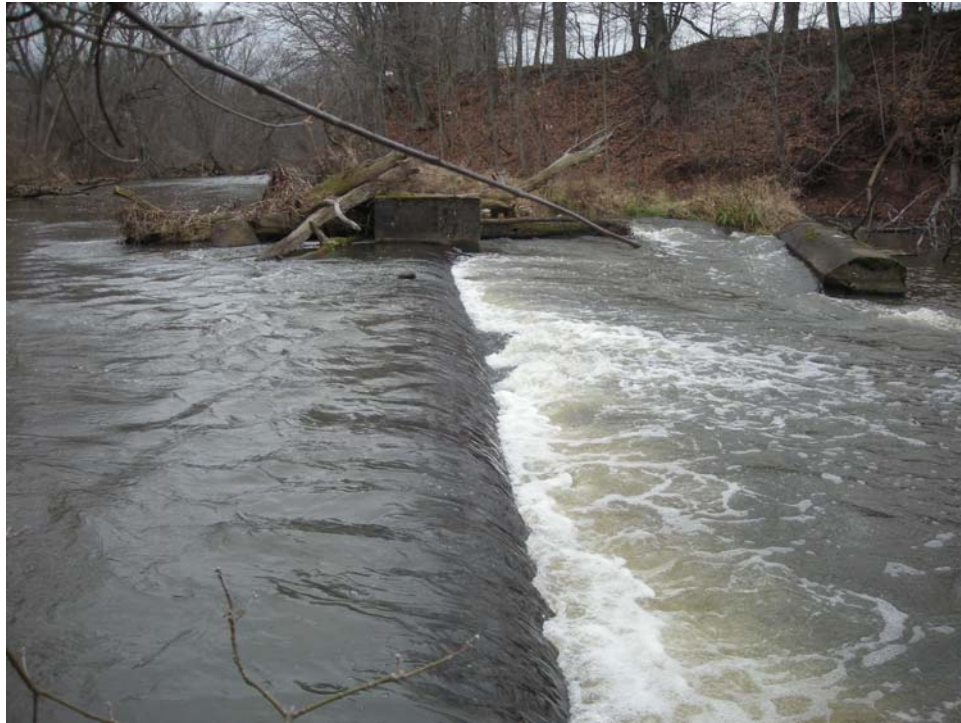
Photo: P55A  
Direction of view: SW  
Description: Intake culvert in mid-channel.

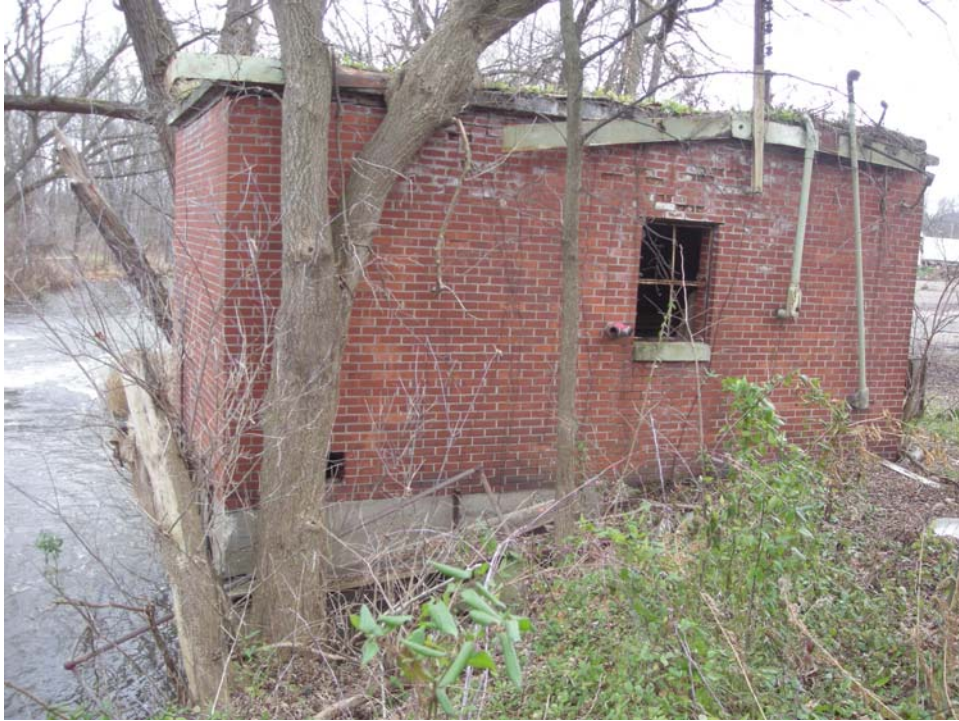
Photo: P56A  
 Direction of view: N  
 Description: Pump house on RDB.

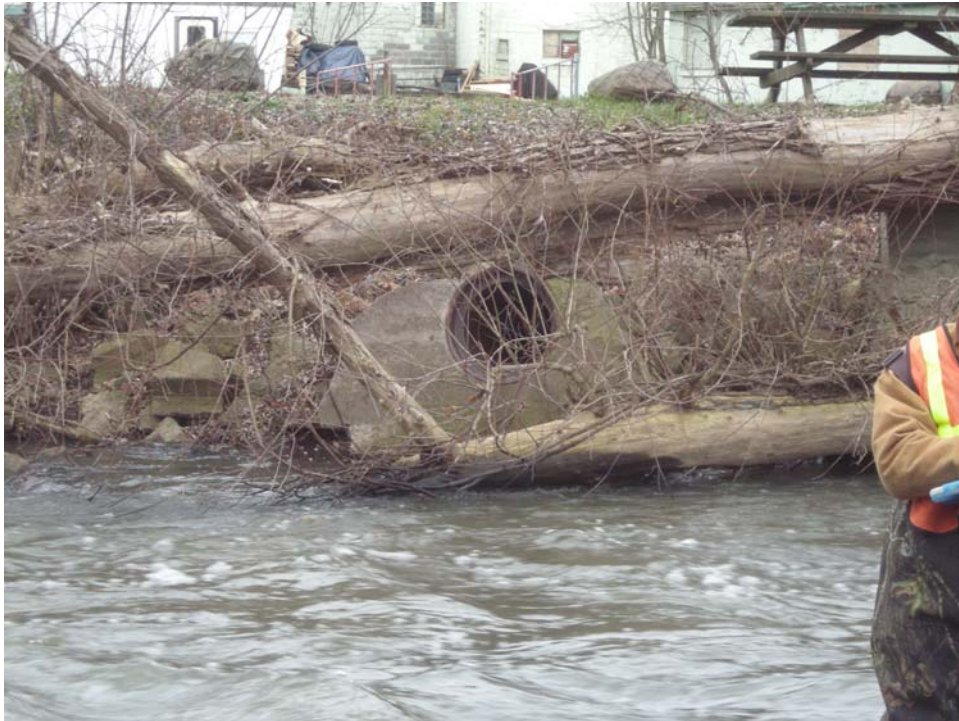
Photo: P57A  
 Direction of view: E  
 Description: Section of concrete culvert on RDB.

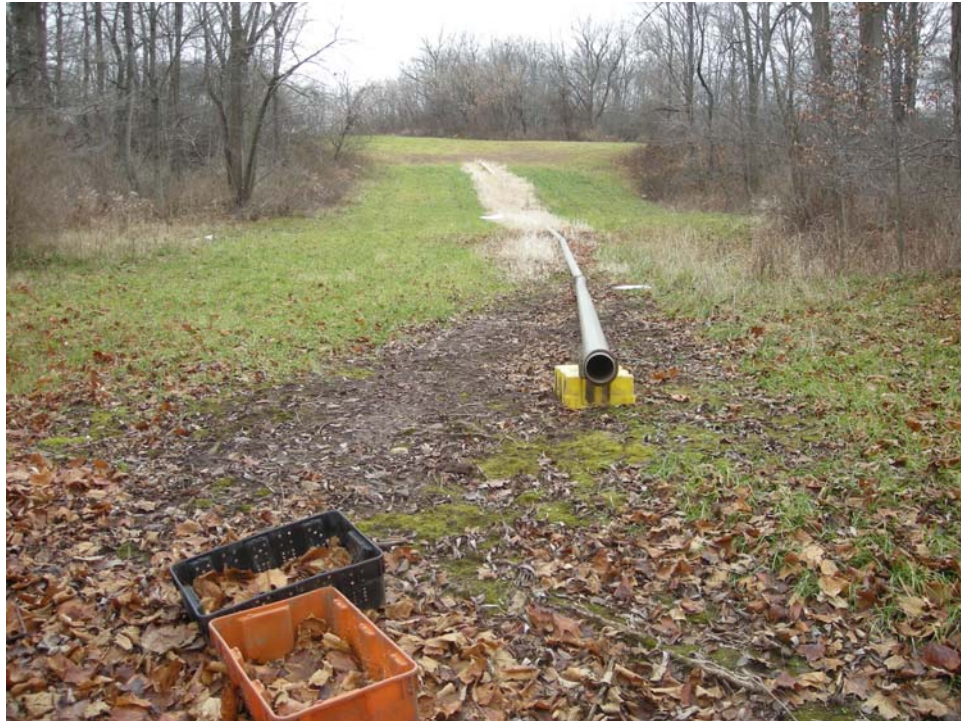
Photo: P61A  
 Direction of view: W  
 Description: Irrigation section along LDB.

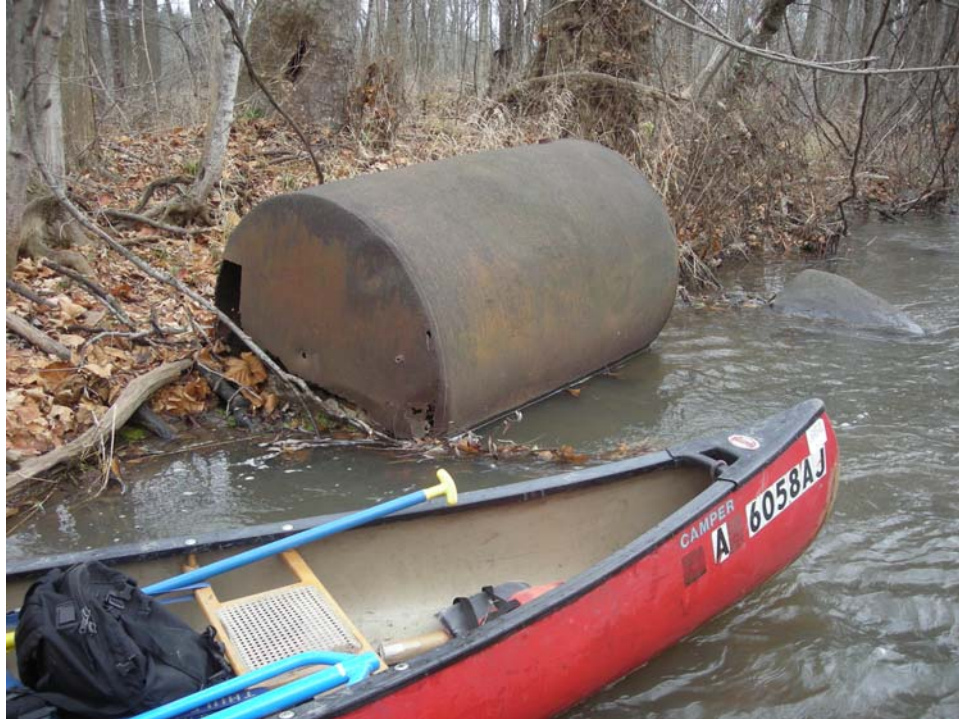
Photo: P62A  
 Direction of view: NW  
 Description: Empty tank along LDB.

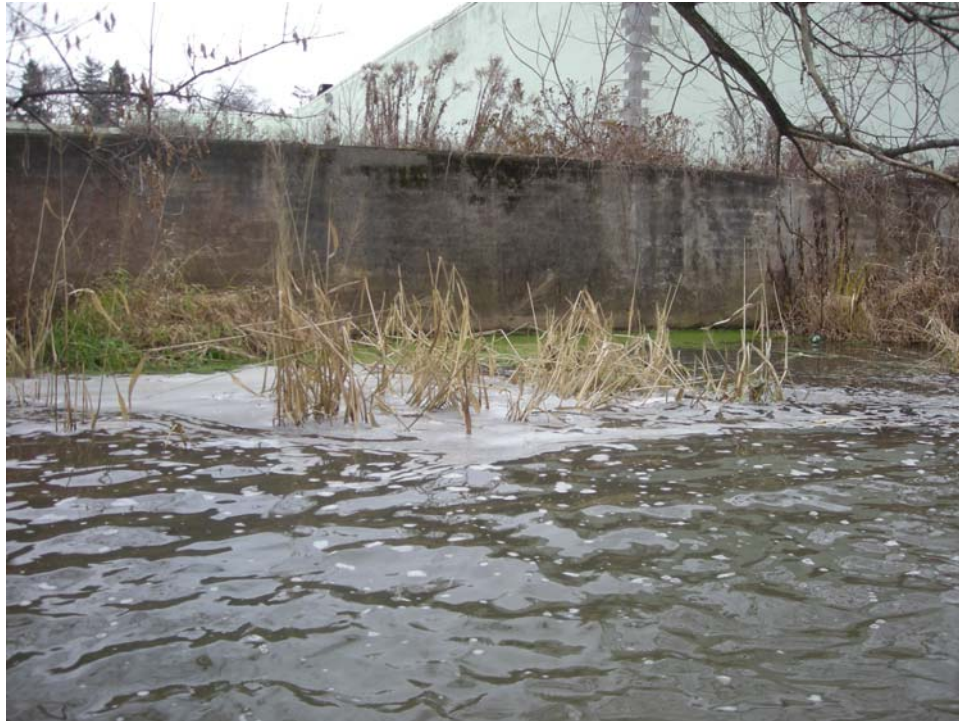
Photo: P63A  
 Direction of view: SE  
 Description: At SED 13, inundated wetland along retaining wall on RDB.

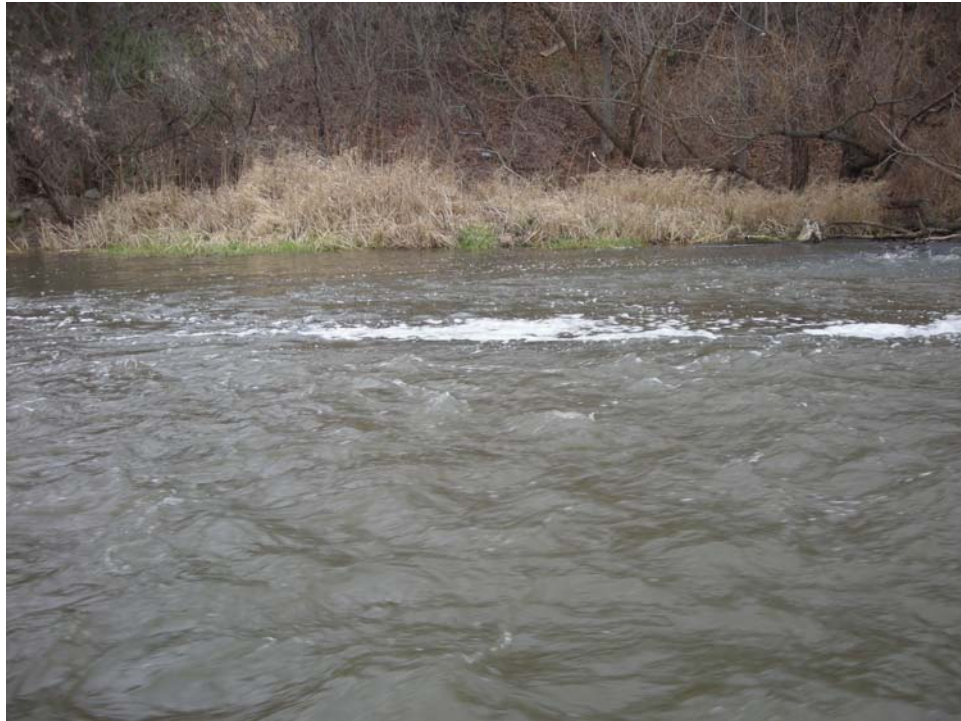
Photo: P69A  
 Direction of view: E  
 Description: At SED 15, view from LDB to RDB across creek.

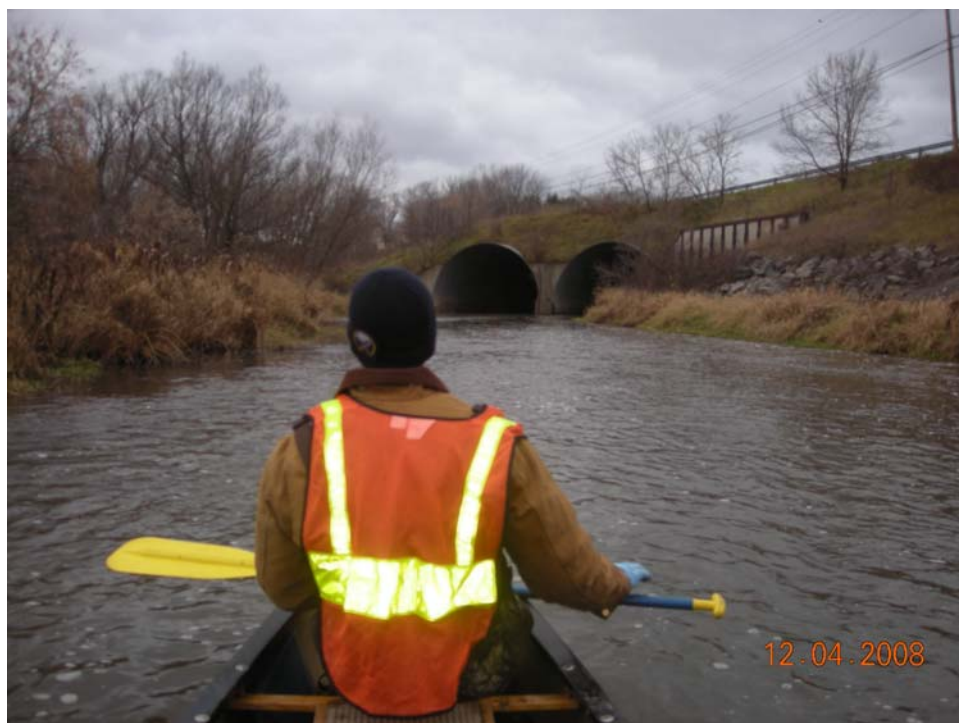
Photo: P72A  
 Direction of view: N  
 Description: Entering the culverts at Ide Road.

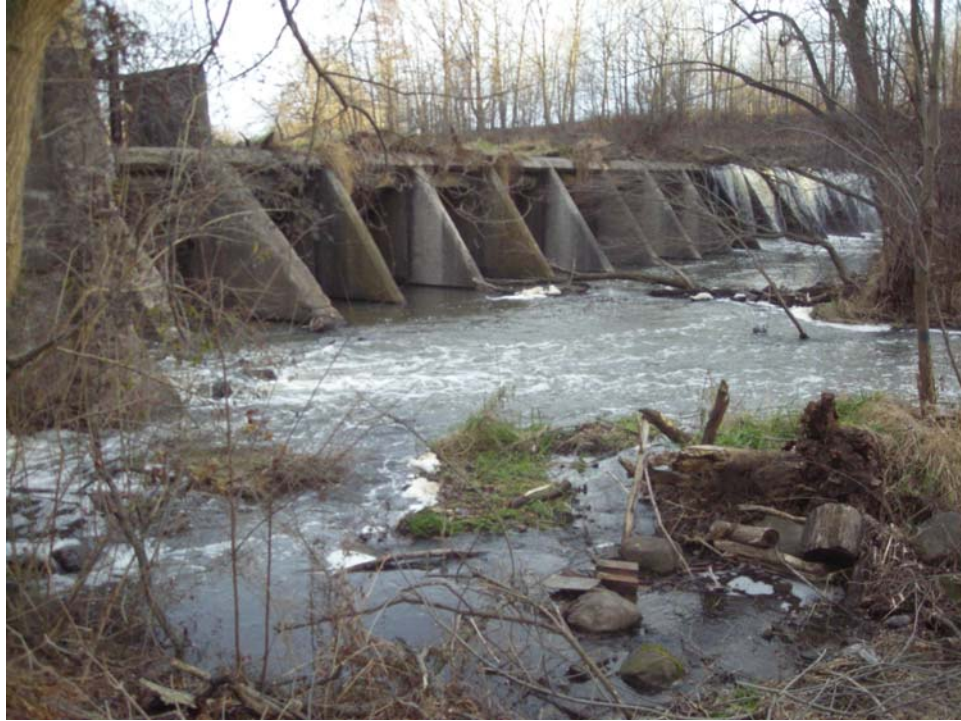
Photo: P74A  
 Direction of view: SW  
 Description: Newfane Dam spillway.

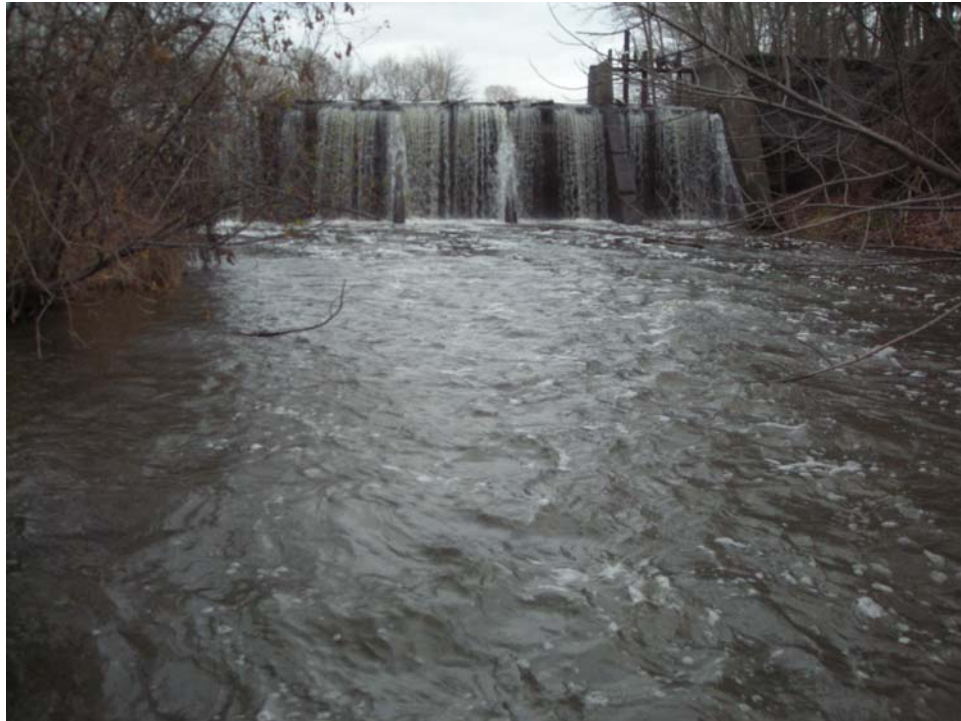
Photo: P75A  
 Direction of view: S  
 Description: View of Newfane Dam spillway from LDB of right channel.

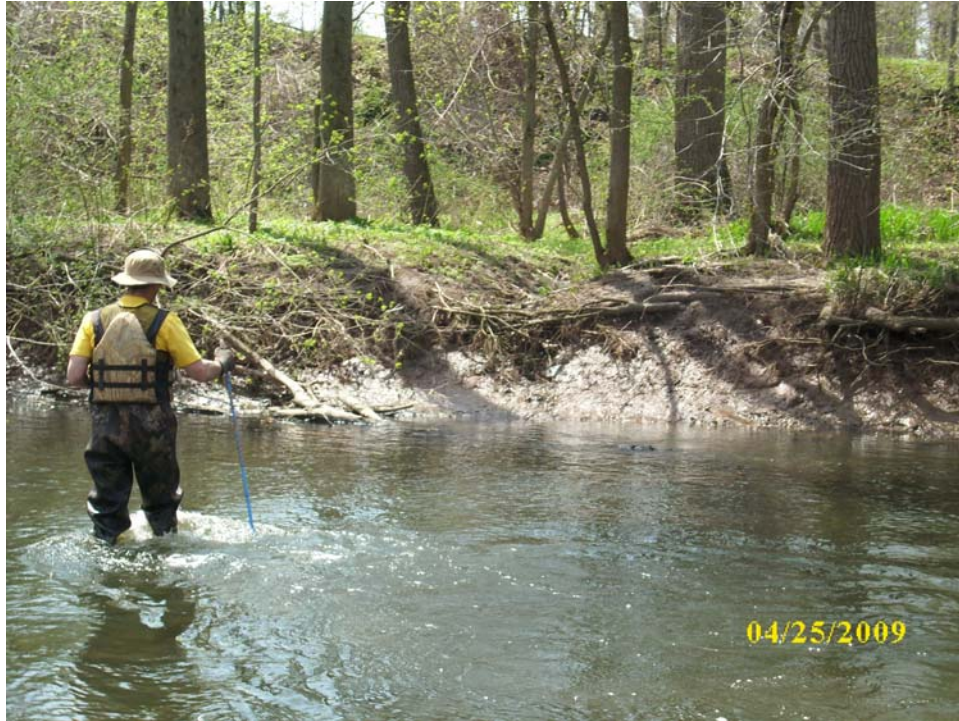
Photo: P117  
 Direction of view: SW  
 Description: Overland drainage along LDB (DRN-042).

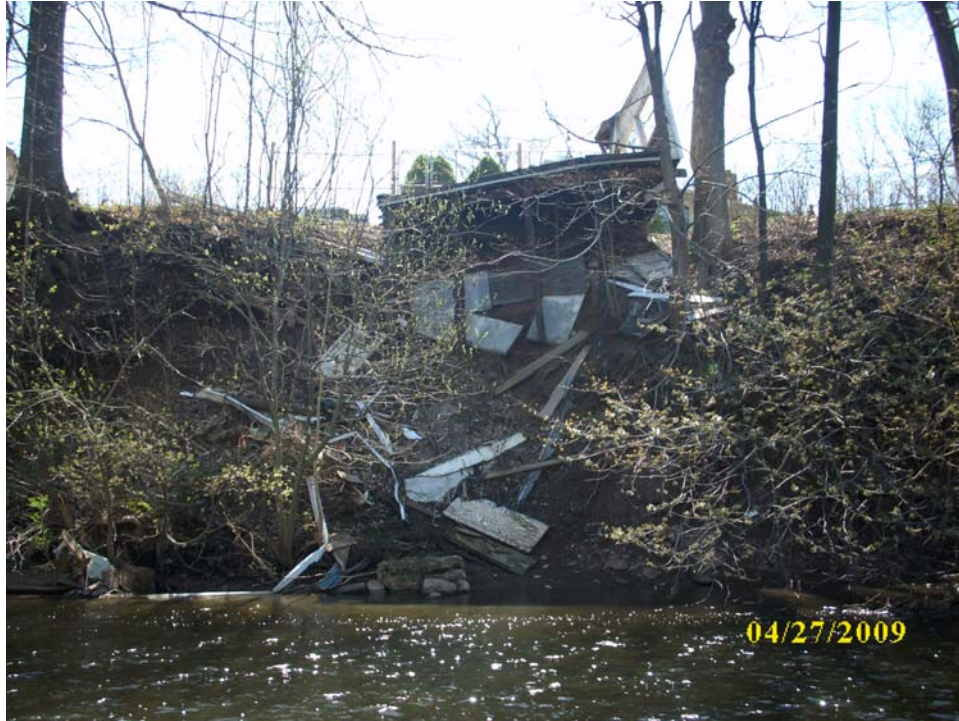
Photo: P69  
 Direction of view: SW  
 Description: Dilapidated structure along RDB.

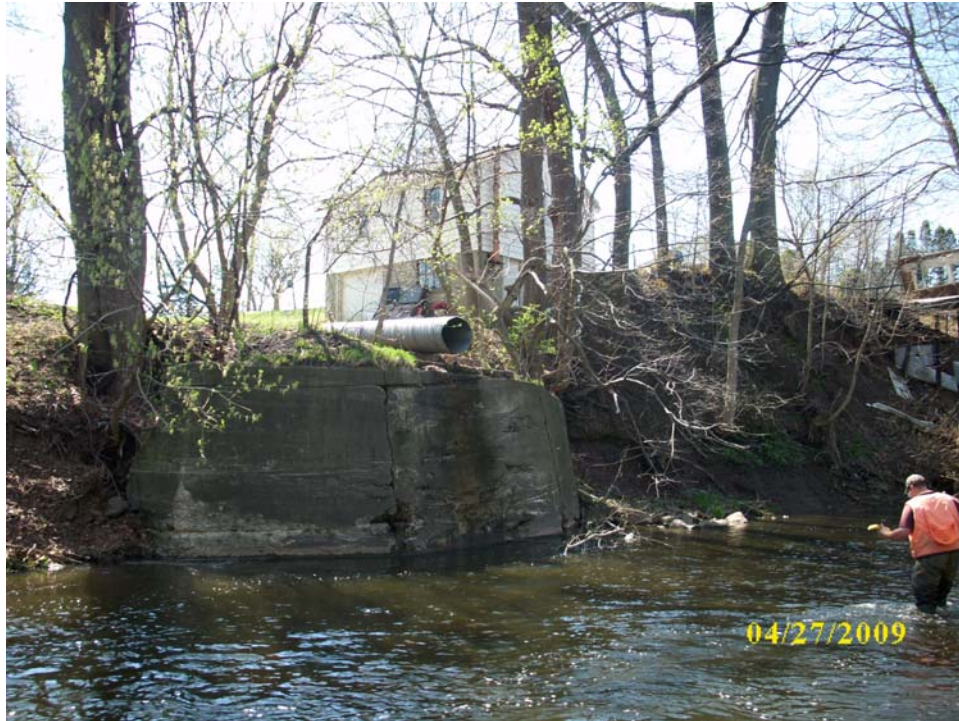
Photo: P125  
 Direction of view: SE  
 Description: Drainage pipe along RDB, old abutment (OUT-023).

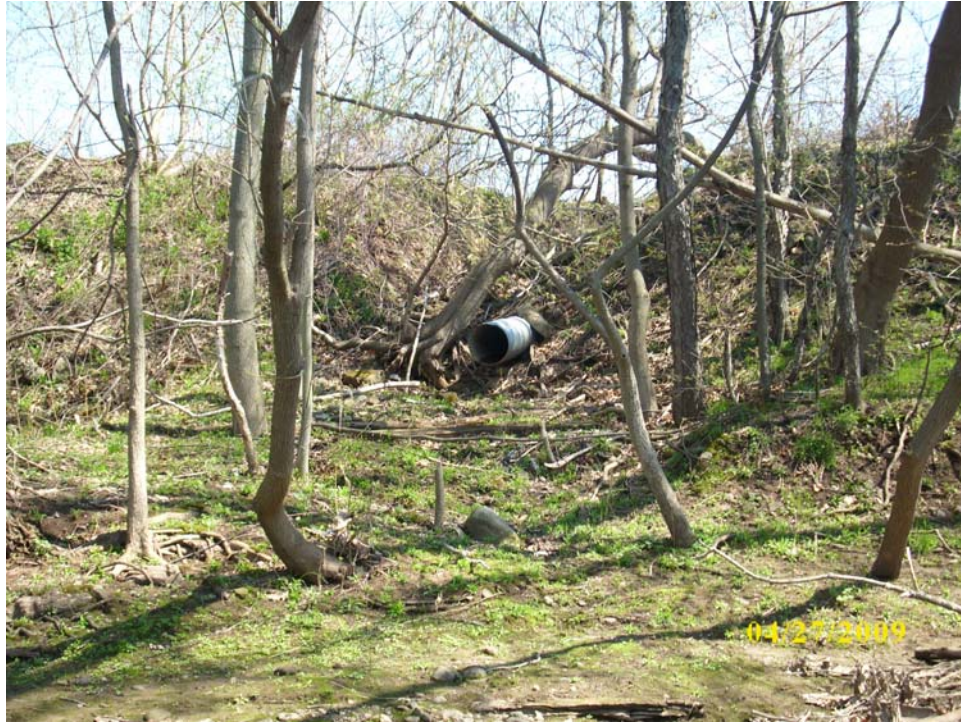
Photo: P72  
 Direction of view: NE  
 Description: Drainage pipe along RDB (OUT-024).

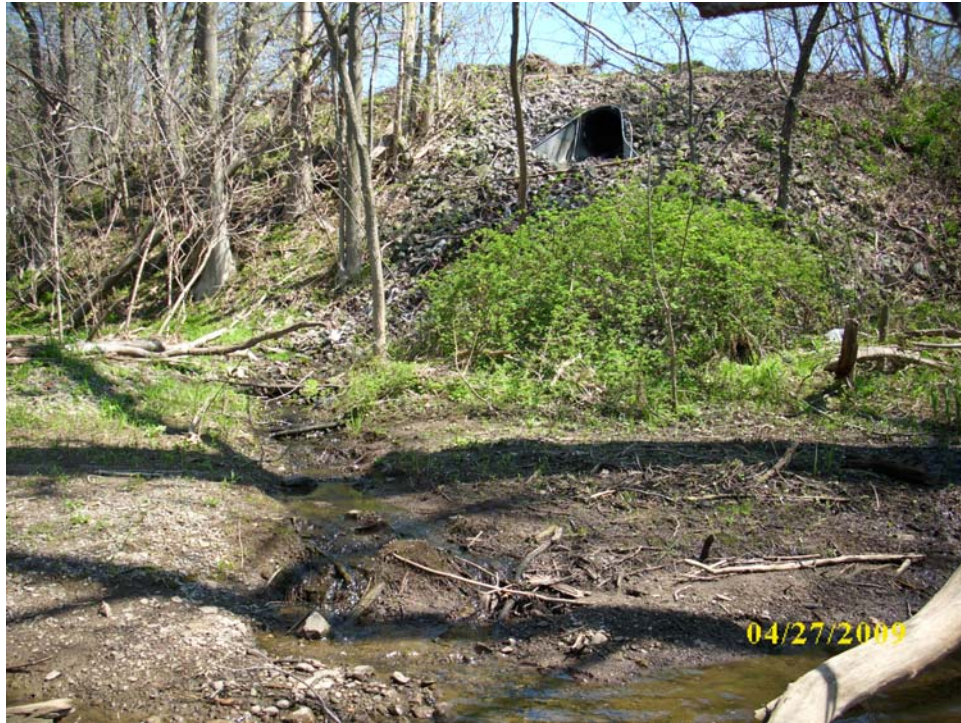
Photo: P73  
 Direction of view: NE  
 Description: Culvert with run-off flowing to creek (OUT-025).

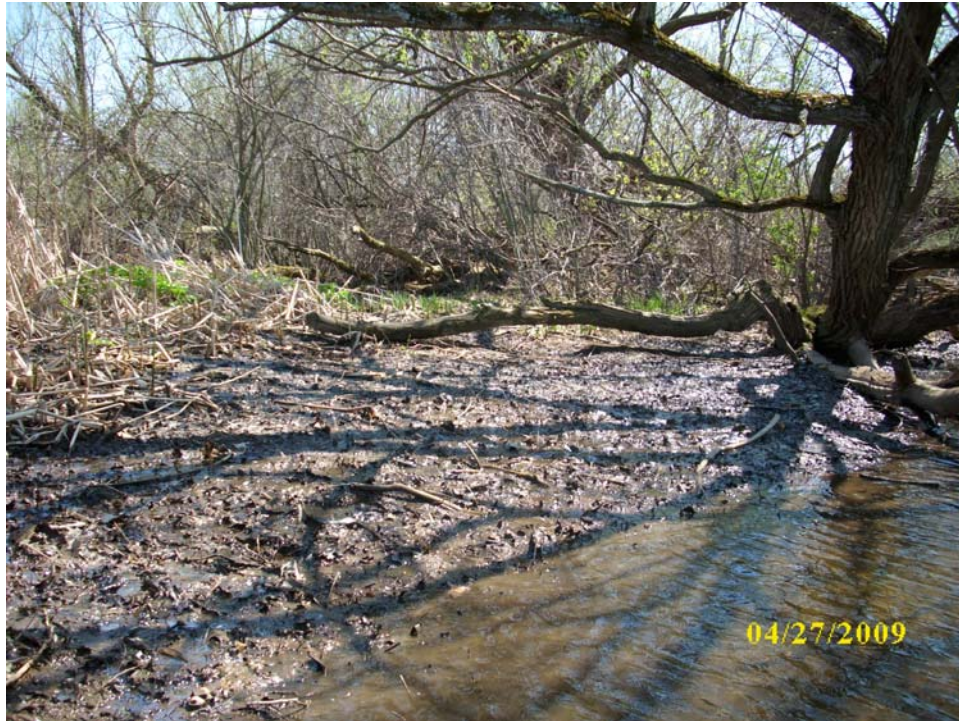
Photo: P130  
 Direction of view: S  
 Description: Drainage to creek at upstream side of cattail marsh.

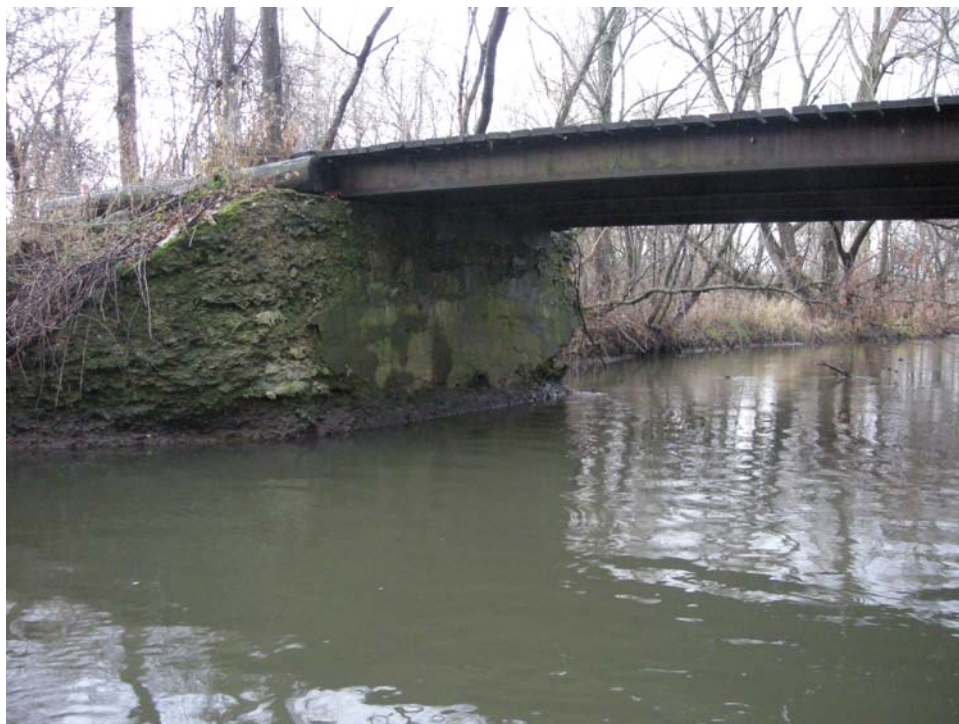
Photo: P22A  
 Direction of view: SE  
 Description: Farm bridge #1 from RDB.

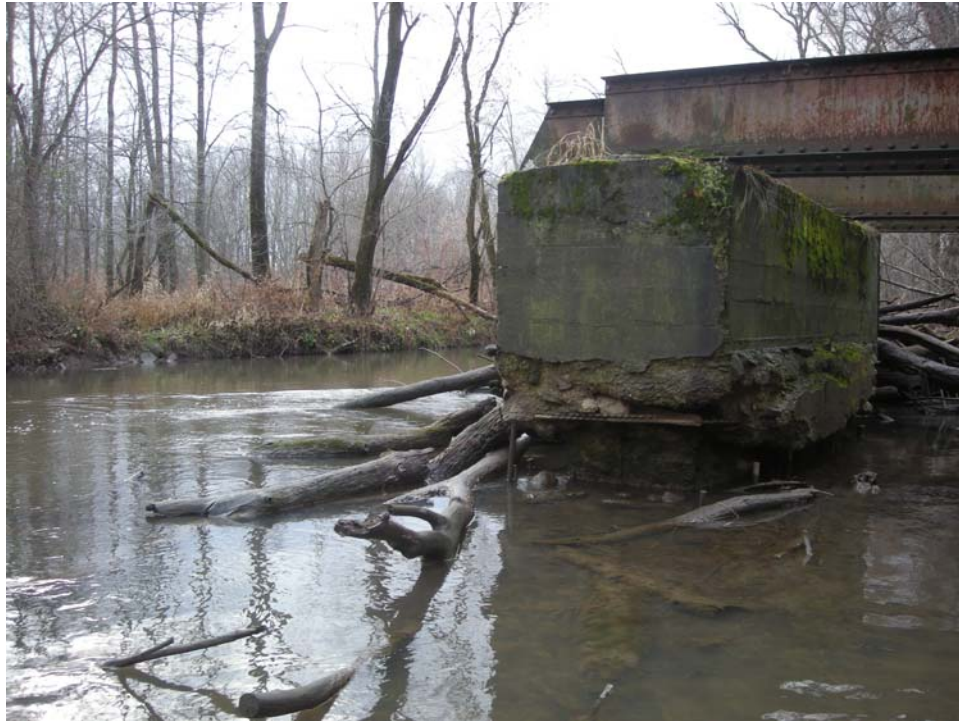
Photo: P24A  
 Direction of view: SE  
 Description: Farm bridge #2 from RDB.

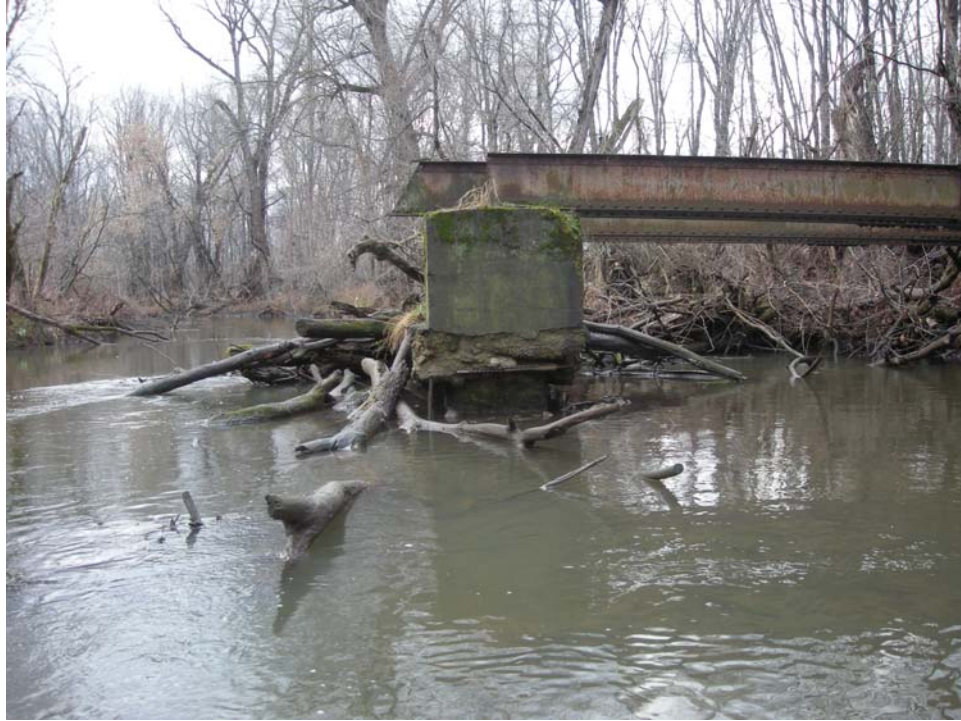
Photo: P26A  
 Direction of view: S  
 Description: Farm bridge #2 from mid-channel.

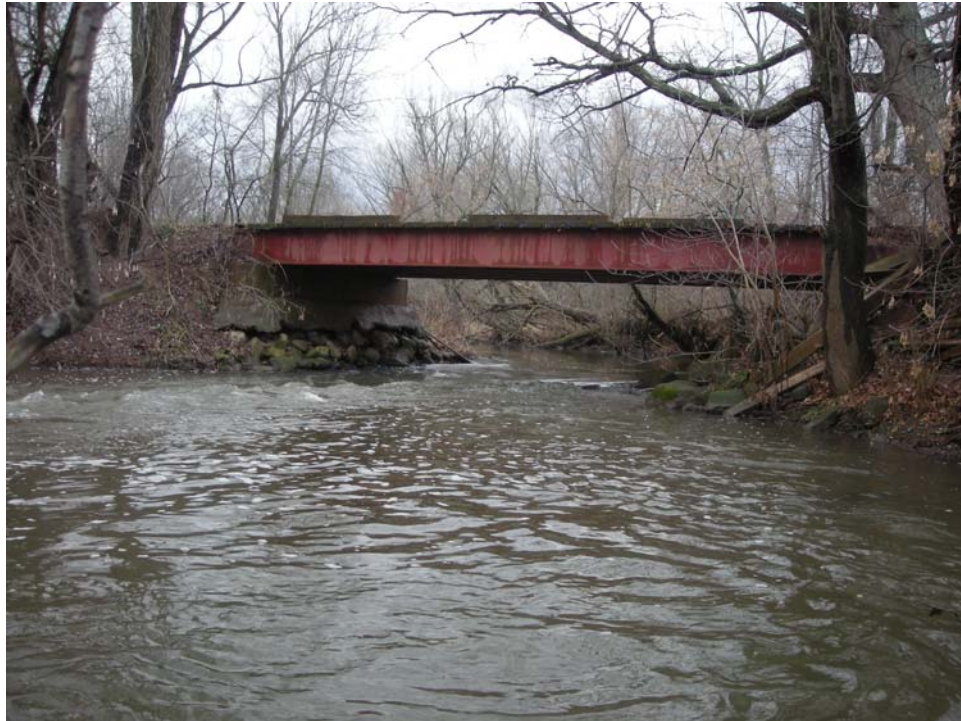
Photo: P27A  
 Direction of view: S  
 Description: Farm bridge #3 from mid-channel.

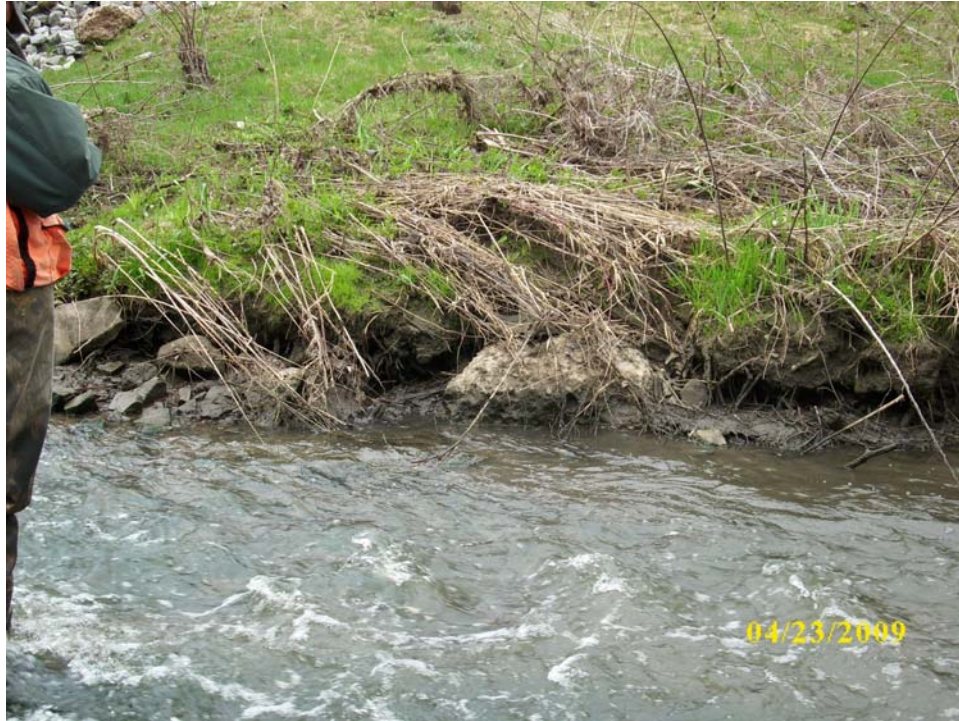
Photo: P22  
 Direction of view: SW  
 Description: Seepage along LDB (DRN-021).

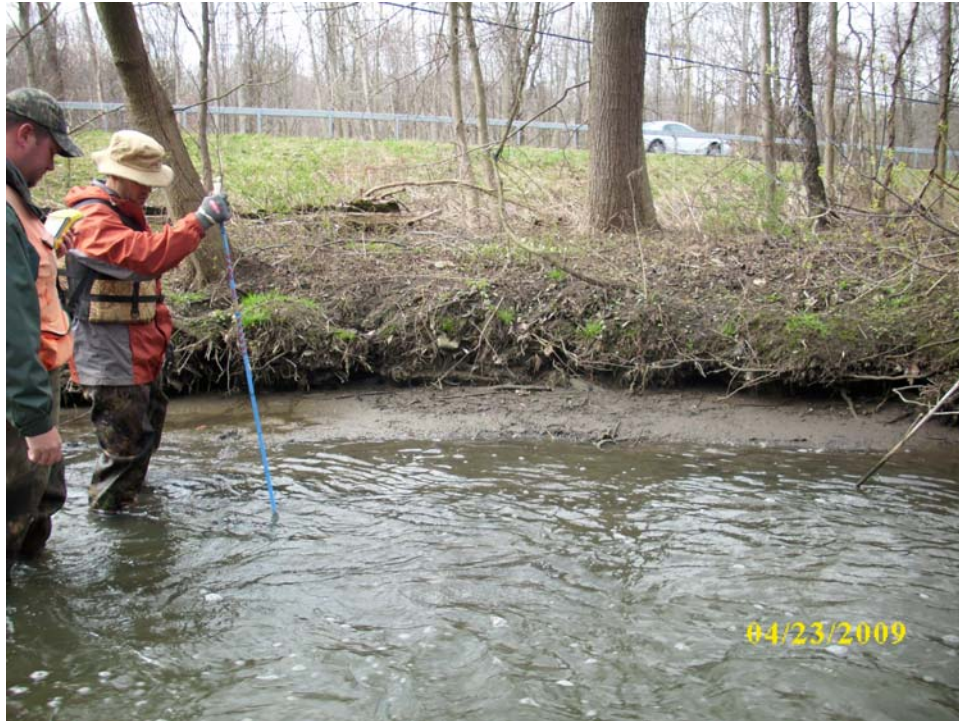
Photo: P23  
 Direction of view: SW  
 Description: Sediment deposit along LDB.

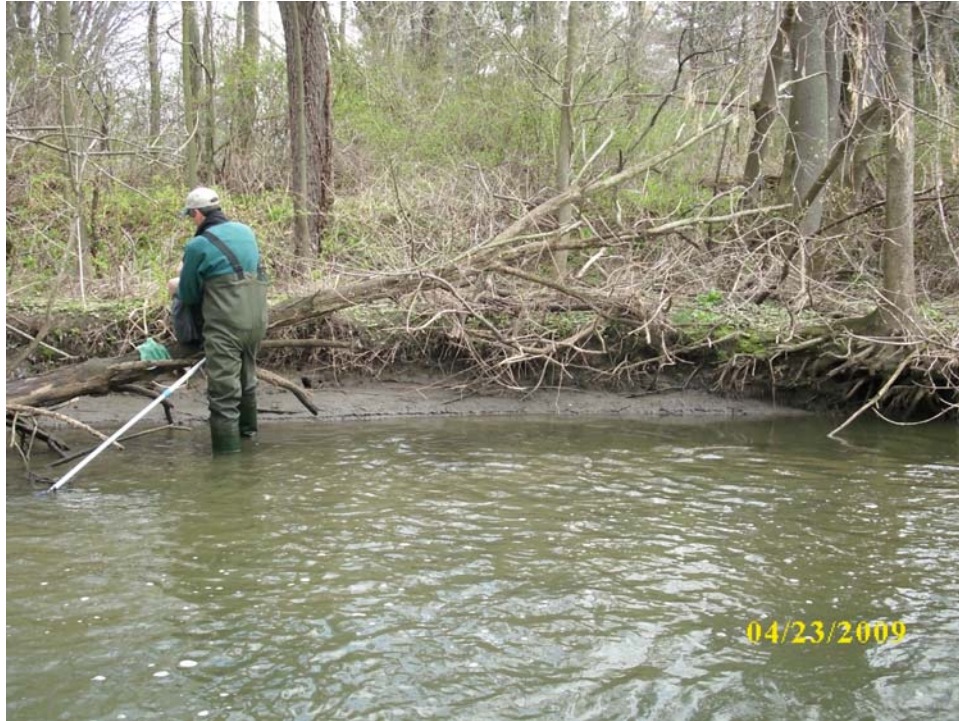
Photo: P24  
 Direction of view: NE  
 Description: Sediment deposit along RDB.

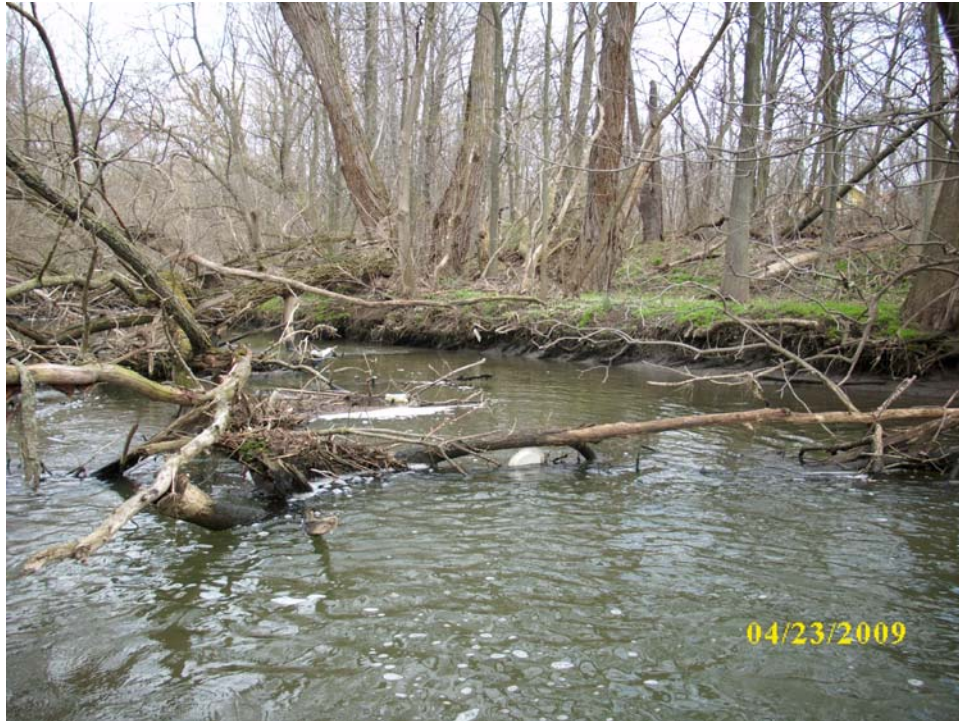
Photo: P25  
 Direction of view: NE  
 Description: LWD obstruction across creek and terrace along RDB (OBS-020).

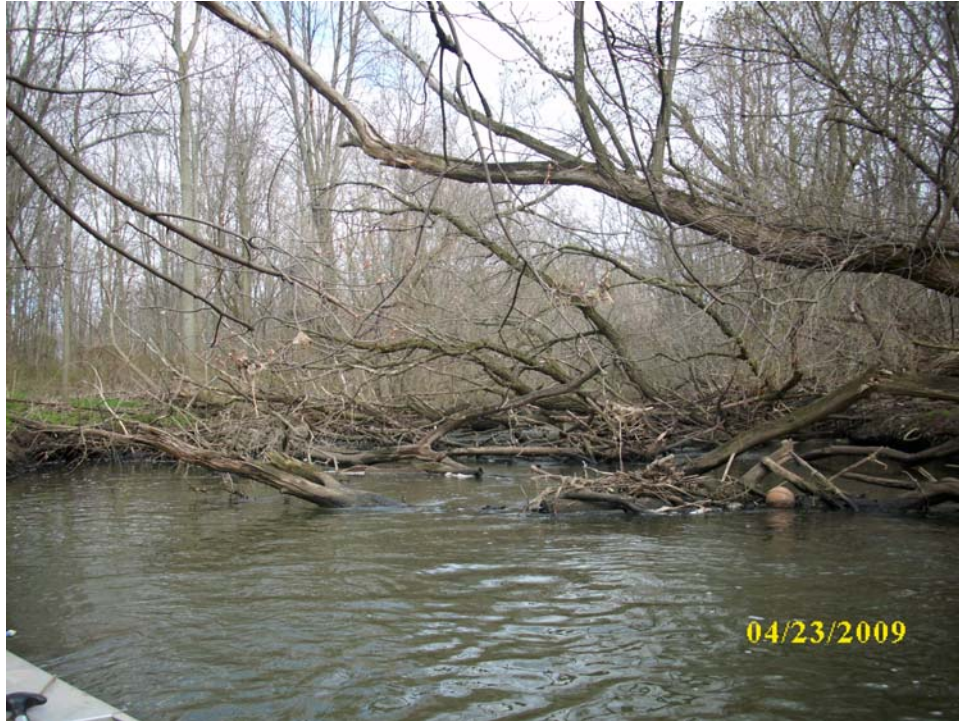
Photo: P26  
 Direction of view: NW  
 Description: LWD obstruction across creek (OBS-021).

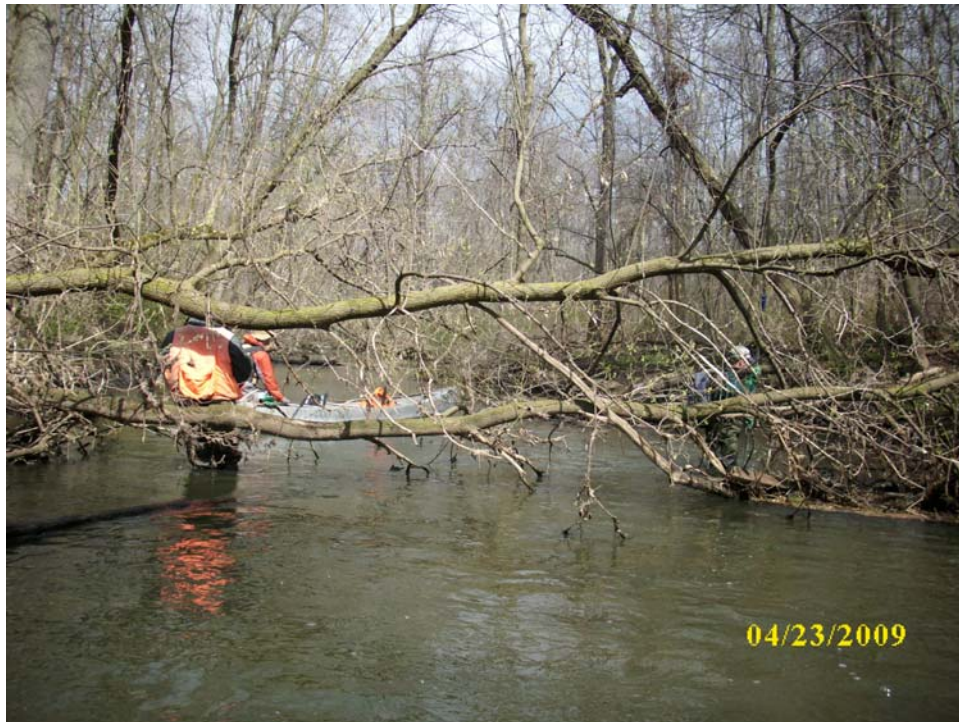
Photo: P28  
Direction of View: N  
Description: LWD obstruction across creek (OBS-022).

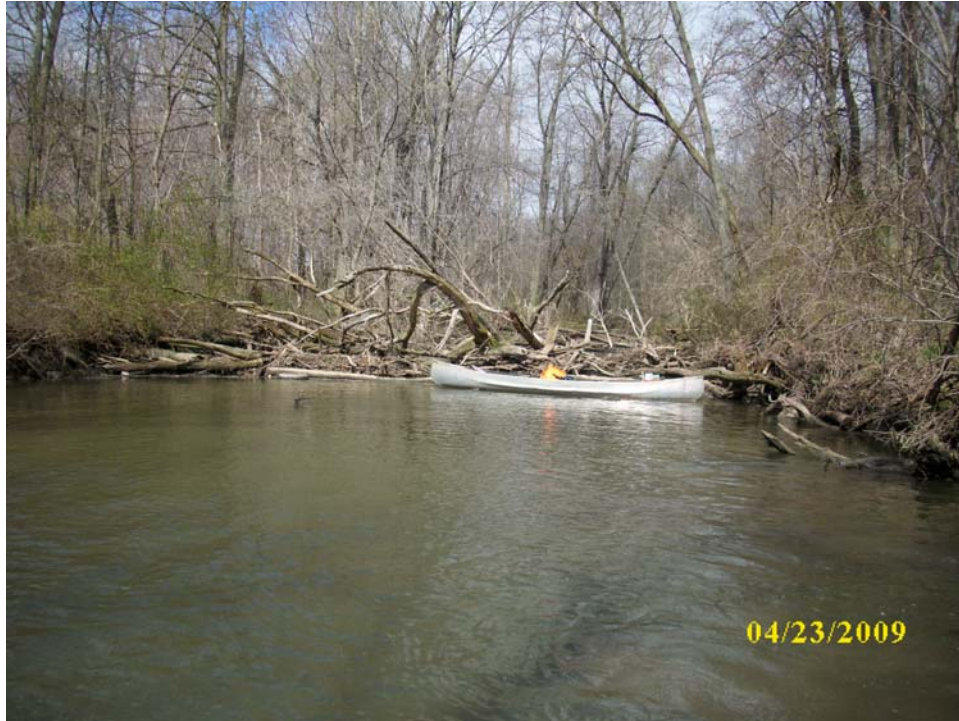
Photo: P32  
 Direction of view: NW  
 Description: LWD obstruction across creek (OBS-023).

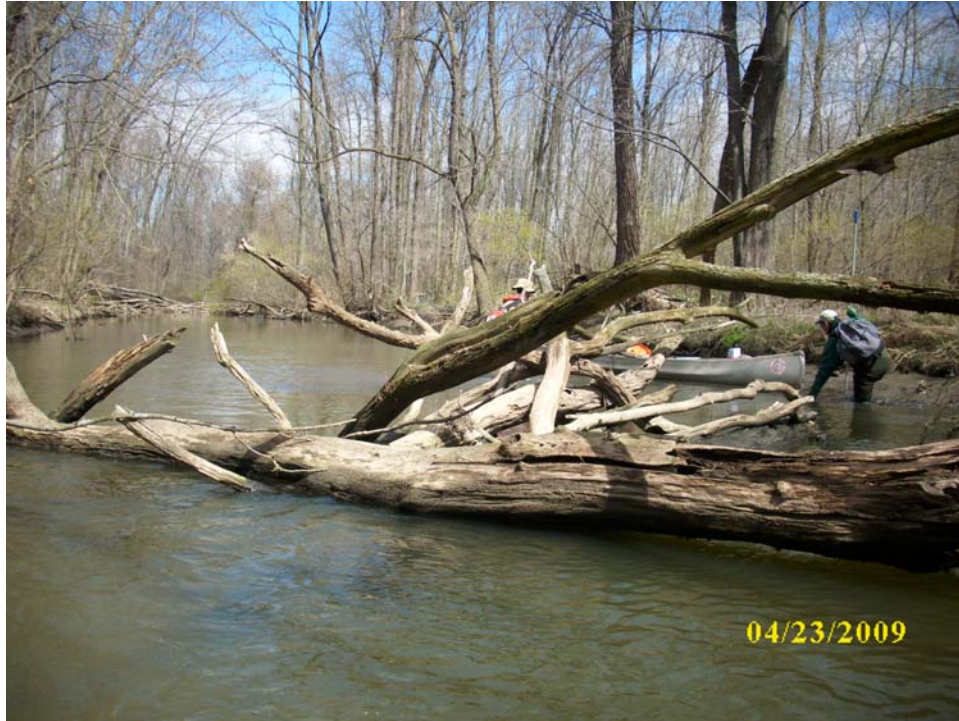
Photo: P34  
 Direction of view: N  
 Description: LWD obstruction across creek (OBS-024).

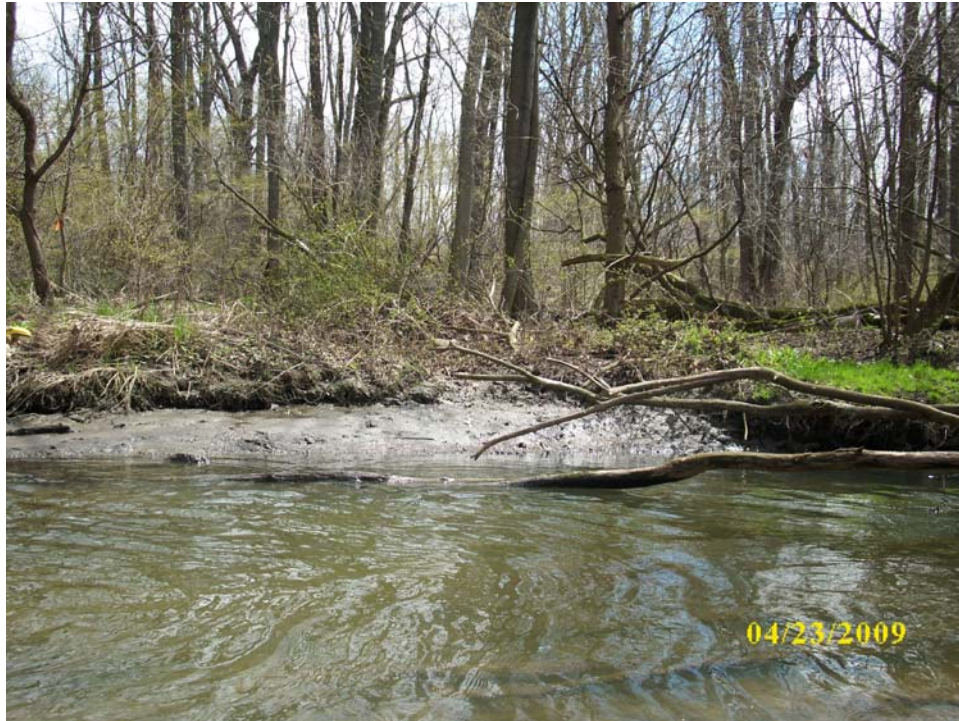
Photo: P35  
 Direction of view: E  
 Description: Overland flow along RDB just downstream of P34 (DRN-024).
