# A

## Survey Figures

# B Survey Data Tables

**Table B-1 Sediment Thickness Points, Eighteenmile Creek, Niagara County, New York**

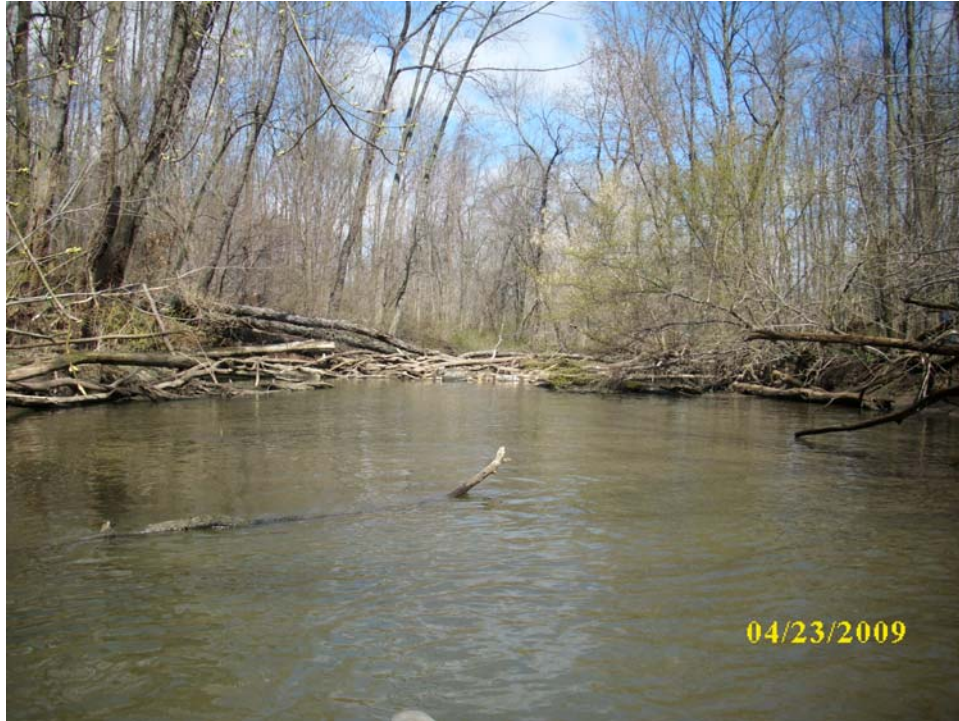
Photo: P36  
 Direction of view: N  
 Description: LWD obstruction across creek (OBS-025).

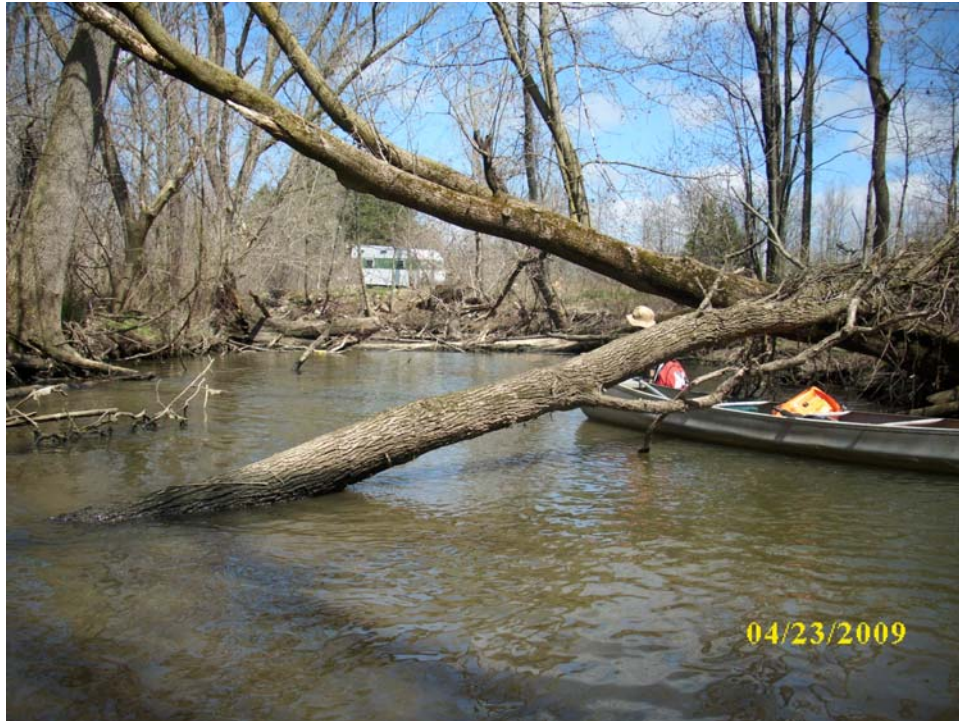
Photo: P37  
 Direction of view: NE  
 Description: LWD obstruction across creek.

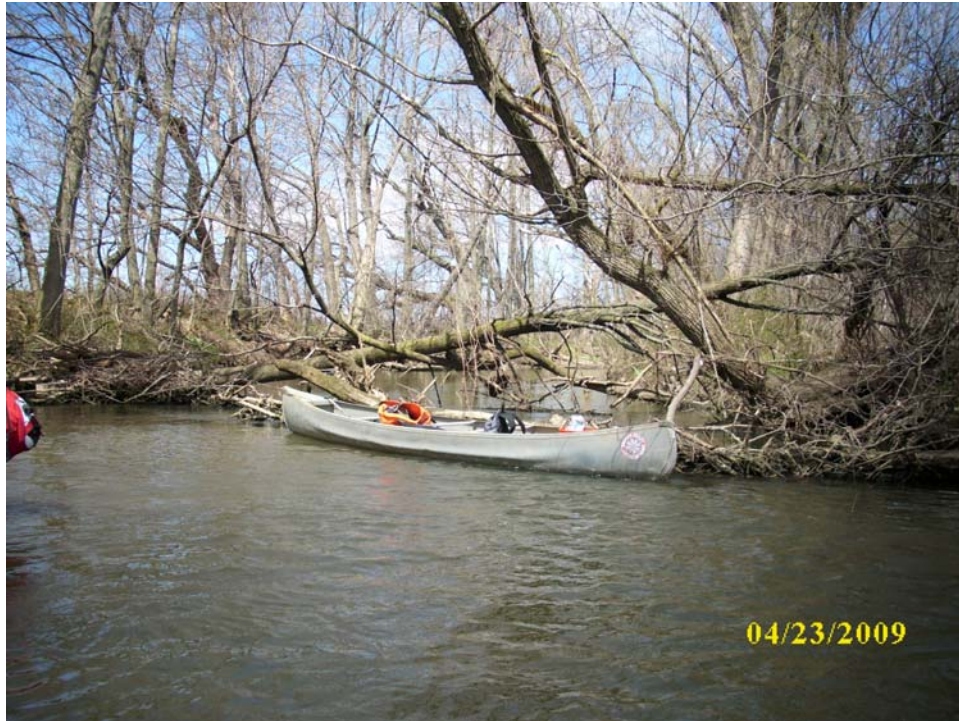
Photo: P39  
Direction of view: N  
Description: LWD obstruction across creek (OBS-026).

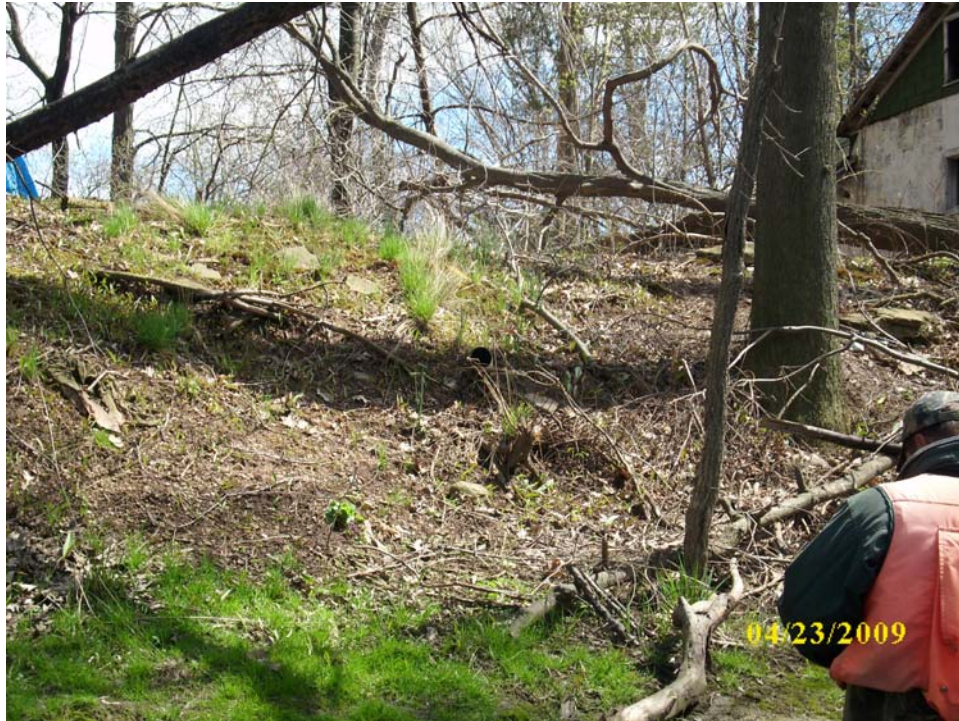
Photo: P43  
 Direction of view: SE  
 Description: PVC pipe outfall along RDB (OUT-020).

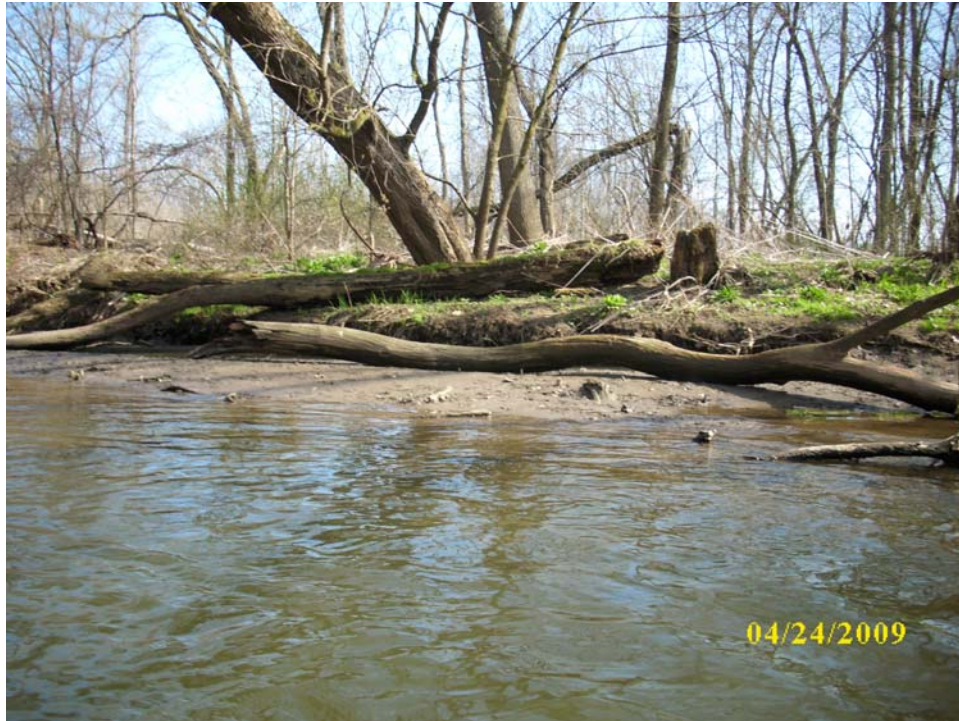
Photo: P61  
 Direction of view: NW  
 Description: Exposed sediment bar across from P60 along RDB.

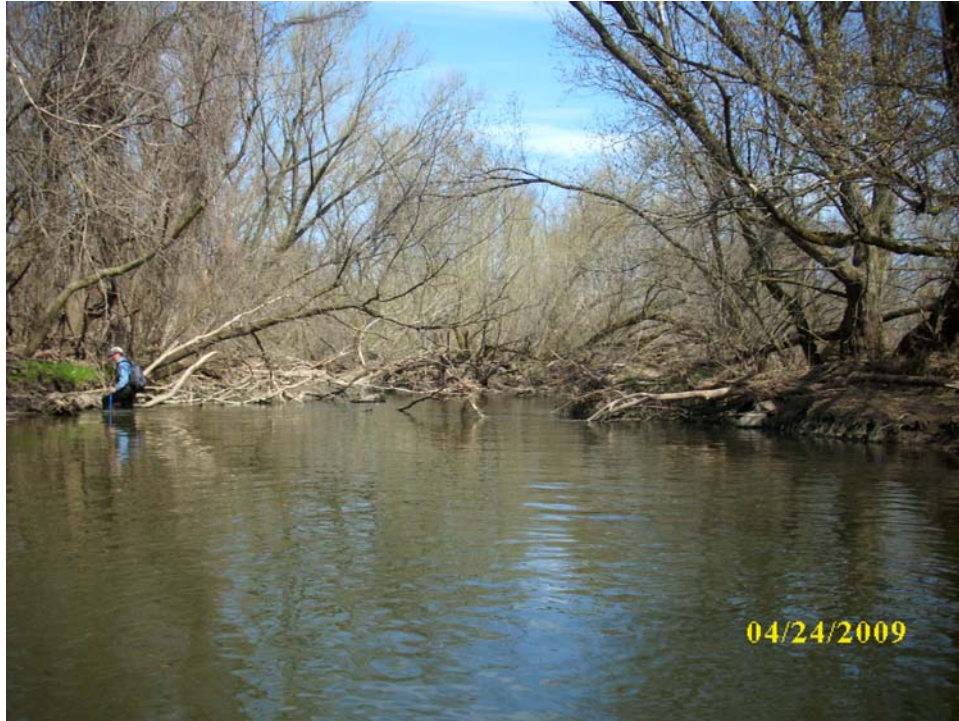
Photo: P100  
 Direction of view: N  
 Description: LWD obstruction across creek (OBS-035).

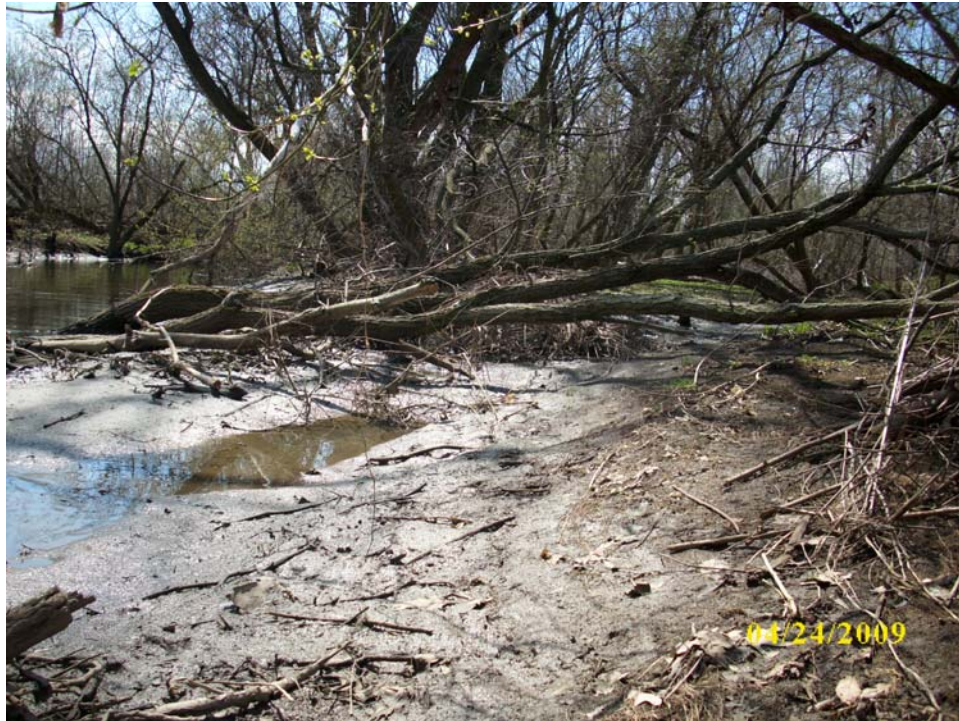
Photo: P101  
 Direction of view: S  
 Description: Wetland discharge along LDB (SED-081).
