Foundation Design, P.C.

June 1, 2012

Reference Photech Imaging Corporation Site – Phase II
1000 Driving Park Avenue, Rochester, NY
Construction Close-Out Letter, 3446.1

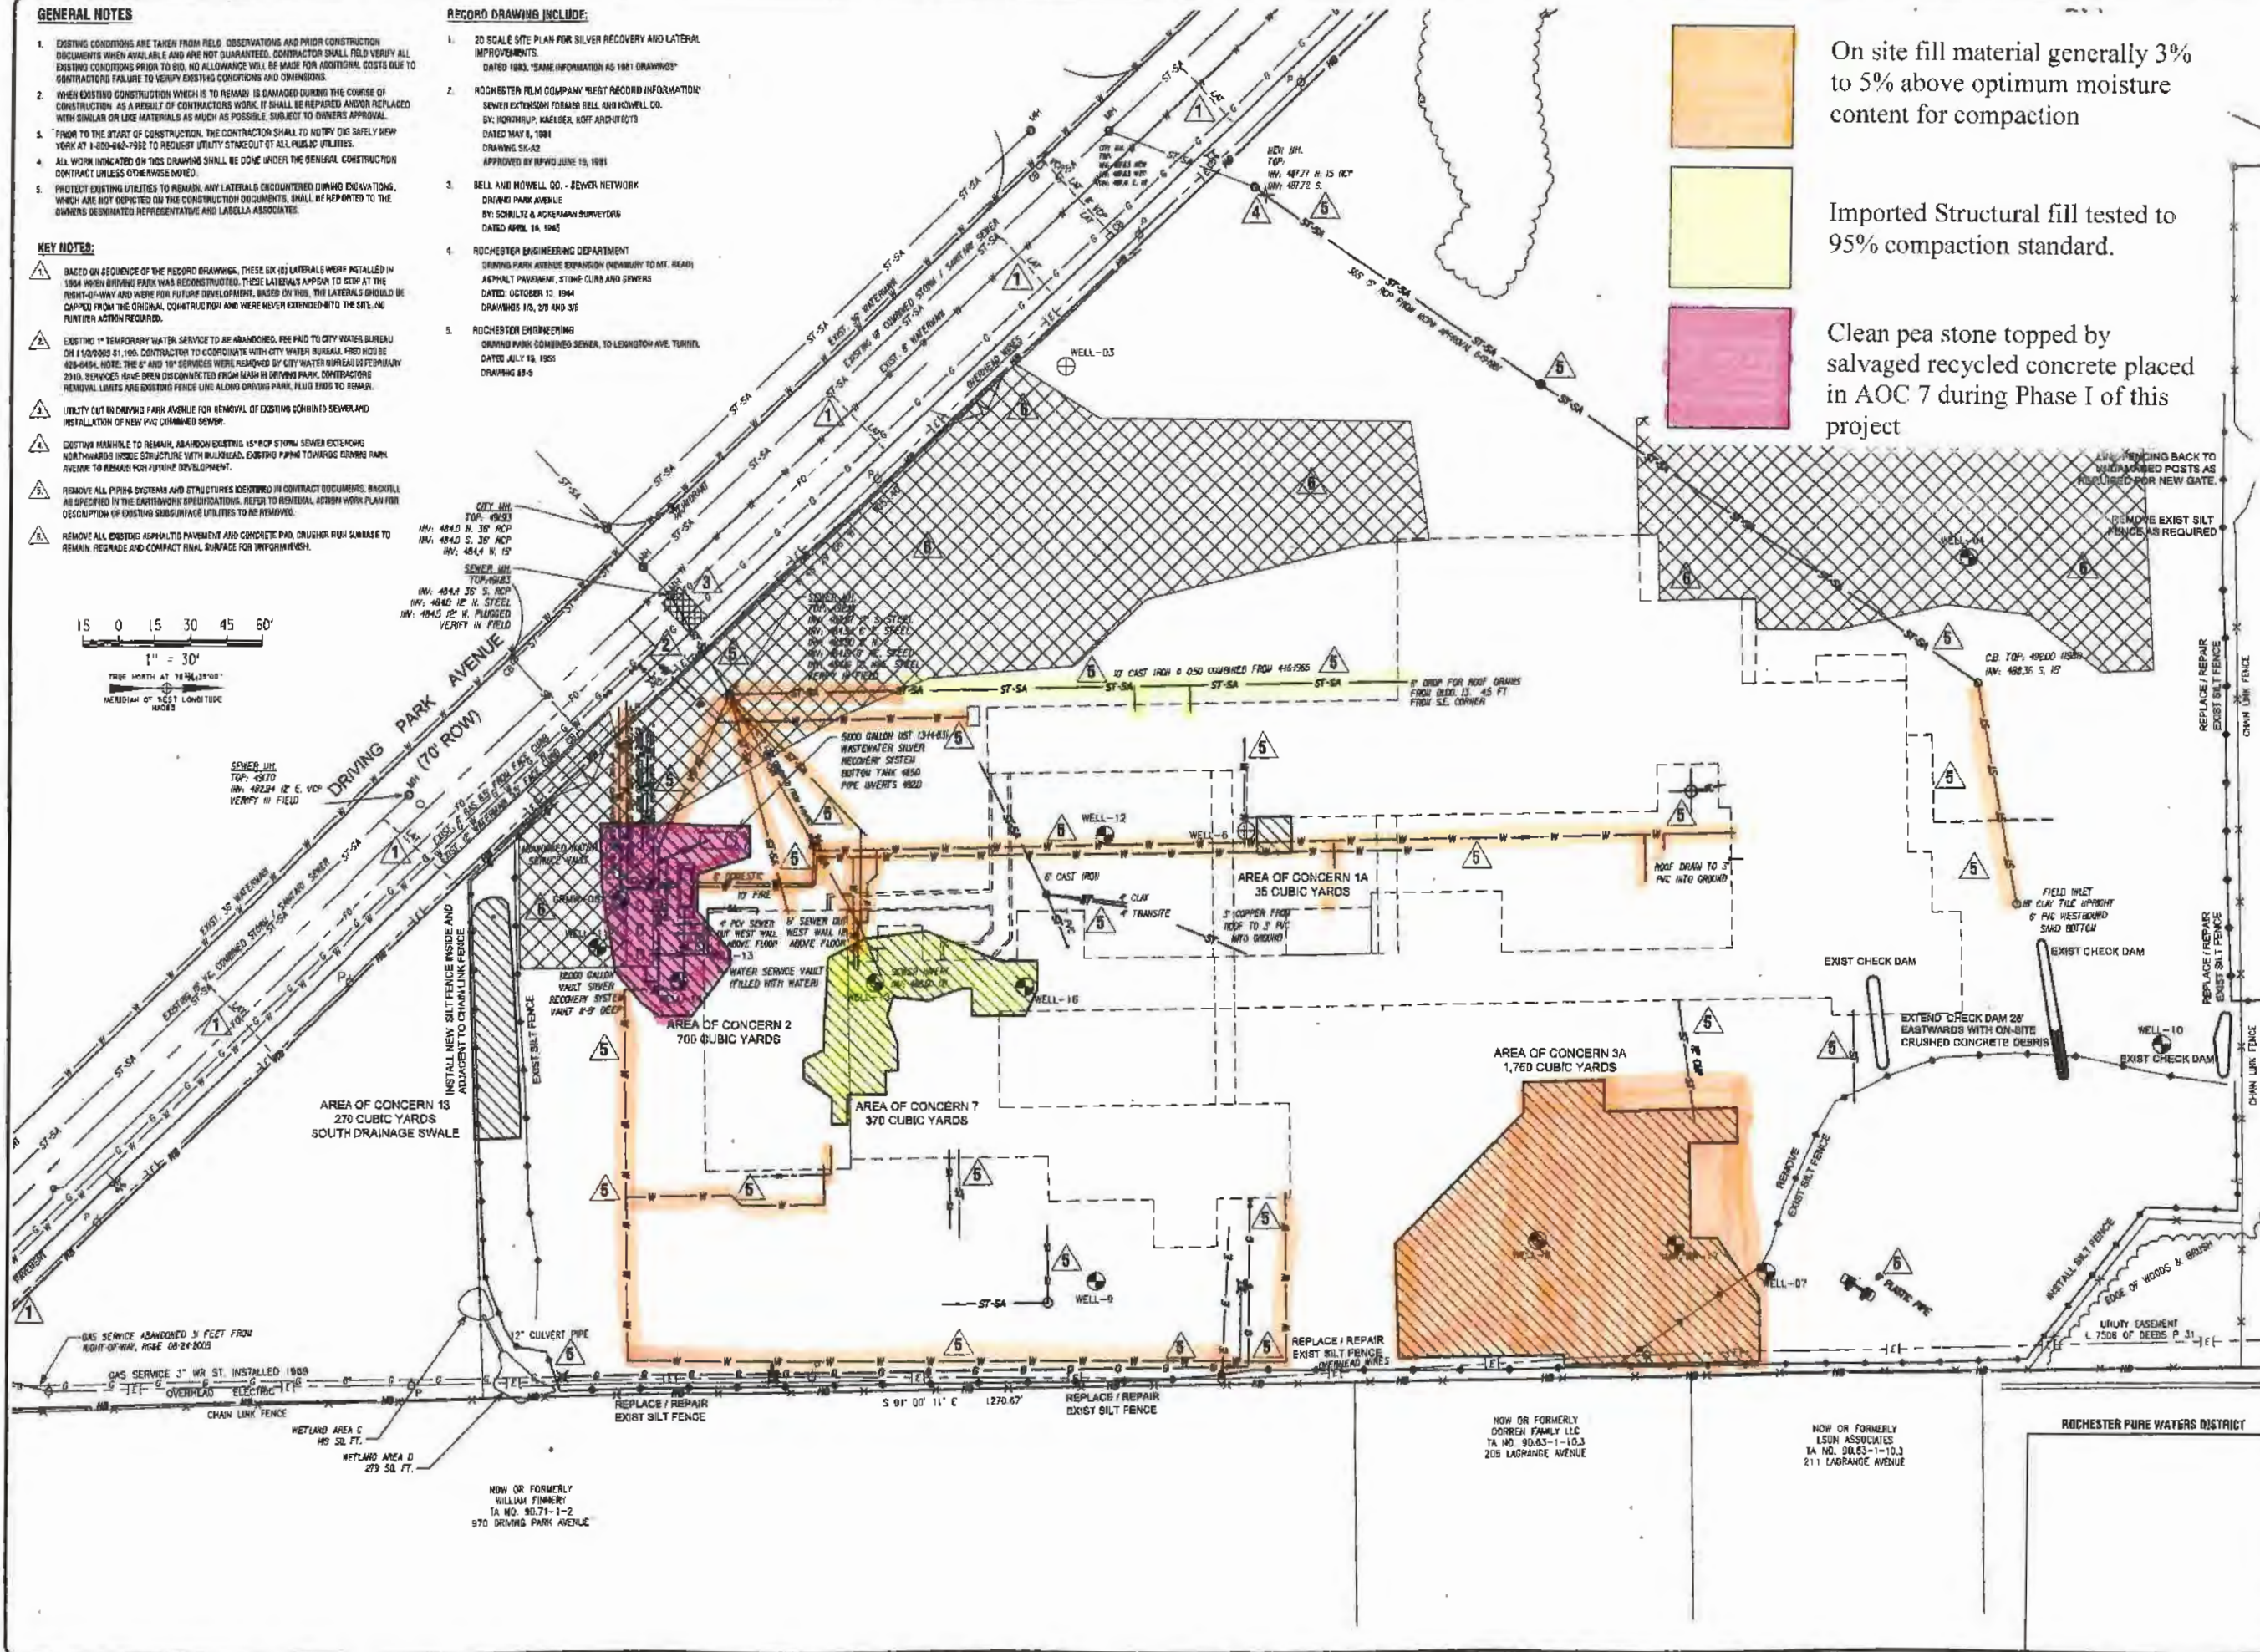
Clean pea stone topped by salvaged recycled concrete placed in AOC 7 during Phase I of this project

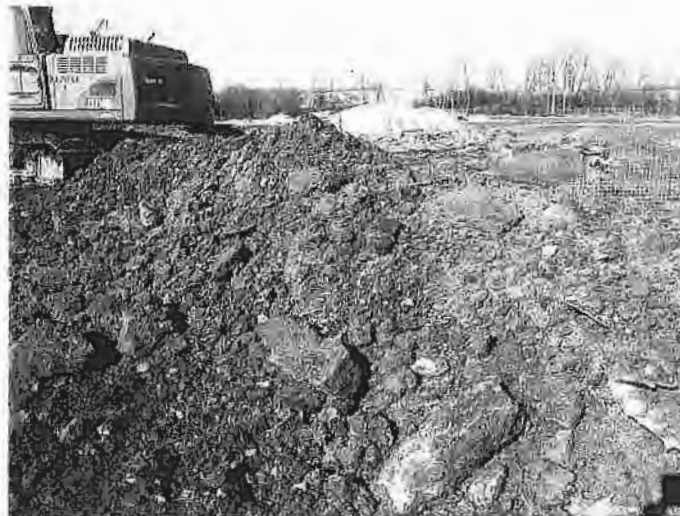
1. I was on site to observe earthwork operations. TREC planned to continued to remove water line per plan on the east side of the site today. TREC continued to attempt to get the water draining from the pipes between the berm under control today.
2. TREC started excavation working from the east property line to the west today. The water line along this side of the site appears to be close to or on the bedrock approximately a minus eight foot depth, the excavation filled with water before the water line was exposed. Backfill over the water line is debris laden we also observed a buried topsoil layer on this side of the site. (See attached photo.) TREC decided that they would look for other areas of the site to continue removal work.

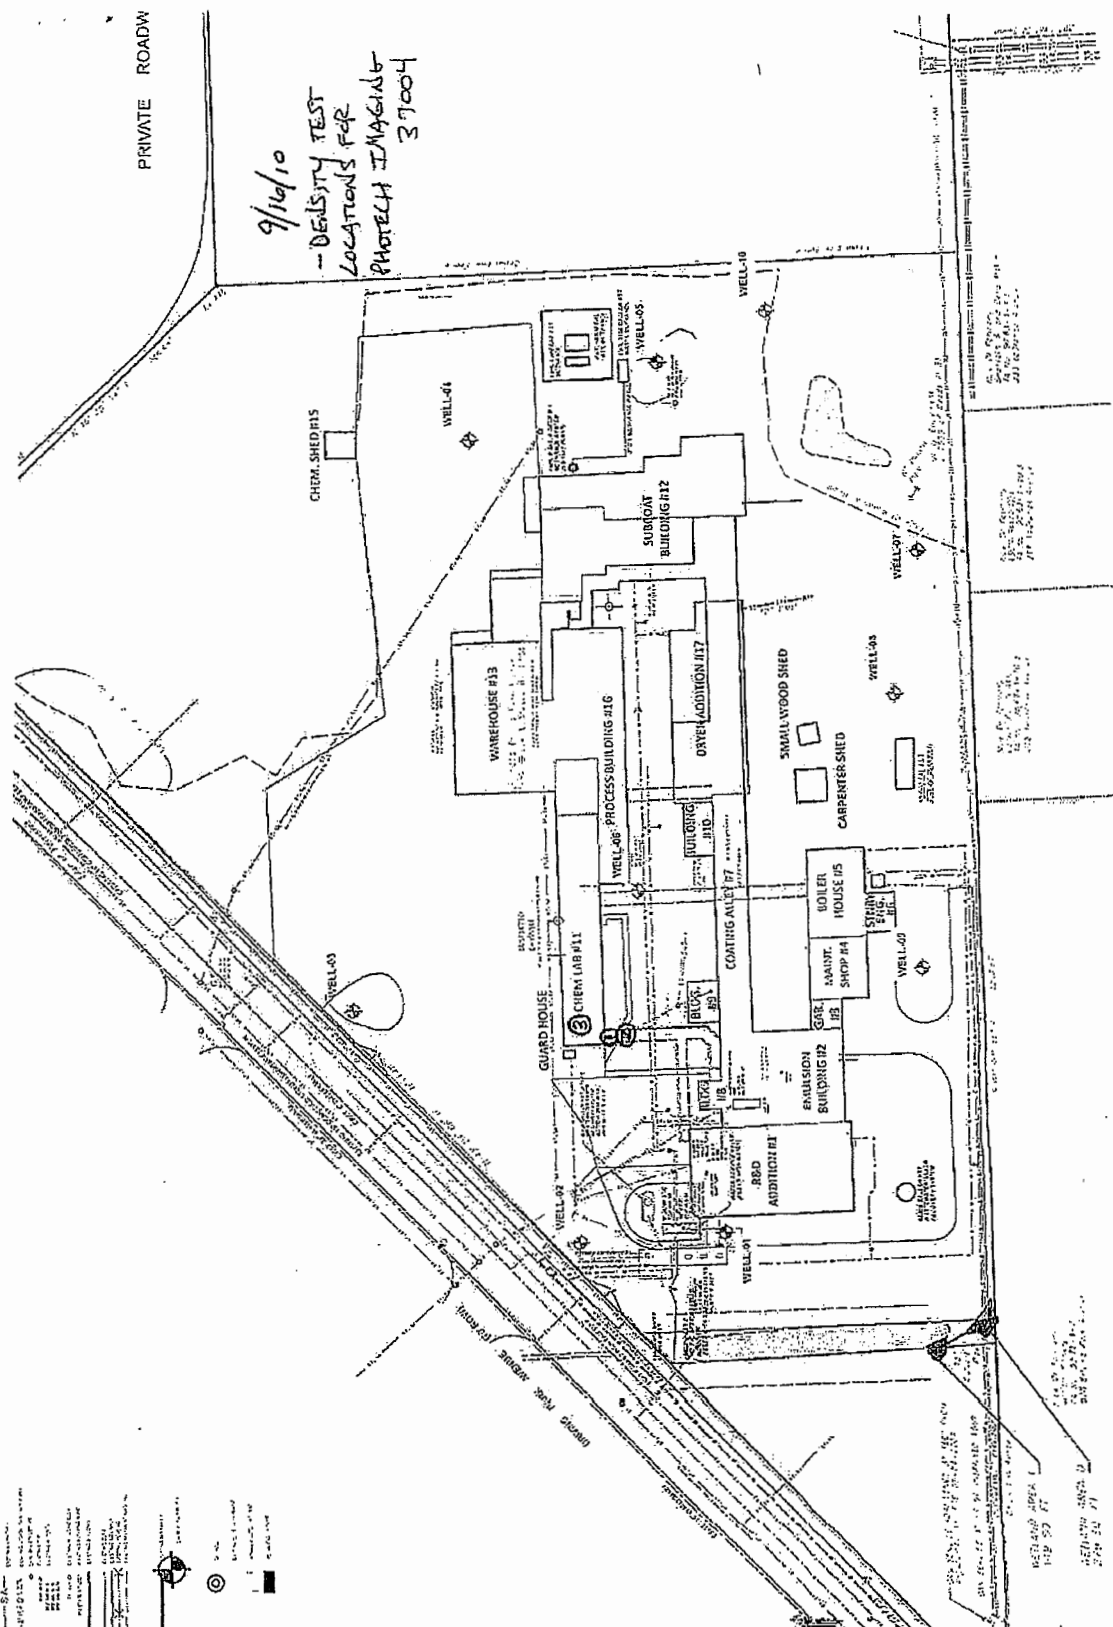
The test results indicate a high moisture content and the required percentage of compaction was not achieved at the locations and elevations shown below. The site contractor decided to leave the soil in place to allow it to dry. This will be listed as NCDD #1 on CME's List of Non-Conformance, Deviations and Deficiencies.

Test #	Test Location	Test Elevation	Moisture Content (%)	OMC (%)	Field Dry Density (pcf)	100% Dry Density (pcf)	Compaction Achieved (%)	Compaction Required (%)
1	See Attached Sketch	493	11.4	8.0	121.4	133.3	91.1	95.0
2	See Attached Sketch	493	12.1	8.0	115.6	133.3	86.7	95.0
3	See Attached Sketch	494	12.2	8.0	118.9	133.3	89.2	95.0

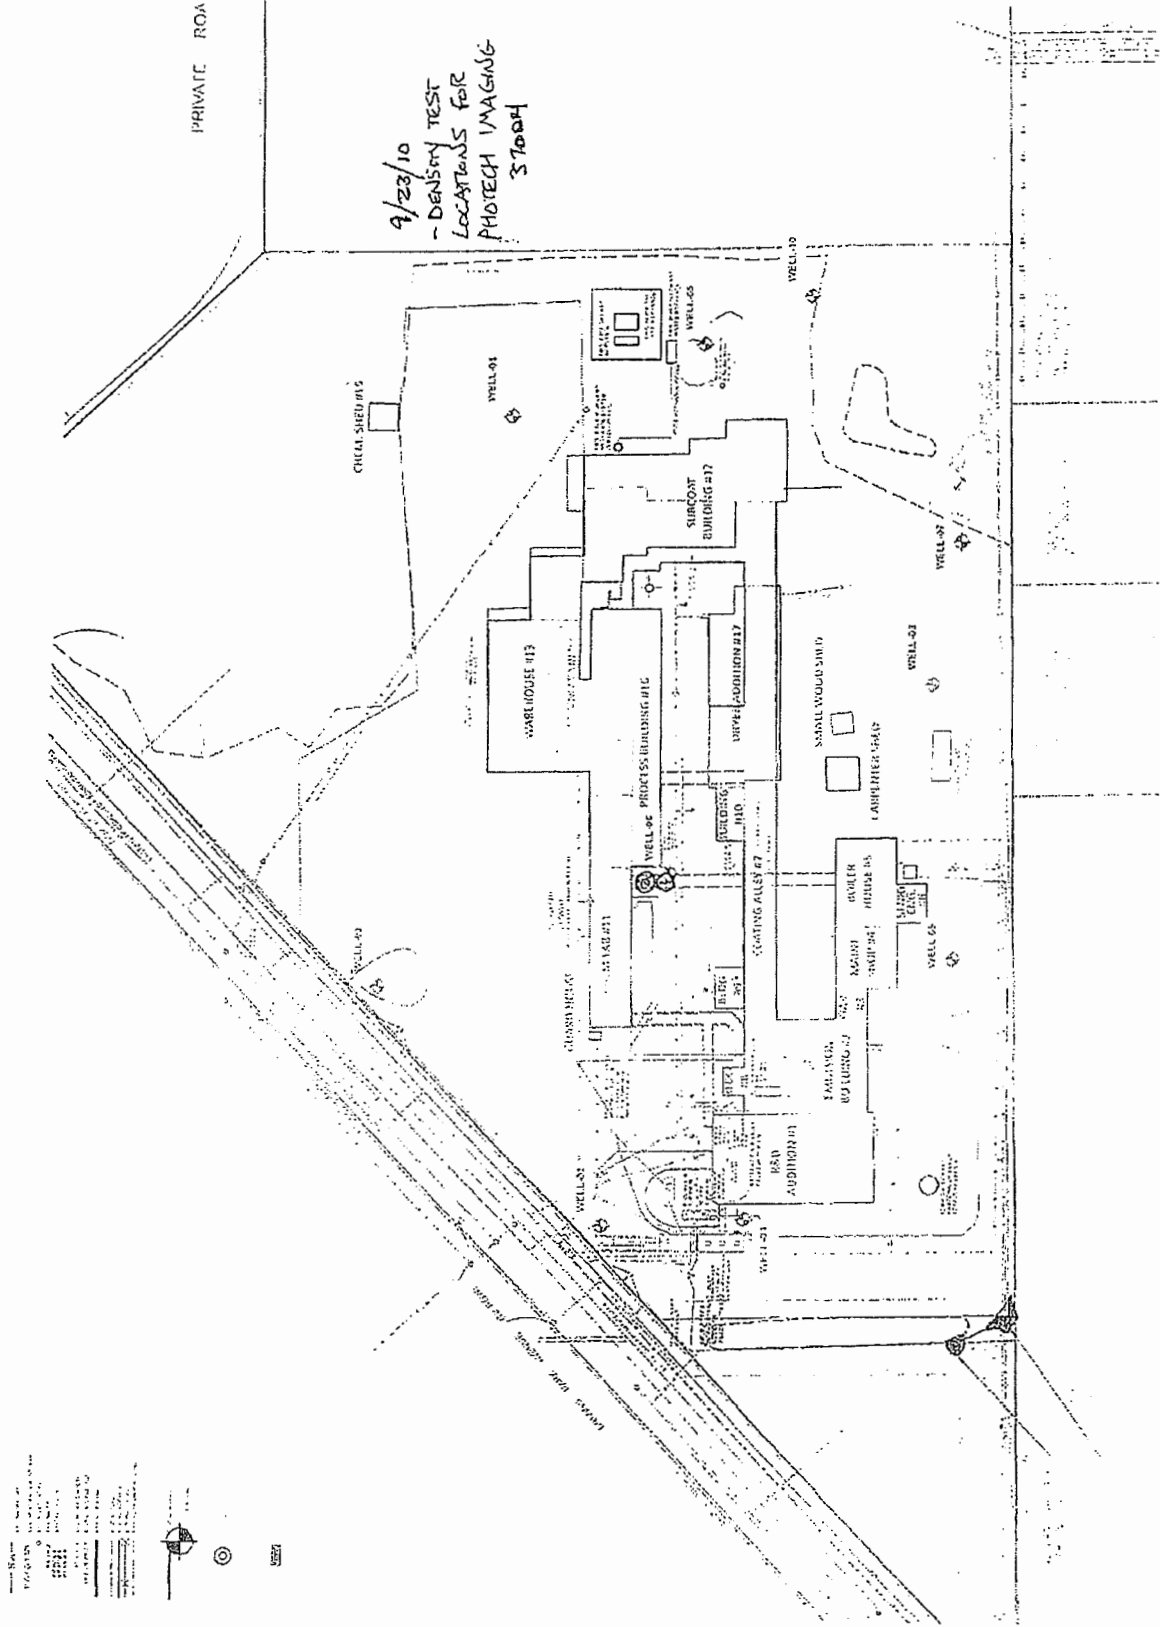
Test #	Test Location	Test Elevation	Moisture Content (%)	OMC (%)	Field Dry Density (pcf)	100% Dry Density (pcf)	Compaction Achieved (%)	Compaction Required (%)
1	See Attached Sketch	481	8.3	9.1	112.3	127.8	87.9	95.0
2	See Attached Sketch	481	7.8	9.1	115.7	127.8	90.5	95.0

The site contractor was informed and agreed to re-work and re-compact the failing area. These areas will be retested on 9/24/10.

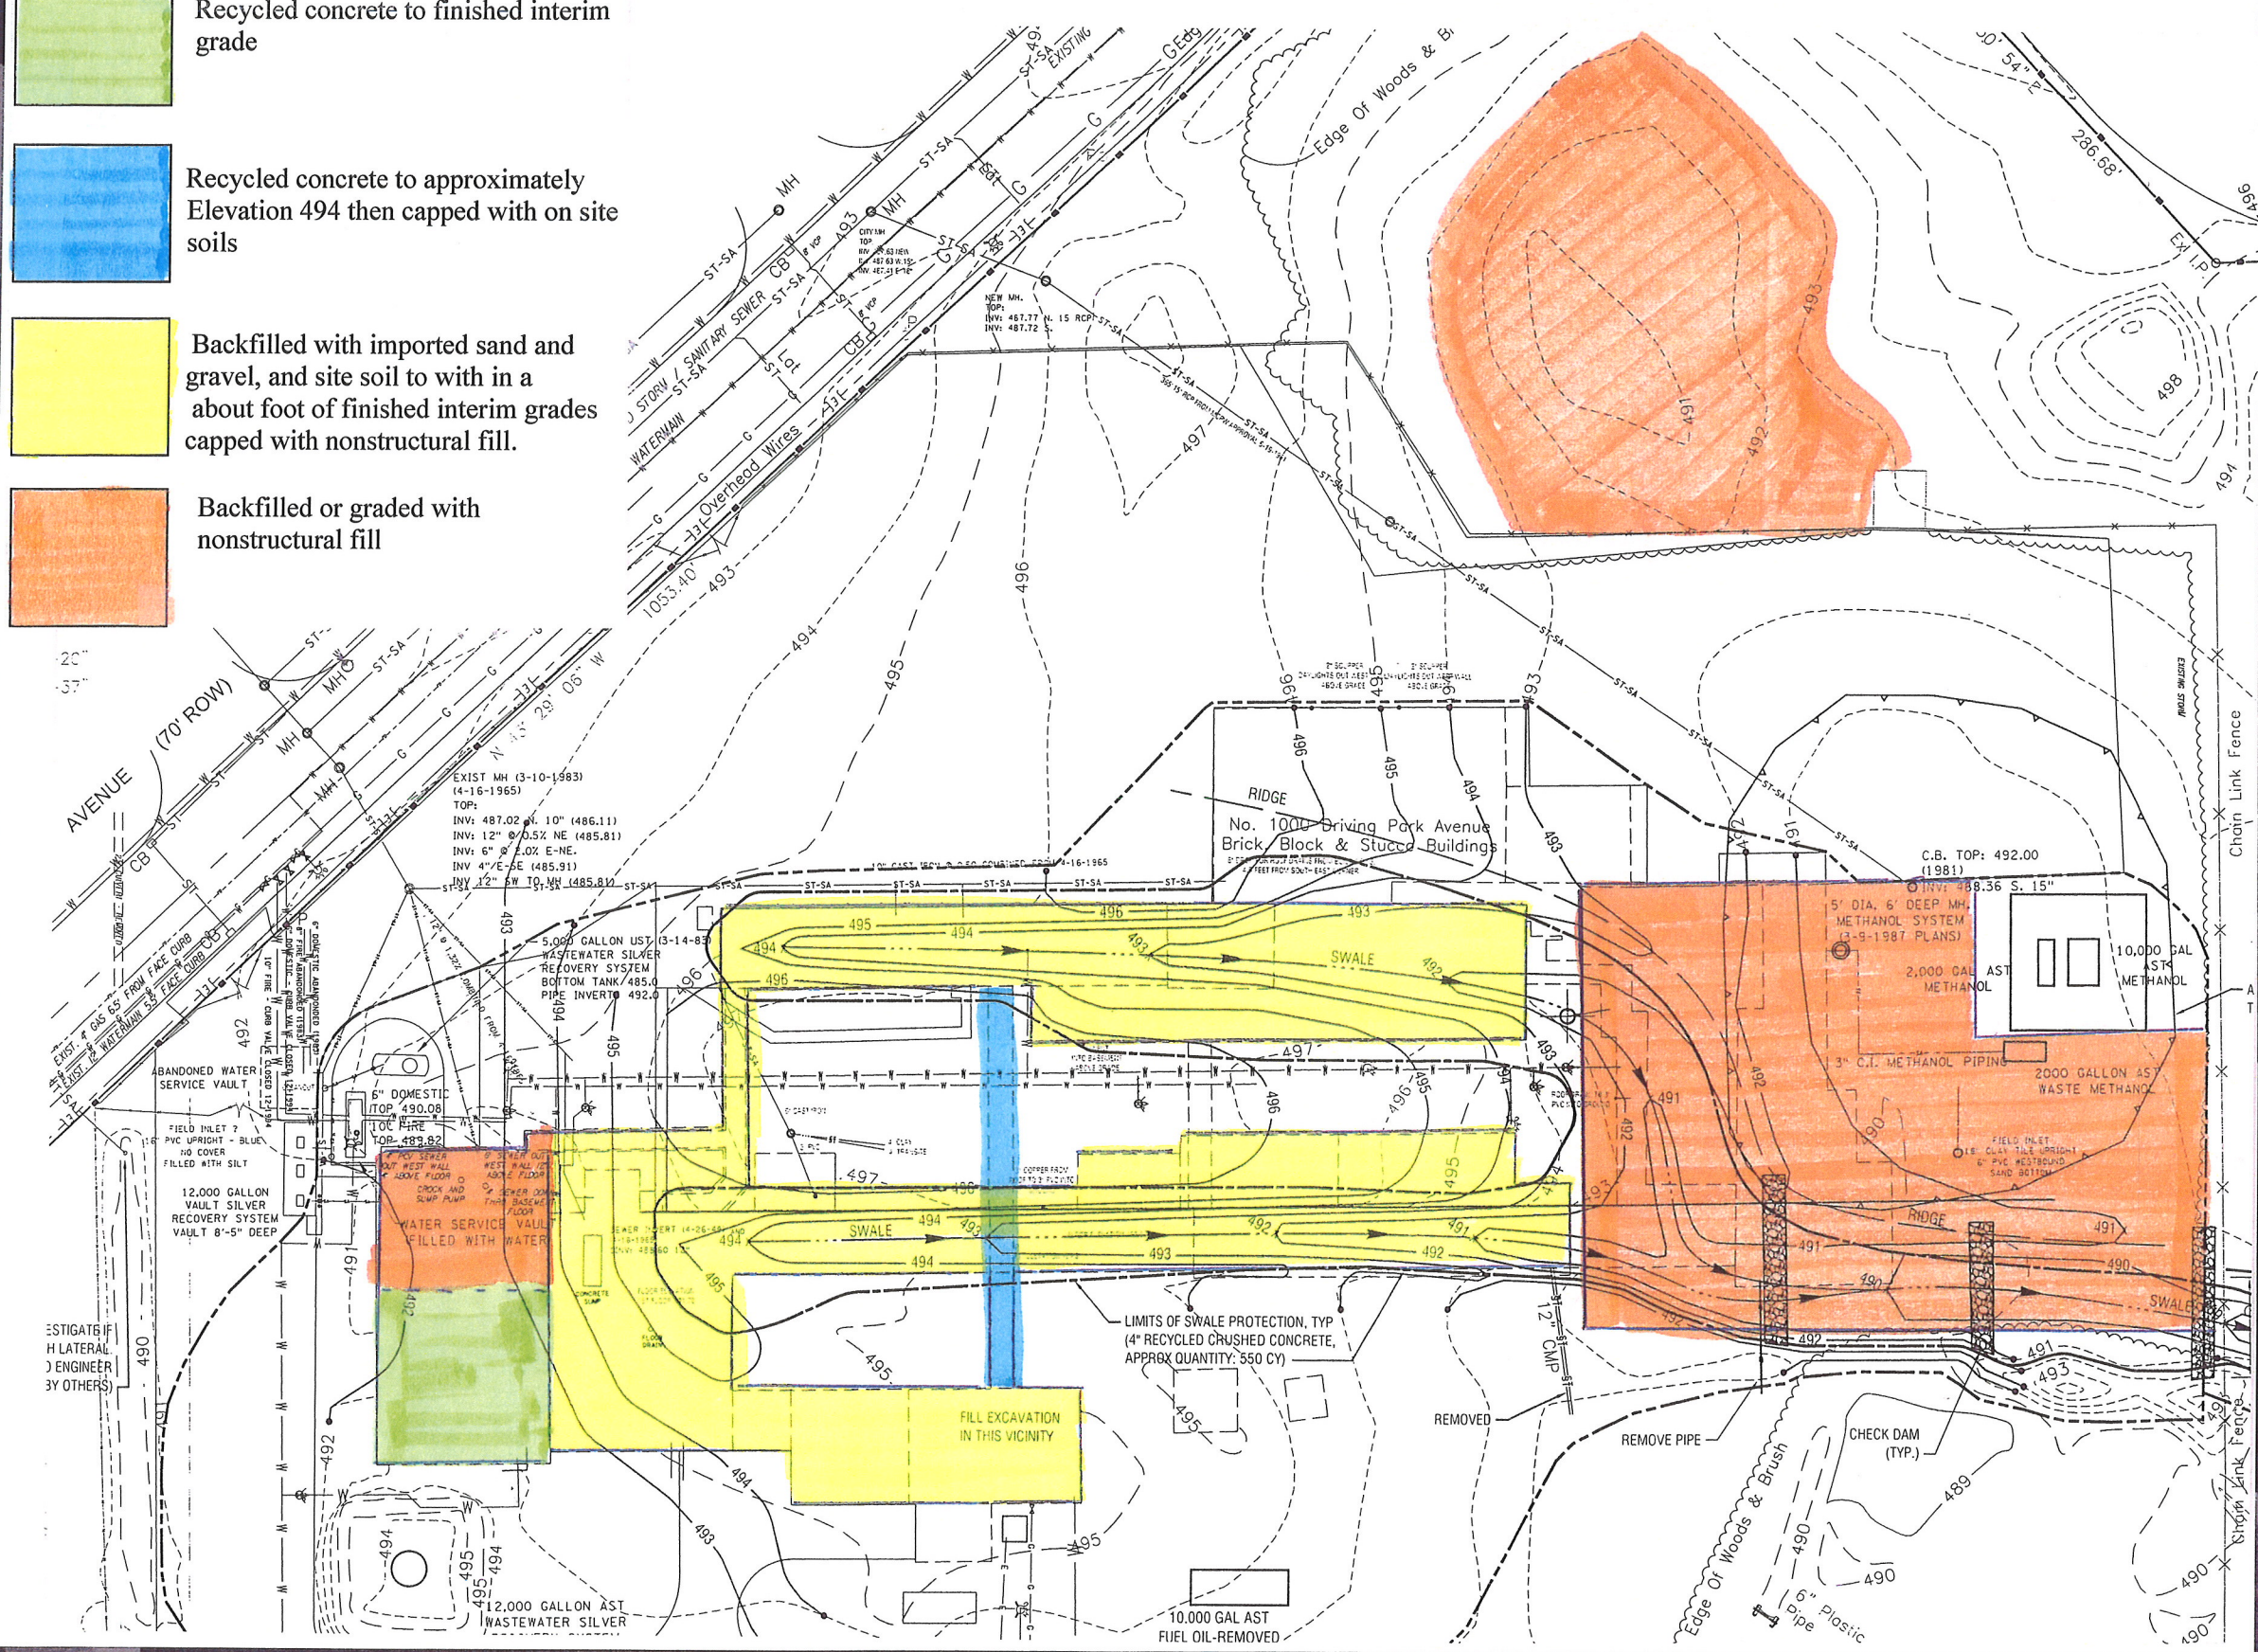
Photech – Phase I Environmental
 1000 Driving Park, Rochester, New York
Fill Placement Plan
 Adapted from: LaBella Associates, P.C.
 Revised Grading Plan

Backfilled or graded with nonstructural fill
