*Re: 2011 Annual Site Management Plan Surface Cover Report
Former Independent Leather Tannery Site (#B-00158)
City of Gloversville, Fulton County
C.T. Male Project No. 10.1125*

C.T. Male Associates, P.C. (C.T. Male) has completed a site visit to observe the site's surface cover at the Former Independent Leather Tannery Site in Gloversville, New York in accordance with NYSDEC approved Site Management Plan dated January 13, 2009. This letter serves as the 2011 Annual Report.

FIGURE 1
SURFACE COVER CONDITION OBSERVATIONS

INDEPENDENT LEATHER TANNERY
ANNUAL SITE MANAGEMENT PLAN MONITORING

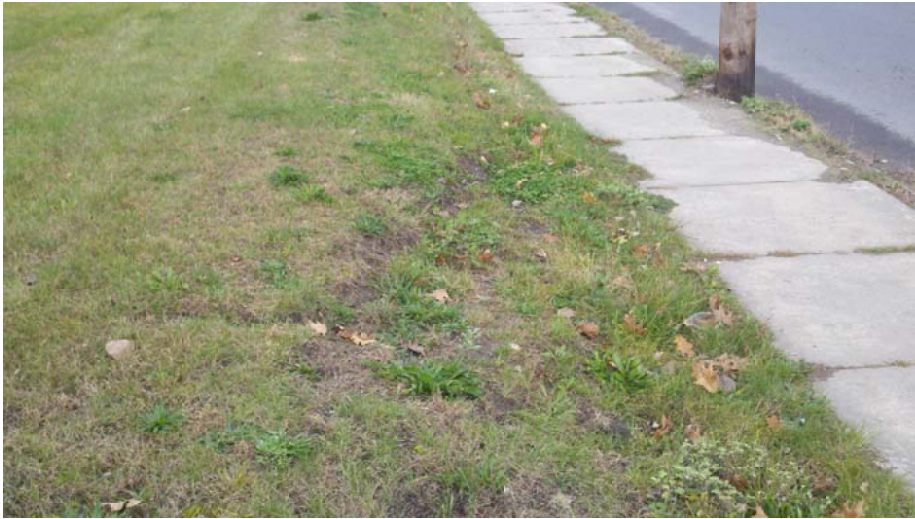
Picture #04.jpg

Picture #01:	Surface cover on the west side of the creek looking south.
Picture #02:	Surface cover (heavy moss) on the western side of the creek looking north across the site.
Picture #03:	Surface cover along South Main Street on the west side of the site.
Picture #04:	Sparse vegetation at the southwest extreme corner of the site.
Picture #05:	Sparse vegetative cover on the west side of the site adjacent to South Main Street.
Picture #06:	Stripped vegetation along the western property line (south end).
Picture #07:	Surface cover on the north end of the site.
Picture #08:	Surface cover in the middle portion of the site on the west side of the creek.
Picture #09:	Stripped vegetation along the western property line (south end).
Picture #10:	Surface cover middle portion of the site, west side, looking south.
Picture #11:	Creek traversing the site, middle section, looking south.
Picture #12:	Creek traversing the site, northern portion, looking north.
