**Department of
Environmental
Conservation**

DAILY INSPECTION REPORT

Site Code #: B-00-184	Date: 07/27/2018	Report #: AT-1
------------------------------	-------------------------	-----------------------

Site Name: Fosters Refrigeration
Location: City of Hudson, Columbia Co.
DEC Proj. Mgr.: Jeff Trad
Contractor: Precision Environmental
Contractor Proj. Mgr.: Steve Phelps

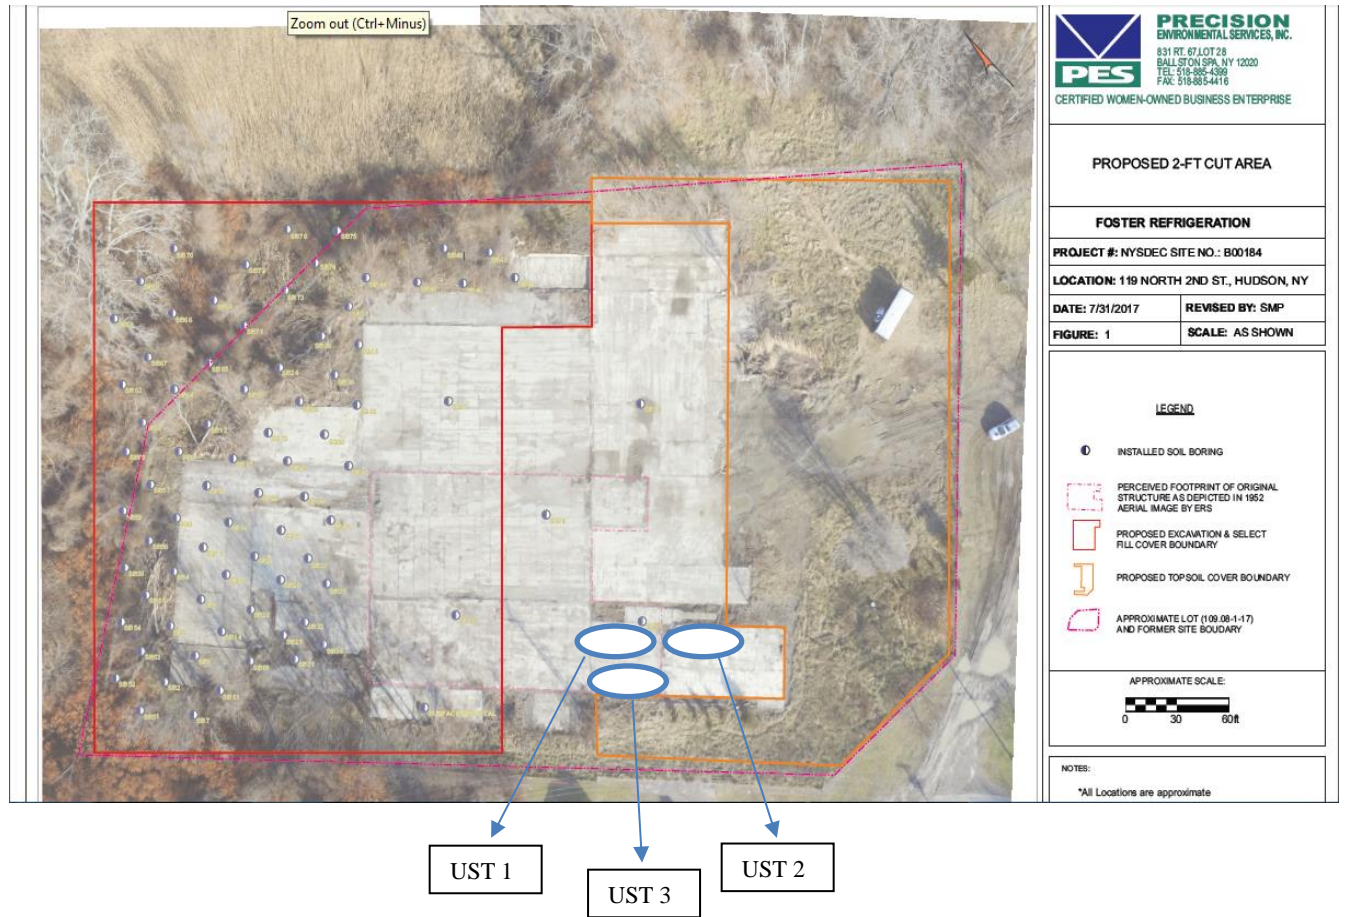
Site Map

Major Issues	Description & Reason
2 nd UST Tank 23.5' x 64" (4000 gal)	It was discovered in this site visit and it is close to active gas line and water line
Oil in UST 1 12.3' x 5' (2000 gal)	Leaking oil from UST has contaminated the soil and soil needs to be tested and kept clean from cross-contamination

2nd UST tank identified next to the 1st one
