***Remedial Investigation Report***  
**Former Boiler House Property**  
**NYSDEC Site No. B00197**  
**US Route 4 and Best Avenue**  
**Town of Stillwater**  
**Saratoga County, New York**

**December 2008**

***Chazen Project No. 30201.14***

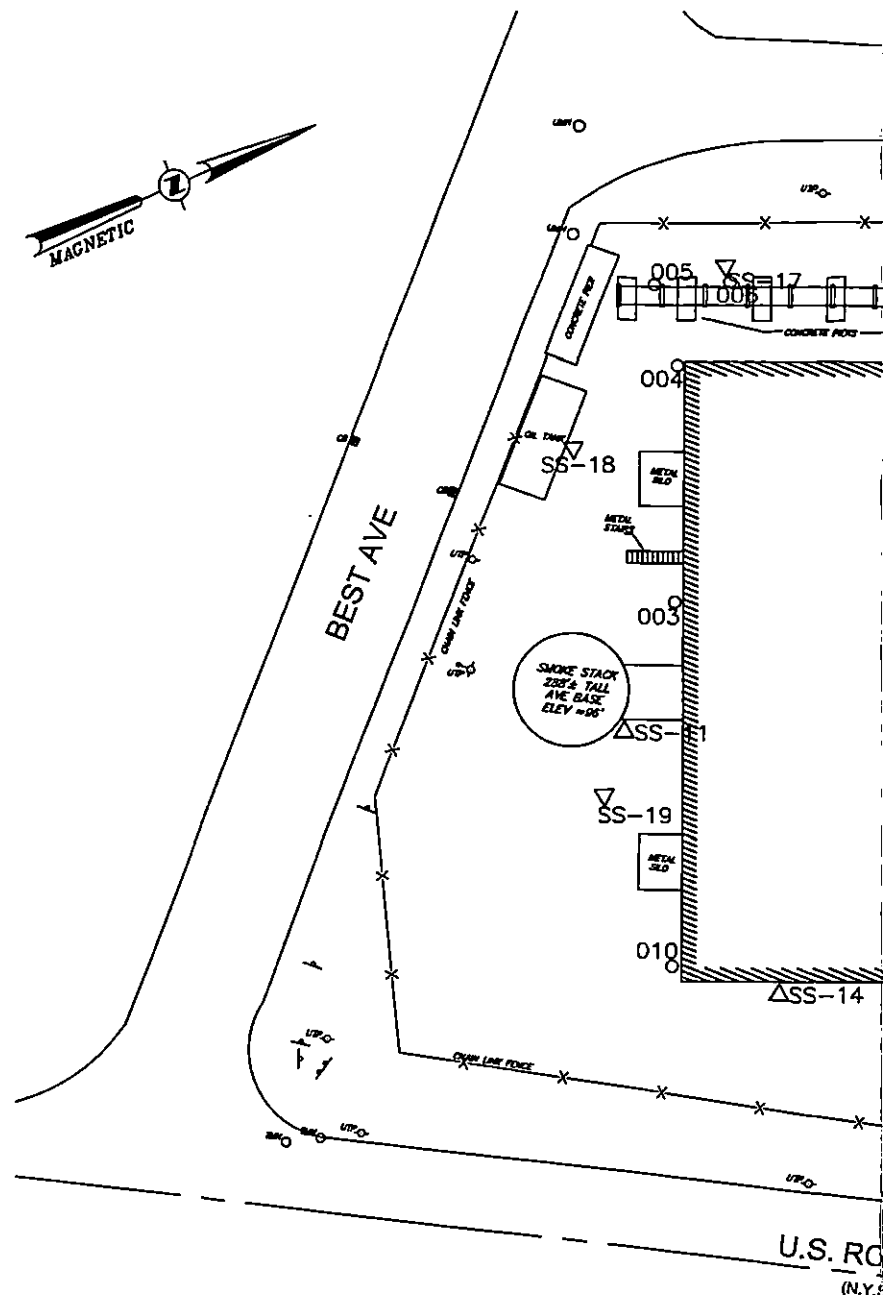
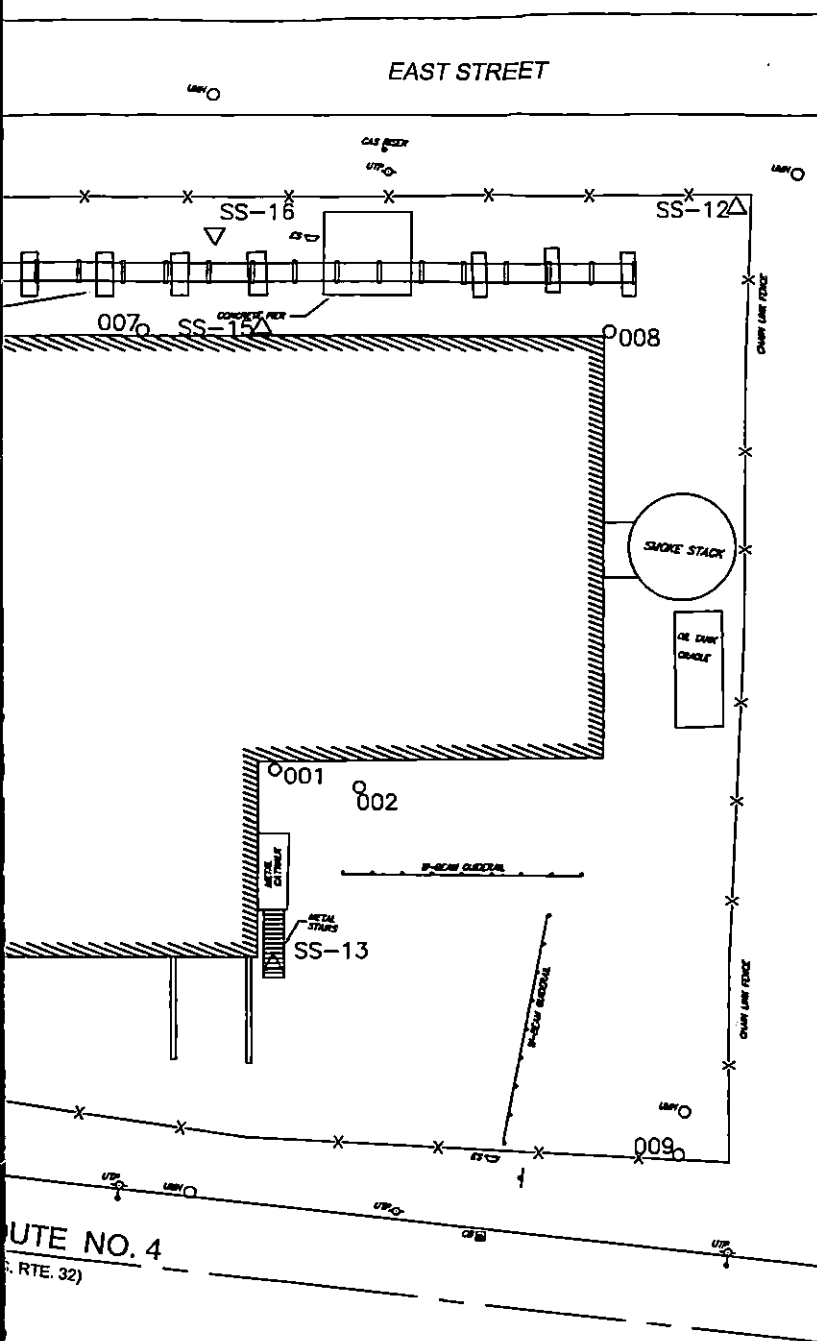
Figure 9  
Lead and Asbestos Surface Soil Sample Location Map

Surface soil samples were collected from ten locations for asbestos analysis (Figure 9). Analytical data indicated that asbestos was not present in shallow soil samples collected on the boiler house property. A copy of the ACM Soil Evaluation Report is attached as Appendix D.

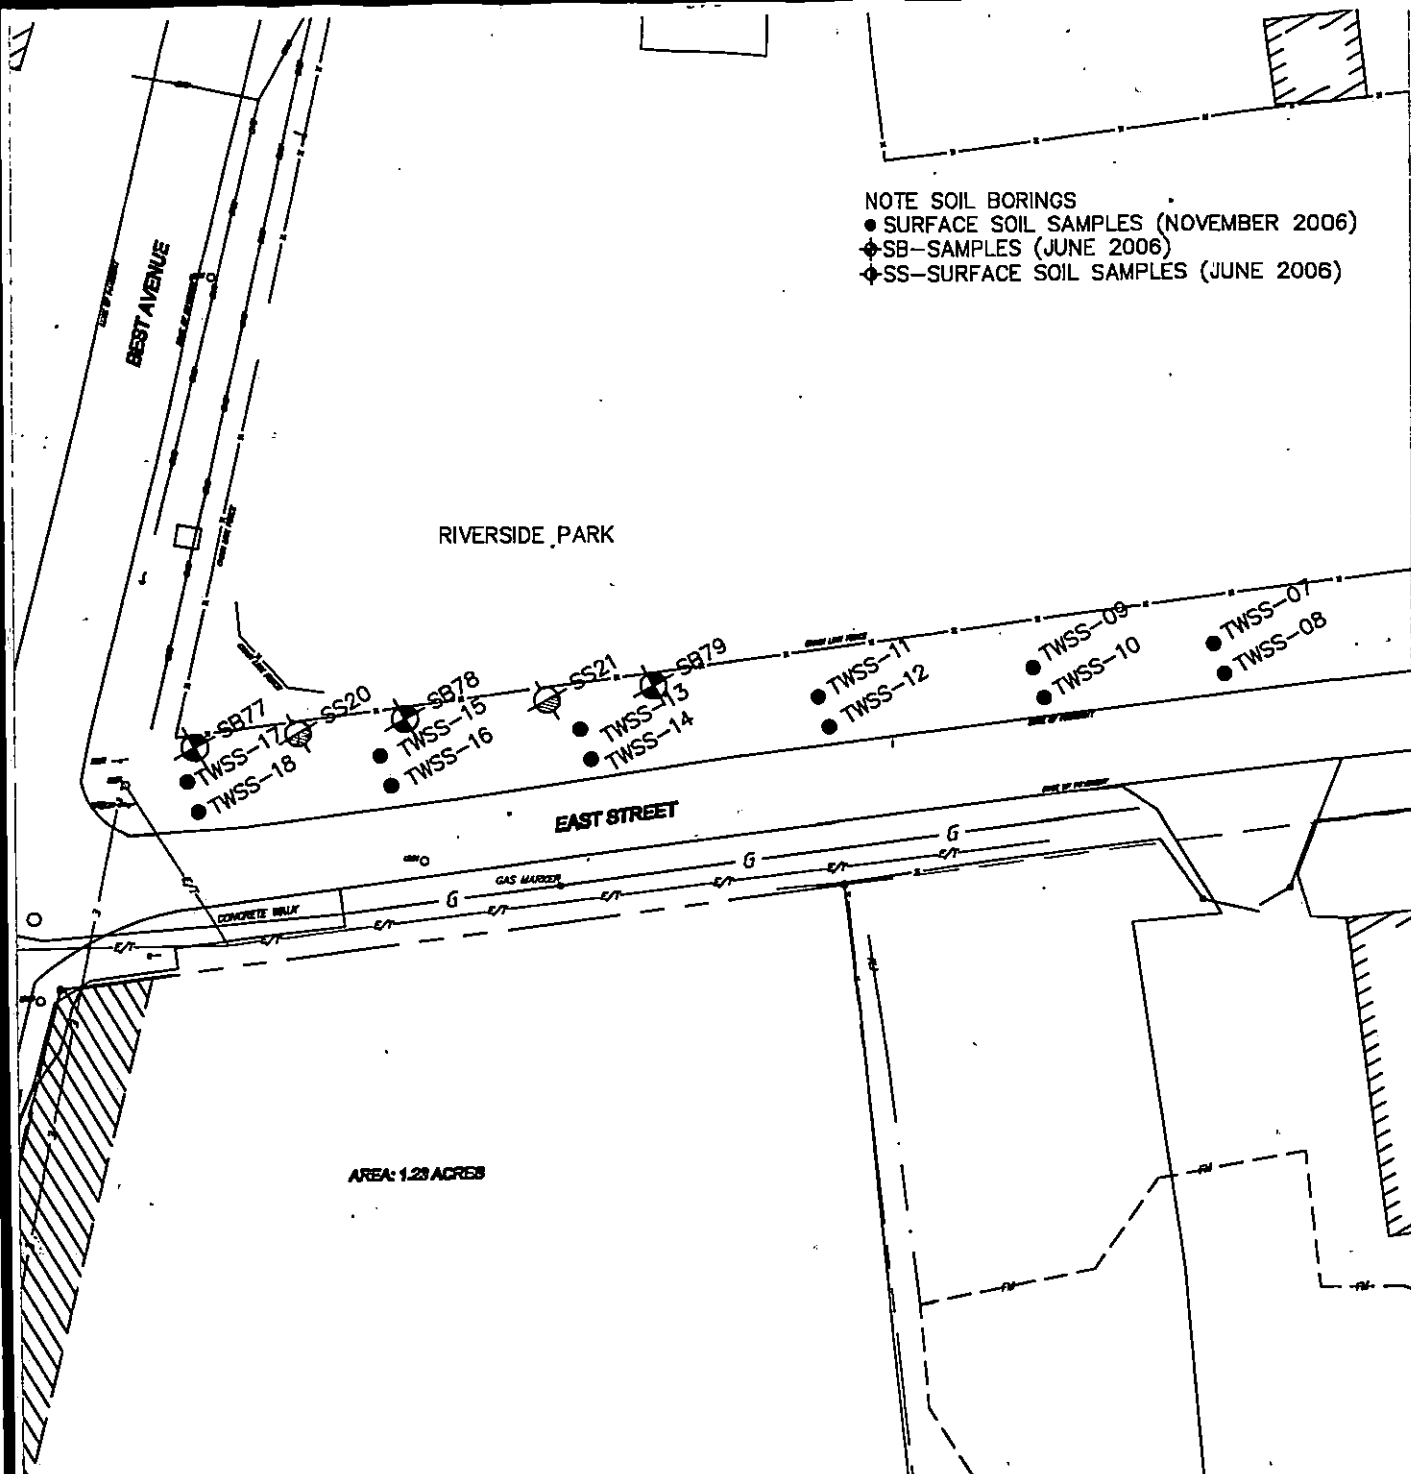
Figure 12  
Surface Soil Sample Locations Adjacent to Riverside Park

The initial offsite sampling on June 6, 2006 consisted of three soil borings (SB-77, SB-78, and SB-79) placed on the west side of East Street (Figure 12). SVOCs were identified in a subsurface soil sample collected from SB-79 which contravened the SCOs for the boiler house site. Following this finding, and at the request of NYSDEC, TCC sampled surface soil in the same area for arsenic, lead, and mercury to determine if elevated concentrations of these metals exist at the ground surface. In one of two surface soil samples (SS-20) collected on July 27, 2006, lead and arsenic were detected at concentrations that exceeded the SCO for the boiler house site.

Twelve surface soil samples (TNSW-7, TNSW-8, TNSW-9, TNSW-10, TNSW-11, TNSW-12, TNSW-13, TNSW-14, TNSW-15, TNSW-16, TNSW-17, and TNSW-18) were collected in the area outside of the fenced perimeter of the park along East Street. Figure 12 depicts the locations of these samples.

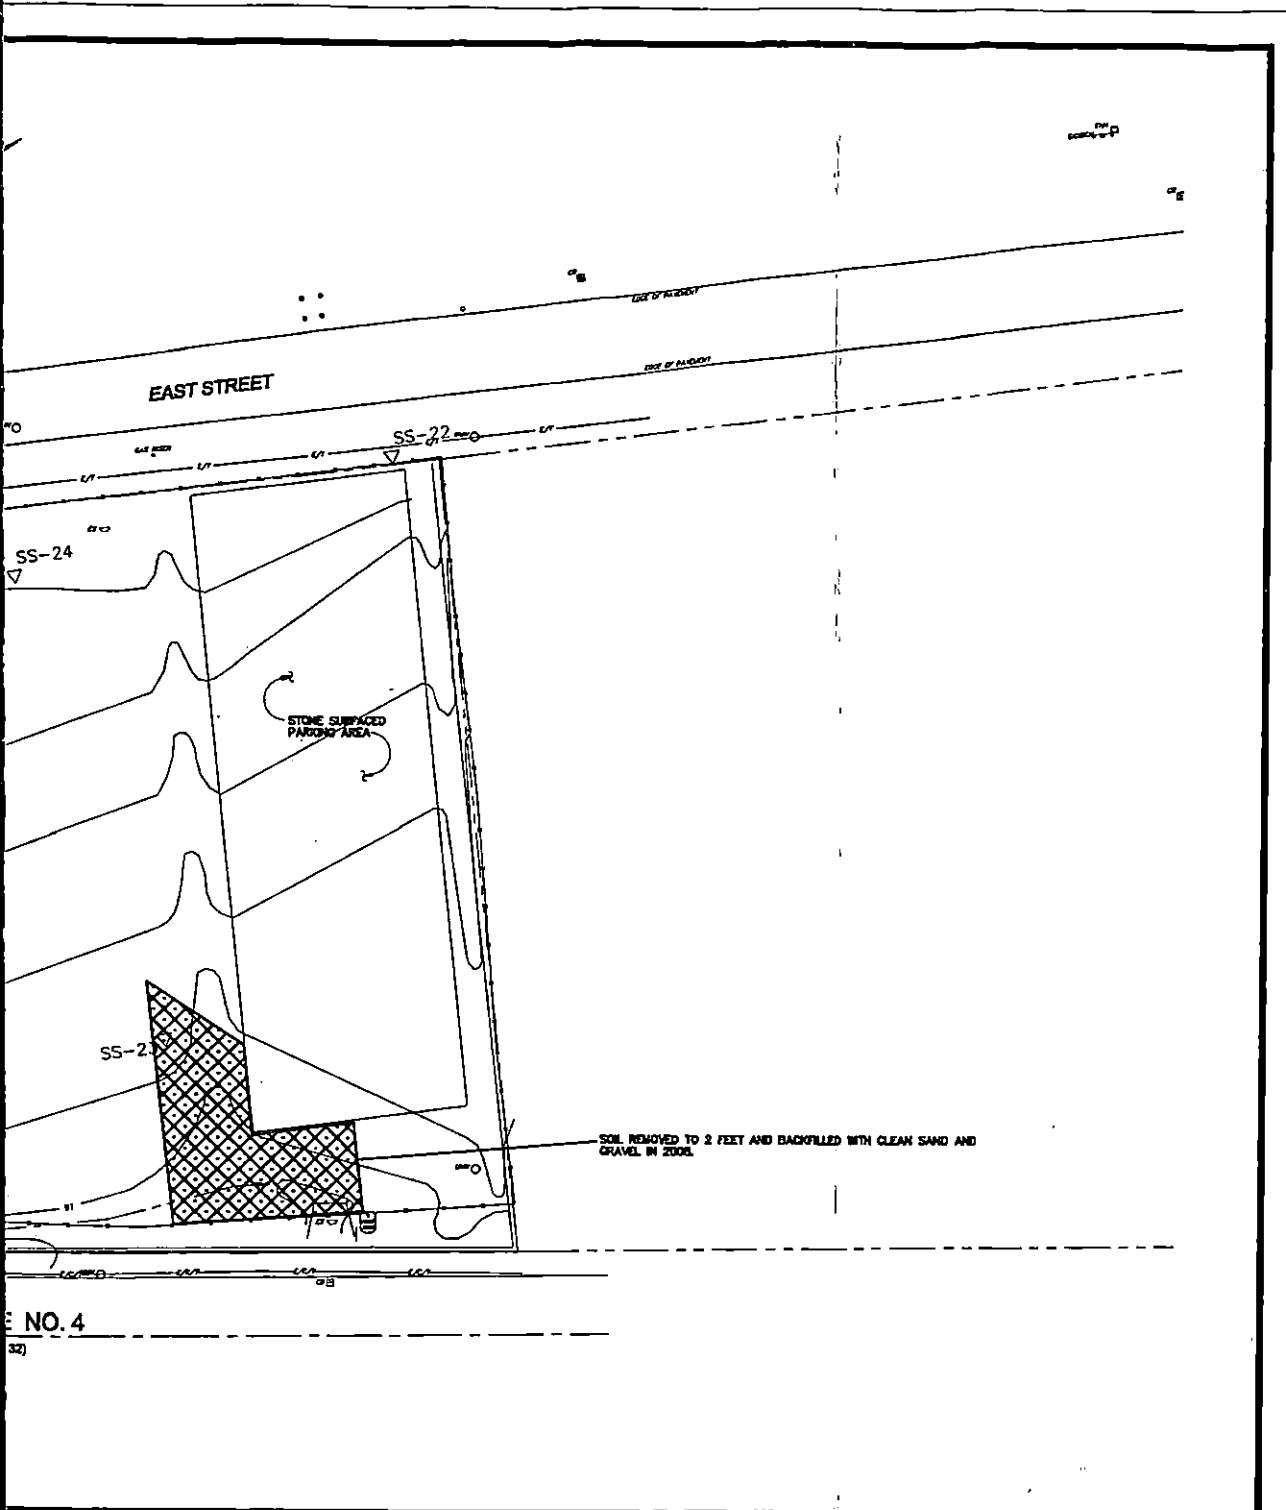
Figure 14  
Post-IRM Surface Soil Sample Locations

Six locations (SS-22 through SS-27) were sampled in 2008 to evaluate the efficacy of site restoration activities. Soil from the surface to a depth of two feet was sampled and analyzed for total lead concentration at 4 locations and PAH compounds at three locations (Figure 14). The results of analysis indicated that lead is present at concentrations that are below the SCOs, and very low concentrations of PAH compounds are present in the top two feet of soil.

At the conclusion of this RI, to confirm post-IRM shallow soil and surface soil conditions, six samples (SS-22 through SS-27) were collected from locations where the only remedial action taken was the placement of topsoil and the planting of a grass cover (Figure 14). Shallow soil was collected from the surface to a depth of two feet. Surface soil samples (SS-22S through SS-27S) were collected at the same locations from the surface to a depth of six inches.
