***Remedial Investigation Report***  
**Former Boiler House Property**  
**NYSDEC Site No. B00197**  
**US Route 4 and Best Avenue**  
**Town of Stillwater**  
**Saratoga County, New York**

**VOLUME 1 of 7**

**February 2009**

***Chazen Project No. 30201.14***

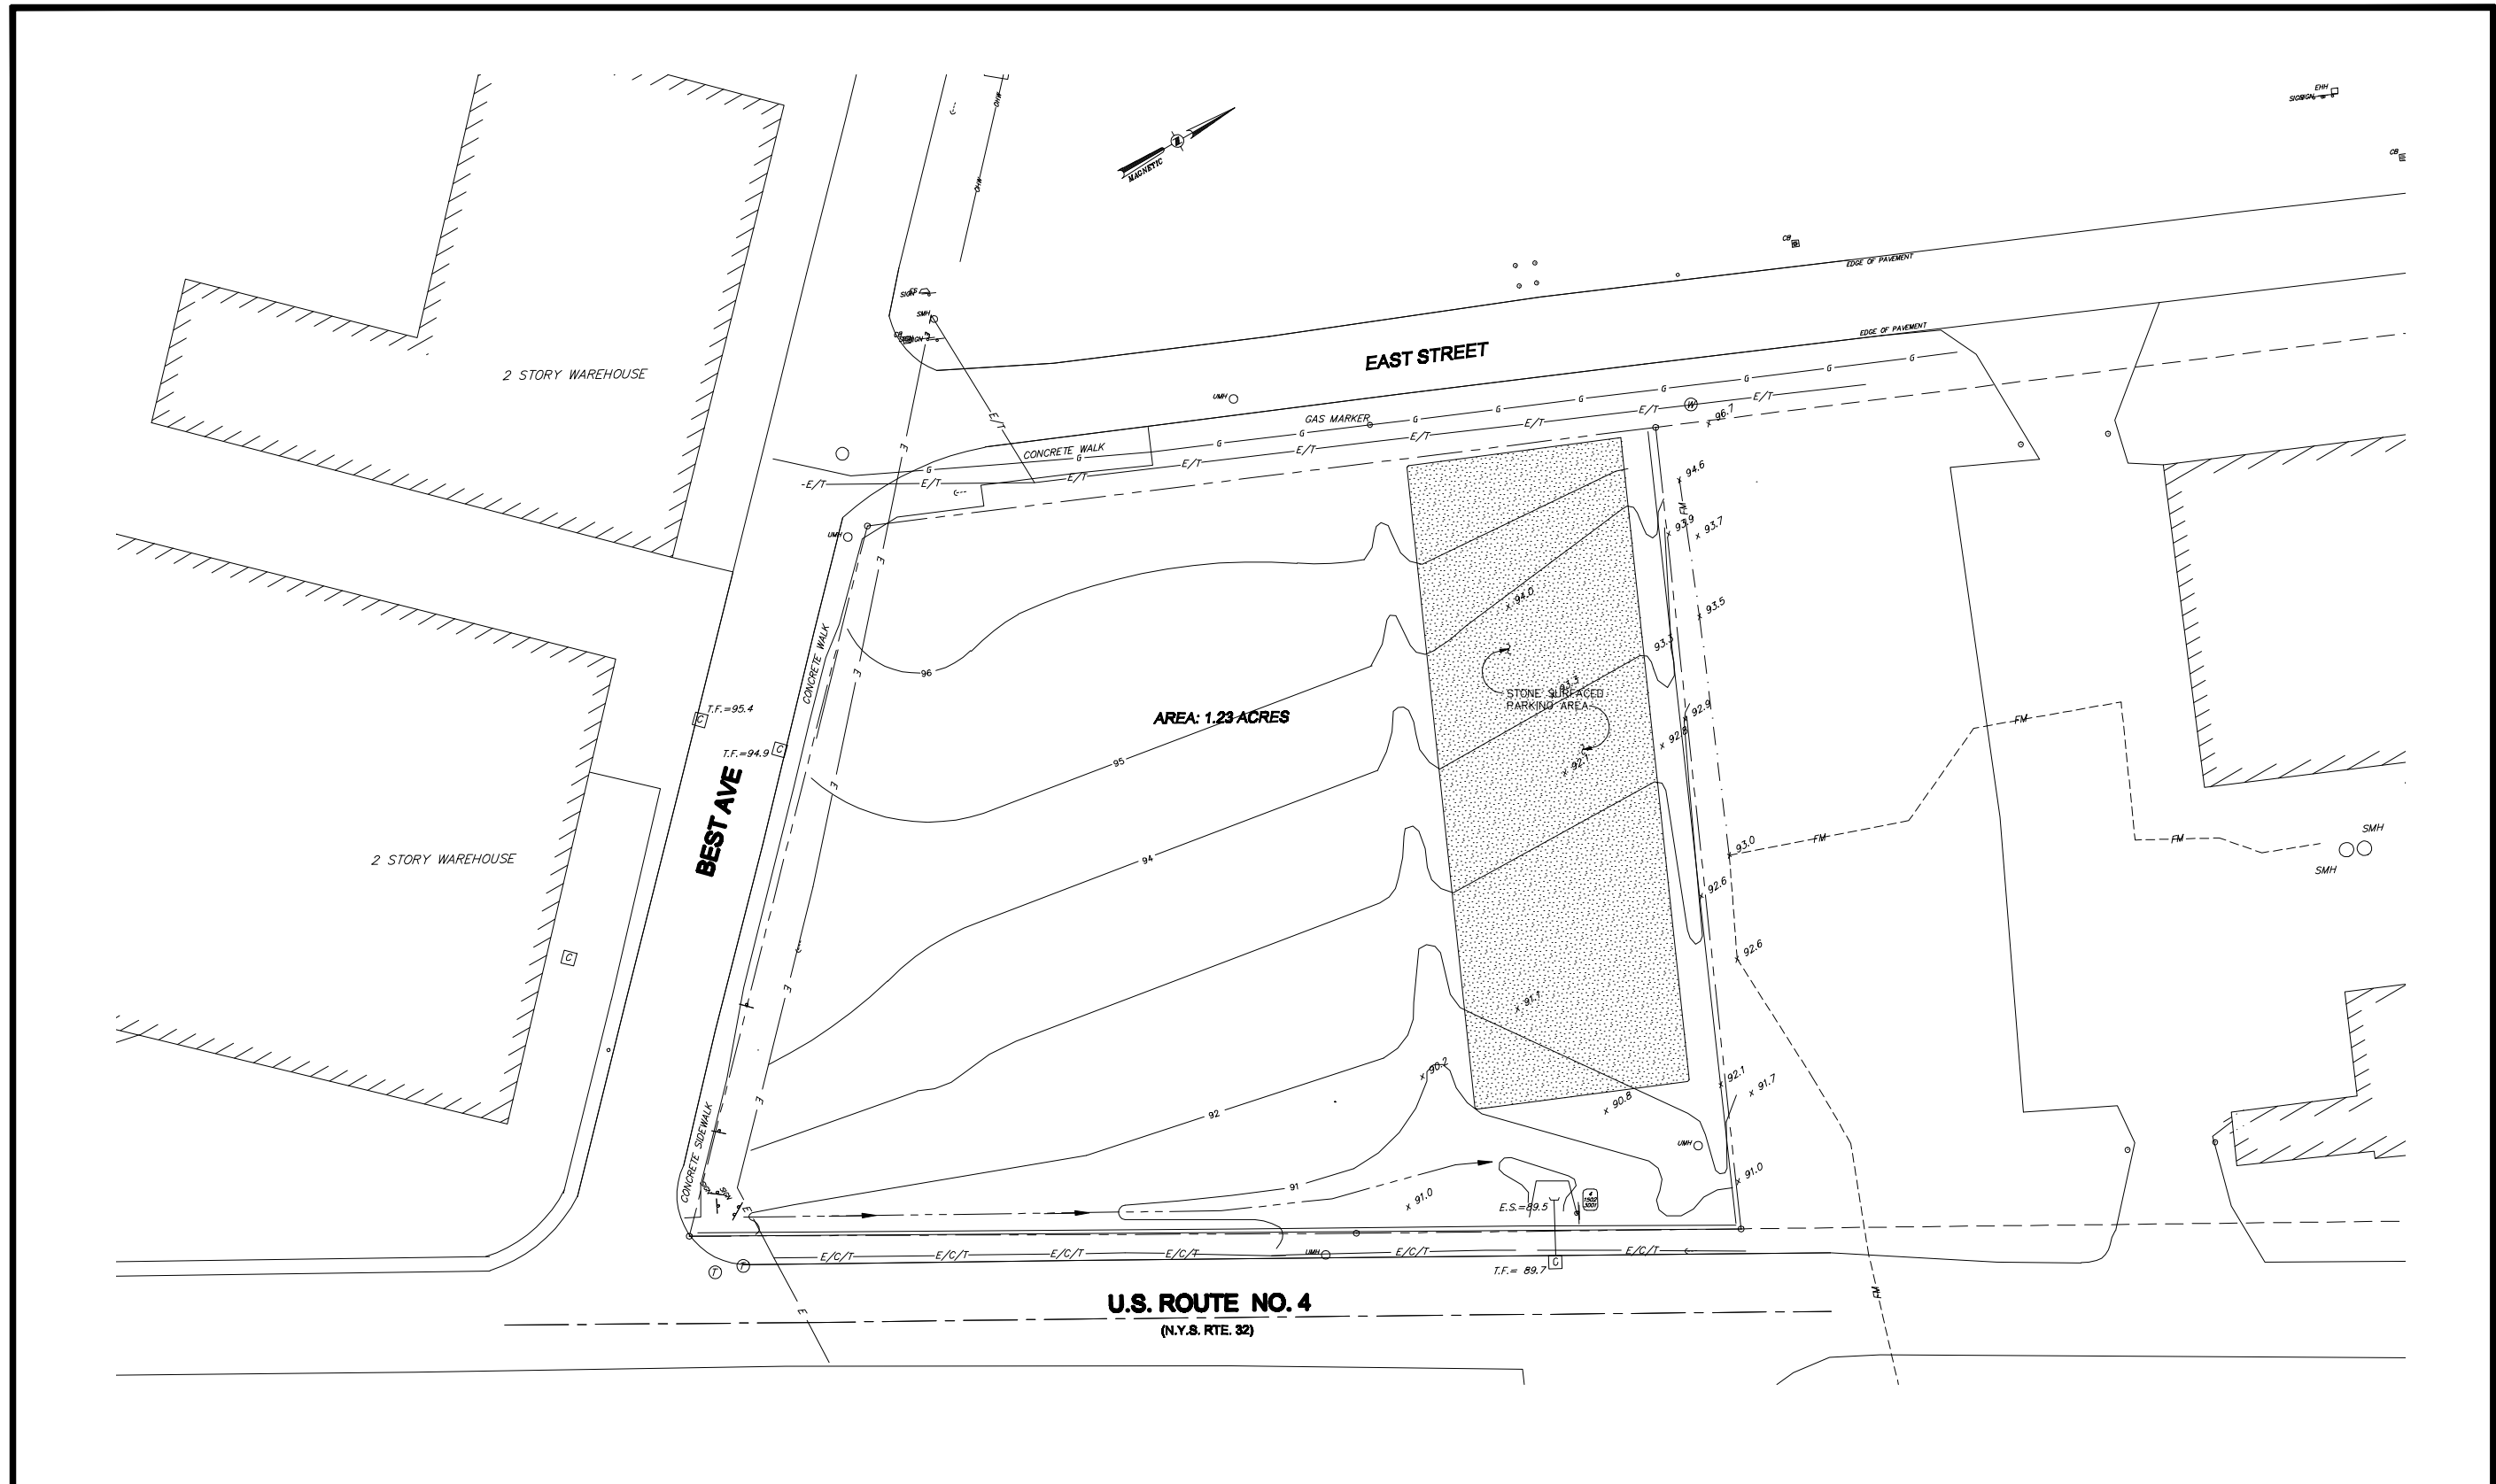
Figure 3  
Current Conditions Site Plan Map

As an Interim Remedial Measure and to restore the site to a usable state, fill and topsoil were imported to the site and graded over existing materials. Up to two feet of crushed building material or imported fill was placed over excavated areas, and at least 6-inches of topsoil were placed over all areas to establish a grass cover. The state of the site at the conclusion of the remedial investigation (and the current site condition) is a grass-covered field and gravel parking area, which are being utilized by the Town of Stillwater as a public park (Figure 3).

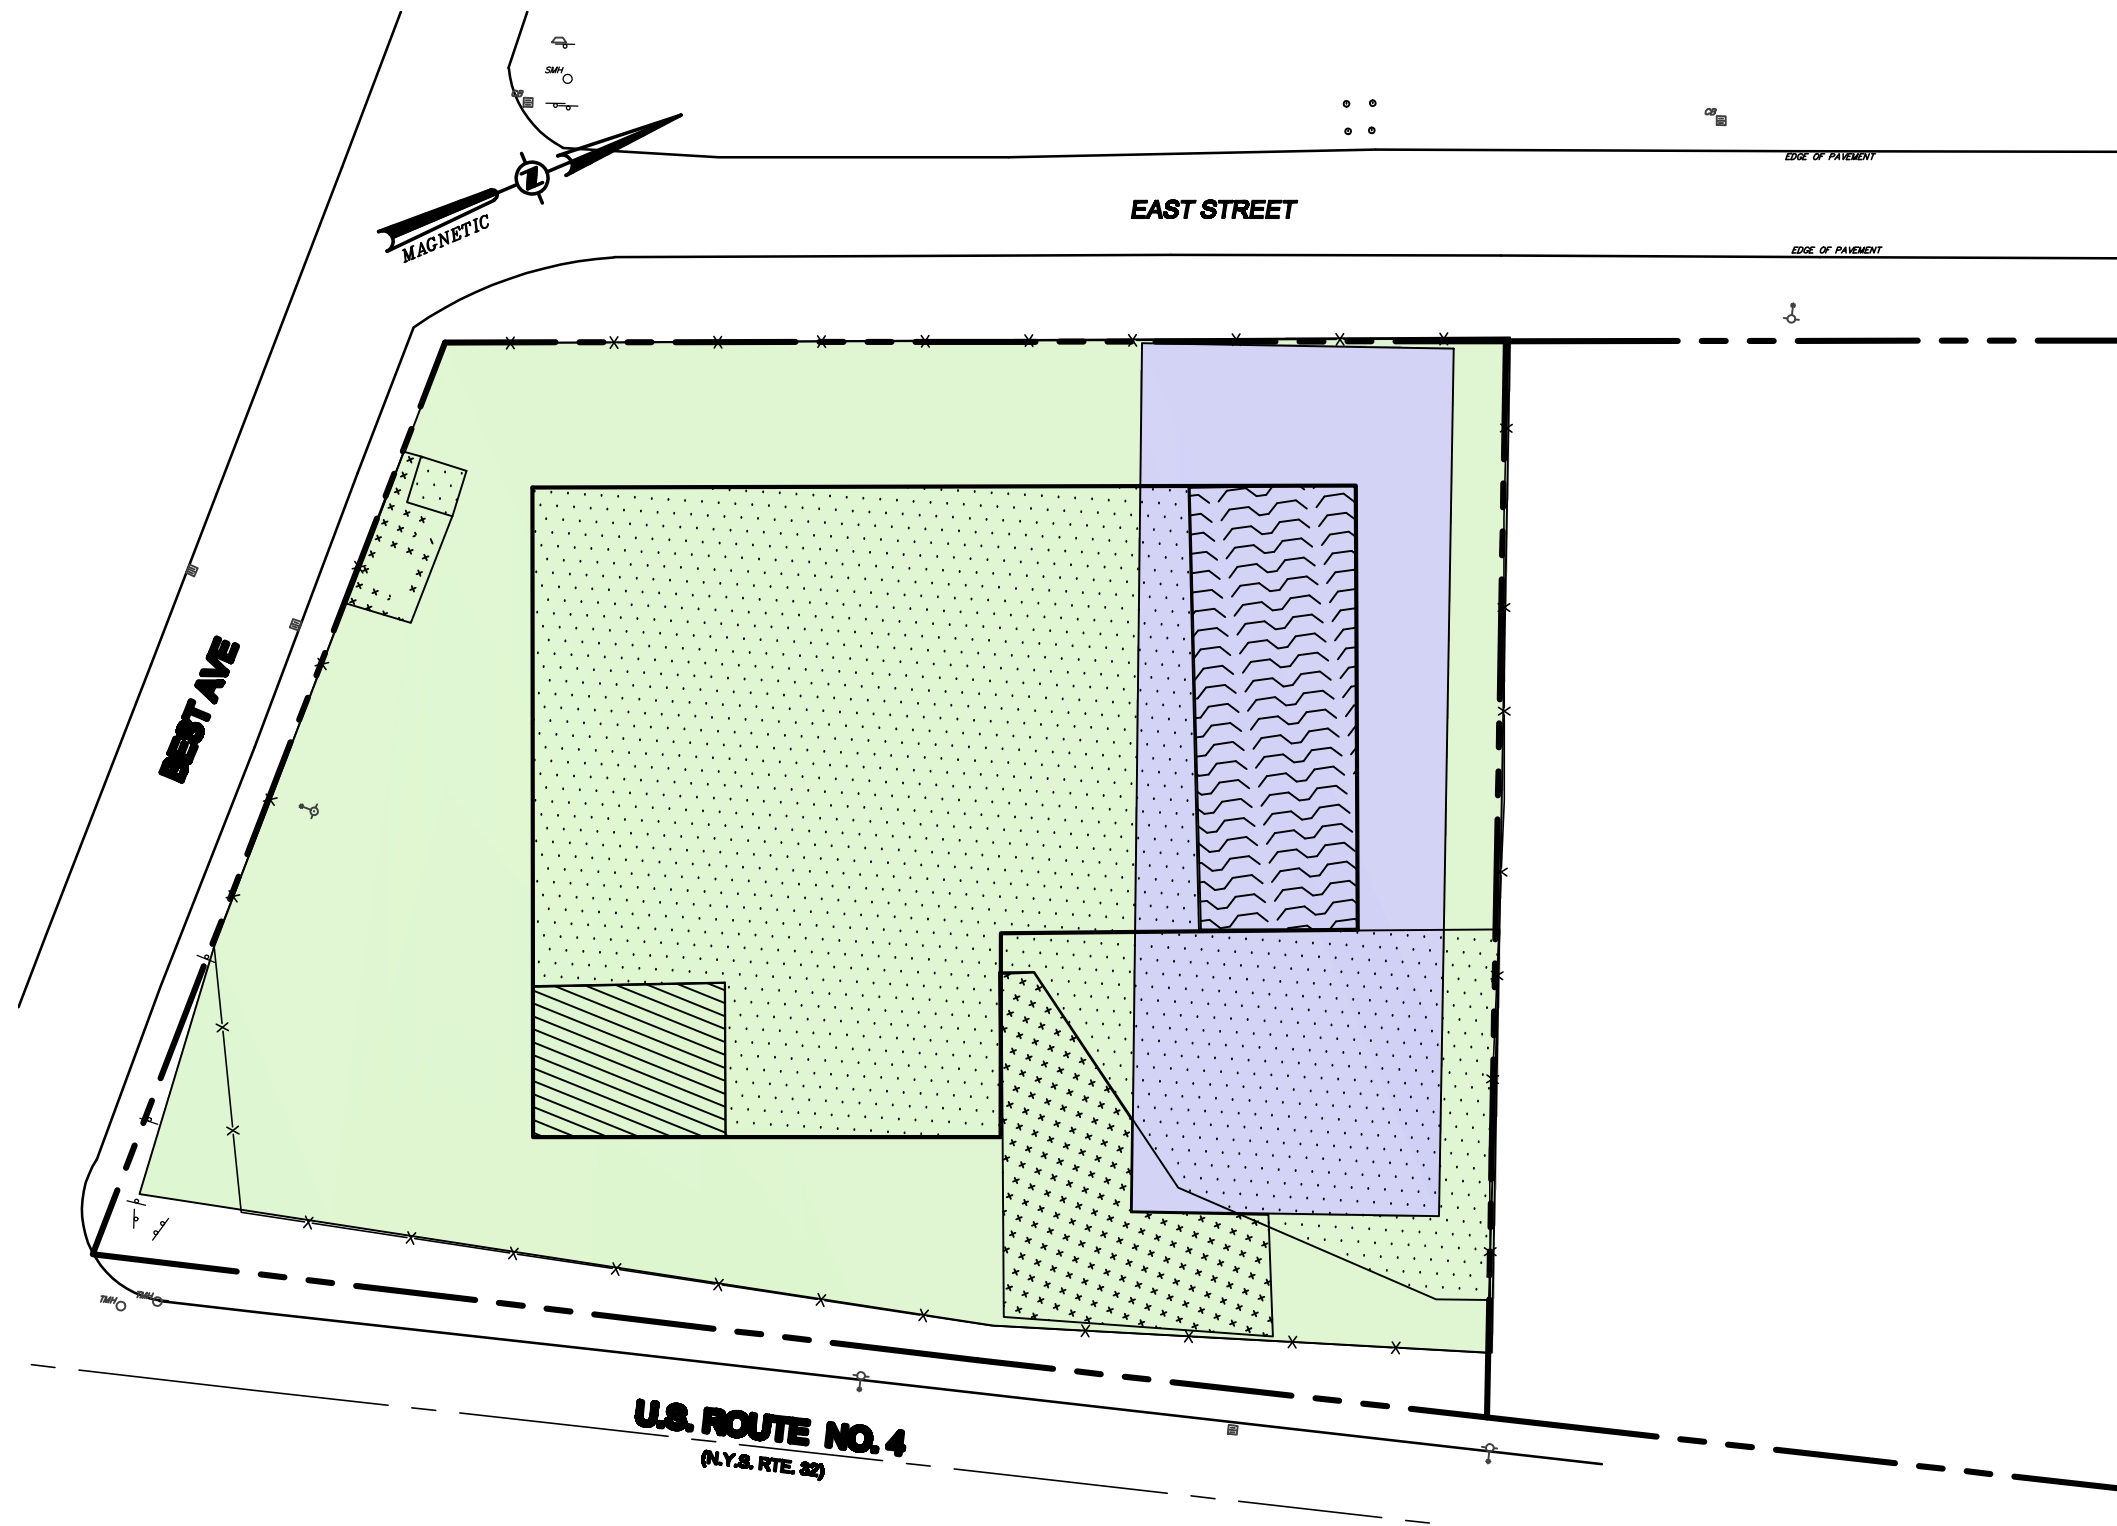
Figure 15  
Summary of Excavations and Backfill Materials

As a result of the IRMs completed at the site, no known impacts remain in the surface soil (0-6-inches). No known impacts are present in the soil from the surface to two feet deep over the majority of the site. An excavation and backfill map is presented in Figure 15 which shows all locations where excavation and/or fill activities have taken place on the site.

As a result of site restoration activities, a clean, imported soil layer exists across the site (Figure 15). In areas where soil was excavated or in areas where the buildings were backfilled, this layer is a minimum of two-feet thick. In the areas of the site where no COCs were found exceeding SCOs, a 6-inch layer of clean, imported topsoil was placed during site restoration for establishing a new grass cover.
