Former G & C Services

255 East 138th Street
Bronx, New York 10451

May 28, 2025

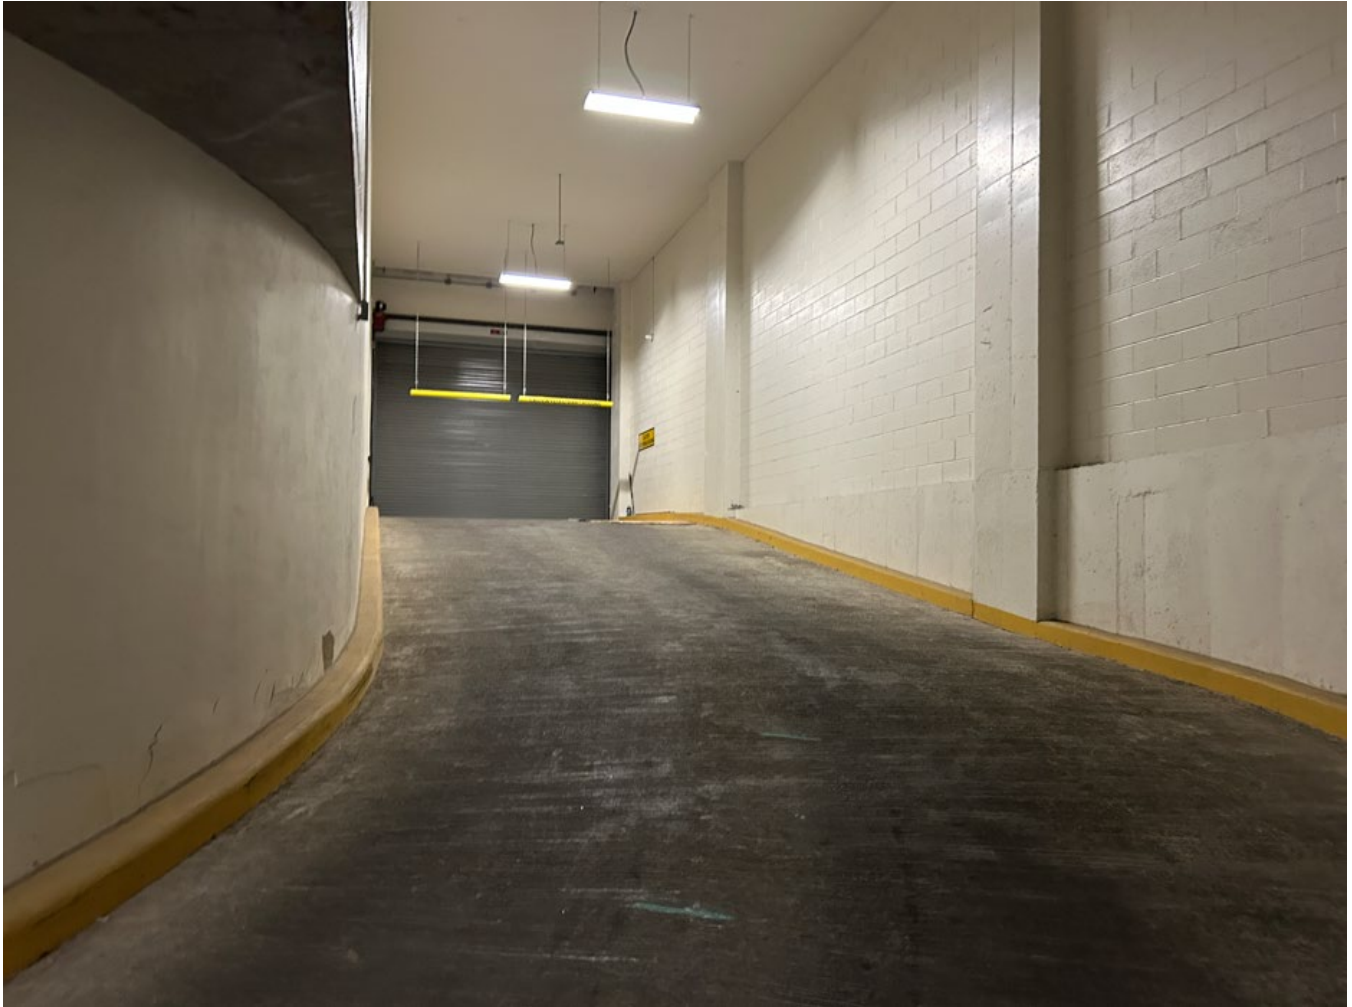
Photograph No. 2: View of the sub-grade parking garage ramp and sidewalls, facing northeast. Note: The ramp is part of the composite cover system in the Track 4 Remedial Area.

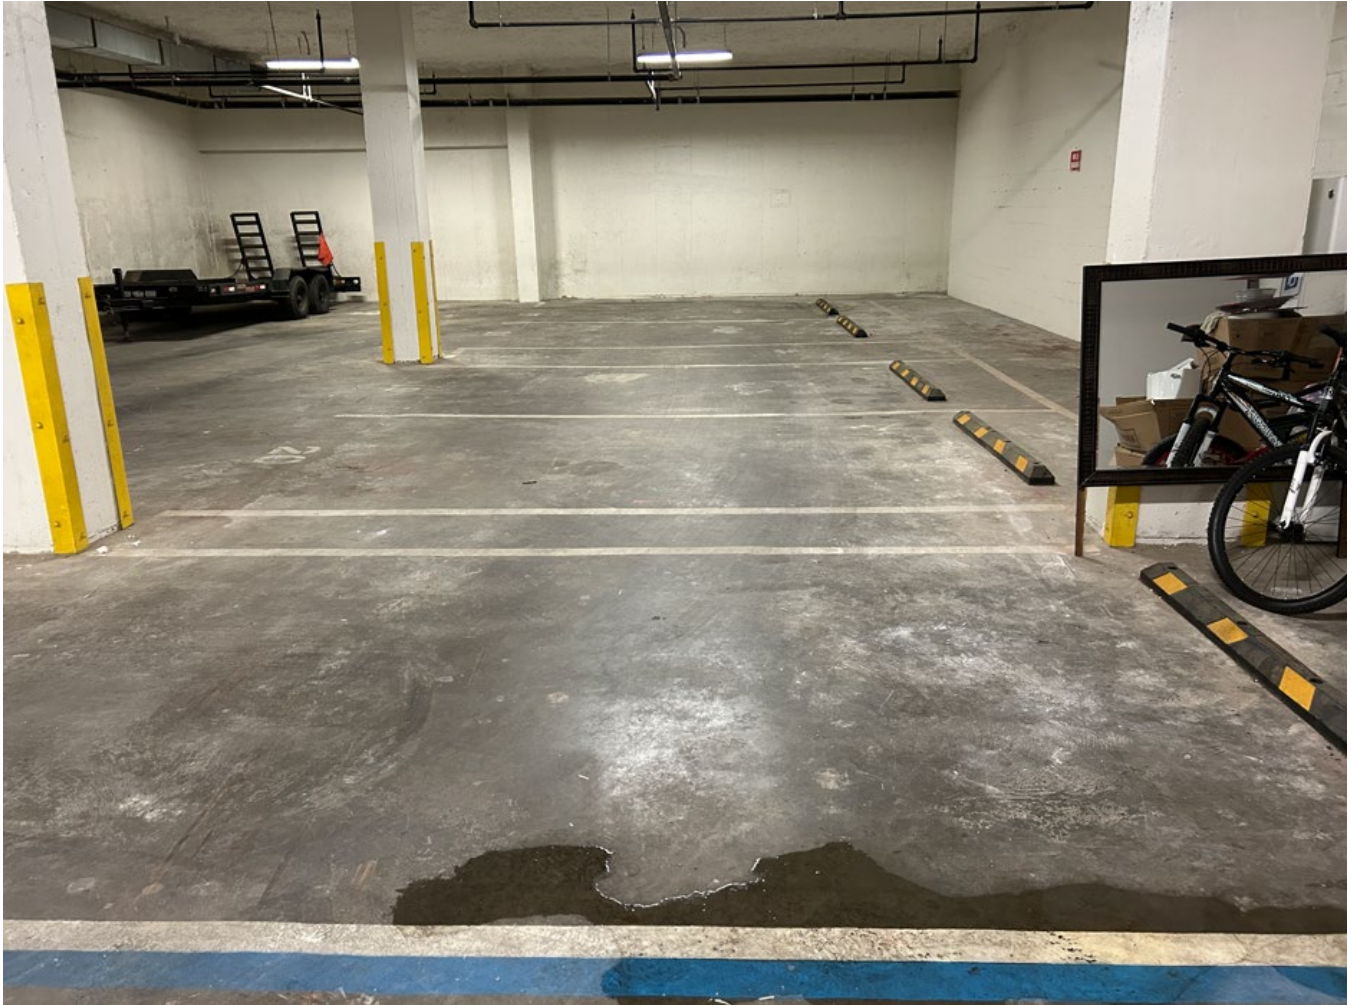
Photograph No. 3: View of the sub-grade parking garage and sidewalls, facing north. Note: The parking garage is part of the composite cover system in the Track 1 and 2 Remedial Areas.

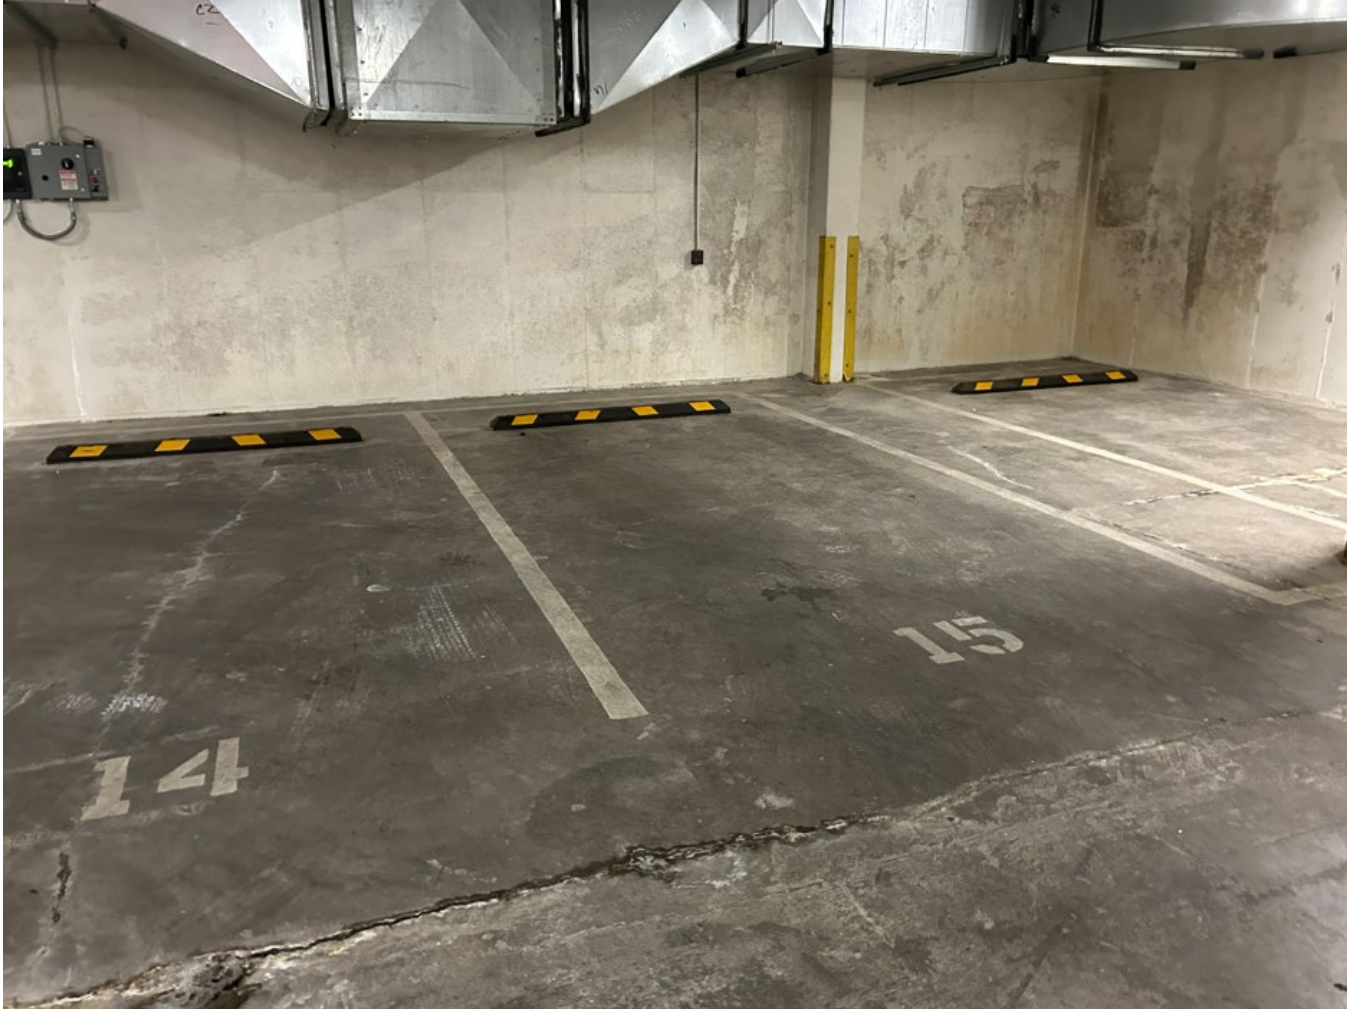
Photograph No. 4: View of the sub-grade parking garage and sidewalls, facing northeast. Note: The parking garage is part of the composite cover system in the Track 1 and 2 Remedial Areas.

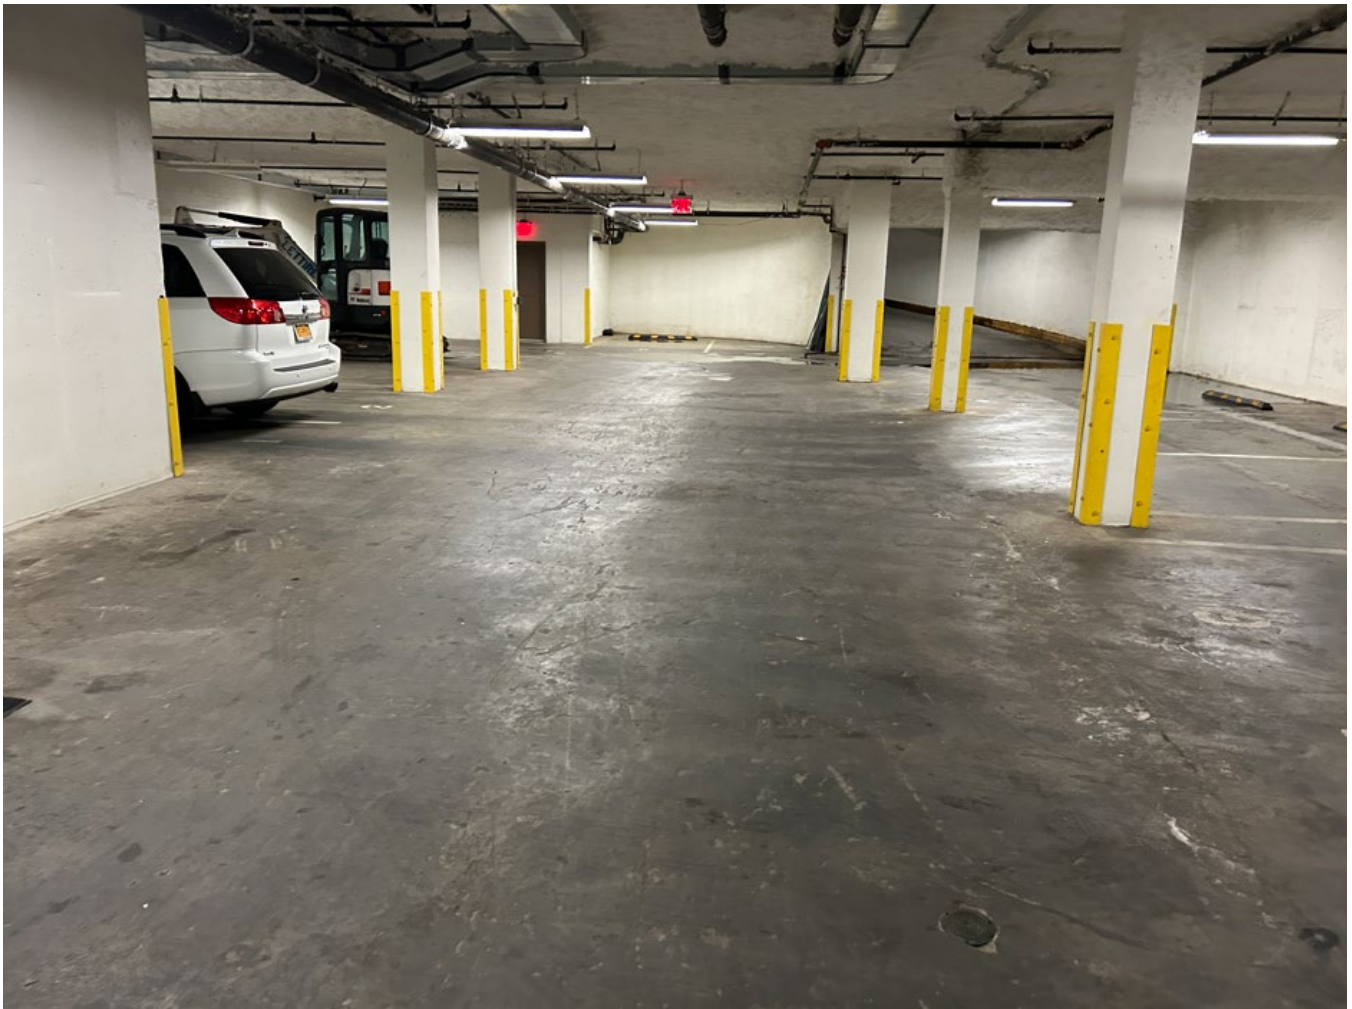
Photograph No. 5: View of the sub-grade parking garage and sidewalls, facing west. Note: The parking garage is part of the composite cover system in the Track 1 and 2 Remedial Areas.

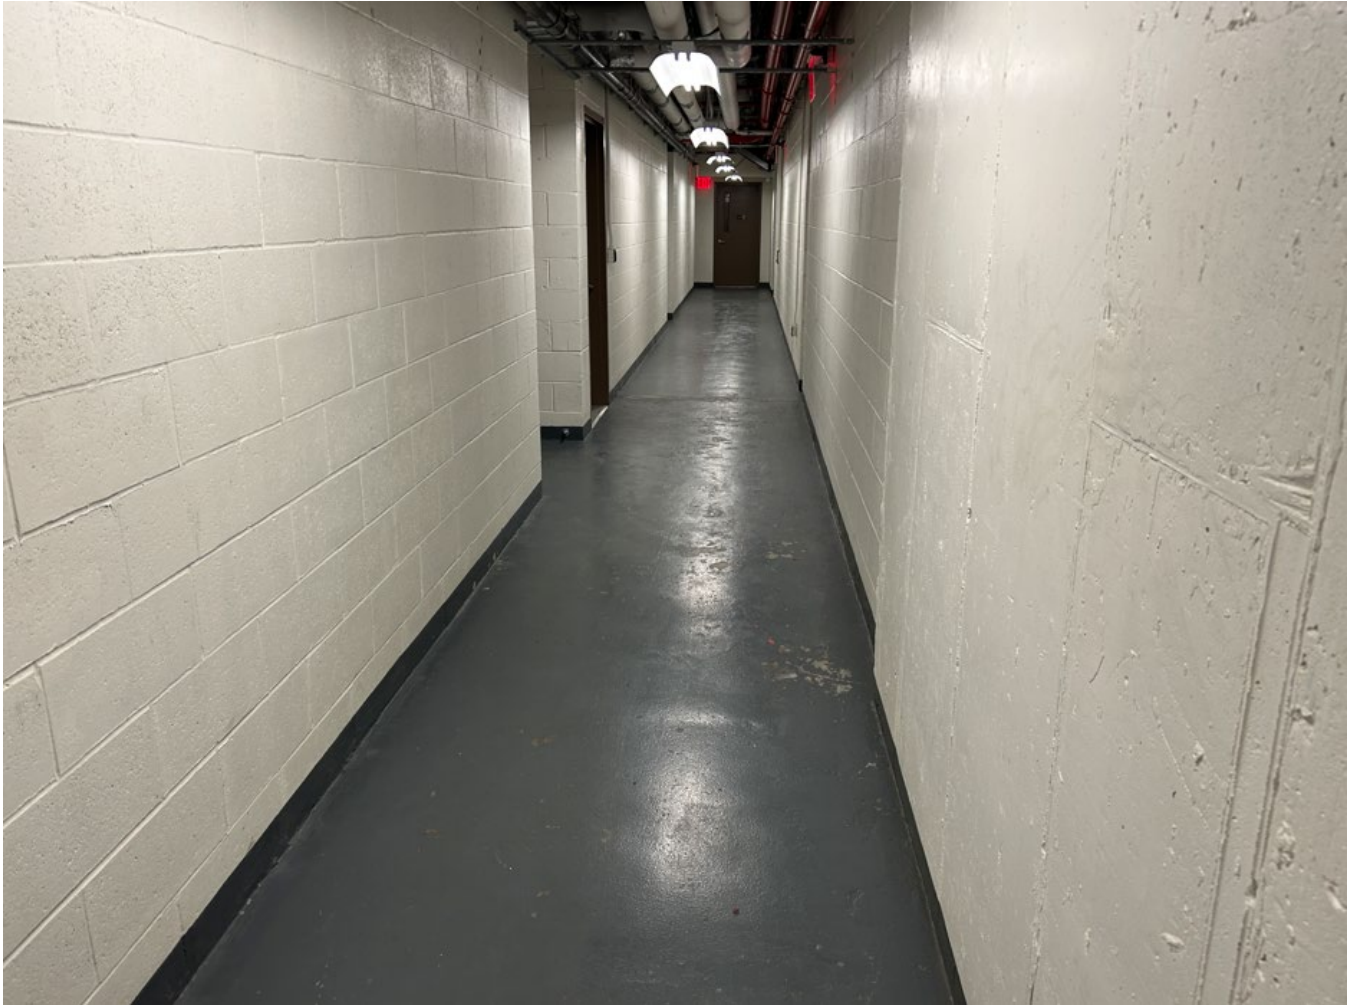
Photograph No. 6: View of the composite cover system in the basement hallway, facing northwest. Note: The basement is part of the composite cover system in the Track 1 and 2 Remedial Areas.

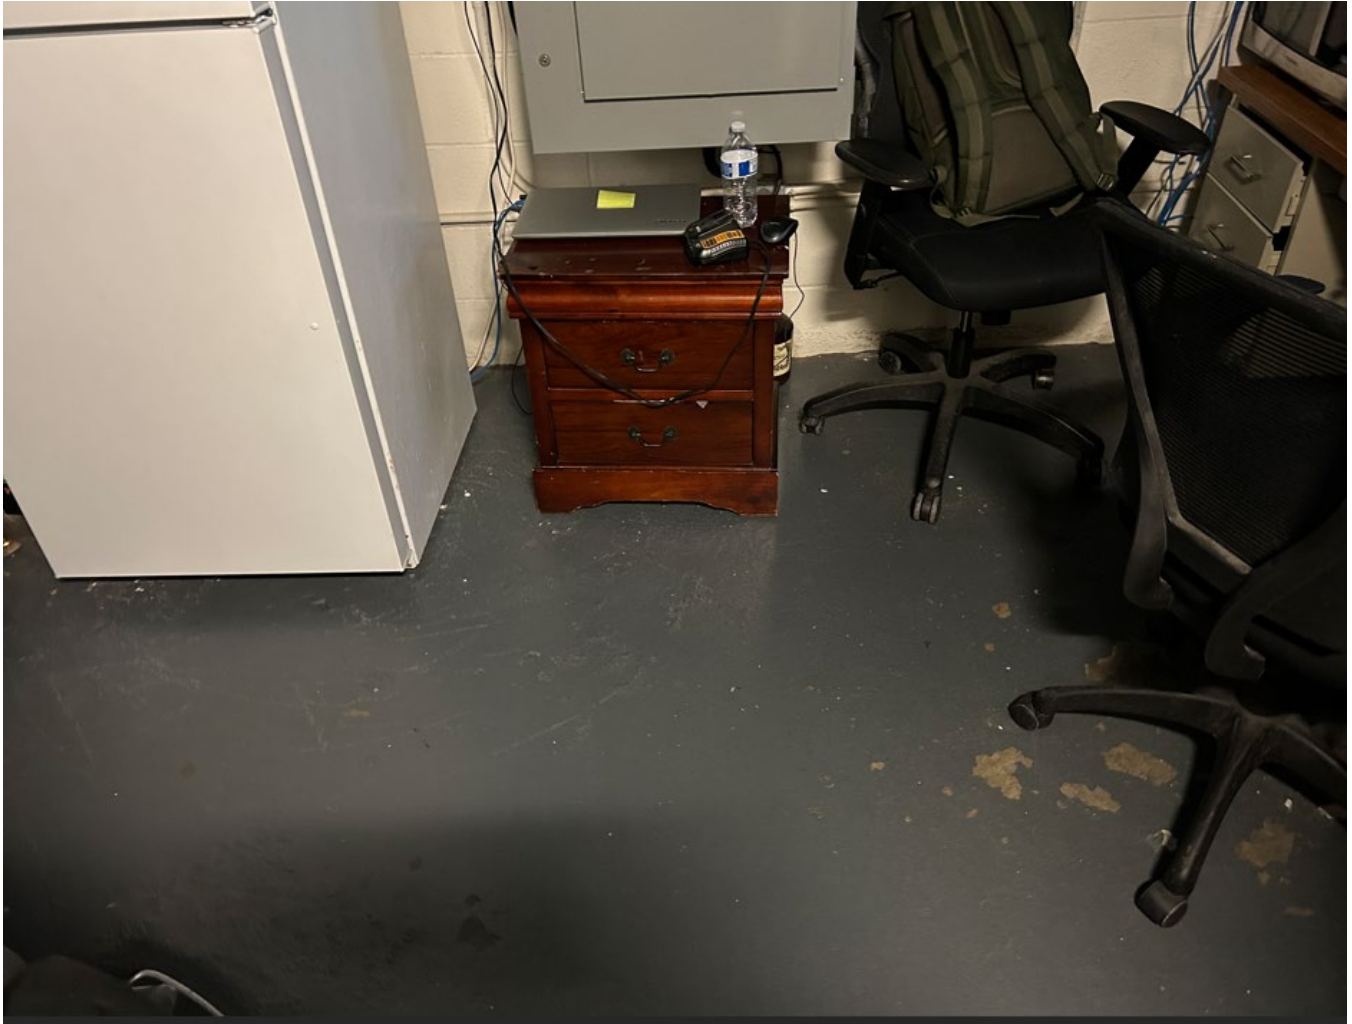
Photograph No. 7: Close-up view of the composite cover system in the basement maintenance closet.

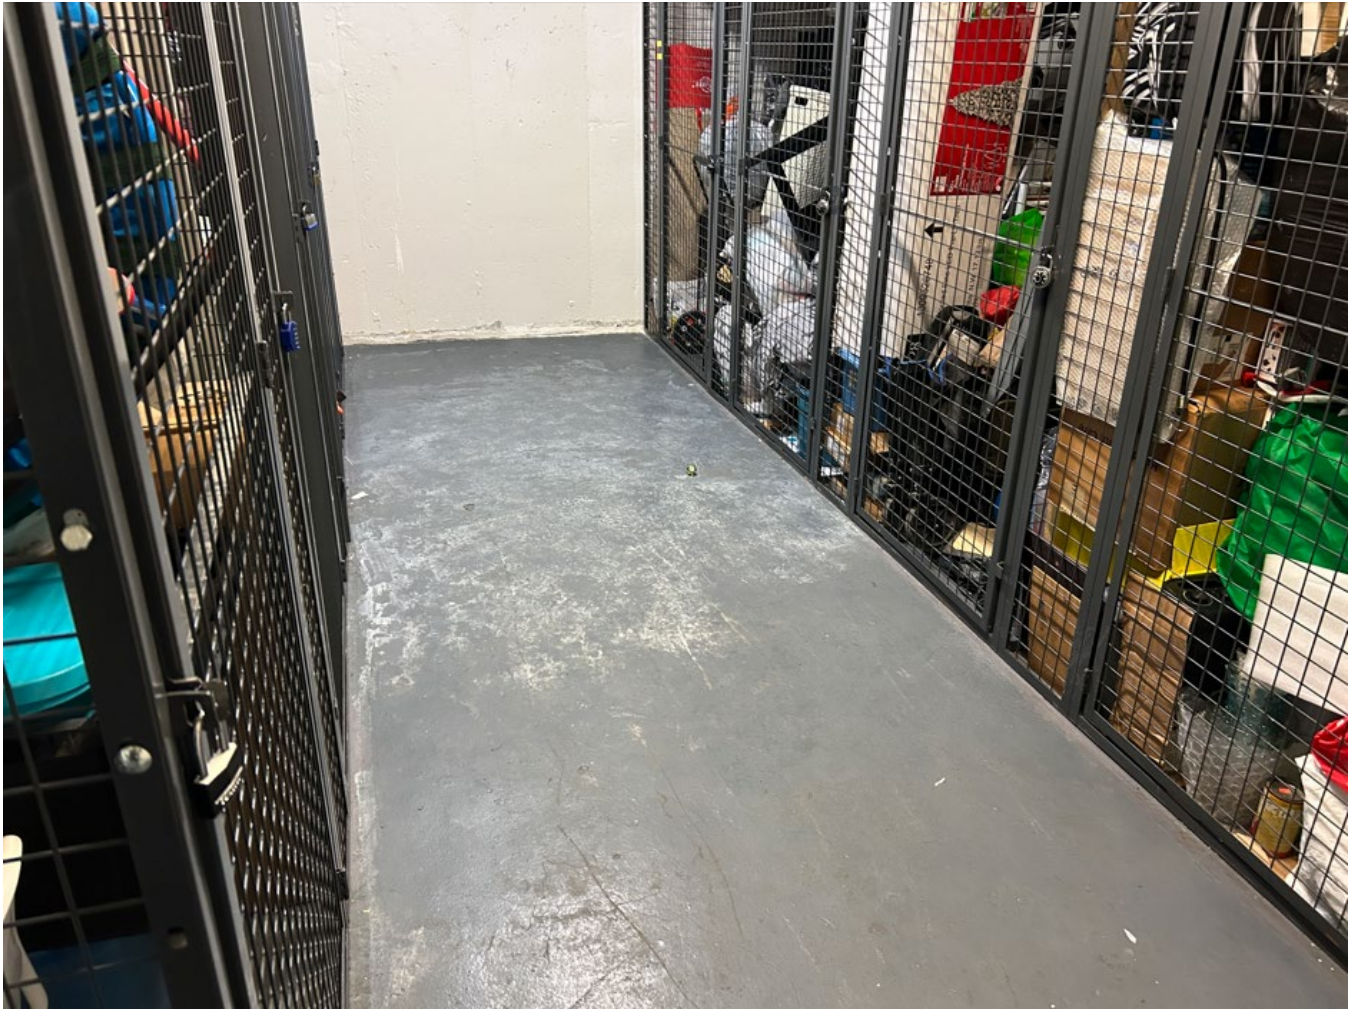
Photograph No. 8: View of the composite cover system in the tenant storage room, located in the basement.

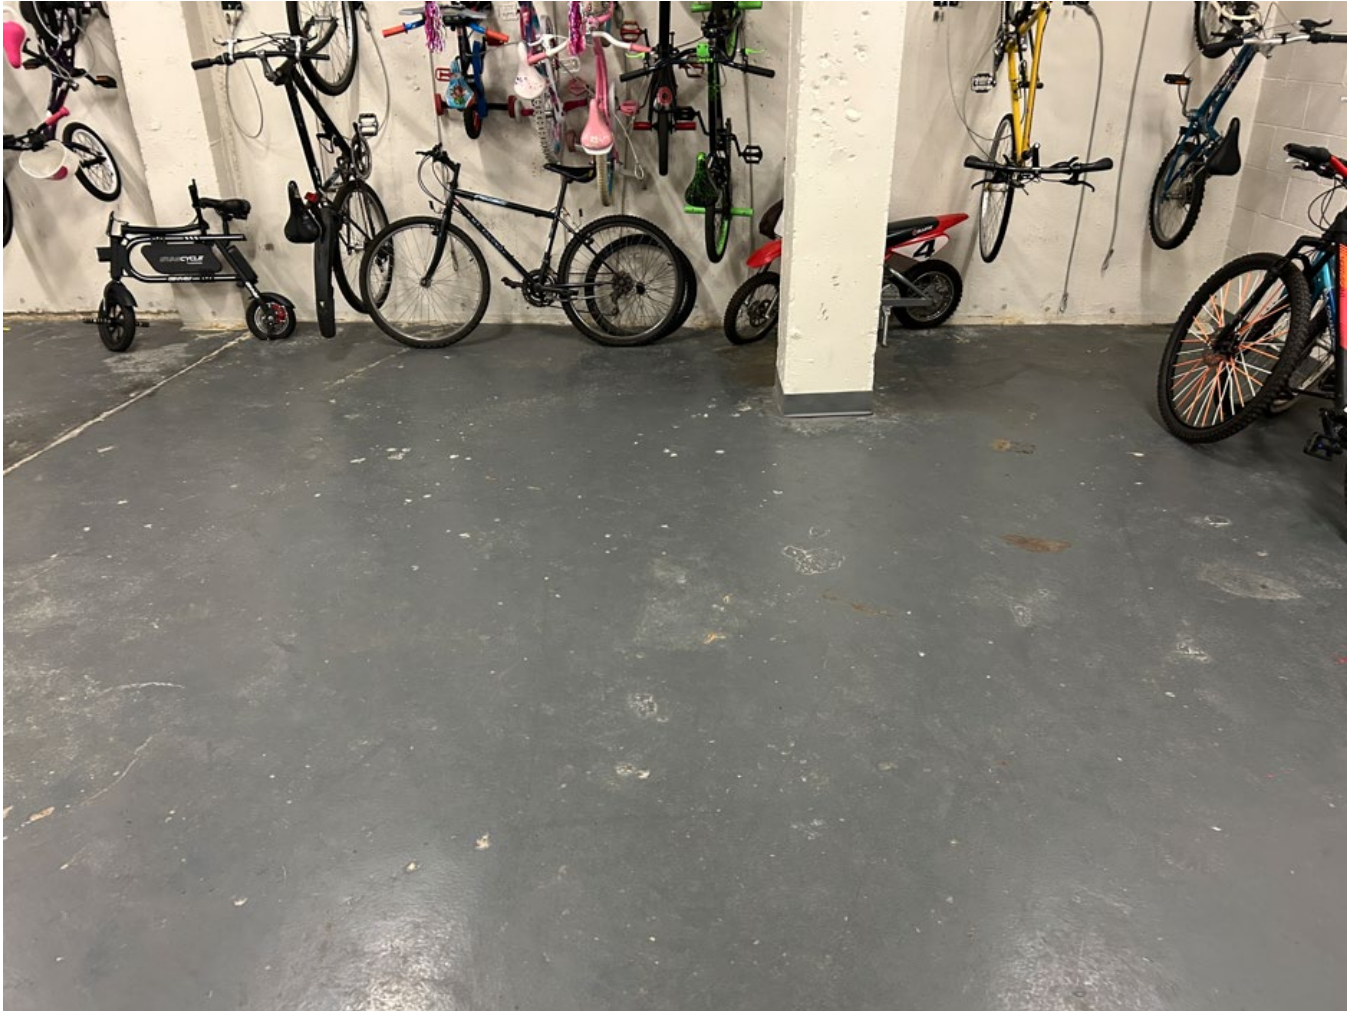
Photograph No. 9: View of the composite cover system in the bike storage room, located in the basement.

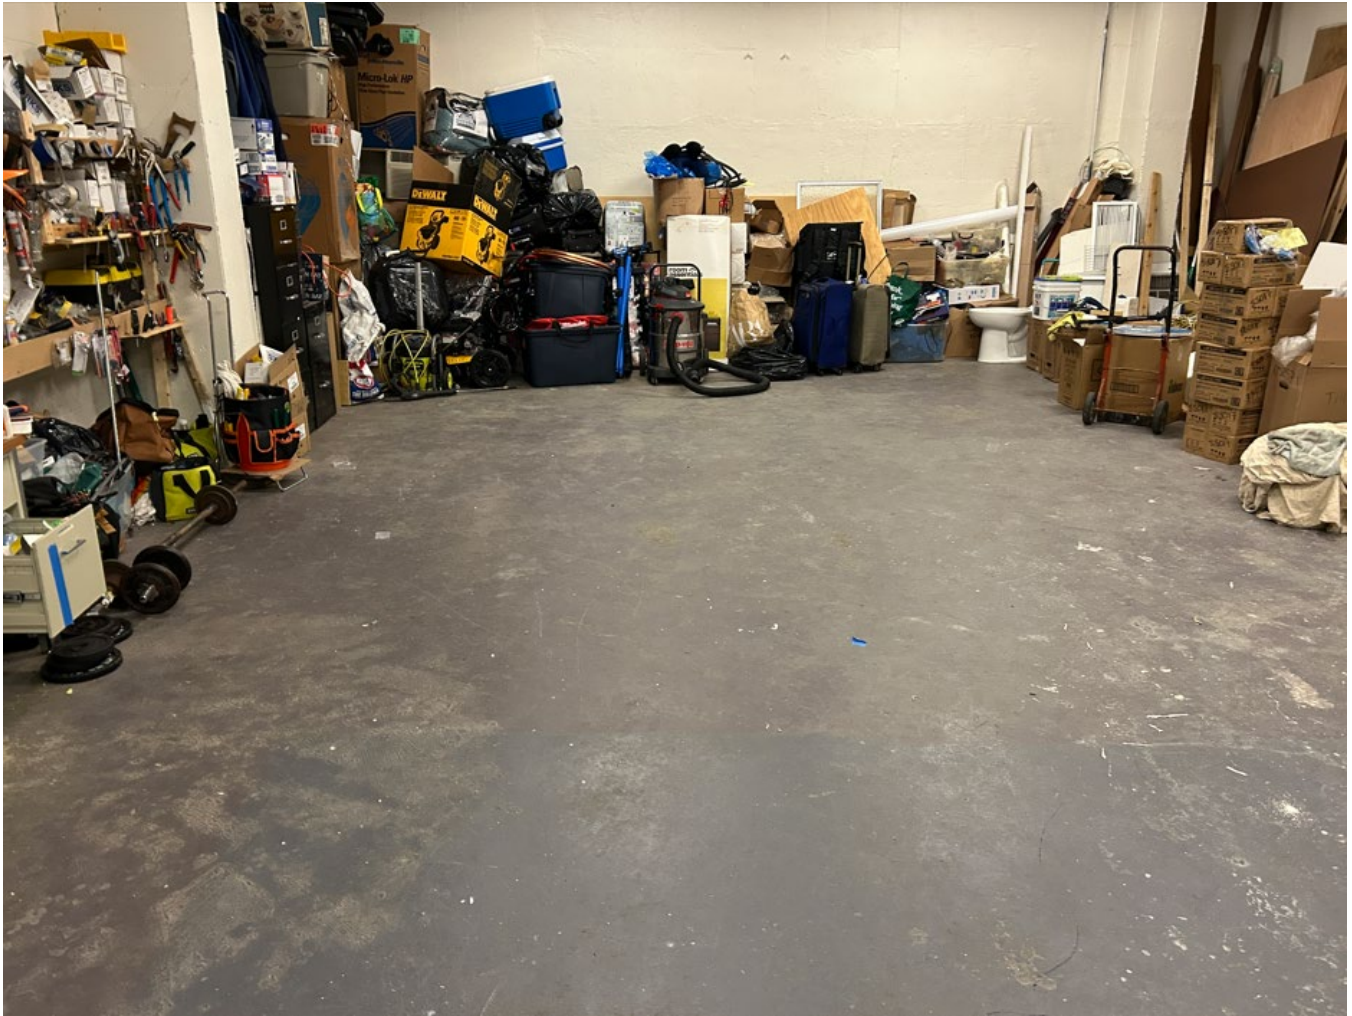
Photograph No. 10: View of the composite cover system in the commercial tenant's storage room, located in the basement.

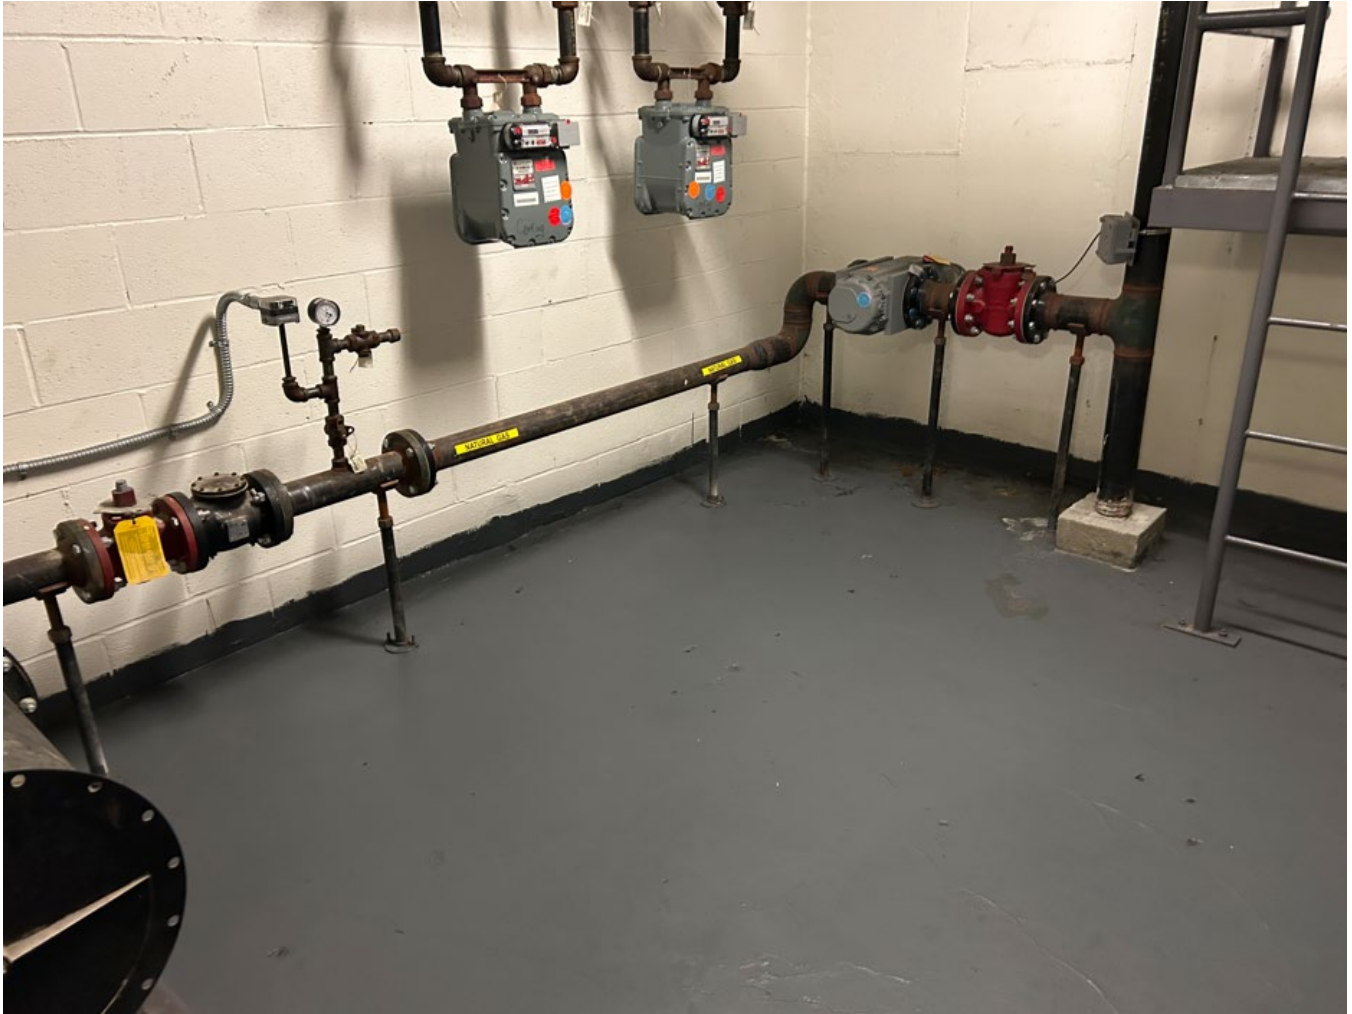
Photograph No. 11: View of the composite cover system in a utility room, located in the basement.

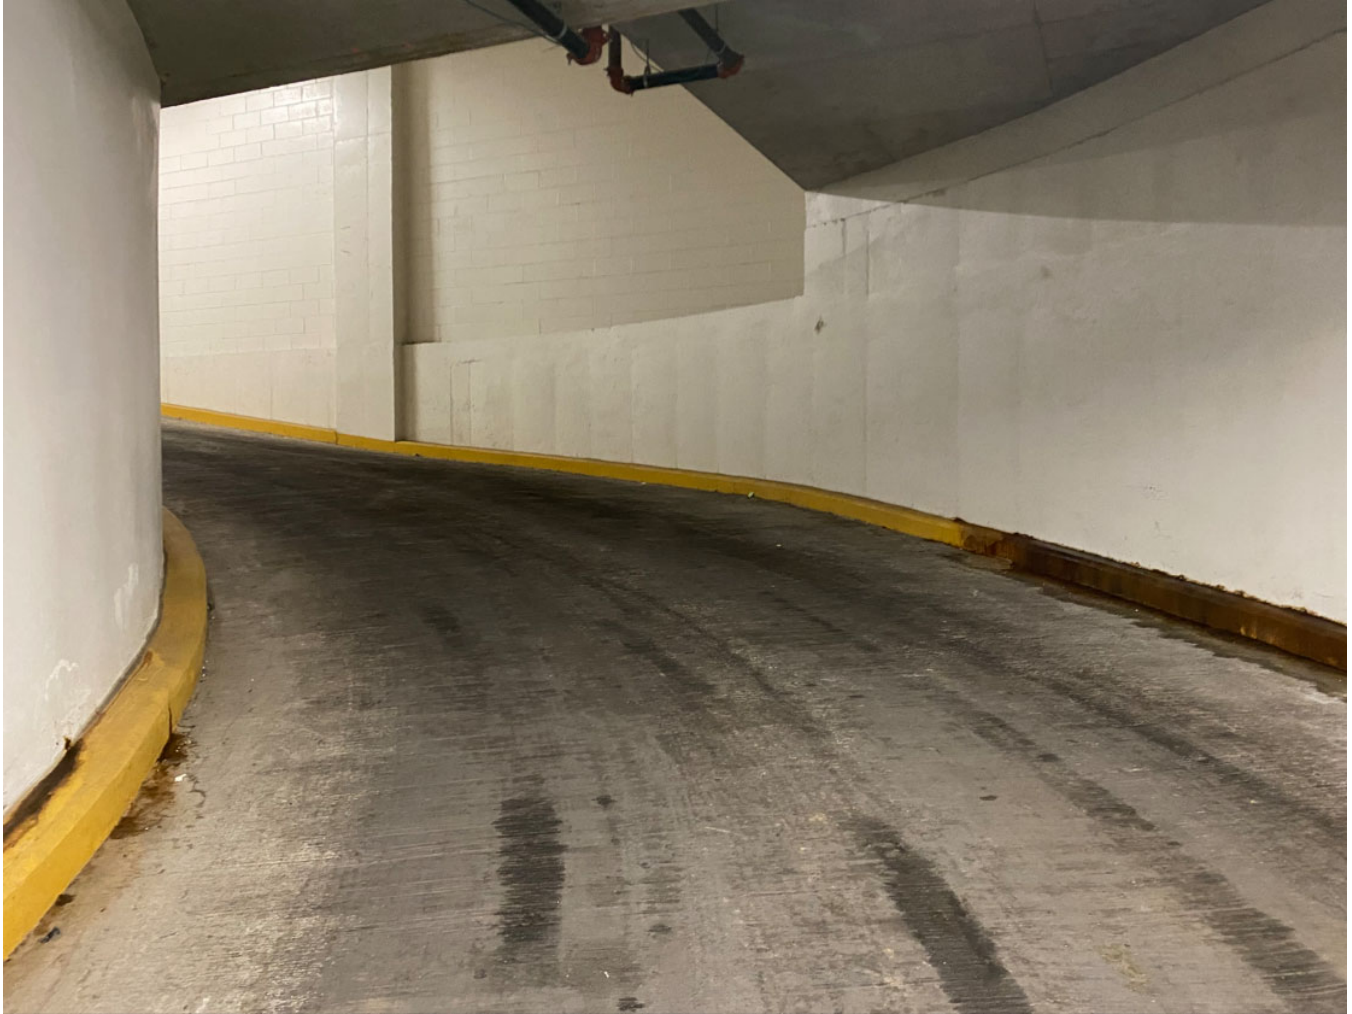
Photograph No. 1: View of the sub-grade parking garage ramp and sidewalls, facing northeast. Note: The ramp is part of the composite cover system in the Track 4 Remedial Area.

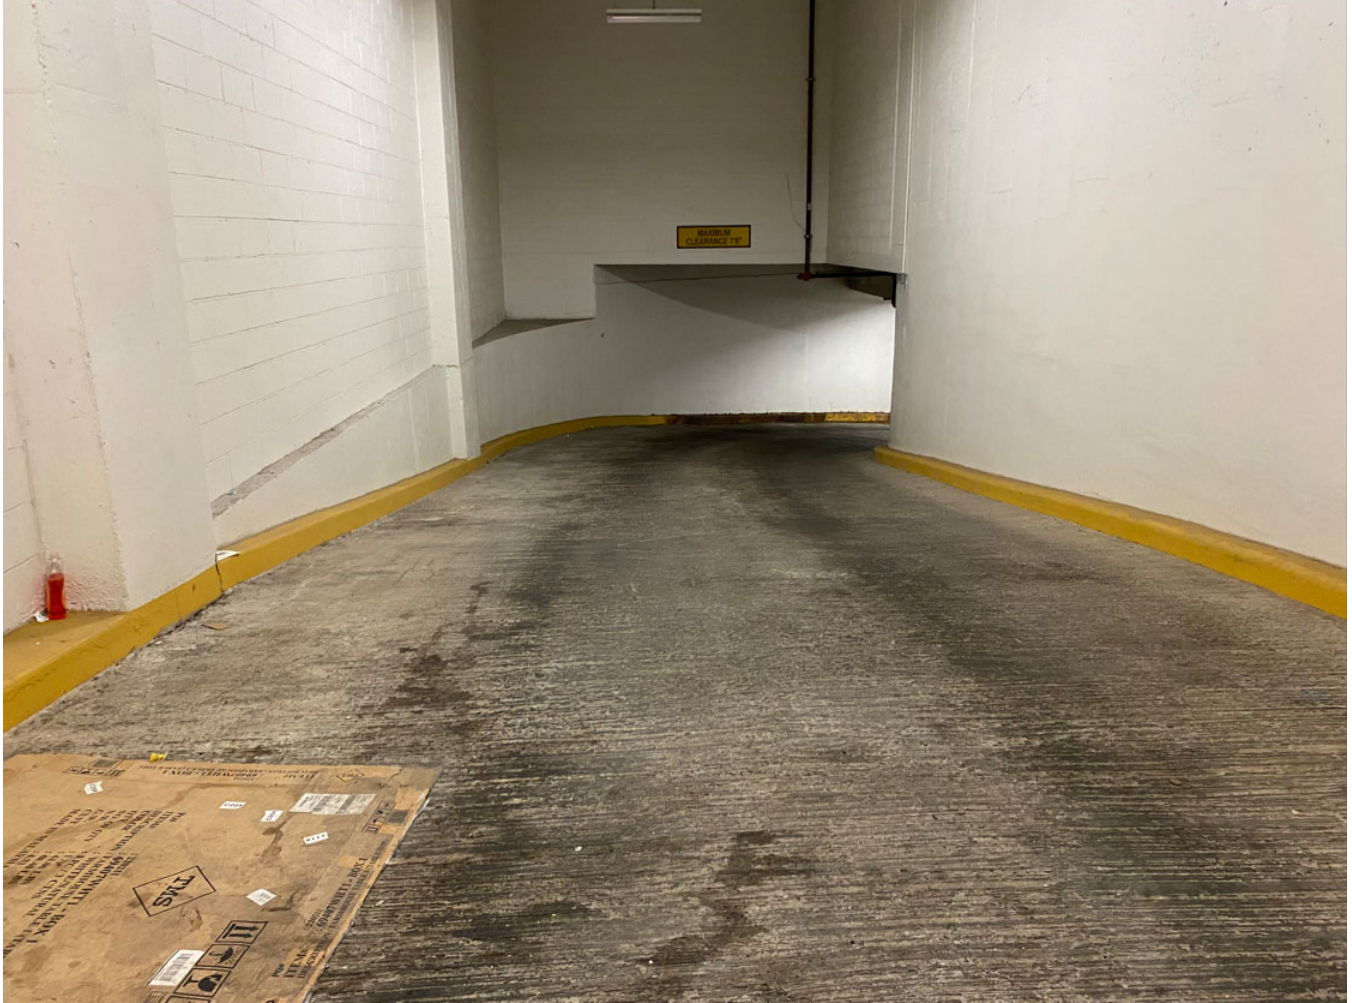
Photograph No. 2: View of the sub-grade parking garage ramp and sidewalls, facing southeast. Note: The ramp is part of the composite cover system in the Track 4 Remedial Area.

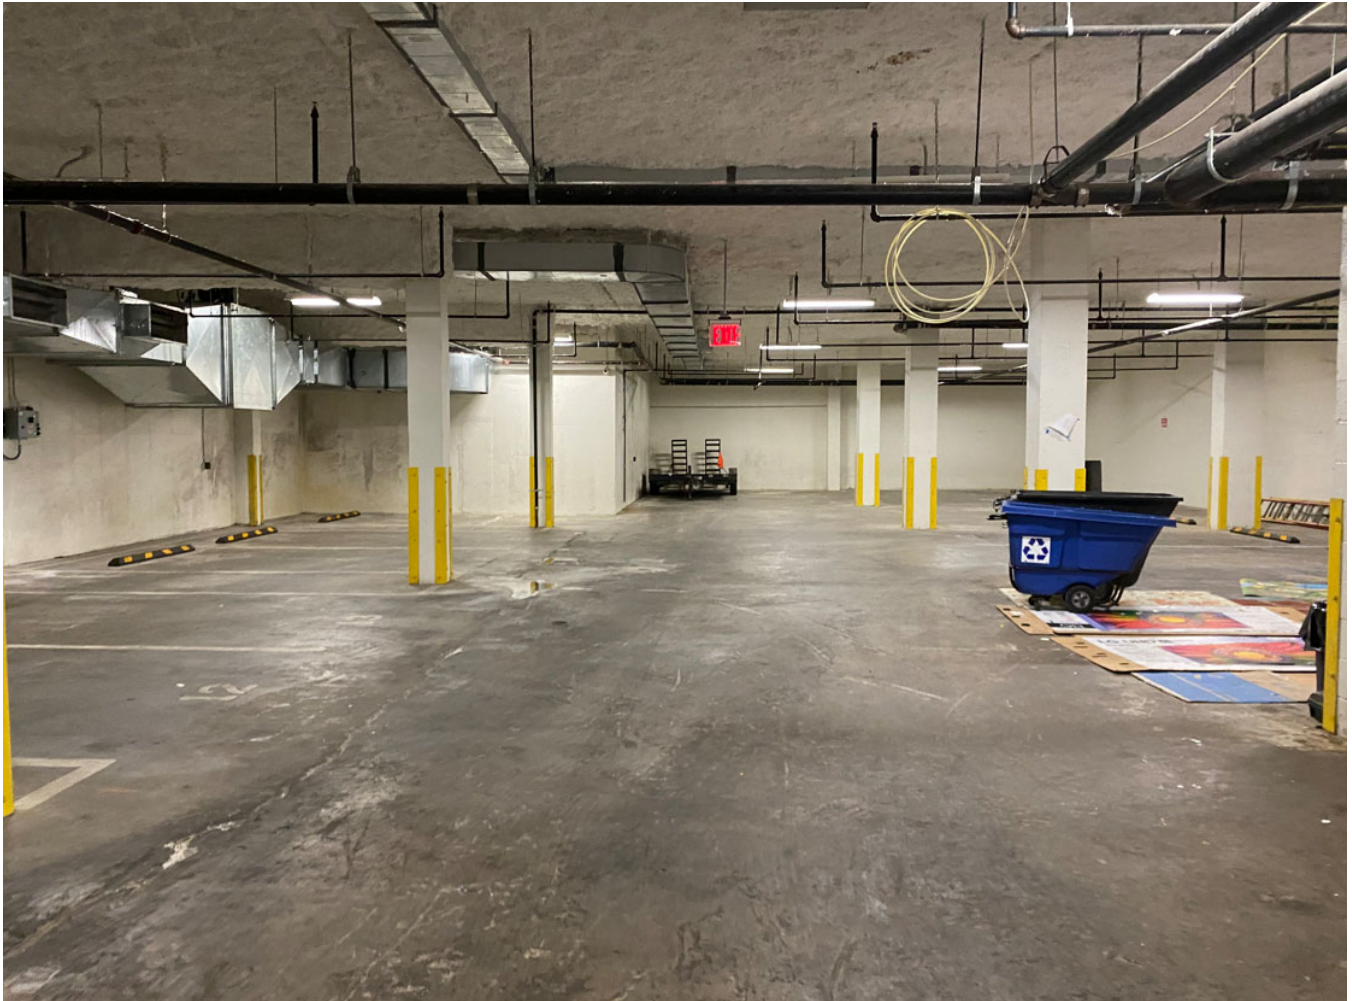
Photograph No. 3: View of the sub-grade parking garage and sidewalls, facing north. Note: The parking garage is part of the composite cover system in the Track 1 and 2 Remedial Areas.

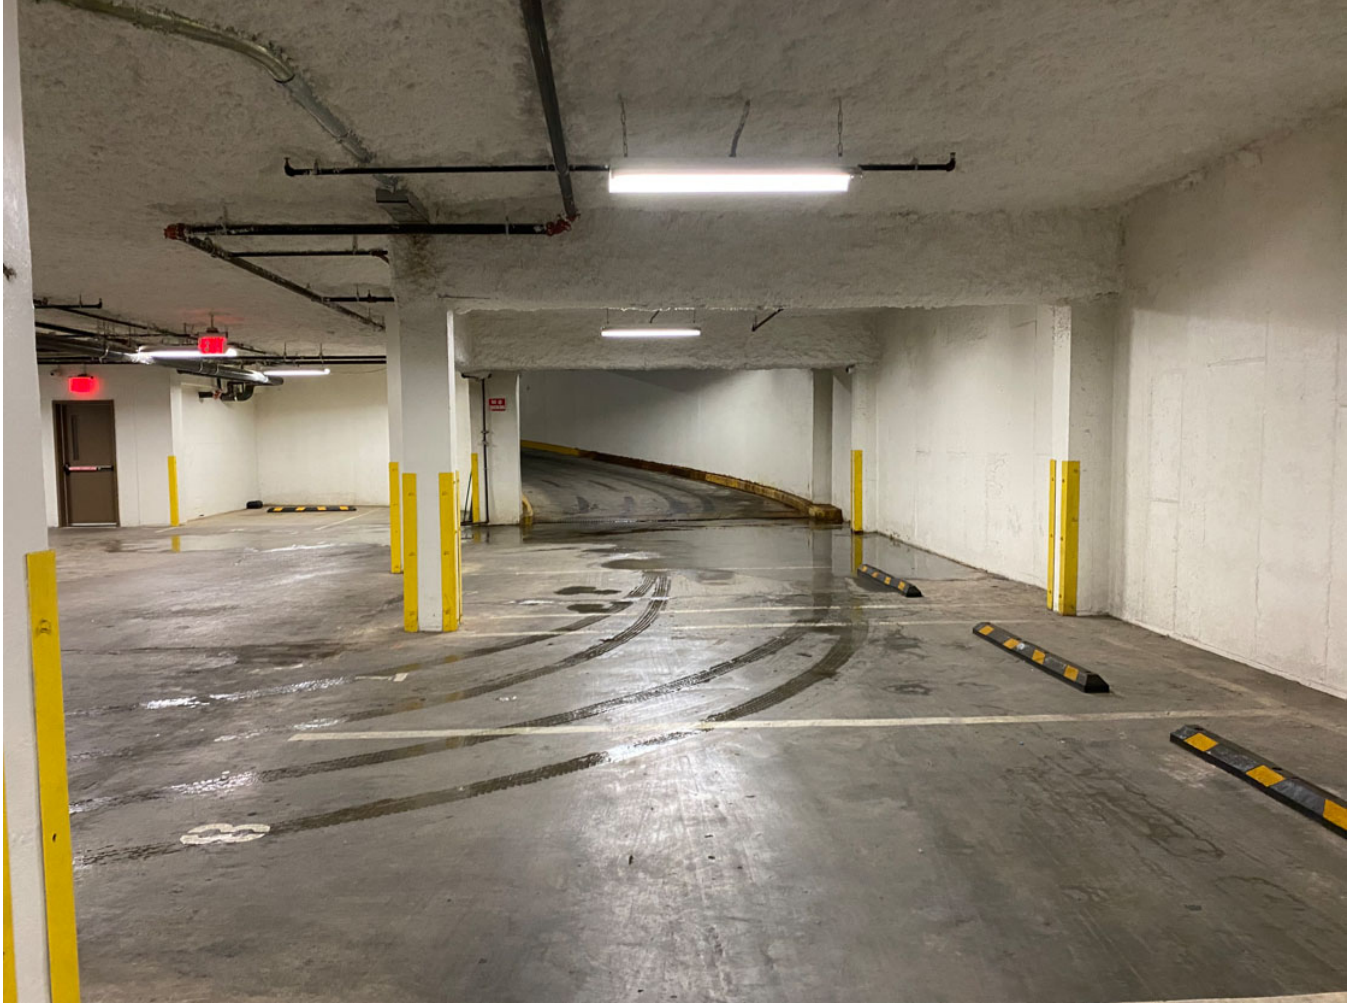
Photograph No. 5: View of the sub-grade parking garage and sidewalls, facing west. Note: The parking garage is part of the composite cover system in the Track 1 and 2 Remedial Areas.

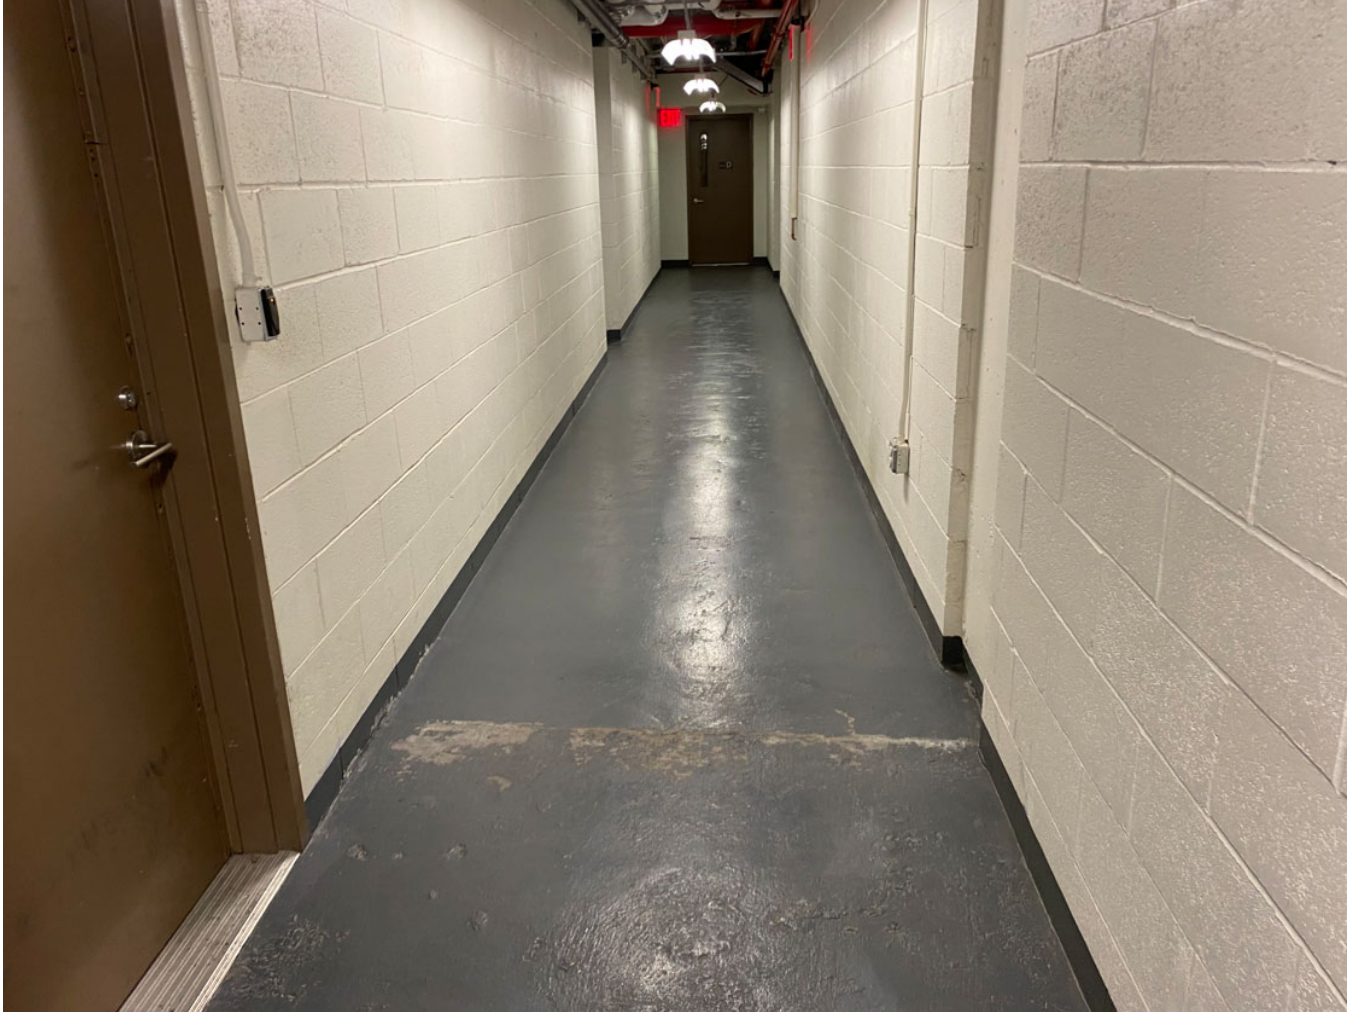
Photograph No. 6: View of the composite cover system in the basement hallway, facing northwest. Note: The basement is part of the composite cover system in the Track 1 and 2 Remedial Areas.

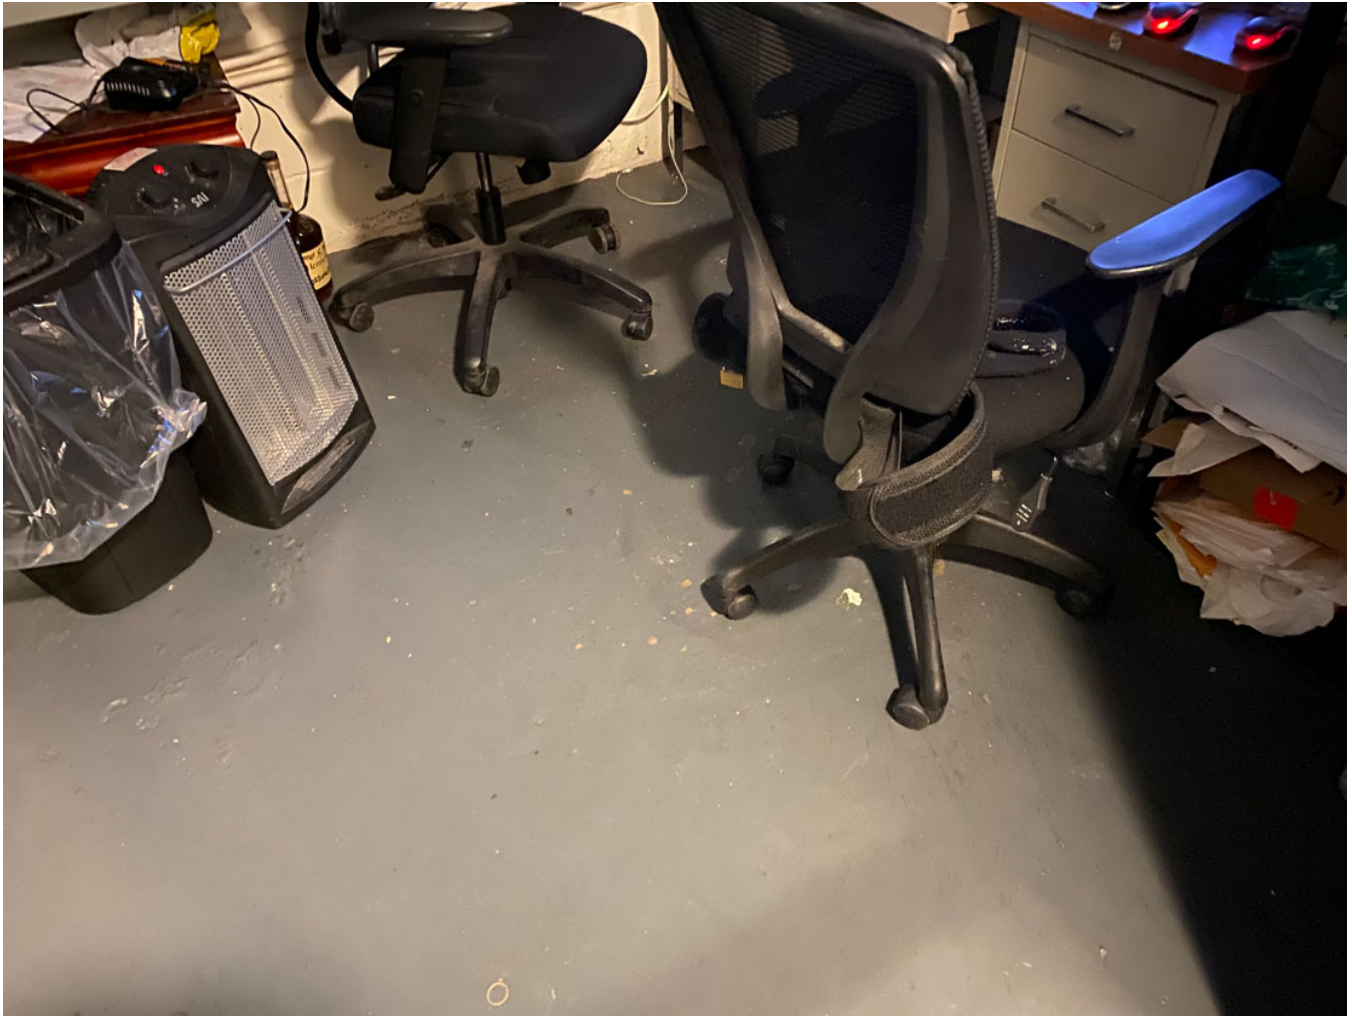
Photograph No. 7: Close-up view of the composite cover system in the basement maintenance closet.
