Former G & C Services

255 East 138th Street
Bronx, New York 10451

May 28, 2025

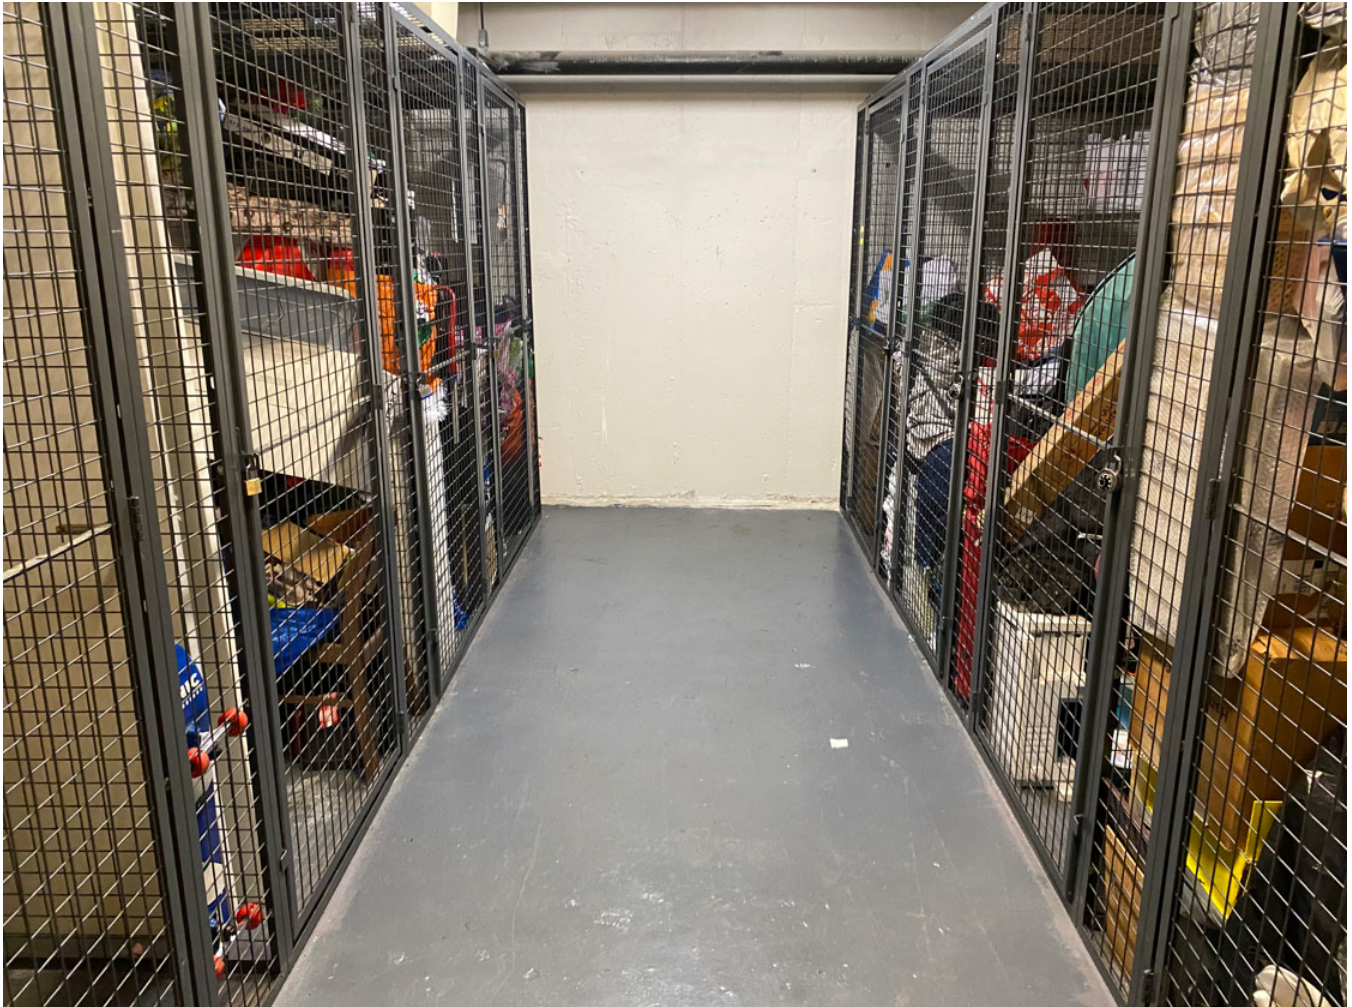
Photograph No. 8: View of the composite cover system in the tenant storage room, located in the basement.

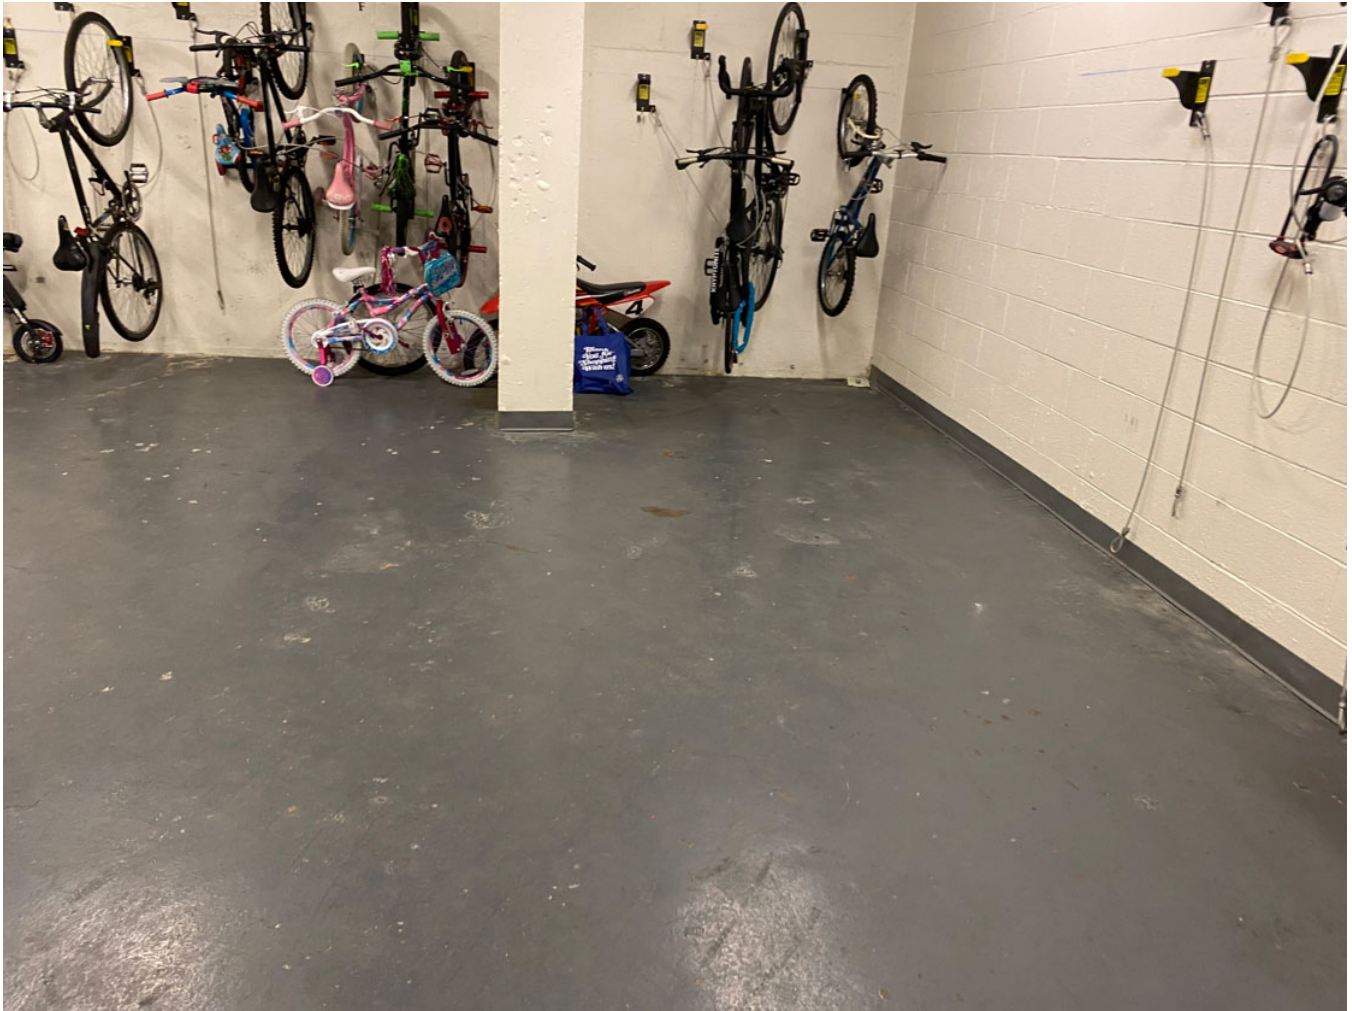
Photograph No. 9: View of the composite cover system in the bike storage room, located in the basement.

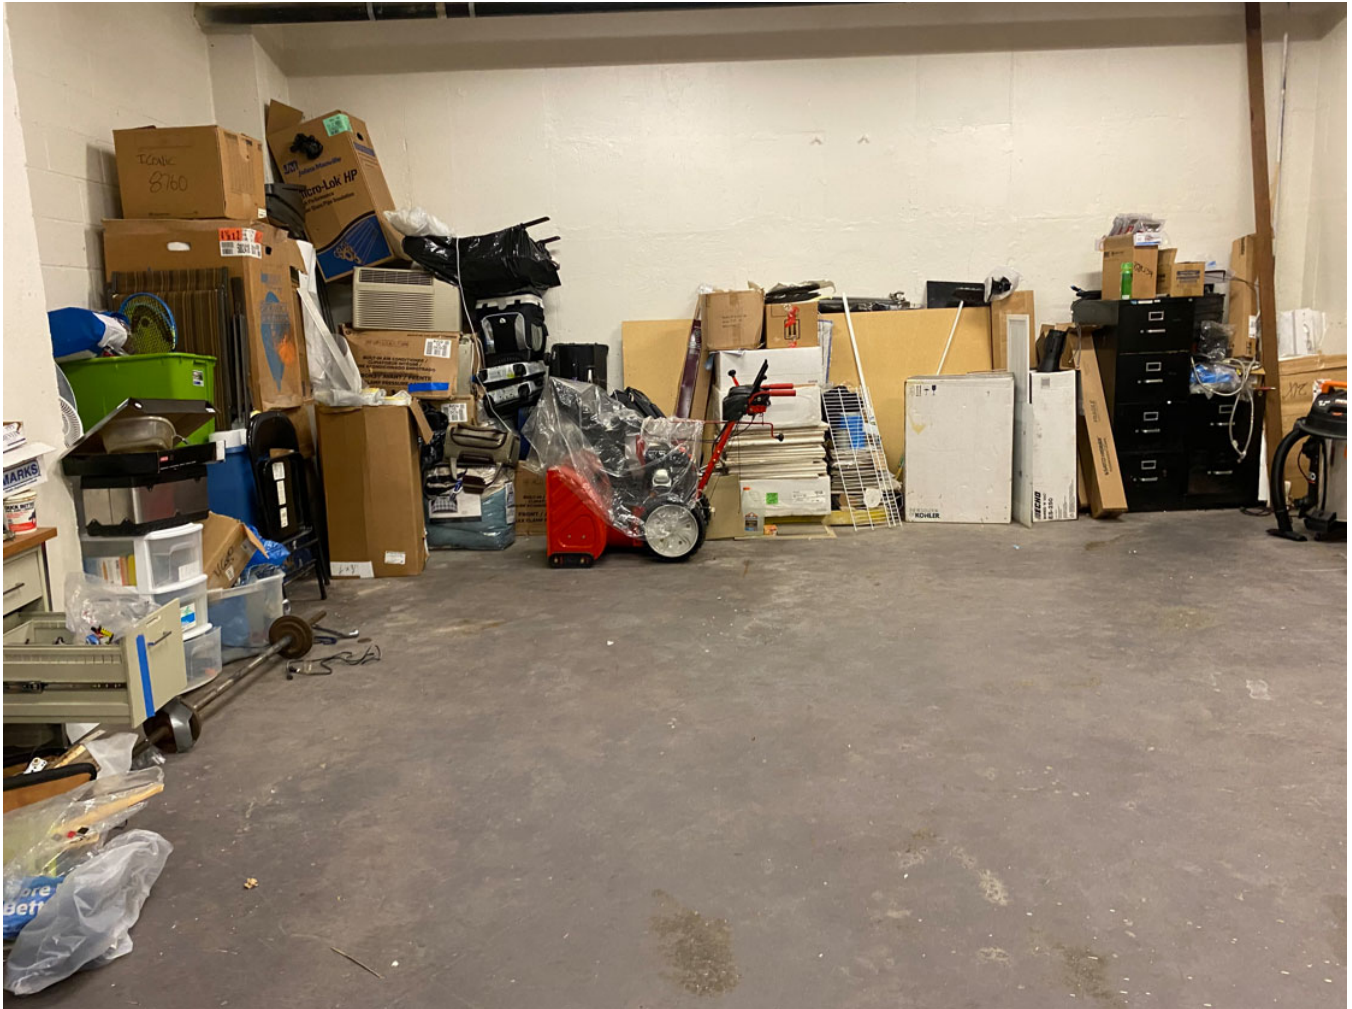
Photograph No. 10: View of the composite cover system in the commercial tenant's storage room, located in the basement.

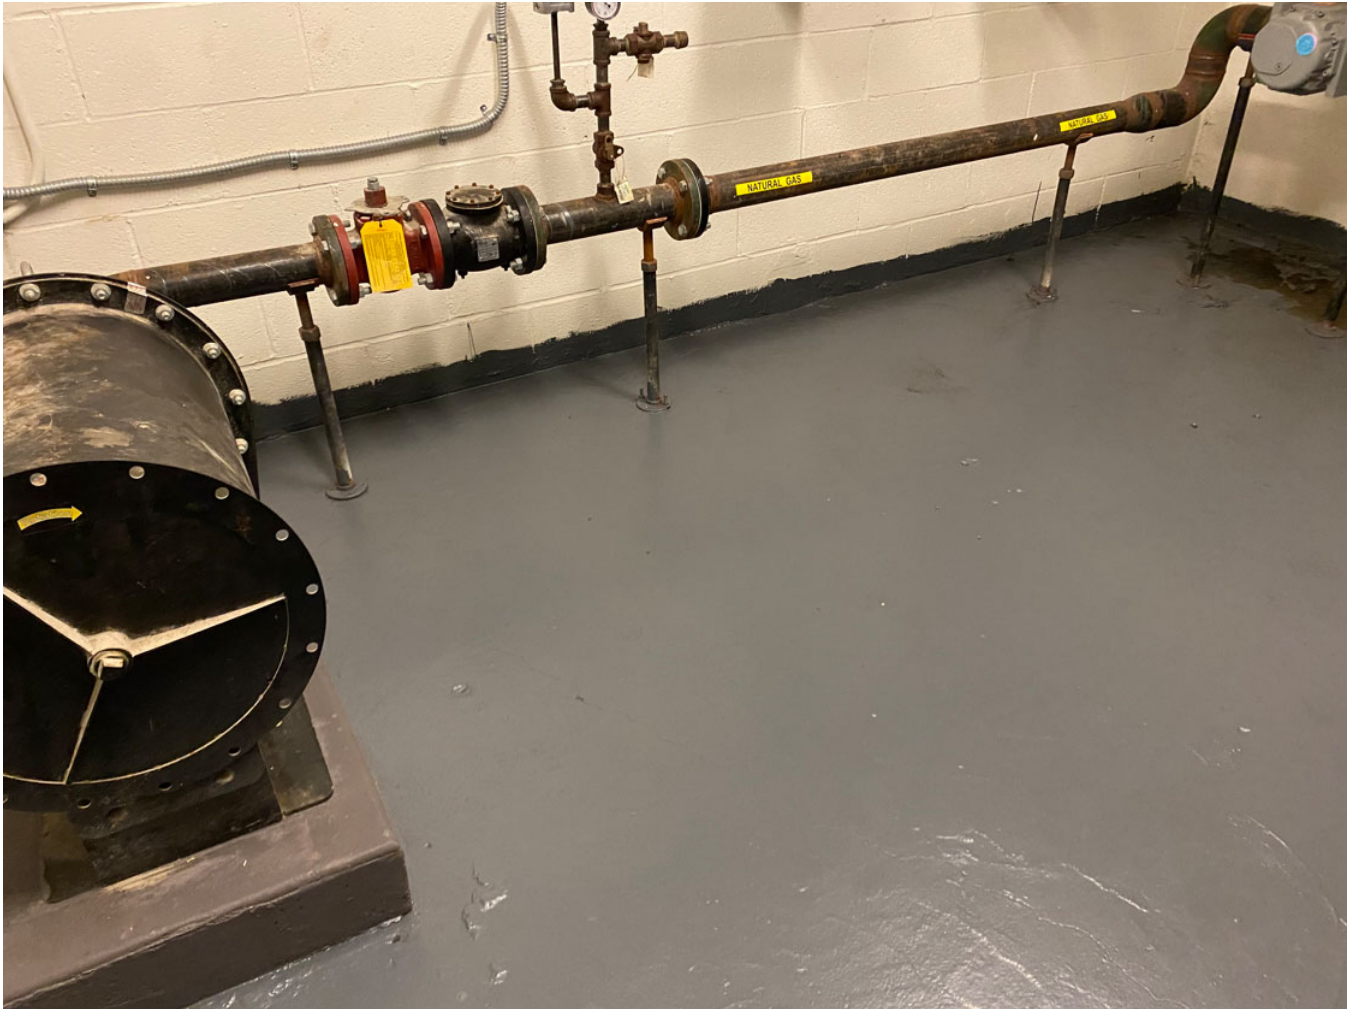
Photograph No. 11: View of the composite cover system in a utility room, located in the basement.

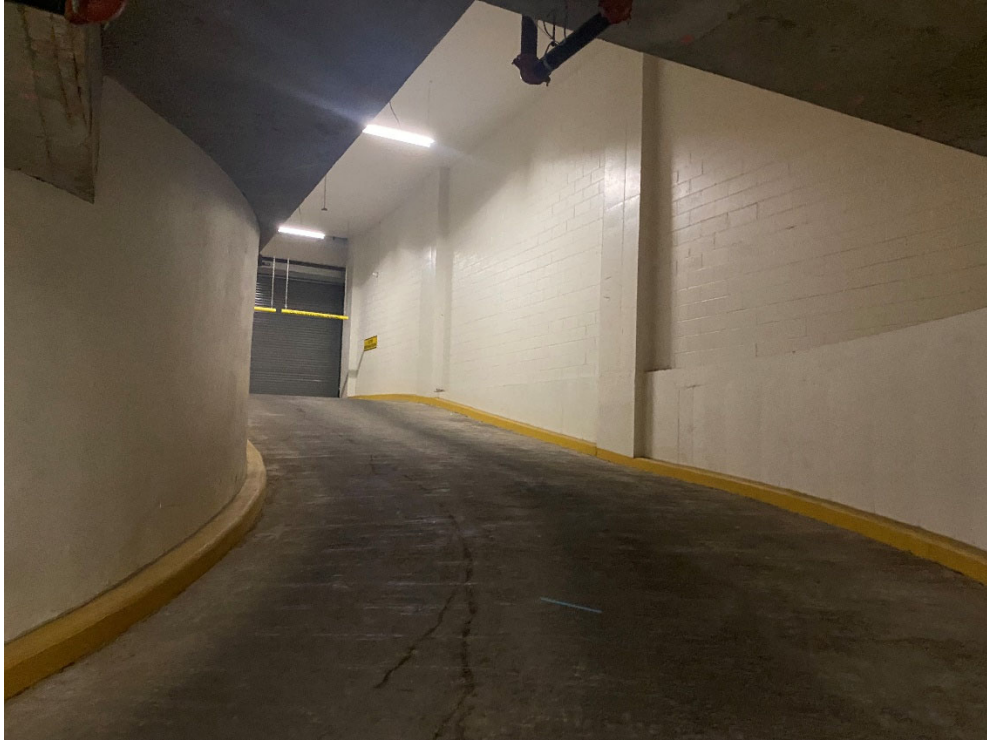
Photograph No. 1: View of the sub-grade parking garage ramp and sidewalls, facing northeast. Note: The ramp is part of the composite cover system in the Track 4 Remedial Area.

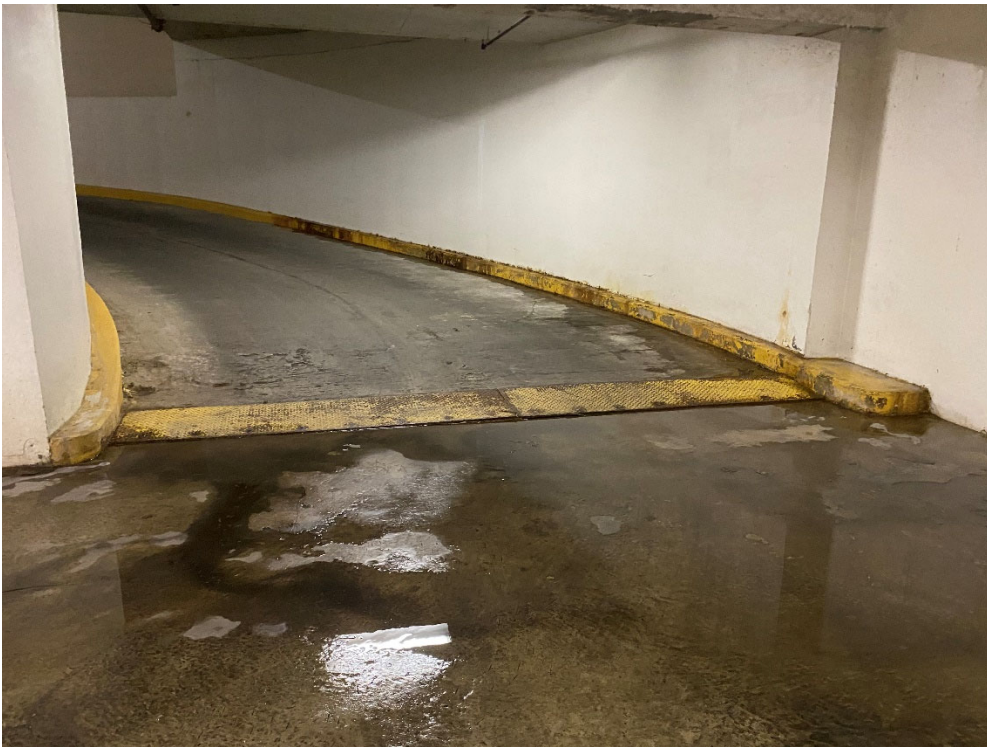
Photograph No. 2: View of the sub-grade parking garage ramp and sidewalls, facing northwest. Note: The ramp is part of the composite cover system in the Track 4 Remedial Area.

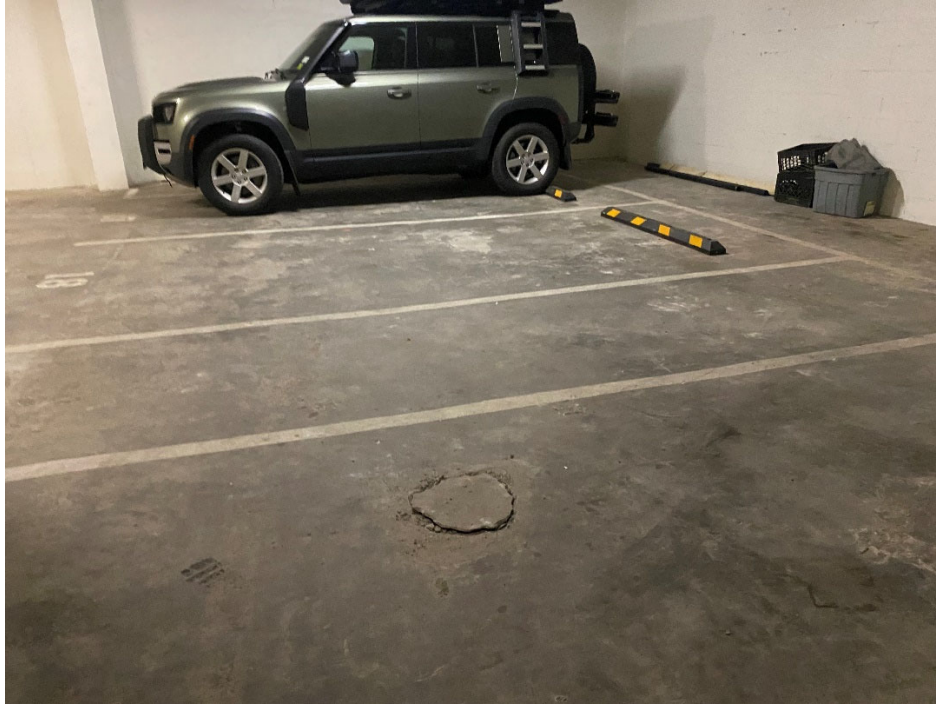
Photograph No. 3: View of the sub-grade parking garage and sidewalls, facing north. Note: The parking garage is part of the composite cover system in the Track 1 and 2 Remedial Areas.

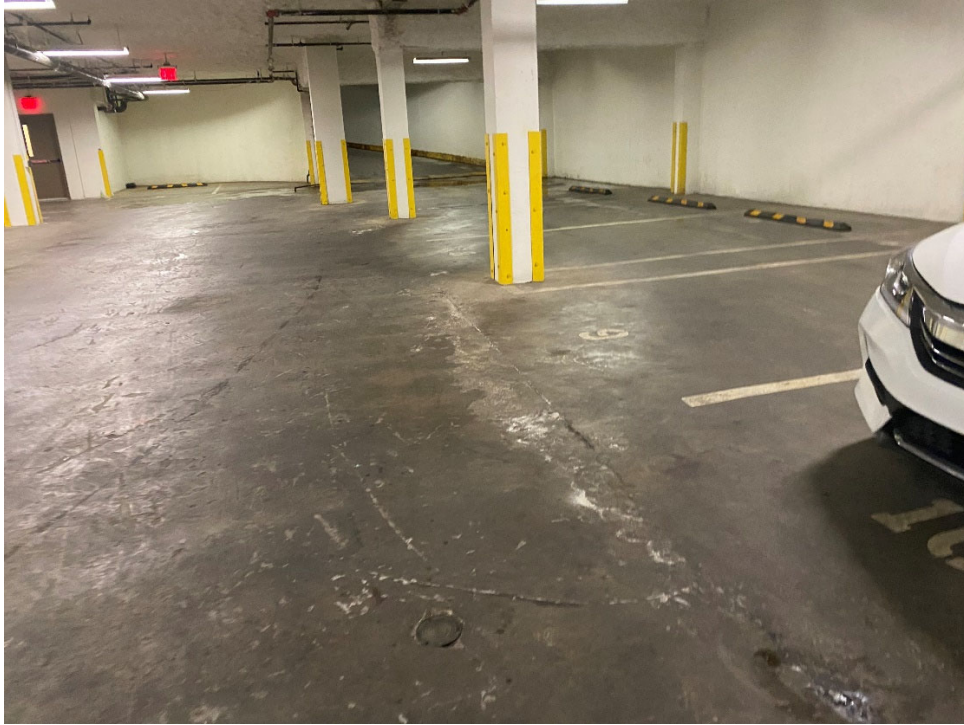
Photograph No. 5: View of the sub-grade parking garage and sidewalls, facing west. Note: The parking garage is part of the composite cover system in the Track 1 and 2 Remedial Areas.

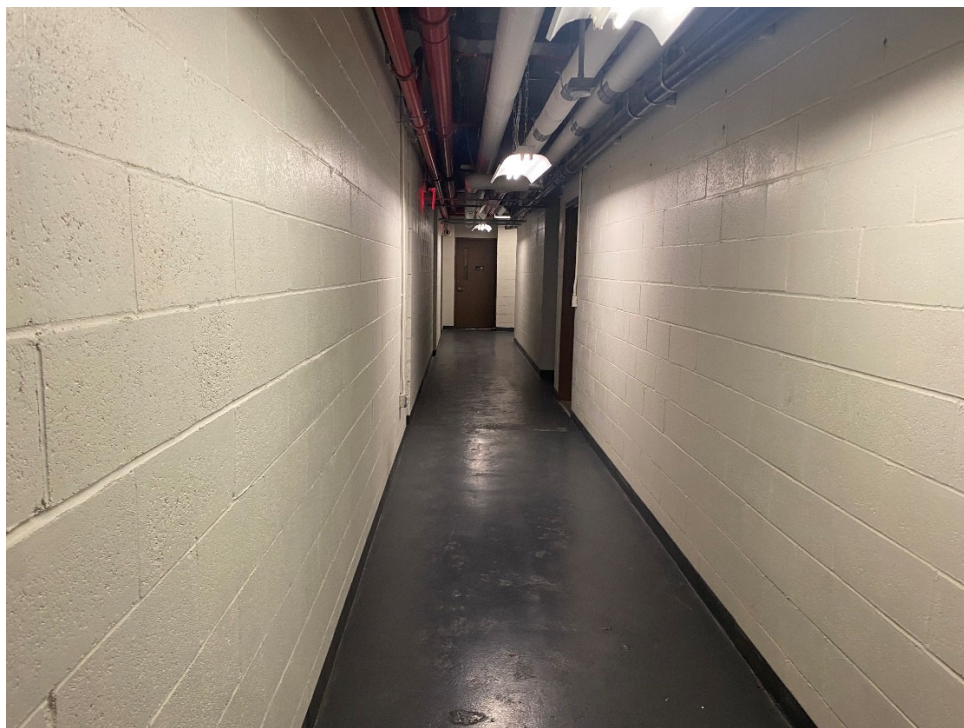
Photograph No. 6: View of the composite cover system in the basement hallway, facing northwest. Note: The basement is part of the composite cover system in the Track 1 and 2 Remedial Areas.

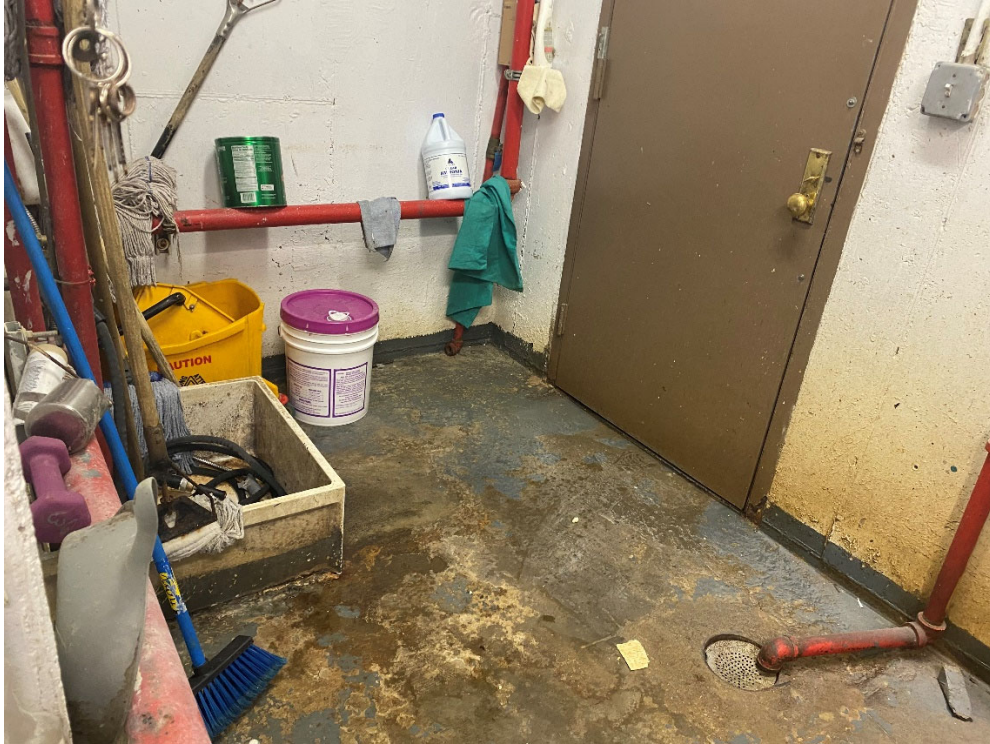
Photograph No. 7: Close-up view of the composite cover system in the basement maintenance closet.

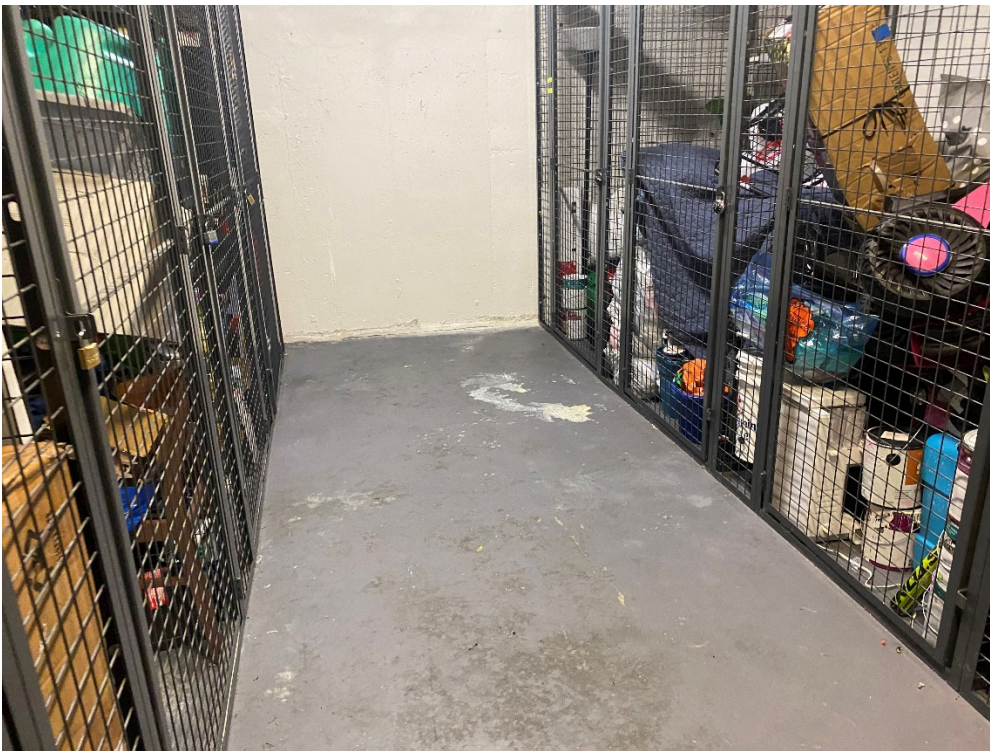
Photograph No. 8: View of the composite cover system in the tenant storage room, located in the basement.

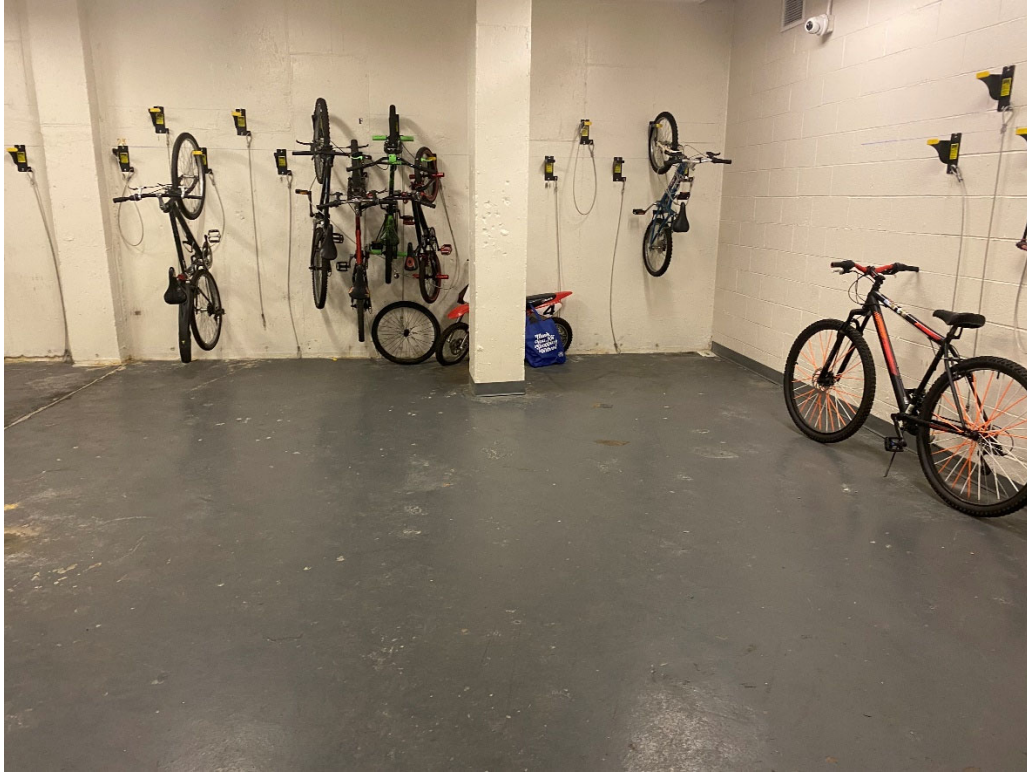
Photograph No. 9: View of the composite cover system in bike storage room, located in the basement.

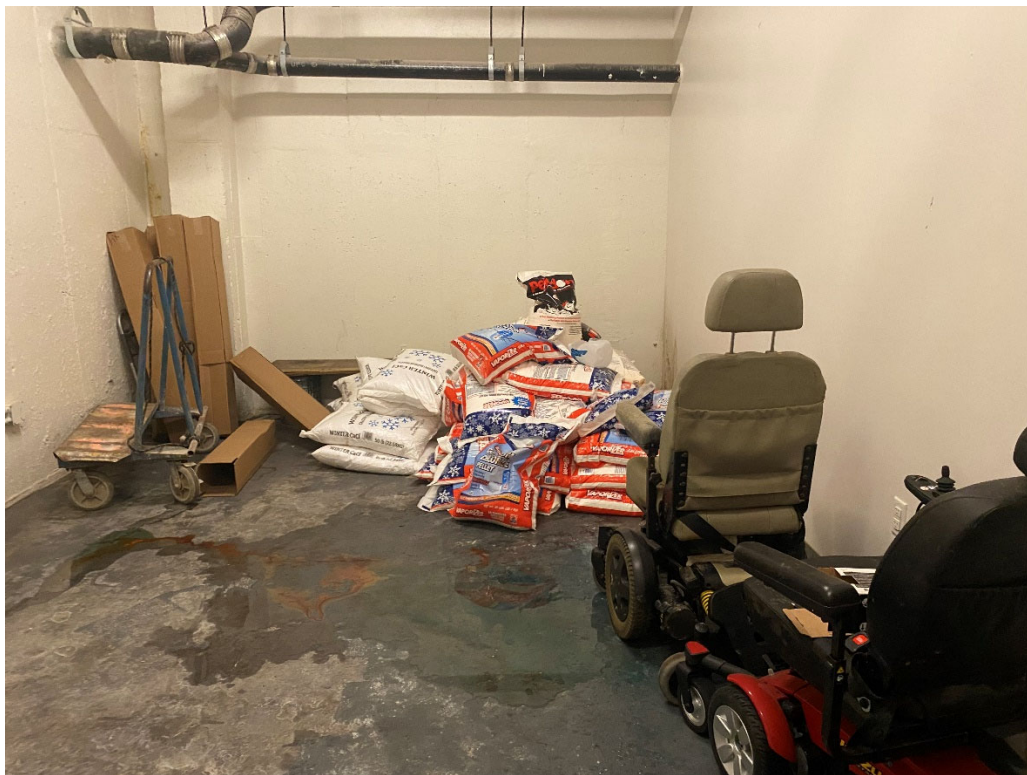
Photograph No. 10: View of the composite cover system in the commercial tenant's storage room, located in the basement.

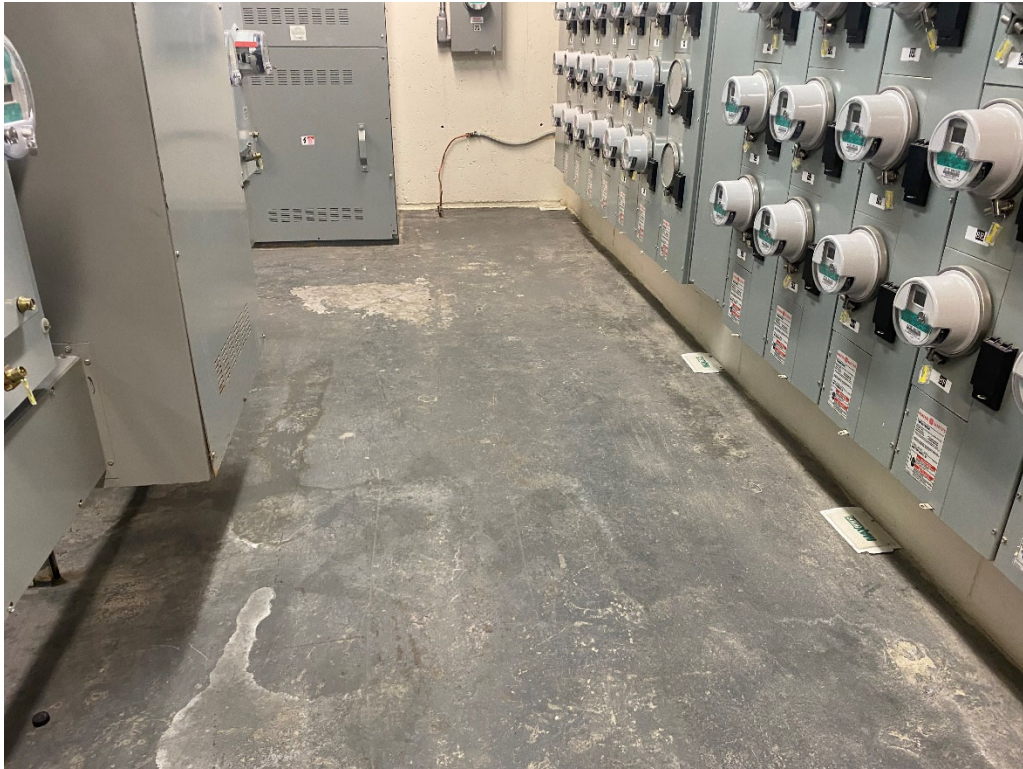
Photograph No. 11: View of the composite cover system in a utility room, located in the basement.
