3500 Park Avenue Apartments Site

3500 Park Avenue

Periodic Review Report

NYSDEC Brownfield Cleanup Program Site Number: C203096

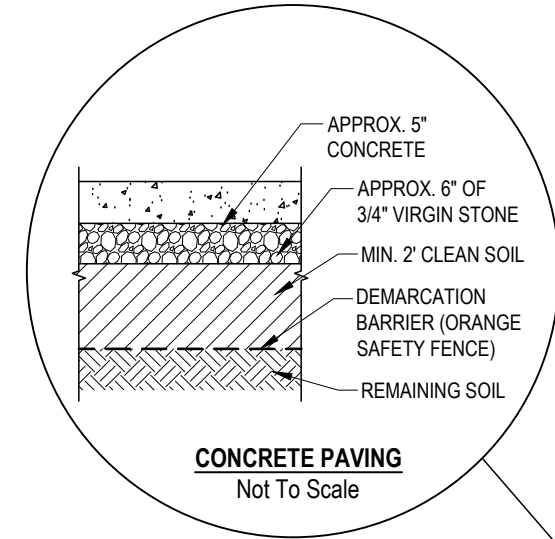
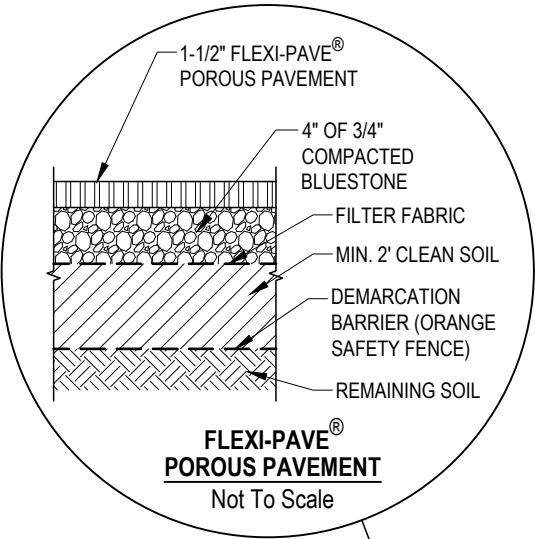
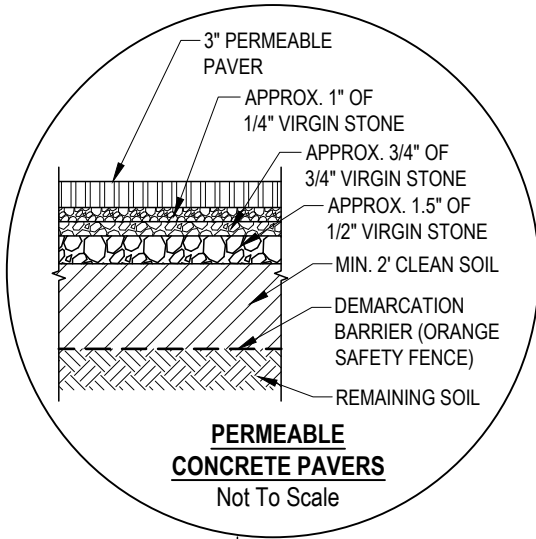
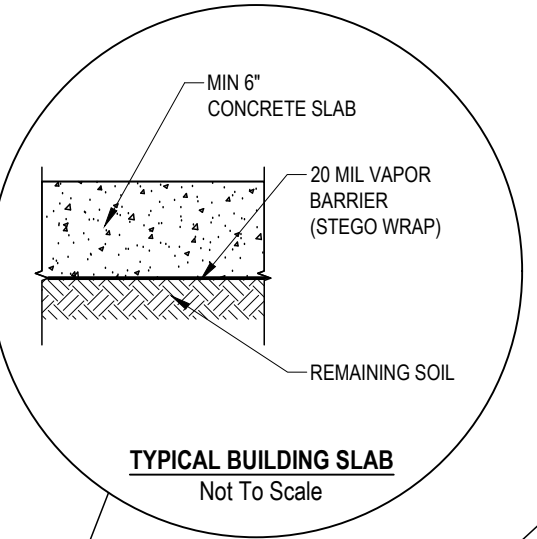
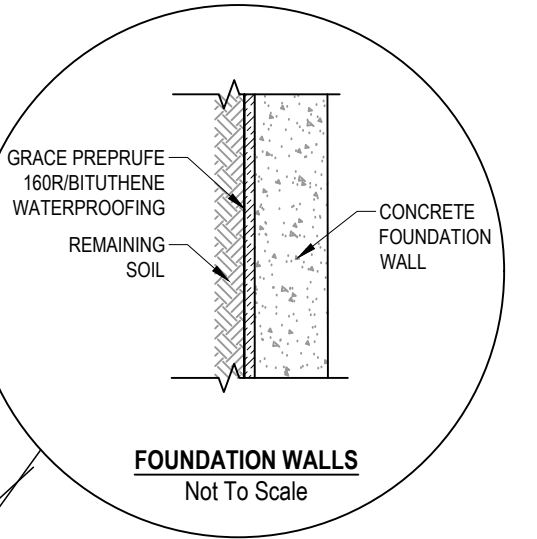
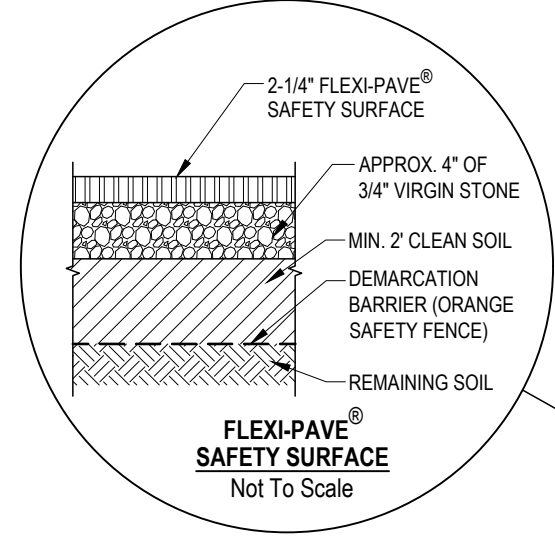
DATE	5/17/2021
PROJECT NO.	12477
FIGURE	3

The demarcation barrier installed beneath the two-foot clean fill buffer and underlying remaining soil was not disturbed during the additional rear courtyard construction activities performed in 2020 following approval of the SMP and FER and issuance of the COC in 2019. The additional site cover system components installed in the rear courtyard of the Site are included in the revised Site Cover System Plan provided as Figure 3.
