Daily Activity Report	
		100 East 149 th Street Site	
		100 East 149 th Street, Bronx, New York	
		BCP No. C203159	
General Site Information			
Date:	Friday, December 1, 2023		
Weather:	Cloudy, 37-51°F		
Wind Direction/Speed:	NE 7 mph		
Touchstone Personnel on Site:	Firat Ataman		
Touchstone Equipment on Site:	Mini RAE 3000 Photoionization Detectors [(PID) x 2] and DustTrak Aerosol Monitors (x1)		
Visitors:	NYSDEC Project Manager Erick Bower		
Contractor Information			
Contracting Company	Main Personnel	Equipment	
Drilling Contractor: PG Environmental Services, Inc.		Excavator, Jack Hammer	
Description and Location of Work Activities Performed			
<p>The Community Air Monitoring Program (CAMP) was implemented throughout the workday until it began to rain in the afternoon. Upwind CAMP readings were high due to the proximity of the dust monitor to the excavator and due to work/repairs being conducted on the sidewalk.</p> <p>Touchstone performed a Site Investigation in the southern portion of the Site to investigate a suspect underground storage tank (UST) anomaly identified in former investigations of the Site and to investigate the cause of refusals in the area during the implementat

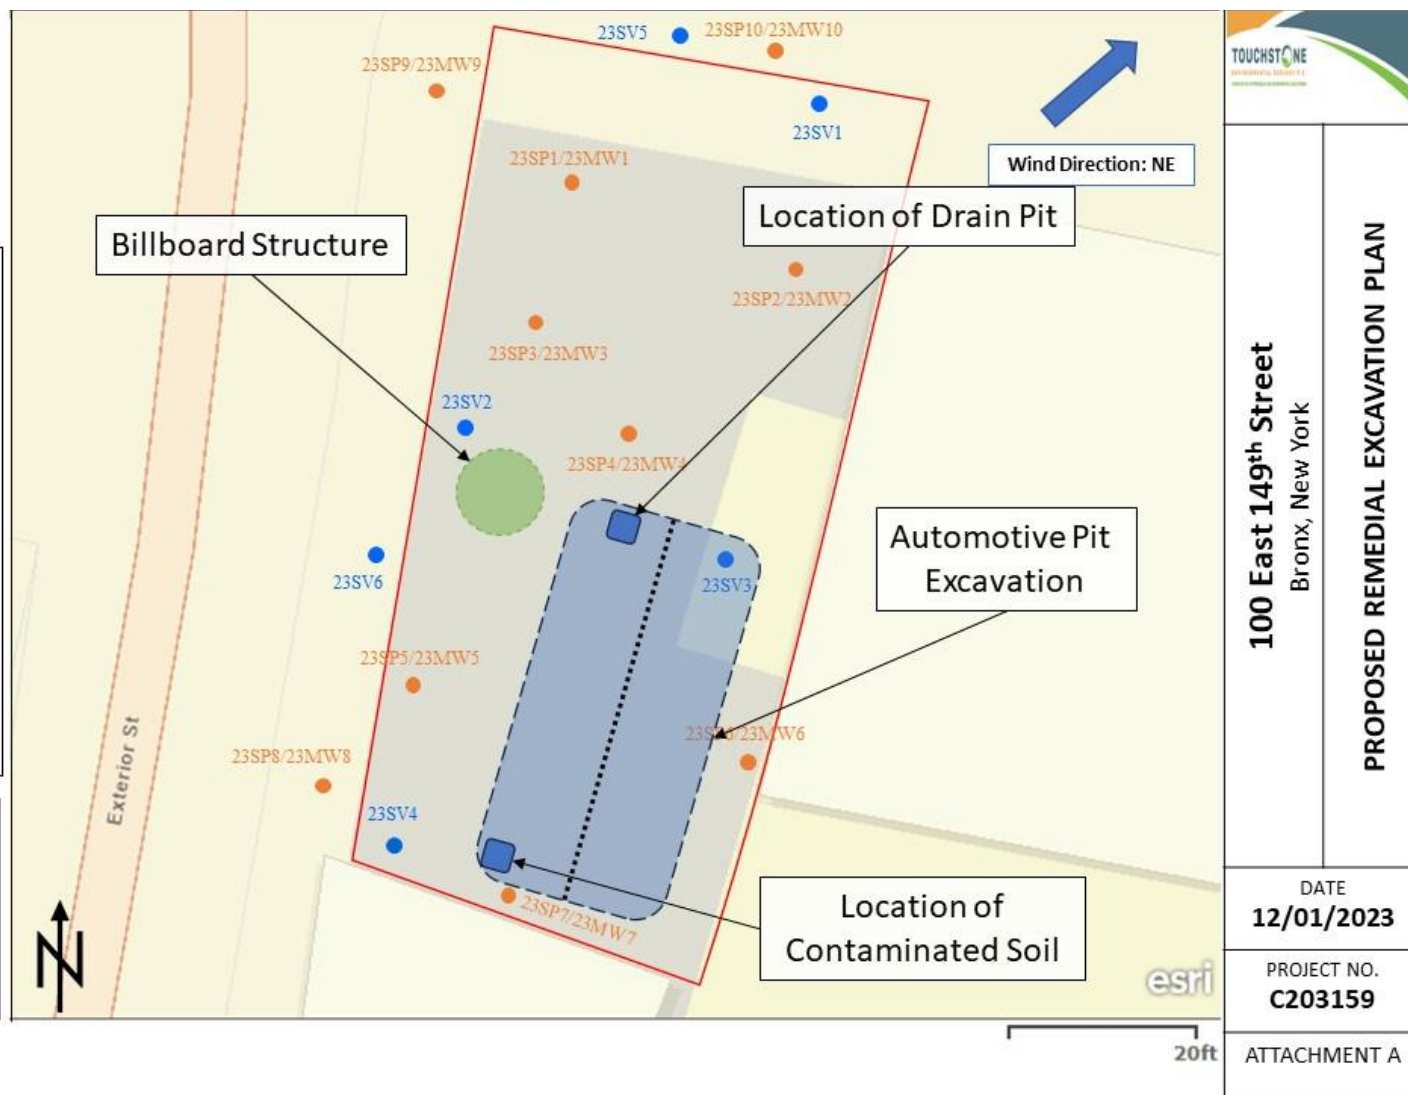
100 East 149th Street Site Map

A Site Investigation was performed which included the use of an excavator in the southern portion of the Site. An automotive repair pit and drain pit were identified. Contaminated soil was identified during the excavation and was properly separated and stored in a drum at the Site for disposal. An old hydraulic oil tank was also identified. The tank was dry and was wrapped in plastic. A concrete footing and steel post from a former billboard were identified on the western portion of the Site,
