**PERIODIC REVIEW REPORT  
2019/2020**

**353 MCKIBBIN STREET  
BROOKLYN, NEW YORK  
NYSDEC BCP SITE NO. C224102**

**December 10, 2020**

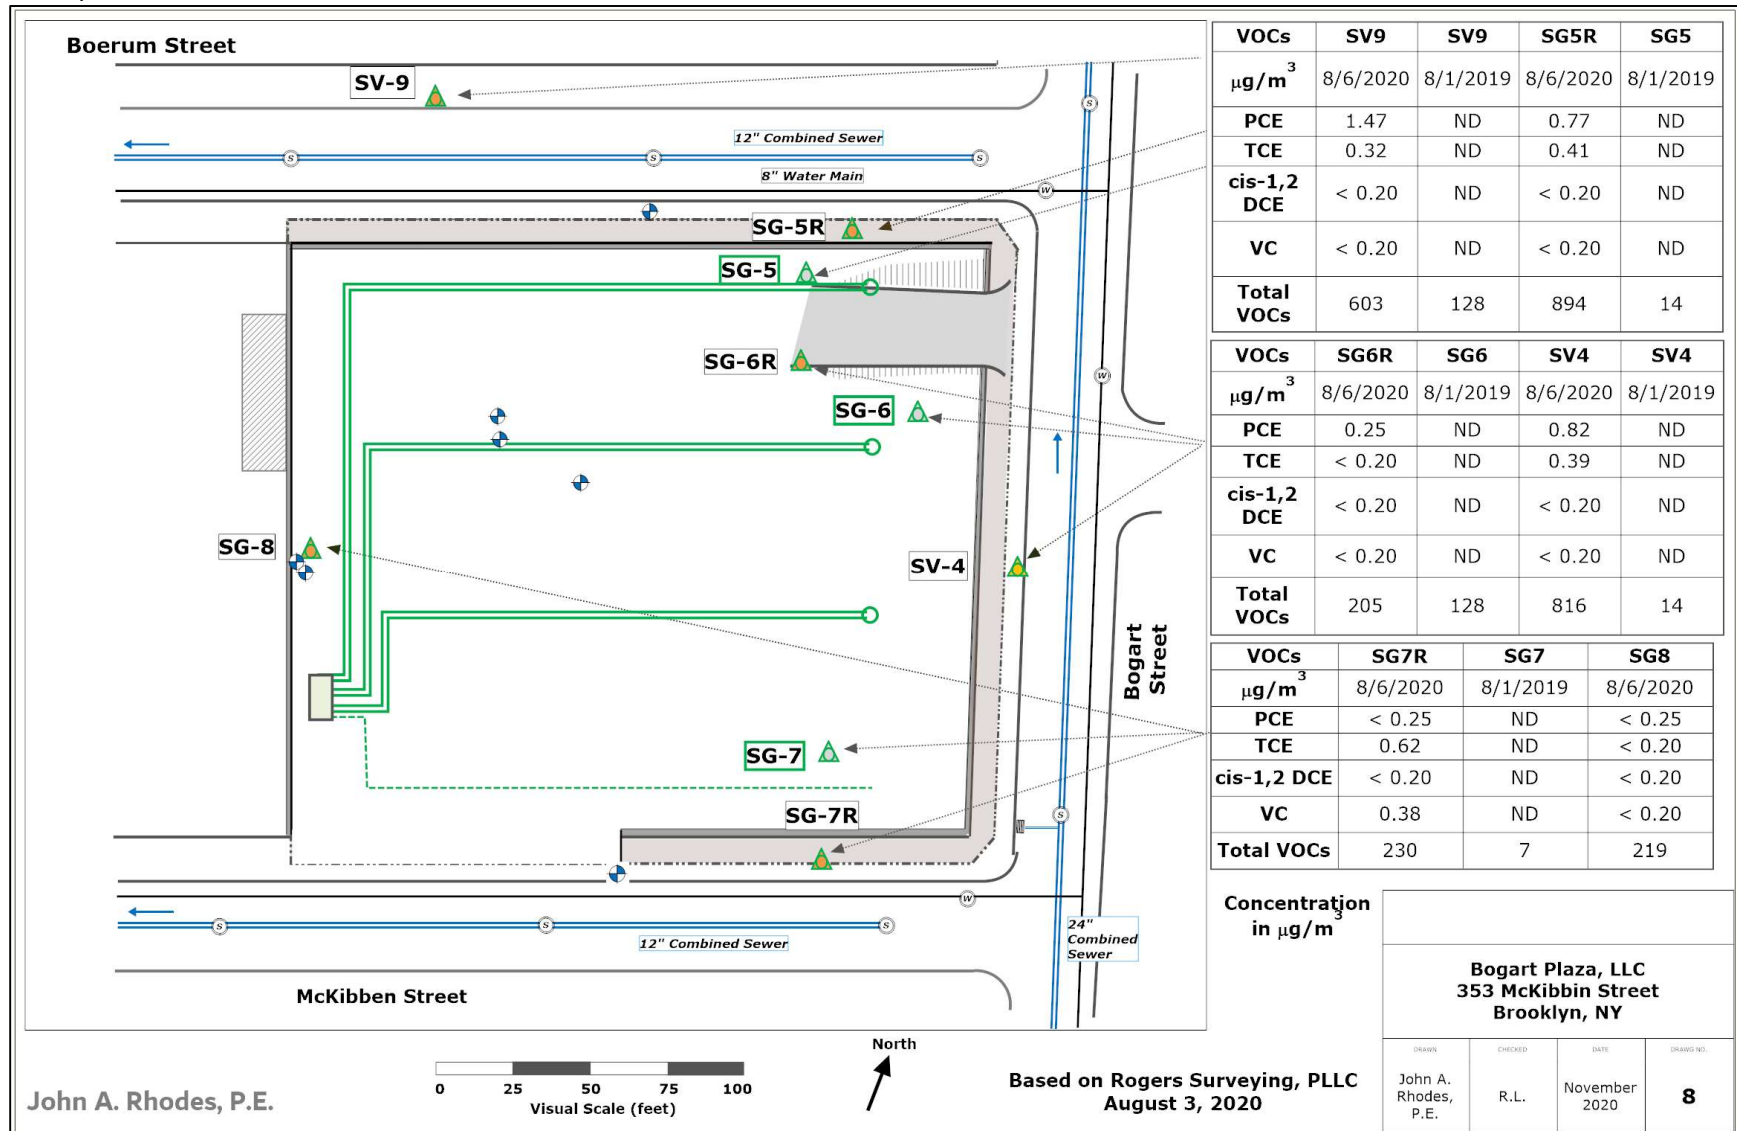
Figure 5 Soil Vapor Analytical Results August 2019 & 2020

The Corrective Measures Report demonstrates that the updated vapor monitoring network is effective and that the SVE system continues to meet the objective of preventing soil vapor contaminants from leaving the property. Pneumatic testing using the newly installed vapor probes with SVE system operating at 300 SCFM show an average zone of influence of 65 feet from SVE pipe (see the CMR). This capture is also reflected in soil vapor concentrations. Figure 5 is a spider map of soil vapor testing results for the August 2019 and 2020 sampling and testing events. Vapor sample

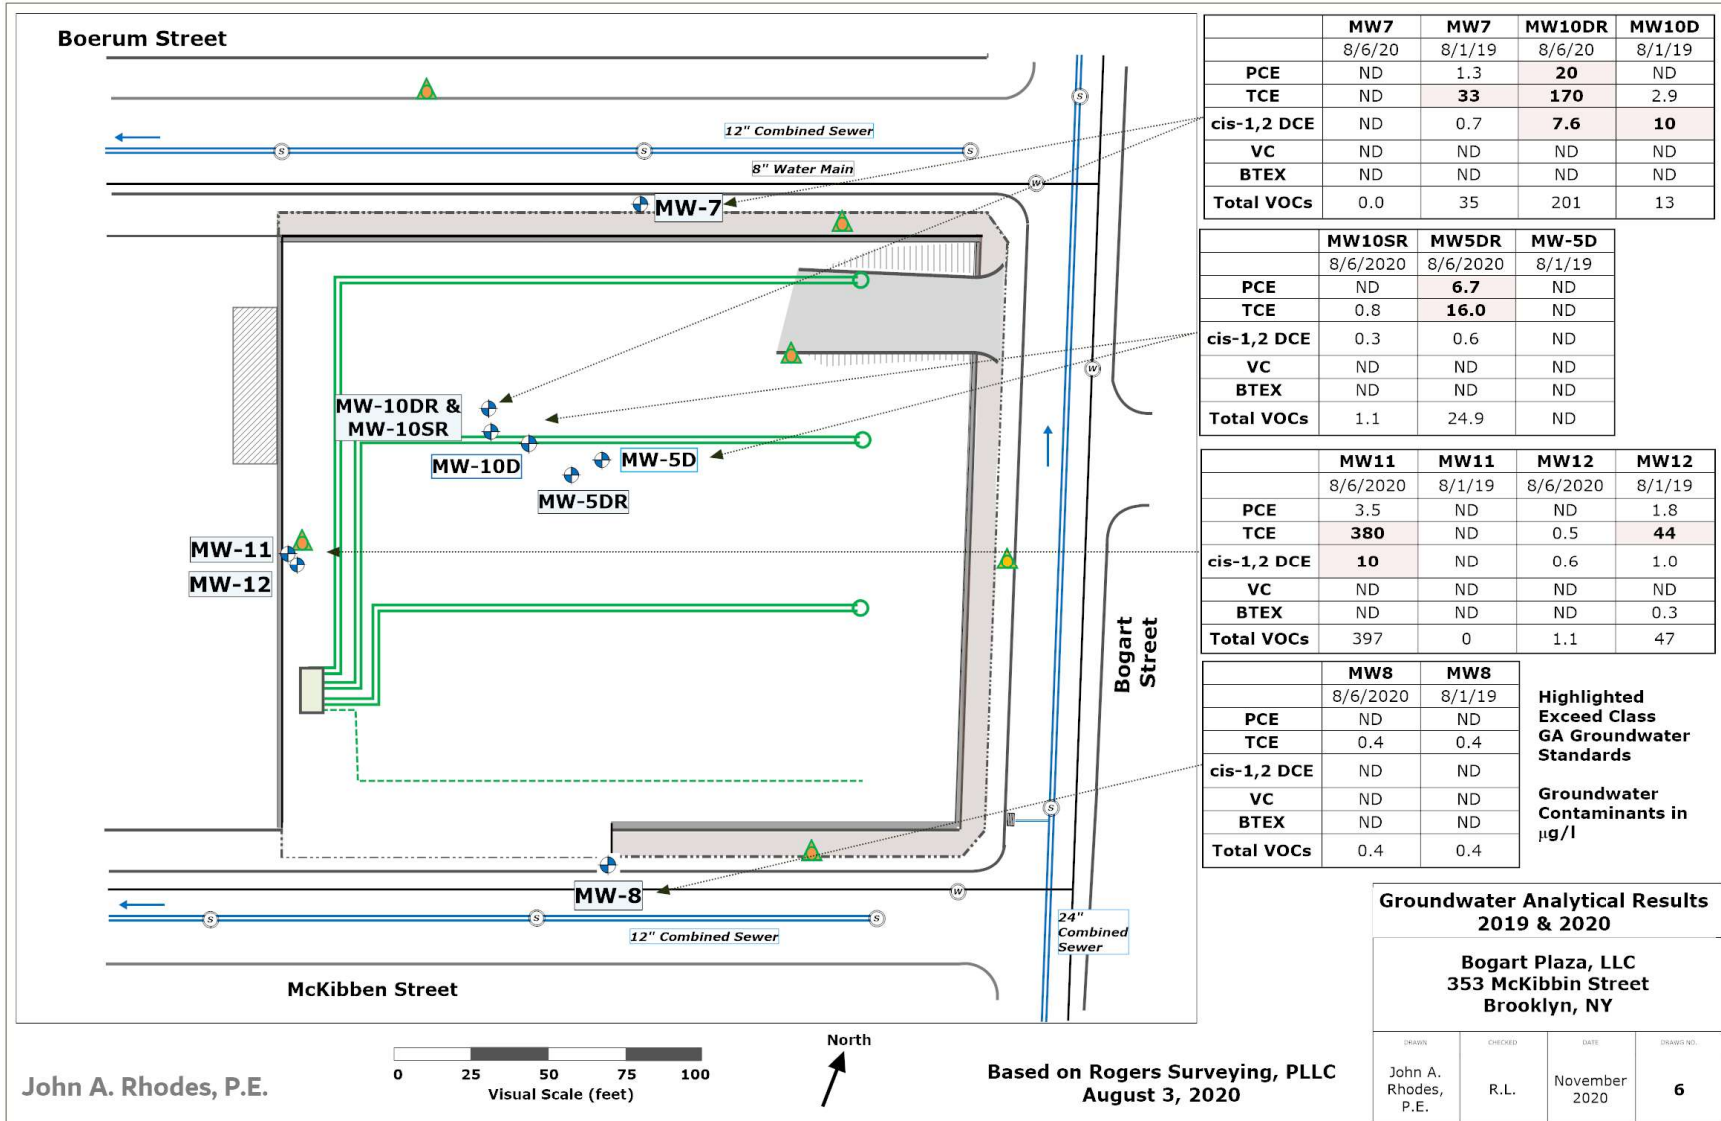
Figure 6 Groundwater Analytical Results August 2019 & 2020

The remaining contaminant of concern in groundwater is principally TCE, with appearances of PCE and 1,2 cis-DCE. Figure 6 in Appendix A provides a spider map of the August 1, 2019 and August 6, 2020 groundwater sampling and testing events for the key remaining contaminants.

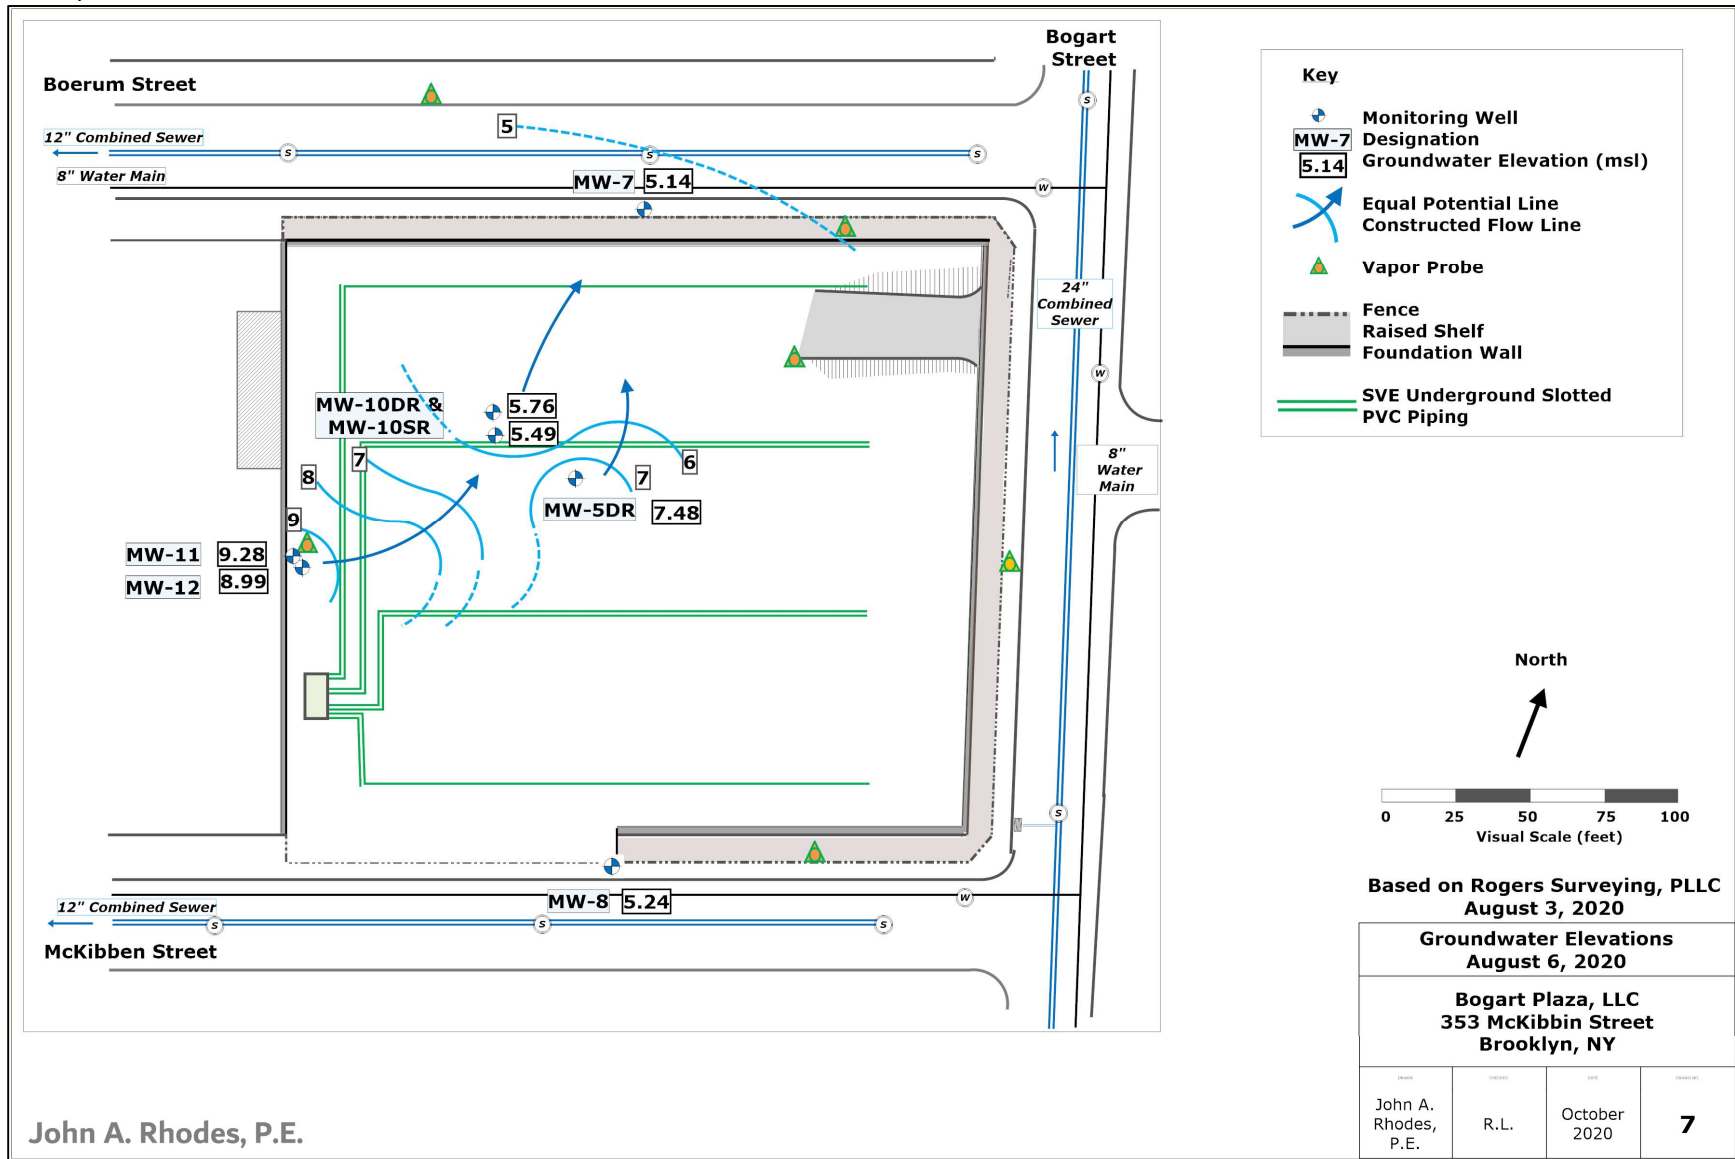
Figure 7 Groundwater Contours August 6, 2020

Groundwater flow is to the north which is consistent with prior measurements. Non-uniform infiltration due to the Site's porous cover and lack of drainage cause differential infiltration rates and variable groundwater potentials. Therefore, groundwater levels within the confines of the Site are sensitive to rain events and associated infiltration. However, evaluation of the numerous measurements since 2015 and comparisons with infiltration data demonstrate resultant flow to the north. Figure 7 provides groundwater contours obtained on August 6, 2020 that show the general flow toward the north consistent with prior groundwater flow conclusions.

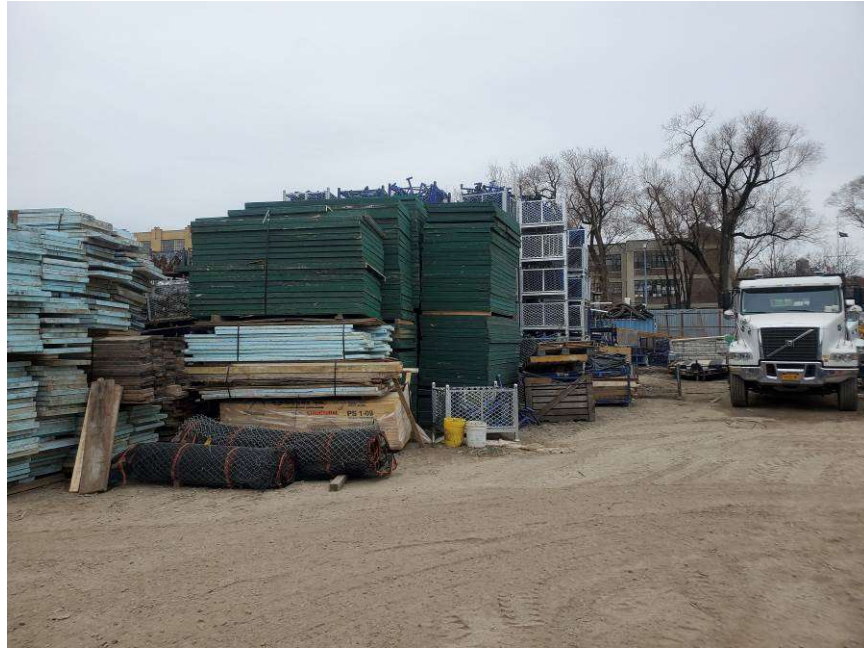
Looking toward Boerum Street
