PERIODIC REVIEW REPORT NOV. 2, 2020 TO NOV. 2, 2021

353 MCKIBBIN STREET BROOKLYN, NEW YORK NYSDEC BCP SITE NO. C224102

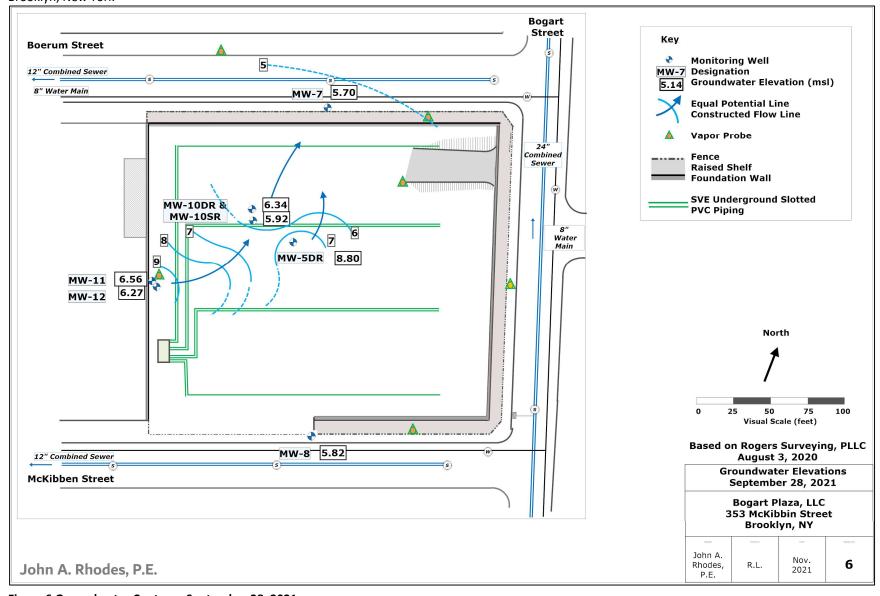
Figure 6 Groundwater Contours September 28, 2021

Groundwater flow is to the north which is consistent with prior measurements. Non-uniform infiltration due to the Site's porous cover and lack of drainage cause differential infiltration rates and variable groundwater potentials. Therefore, groundwater levels within the confines of the Site are sensitive to rain events and associated infiltration. However, evaluation of the numerous measurements since 2015 and comparisons with infiltration data demonstrate resultant flow to the north. Figure 6, Figure 7 and Figure 8 provide groundwater contours. These data and contours show the general flow toward the north consistent with prior groundwater flow conclusions.
