388 Bridge Street
Brooklyn, New York

NYSDEC BCP Site No. C224134

2017 ANNUAL PERIODIC REVIEW REPORT AND ENGINEERING CERTIFICATION

FLS Project Number: 10149-001

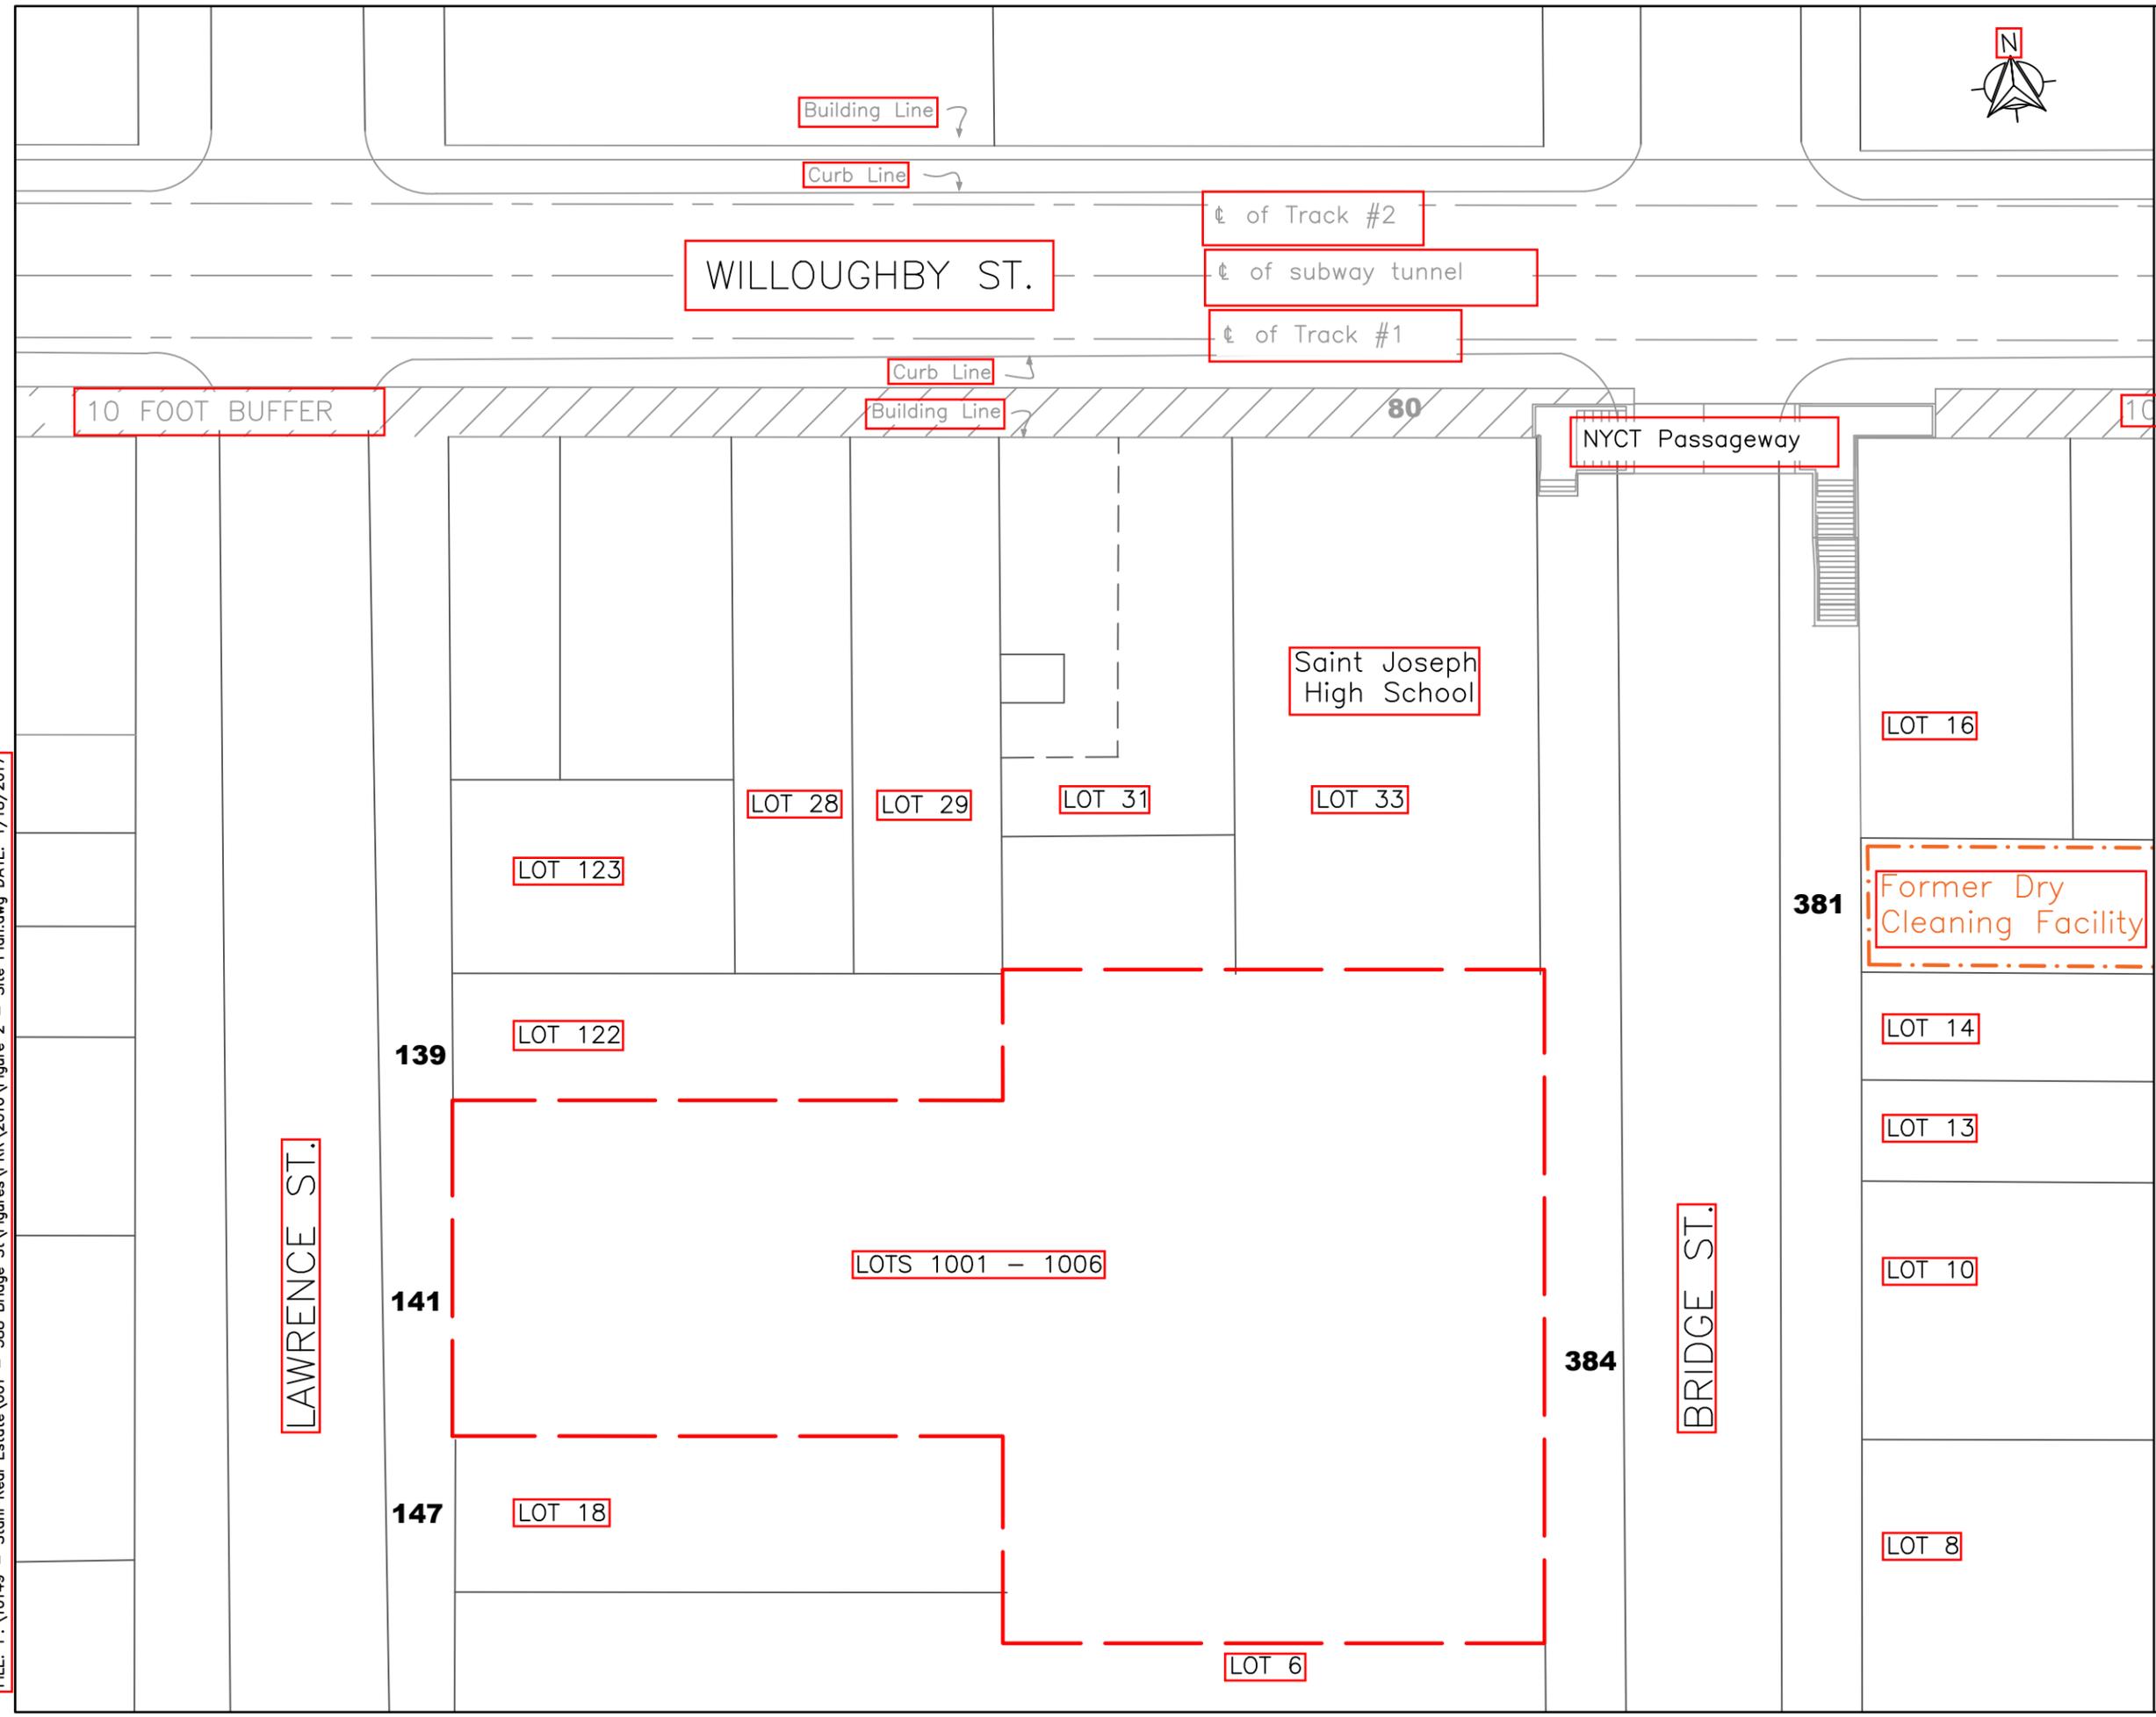
Figure 2

The development on the BCP Site C224134 includes the 53-story residential building with retail spaces on the ground floors and parking from the sub cellar to the 3rd floor of the building. Overall building construction on the Site is complete with some interior retail spaces still under construction. The development footprint is a lot line-to-lot line building as shown in Figure 2.

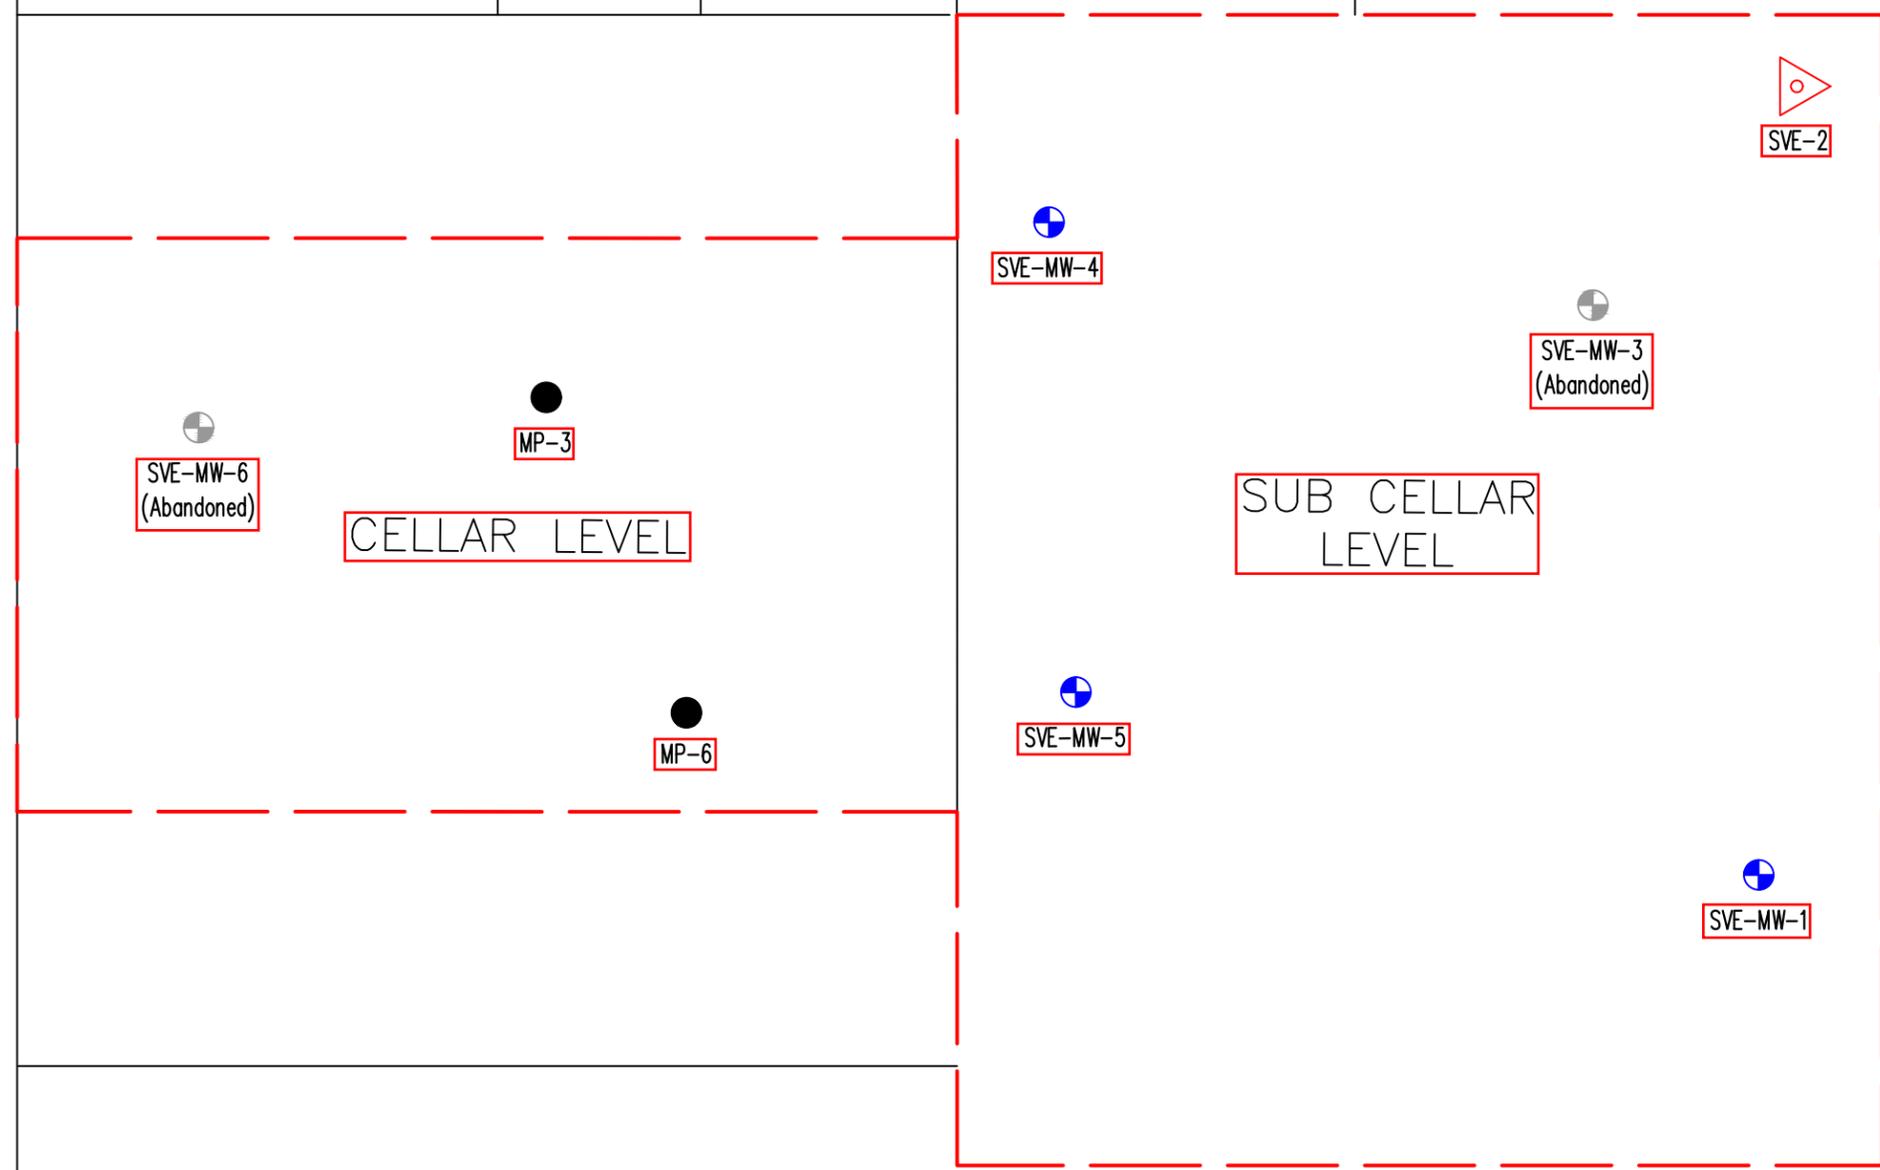
Figure 3

The majority of the existing groundwater monitoring wells were demolished during building construction. As outlined in the SMP, semi-annual groundwater monitoring will be conducted to confirm natural attenuation of chlorinated VOCs in groundwater. Following the installation of the downsized SVE system in January 2016, five of the six SVE wells were converted to groundwater monitoring wells. Of these five, two wells (SVE-MW-3 and SVE-MW-6) were abandoned as they did not extend into the groundwater table. The SVE and groundwater monitoring well locations are shown on Figure 3.

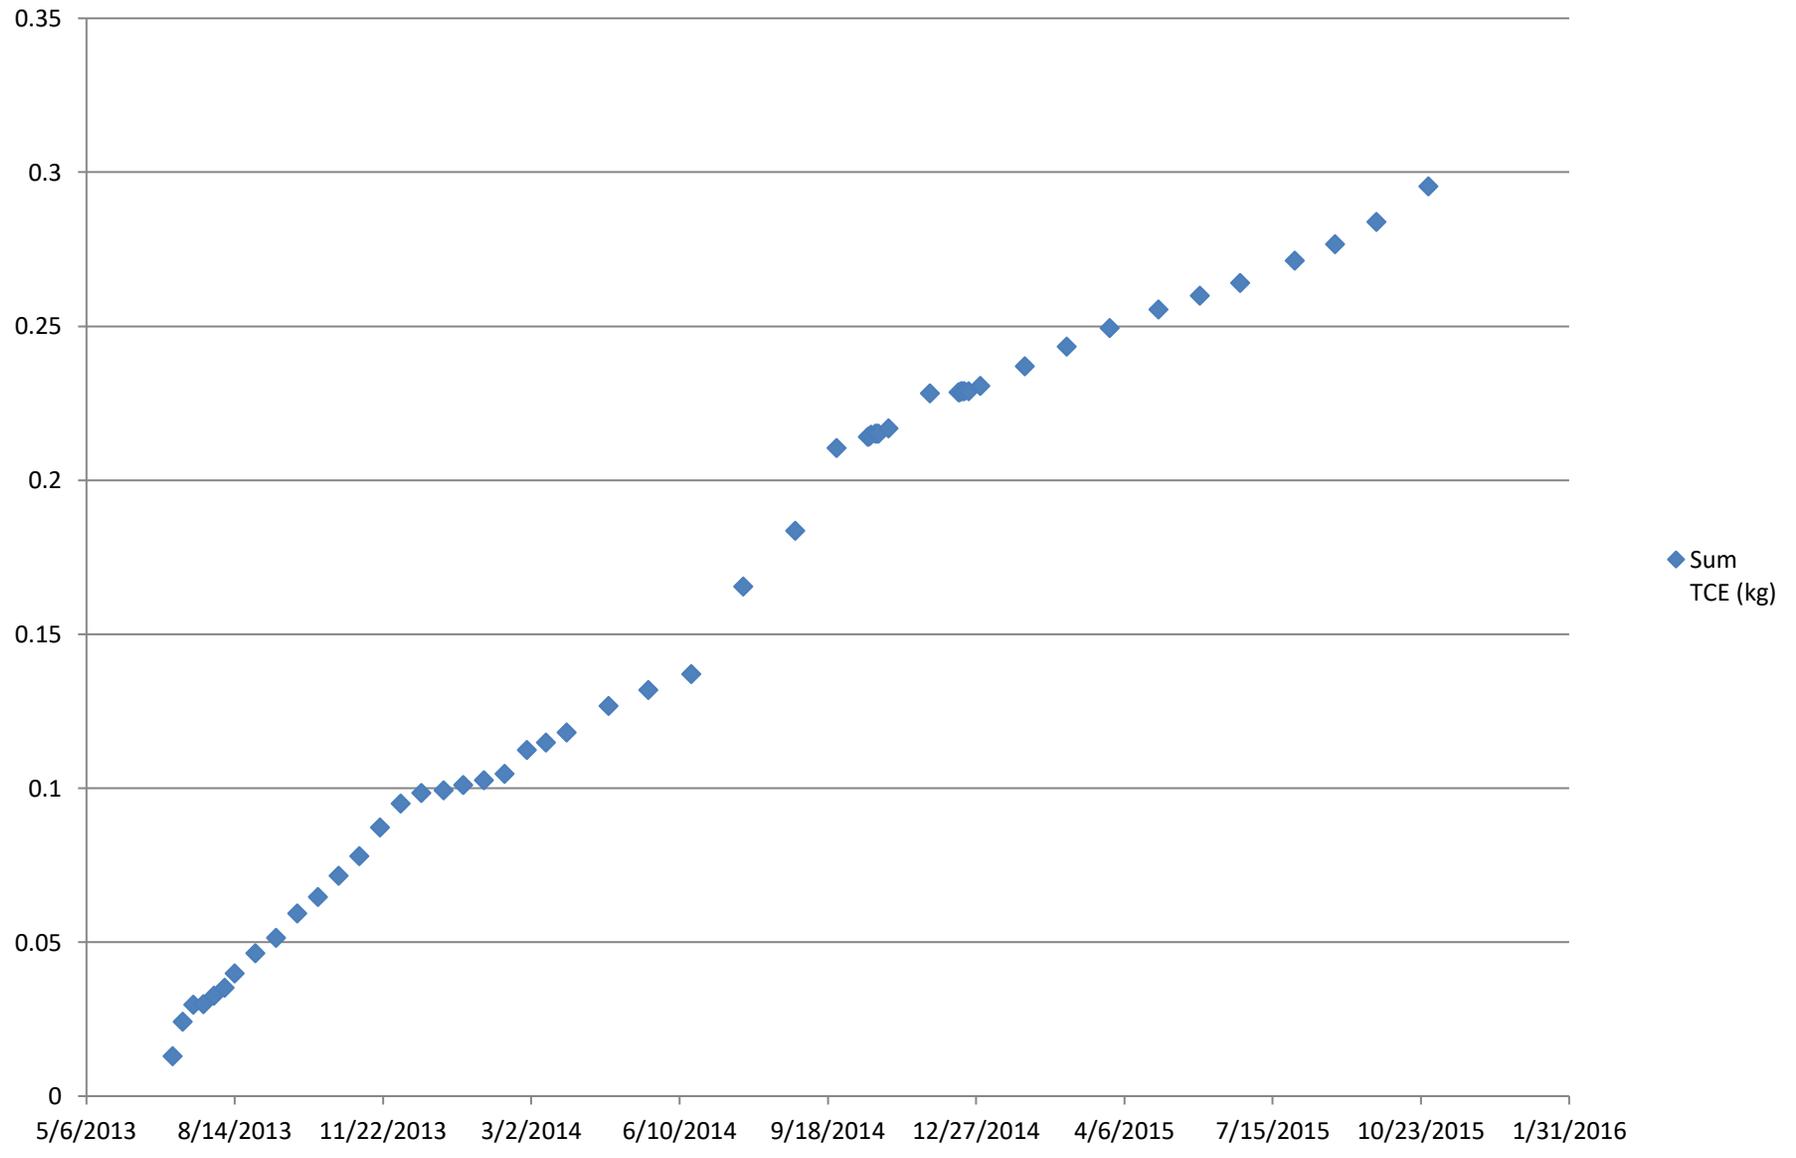
**Figure 5. 2013 SVE System
Contaminant Mass Removal - TCE**

- The highest historical concentrations of PCE ($39,700 \mu\text{g}/\text{m}^3$) and TCE ($120 \mu\text{g}/\text{m}^3$) detected at the 2013 SVE system inlet were recorded on July 3, 2013, one week after the system was turned on.
- In overall, the system installed in 2013 effectively removed 87.88 kilograms (kg) of PCE and 0.30 kg of TCE from June 2013 through October 2016. Graphs showing the accumulative mass removal for PCE and TCE are presented in Figure 4 and 5, respectively.
- Eight (8) quarterly events have been completed since the installation of the 2016 SVE system.
- New carbon was installed in the lead and lag carbon vessels in December prior to the collection of the December 21, 2017 SVE samples. Spent carbon will be disposed to an approved facility under EPA ID No. NYD981079932.

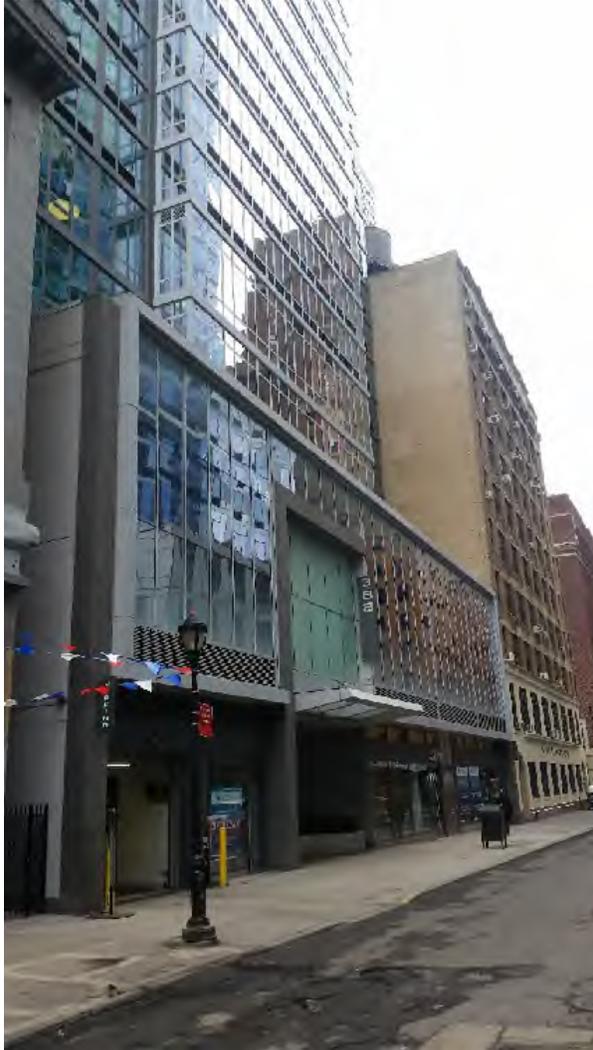
Photo1: View of the building facing north with Bridge Street

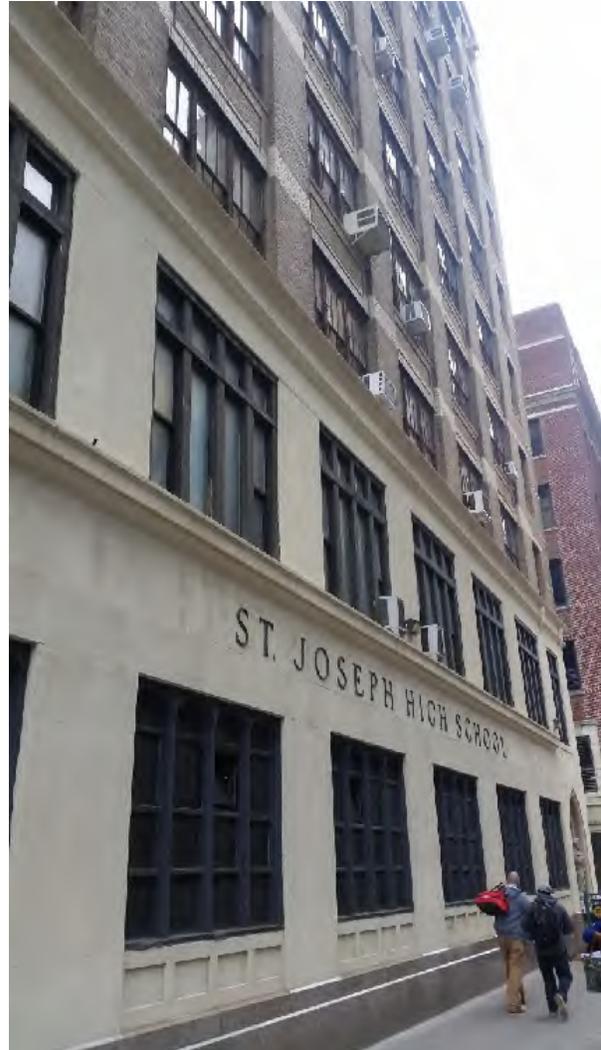
Photo 2: View Saint Joseph High School facing north with Bridge Street
