# Huxley Envelope Industrial Site

## 2024 Periodic Review Report

April 27, 2023 through July 1, 2024

**NYSDEC Site Number: C224147**

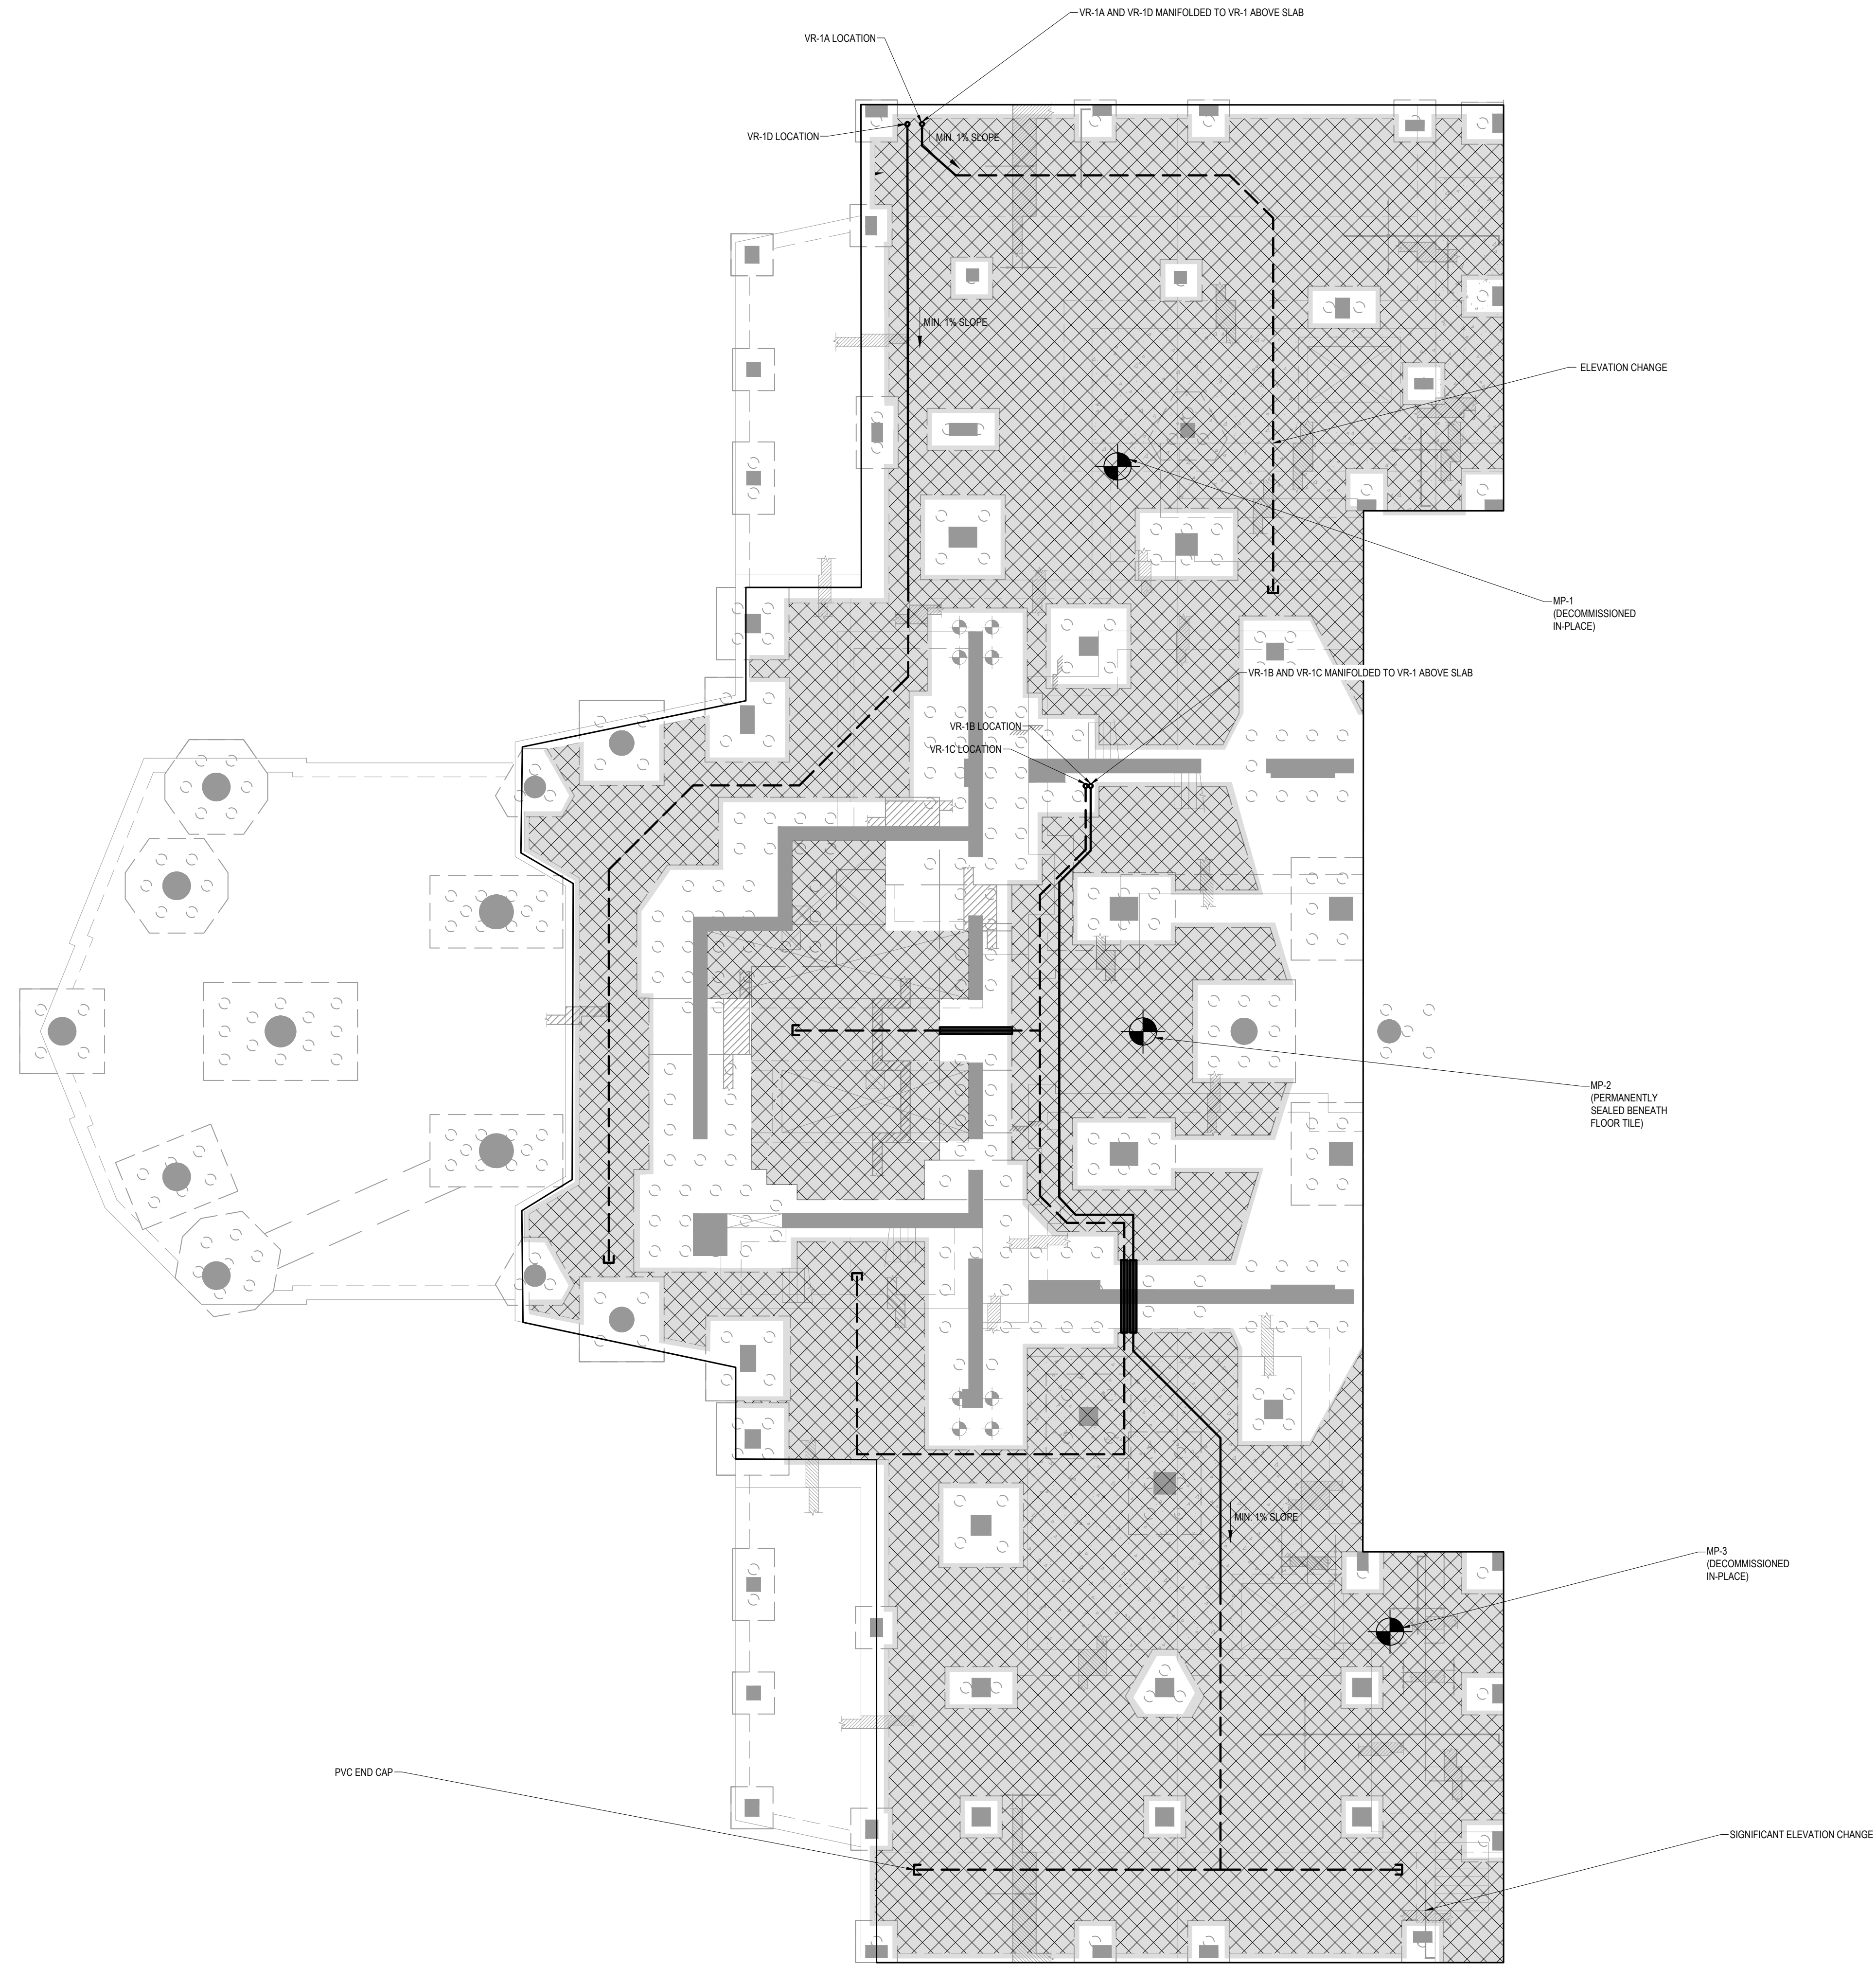
**BUILDING A - VAPOR BARRIER AND SUBSLAB VENTING SYSTEM**  
**LAYOUT AND DESIGN DETAILS**

Aboveground portions of the sub-slab venting system, including the manifold, are enclosed behind drywall and inaccessible. The exhaust stack located on the fourth-floor roof of Building A appeared to be in good condition. The rain cap on the exhaust stack was observed to be missing. The exhaust stack sample port was screened for VOCs using a calibrated PID. PID readings collected from the effluent stack were non-detect. This sample port will continue to be screened for VOCs on an annual basis in accordance with the SMP.

- Portions of the aboveground piping for the sub-slab venting system in Building A are enclosed behind sheetrock walls and inaccessible. The riser pipe and exhaust stack located on the Building A fourth floor mechanical roof was observed to be in good condition. The rain cap on the exhaust stack was observed to be missing and will be replaced.
- In accordance with the NYSDEC-approved July 2020 revision to the SMP, AKRF screened the sample port on the exhaust stack using a photoionization detector (PID). PID readings collected from the effluent stack were non-detect.
