**SITE INSPECTION
FYN PAINT FACILITY
230 KENT AVENUE
BROOKLYN, NEW YORK**

Fyn Paint & Lacquer Co., Inc.

November 2004

LEGGETTE, BRASHEARS & GRAHAM, INC.
Professional Ground-Water and Environmental Engineering Services
110 Corporate Park Drive, Suite 112
White Plains, NY 10604
(914) 694-5711

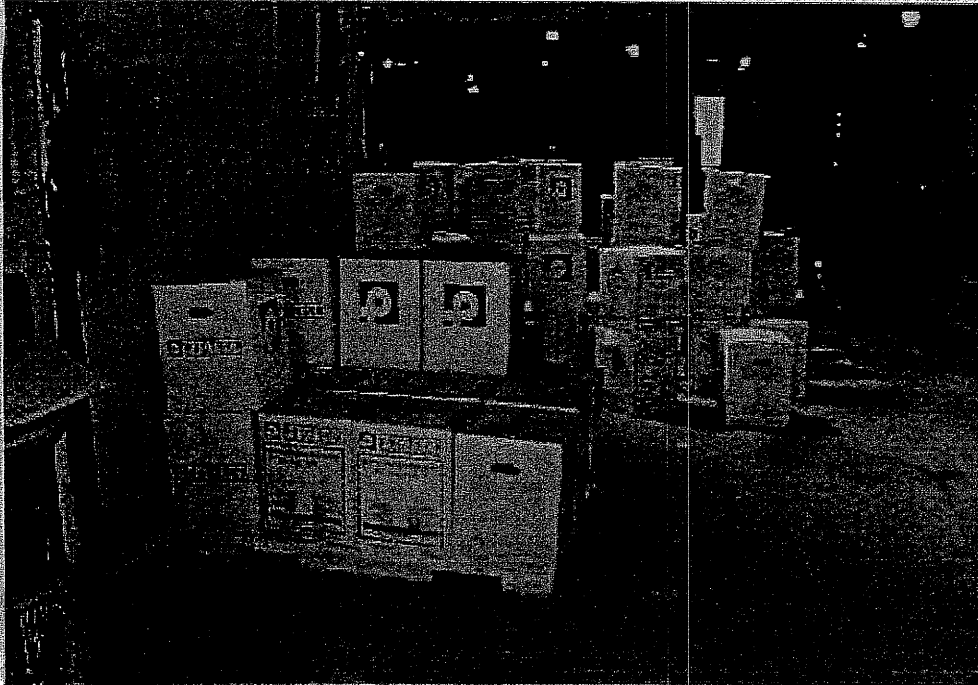
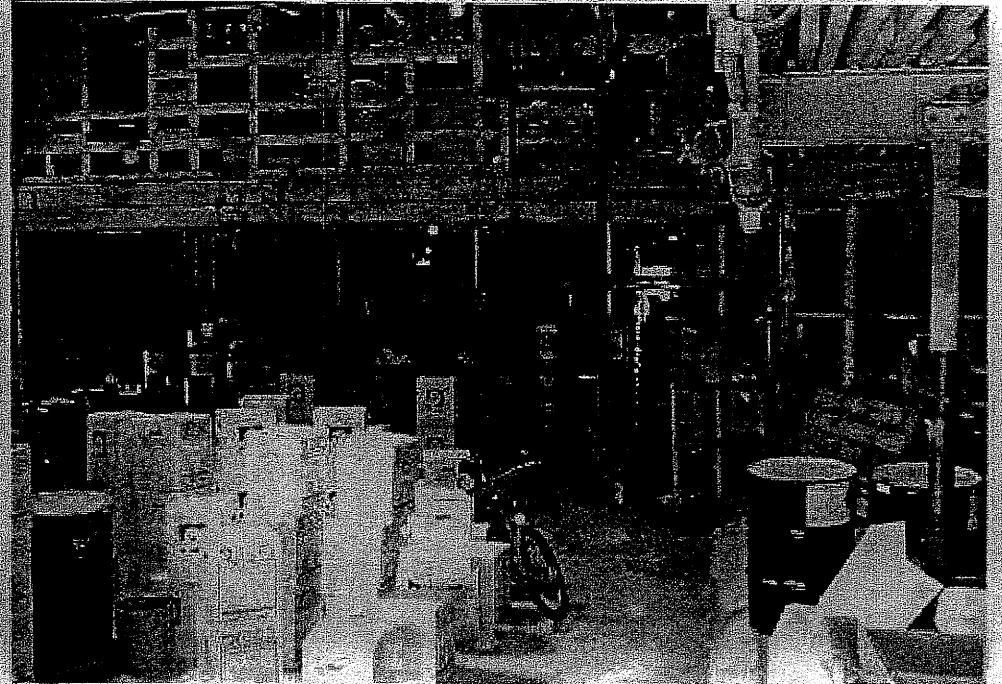
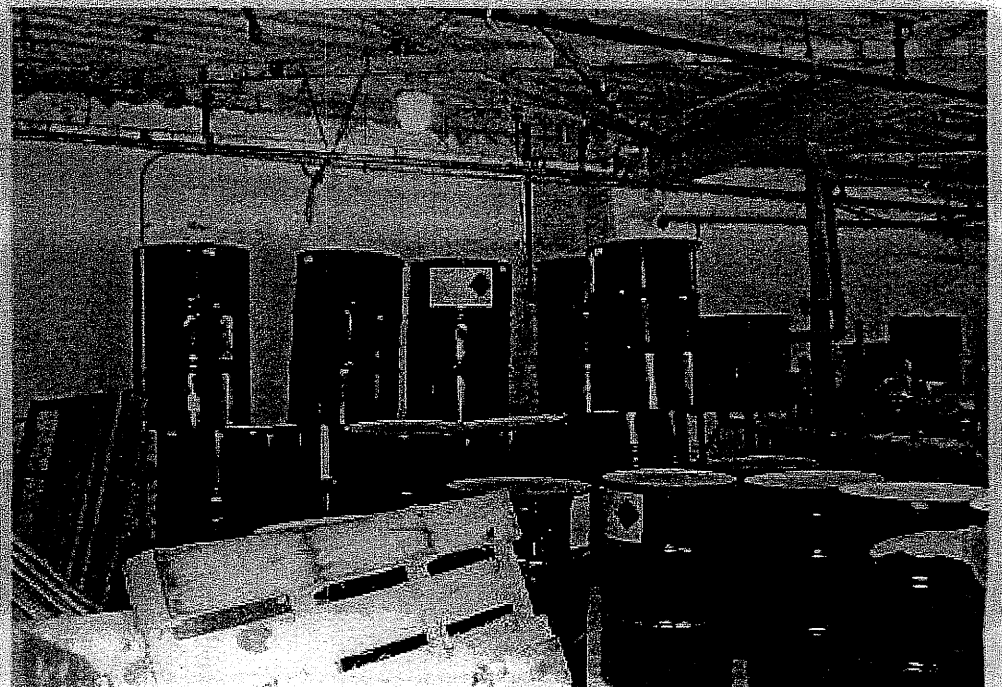
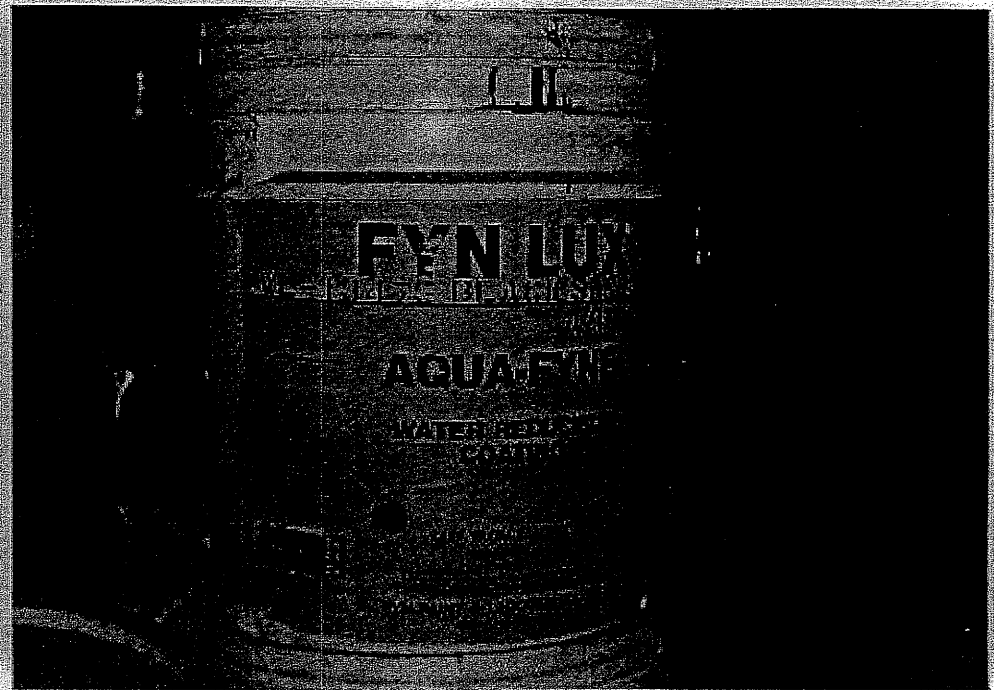
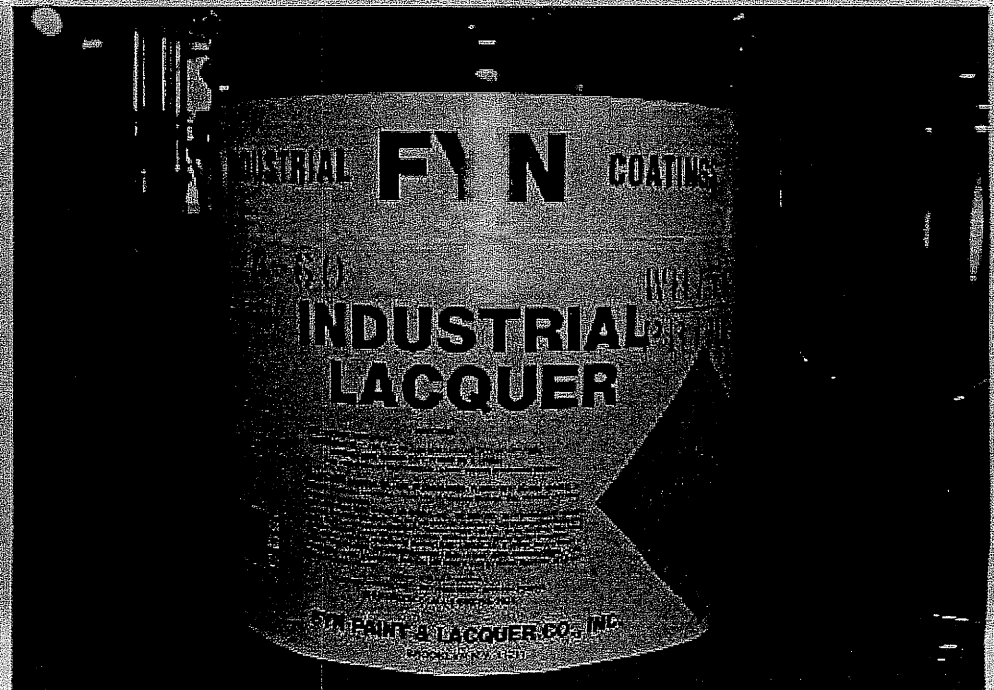
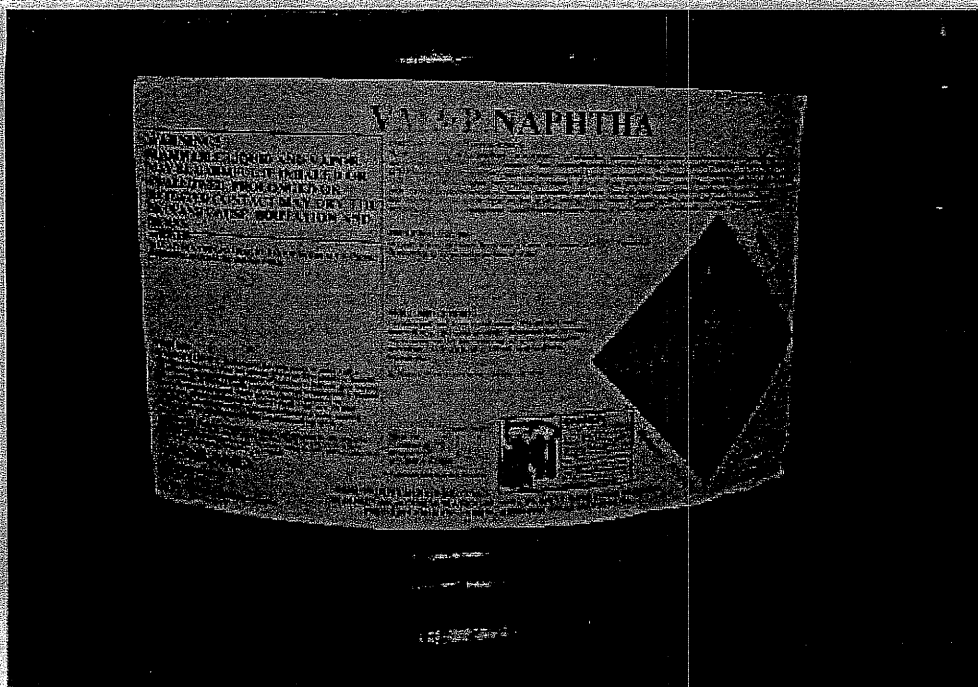
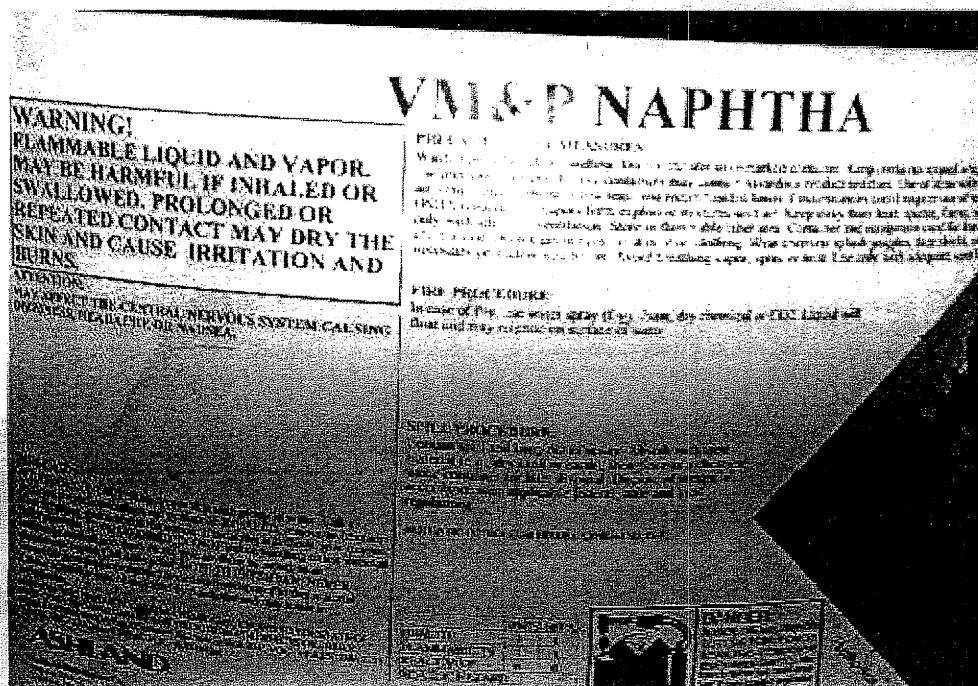
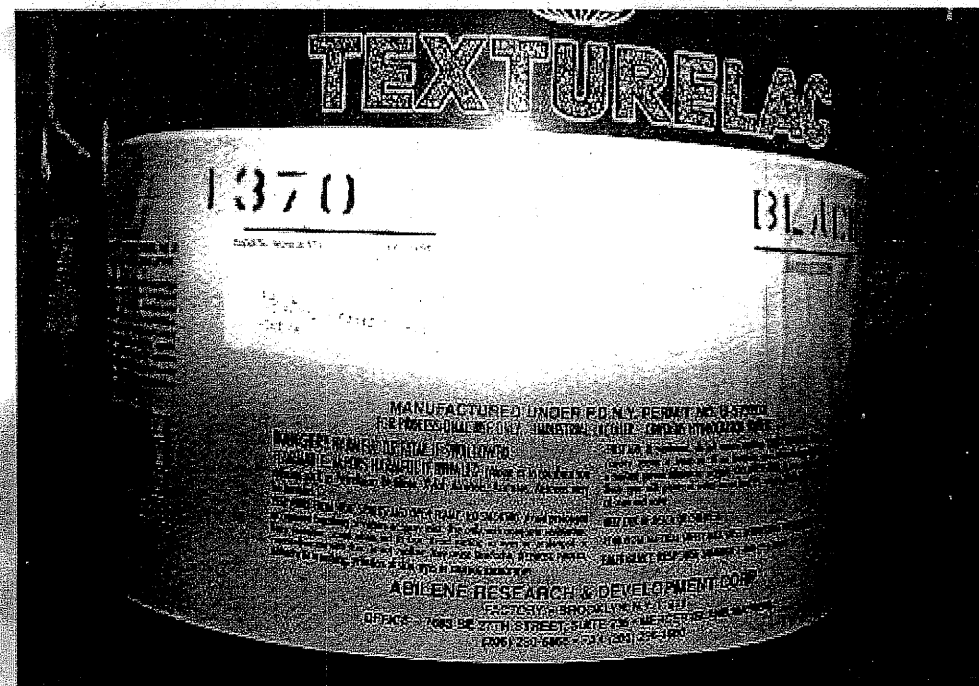
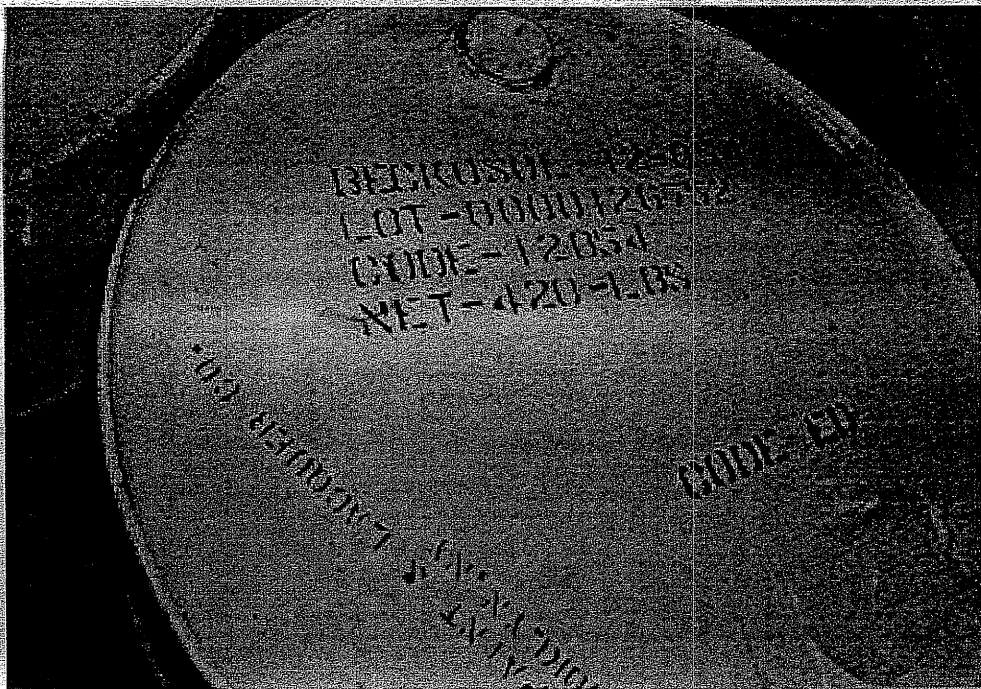
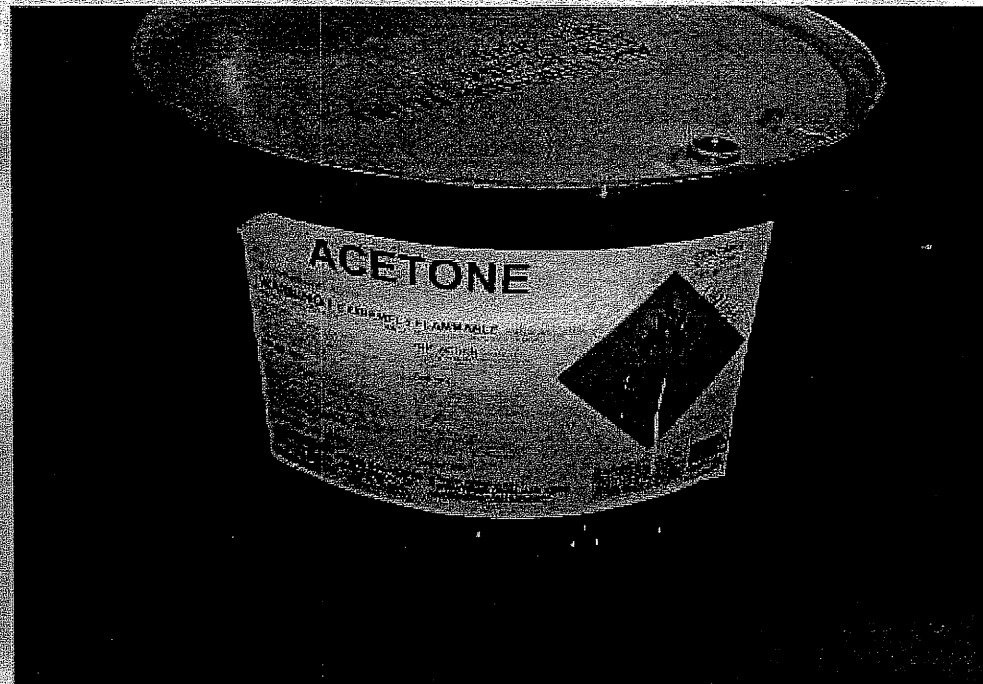
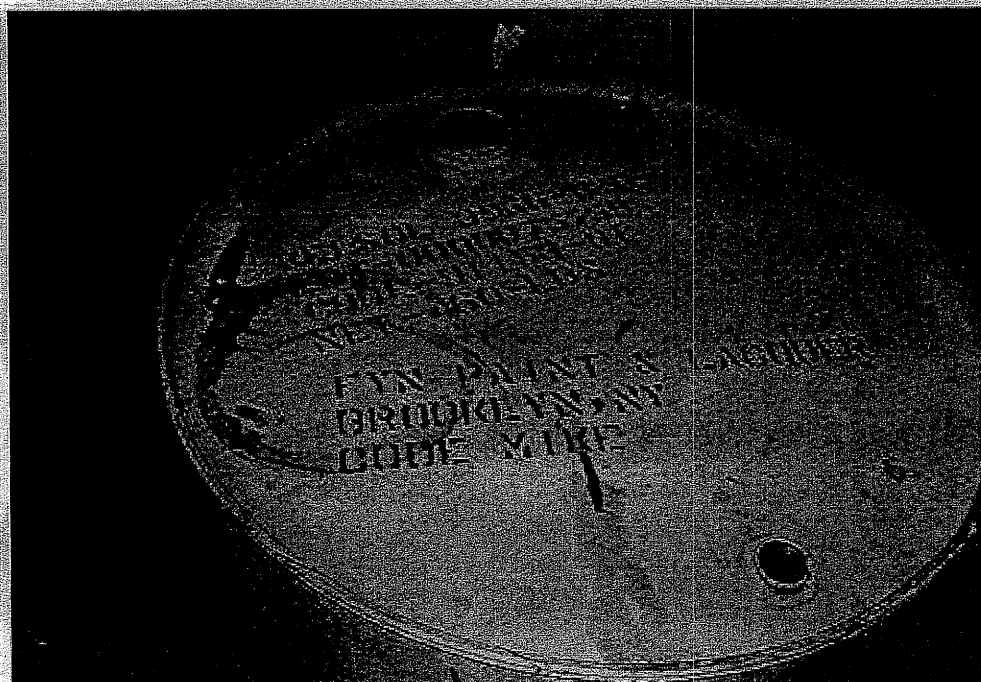
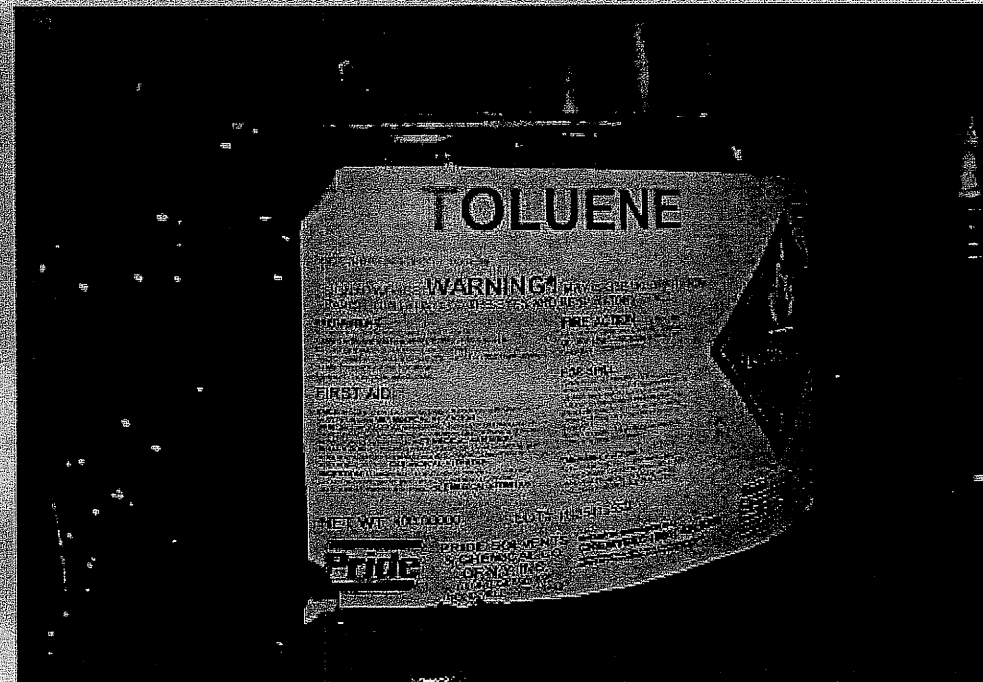
Pictures of the first floor area, showing the storage of chemicals for paint manufacturing are attached. It should be noted that Fyn Pain is a wholesale distributor of powered paint used for coating.
