DAILY FIELD REPORT

Project	Bedford Beverly Brownfield Site	Report No.	106
BCP Site	BCP Site No. C224384	Date	03/06/2024
Location	2359 and 2360 Bedford Avenue, Brooklyn, NY	File No.	0205432
Client	Bedford Beverly Acquisitions LLC	Temperature	43-53°F
Contractor	Haley & Aldrich, Maman Contracting (Maman), International Concrete	Wind Direction	NE to SW, 13 mph
Weather	Cloudy	Personnel on Site	E. Nunez & A. Stewart
Humidity	87%	Time on Site	6:45 am to 2:30 pm

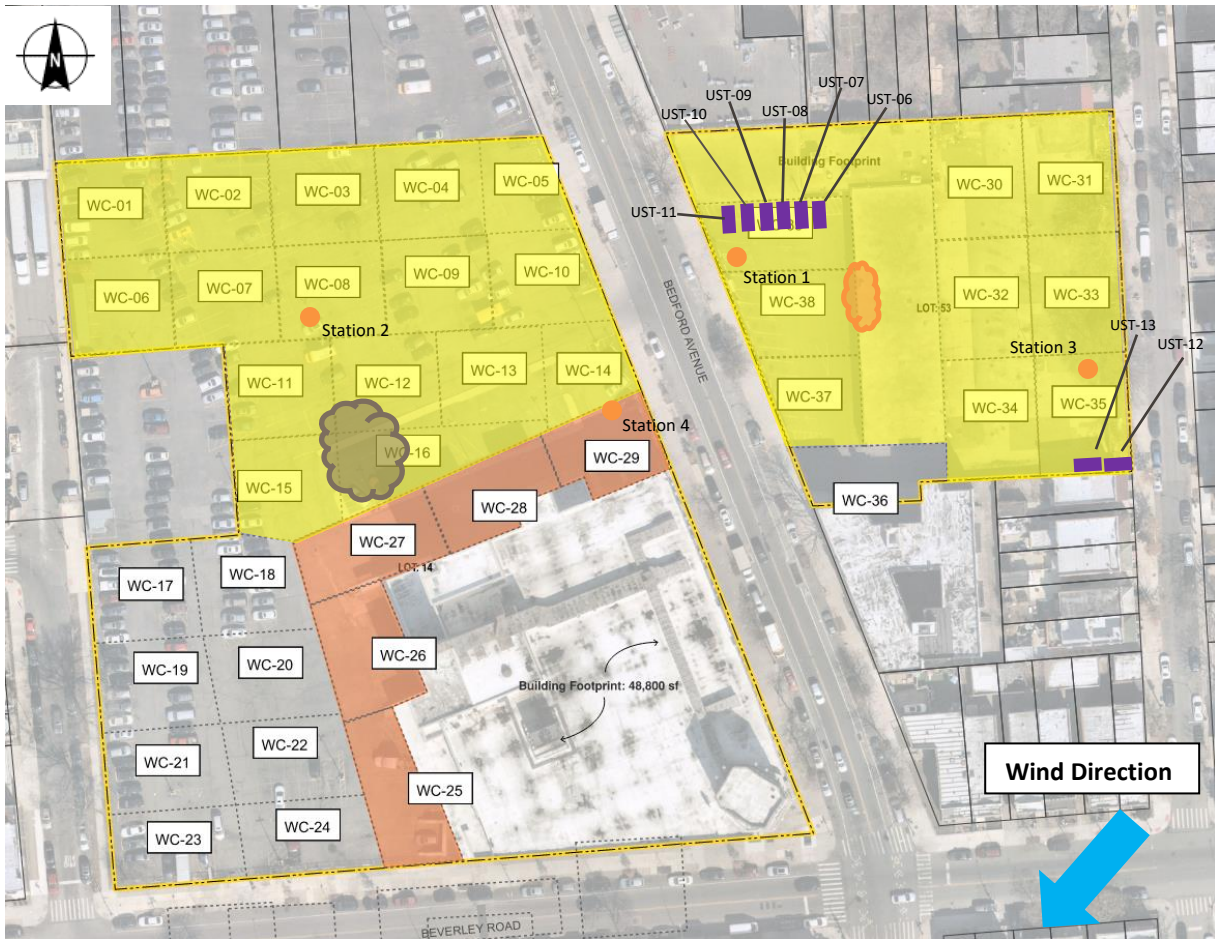
Site Plan:

Reference: Waste Characterization Letter Figure 3 Grid Location Map, prepared by Haley & Aldrich, dated October 2023
