PHASE I ENVIRONMENTAL SITE ASSESSMENT REPORT

817 Bedford Avenue

Brooklyn, New York 11205

Partner Project No. 21-338967.1

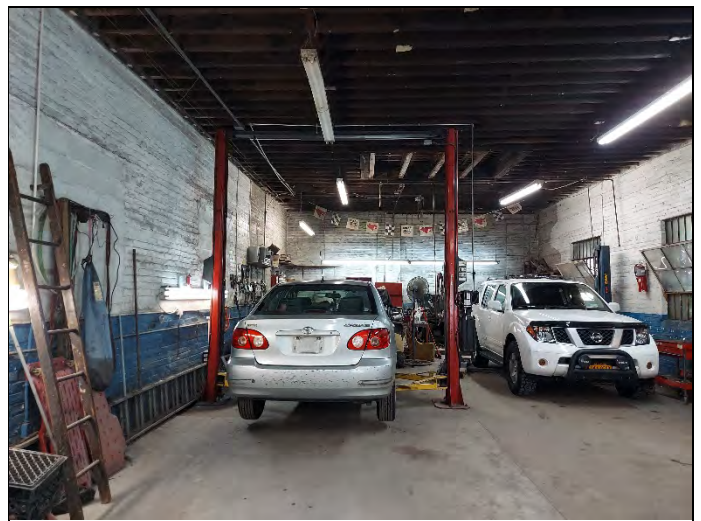
- Based on the historical information review, the subject property has been occupied by automotive repair businesses since as early as 1987 to Present. During the site reconnaissance, Partner observed a floor drain in the northwest portion of the subject building. The floor drain appears to have been installed during the original construction of the building and is connected directly to the municipal sanitary sewer system. Drainage systems have potential to impact the subsurface of the subject property should the system become compromised. Based on the years of automotive repair operations for at least 34 years, and the floor drain/drainage system observed in an area where operations appeared to occur, the subsurface drainage system is considered a *recognized environmental condition*.

17. Floor drain in the northwest portion of the building
