Re: West 19<sup>th</sup> Street Development Site

NYSDEC BCP Site No. C231017

Certification of Institutional Controls/Engineering Controls

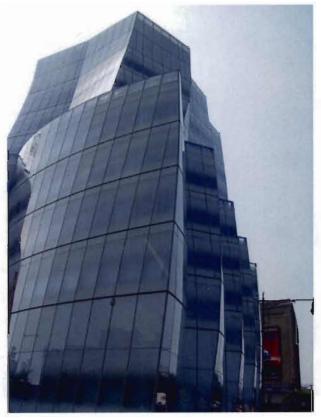
Photo 1

The West 19th Street Development Site is an office building located on one of the numerous parcels used as a former manufactured-gas plant (Photo 1). The building is a mid-rise structure with an undulating glass curtain-wall facade. The building has one below-grade level that includes a concrete pressure slab and cast-in-place concrete foundation walls. The foundation slab is supported on piles. The below-grade area is used for parking, for housing mechanical equipment, and for storage space.

528 West 19th Street,
New York, NY, looking south
