West 19th Street Development Site NYSDEC BCP Site No. C231017

Certification of Institutional Controls/Engineering Controls

Project 110043 - Walkthrough Inspection and Repair Observations

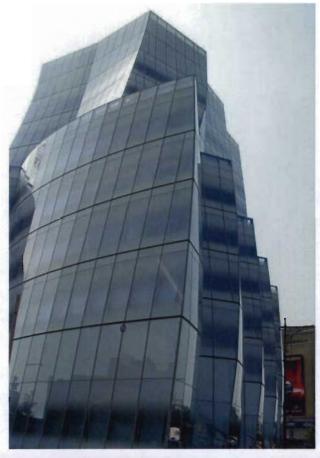
Photo 1

The West 19th Street Development Site is an office building located on one of many parcels used as a former manufactured-gas plant (Photo 1). The building is a mid-rise structure with an undulating glass curtain-wall facade. The building has one below-grade level that includes a concrete pressure slab and cast-in-place concrete foundation walls. The foundation slab is supported on piles. The below-grade area is used for parking, for housing mechanical equipment, and for storage space.

528 West 19th Street,
New York, NY looking south.
