Re: West 19<sup>th</sup> Street Development Site  
NYSDEC BCP Site No. C231017  
Certification of Institutional Controls/Engineering Controls

Walkthrough Inspection and Repair Observations, prepared by Simson Gumpertz & Heger,  
dated March 8, 2012

Project 120115.00 – Walkthrough Inspection and Repair Observations  
West 19th Street Development Site  
528 West 19th Street, New York, NY

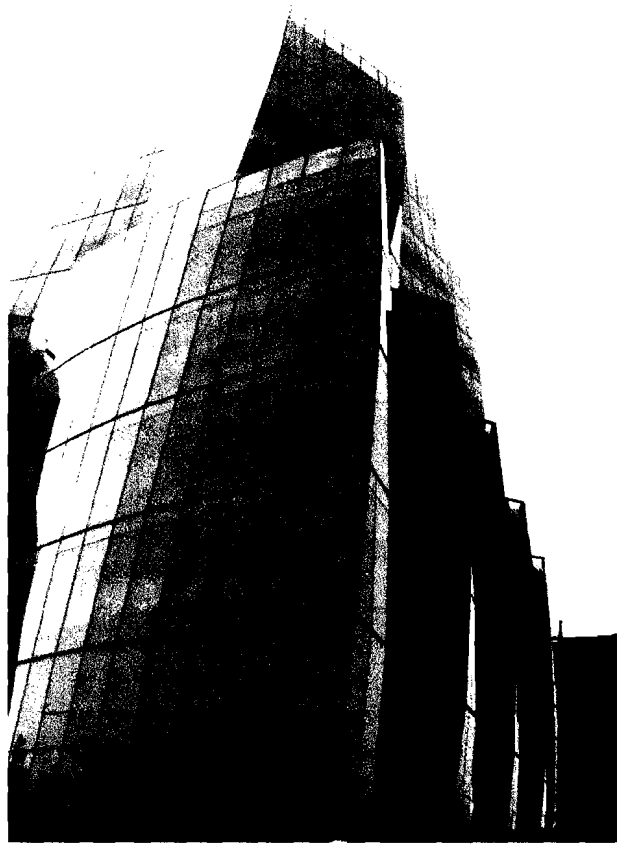
**Photo 1**

The West 19th Street Development Site is an office building located on one of many parcels used as a former manufactured-gas plant (Photo 1). The building is a mid-rise structure with an undulating glass curtain-wall facade. The building has one below-grade level that includes a concrete pressure slab and cast-in-place concrete foundation walls. The foundation slab is supported on piles. The below-grade level is used for parking, mechanical equipment, and storage.

Overview of exterior of IAC building.

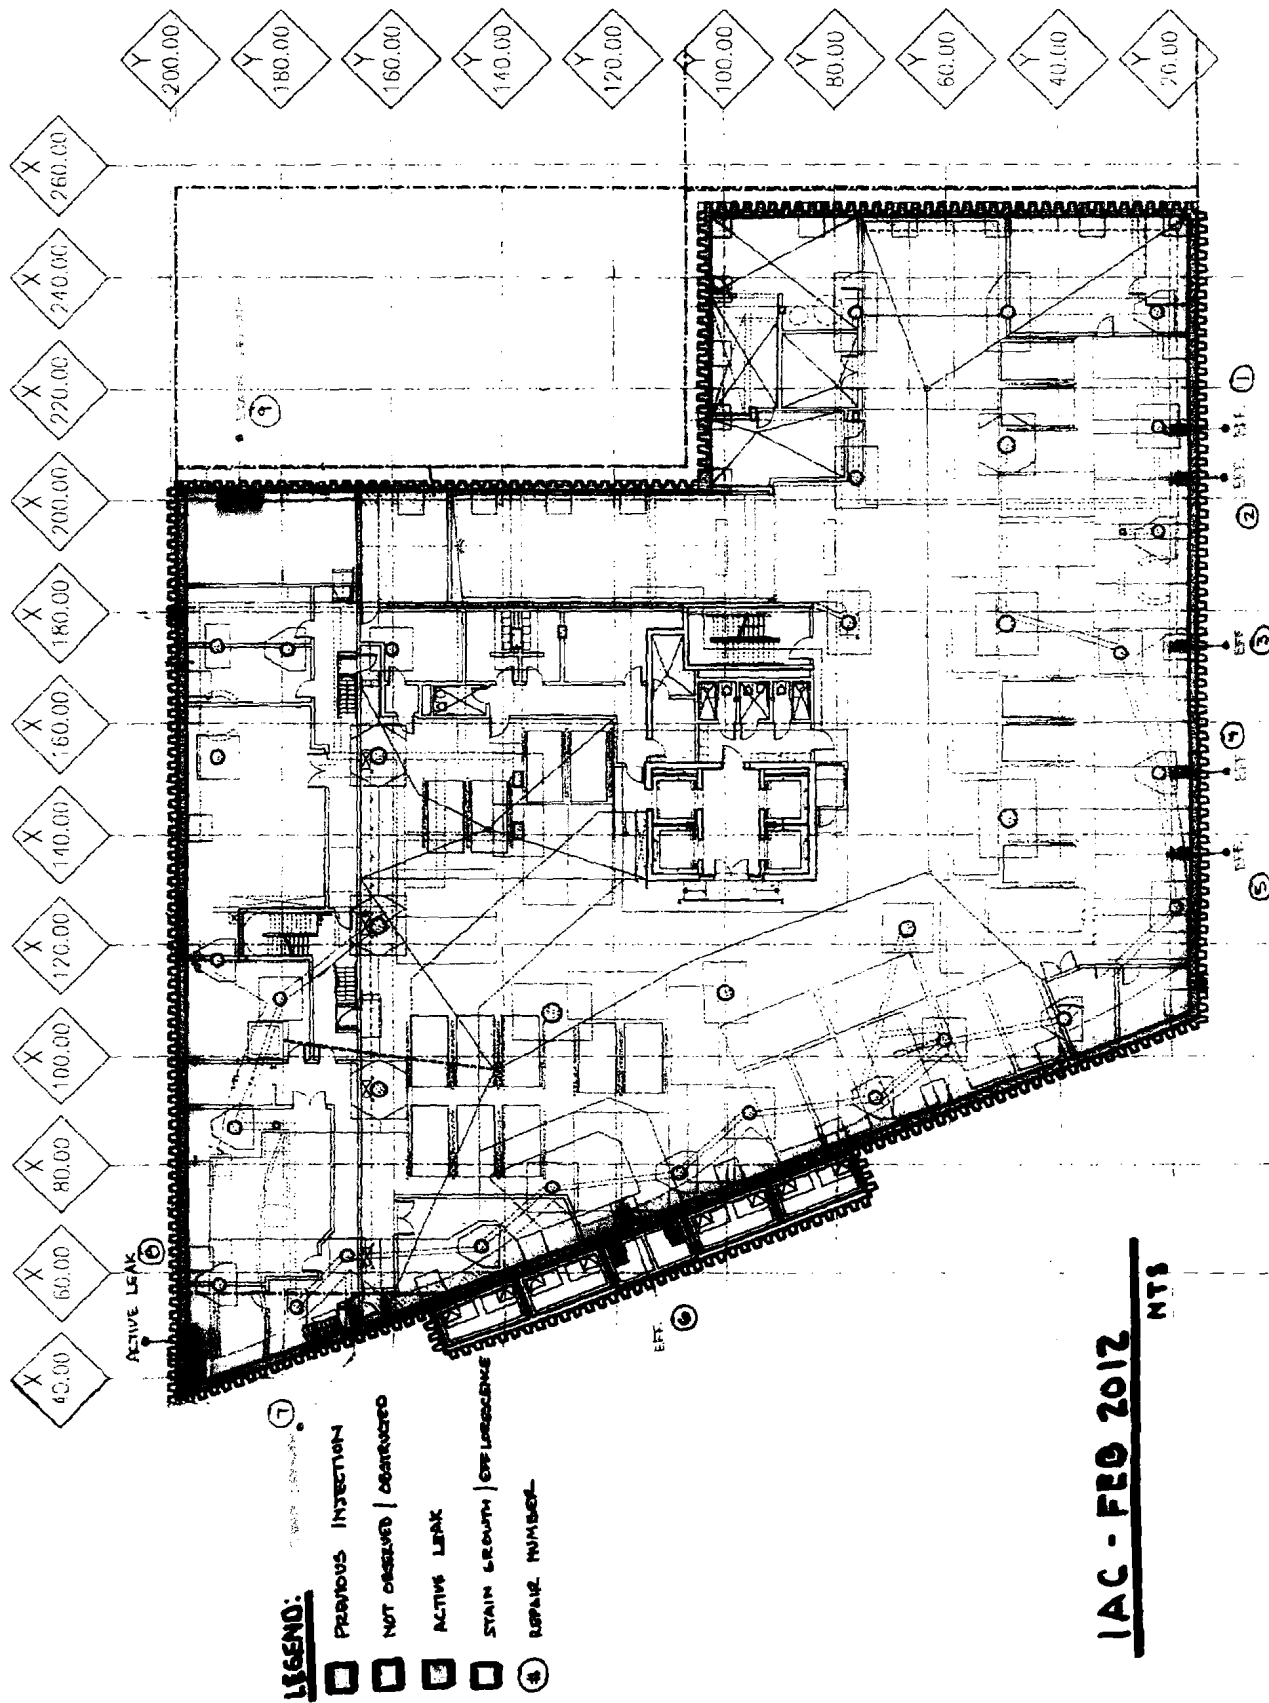
IAC - FEB 2012  
 NTS

REPAIRS COMPLETED 1 MAR 2012.
