# **APPENDIX R**

## **PHOTO LOG OF SITE WORK**

1. Photo log of site work from June 2005 to February 2006

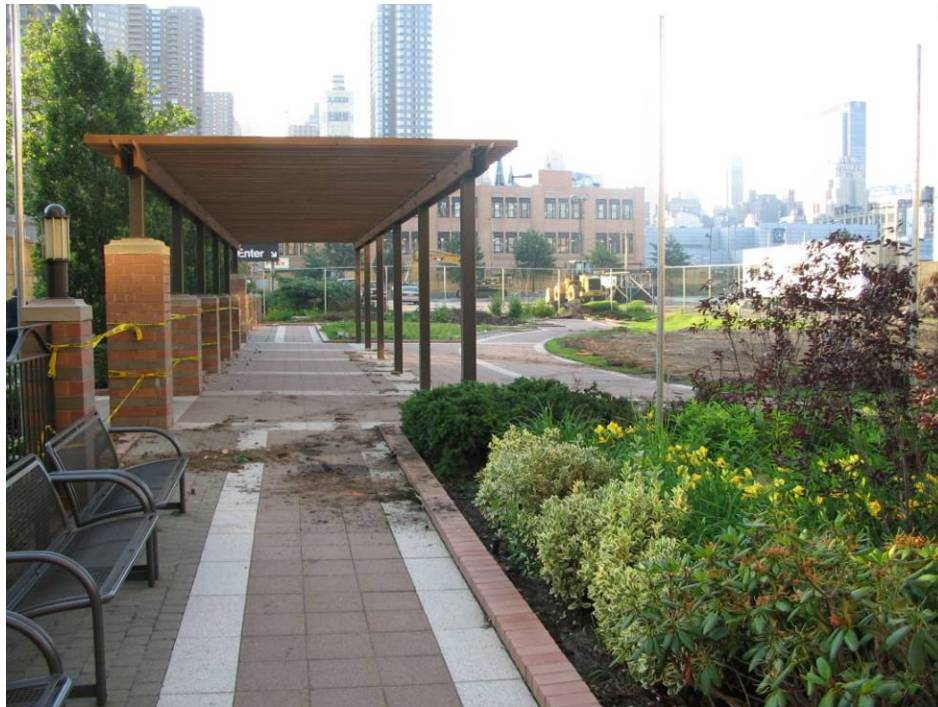
**Photograph No. 2: June 2005 - View of park area (view north).**

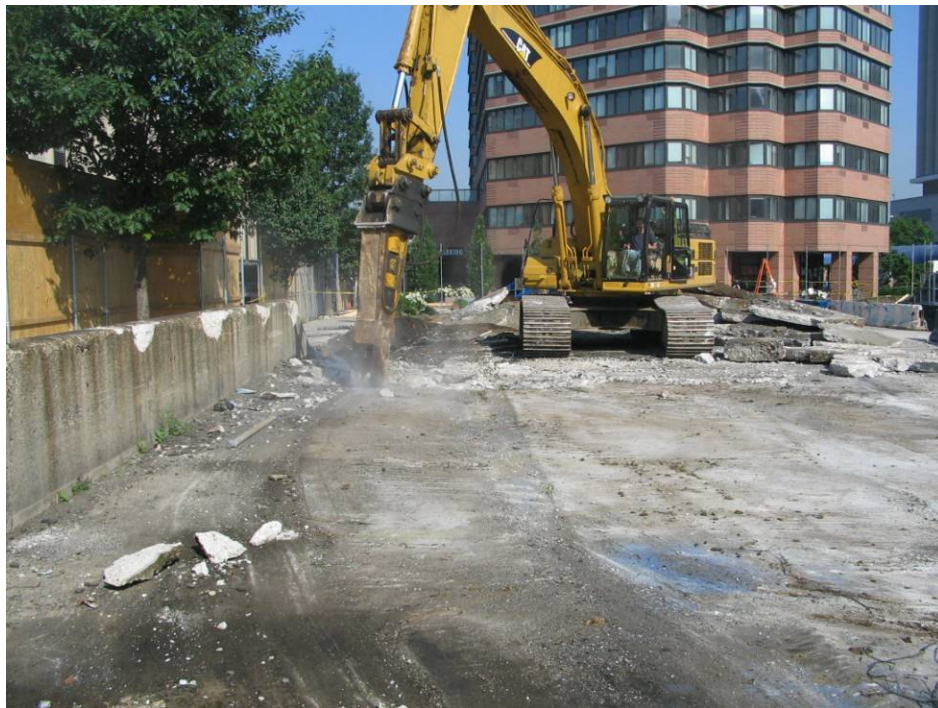
**Photograph No. 4: June 2005 - Working to remove existing surface materials (view west).**

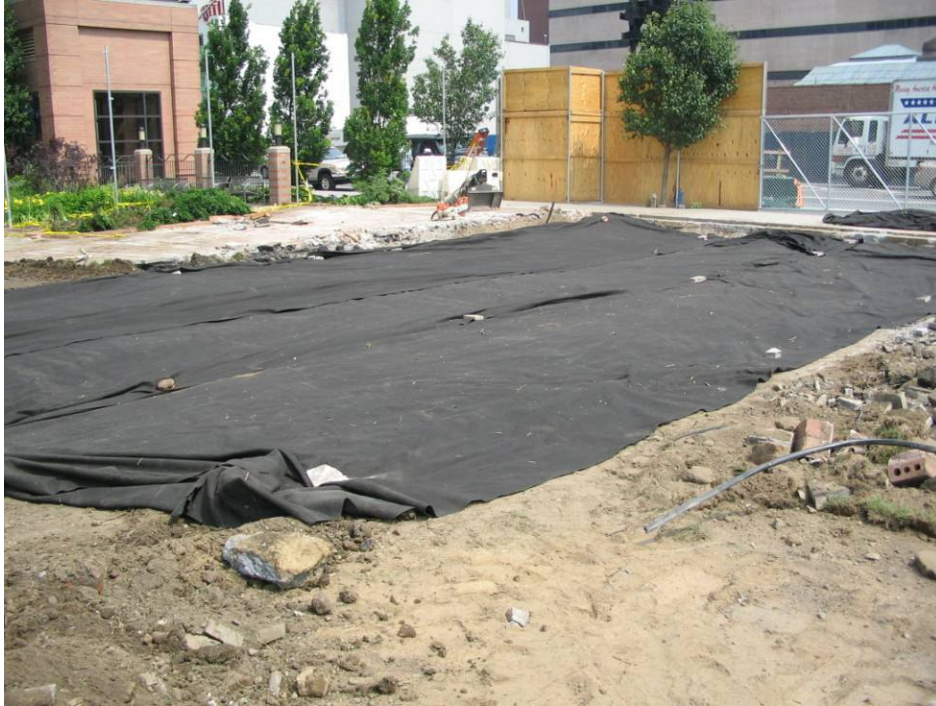
**Photograph No. 5: June 2005 - Filter fabric emplaced in front of Gate #1 (view towards northwest).**

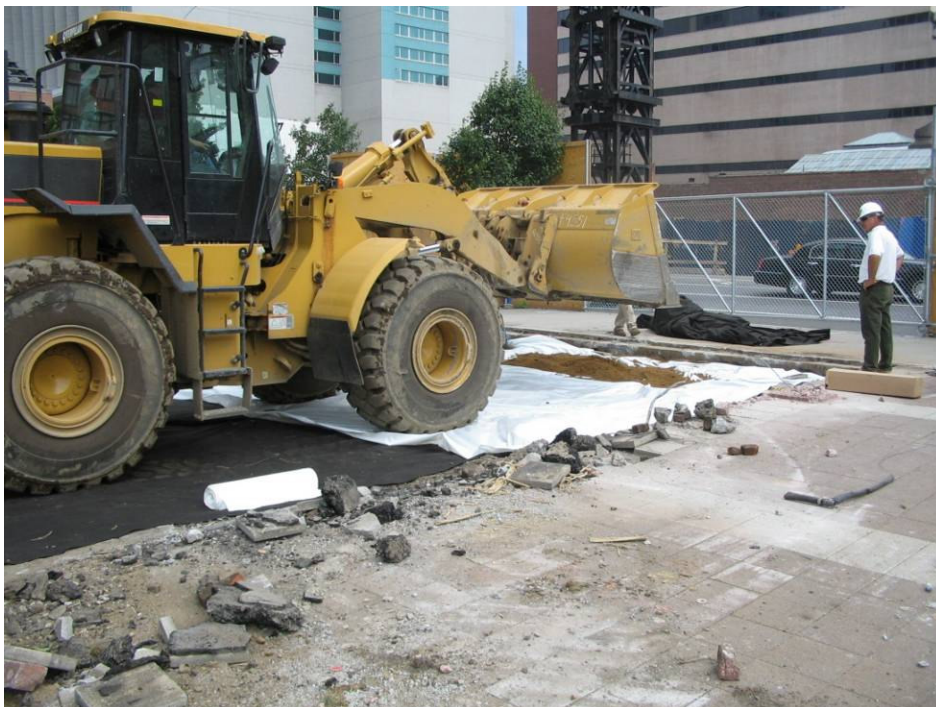
**Photograph No. 6: June 2005 - Placing fill material over filter fabric to prepare truck wash area.**

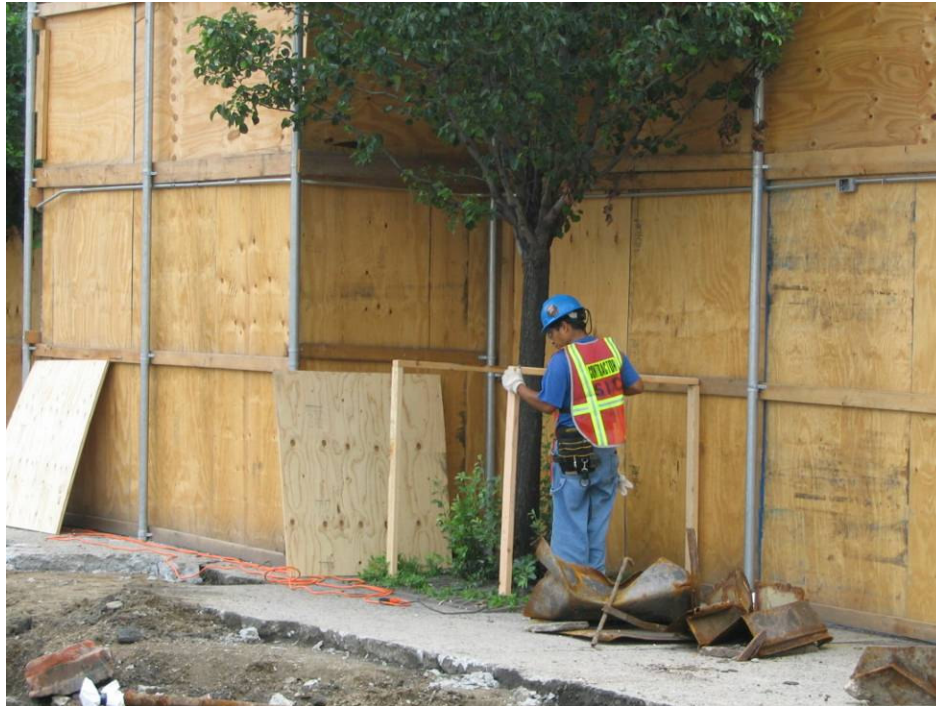
**Photograph No. 7: June 2005 - Assembling plywood barriers around on-site tree trunks.**

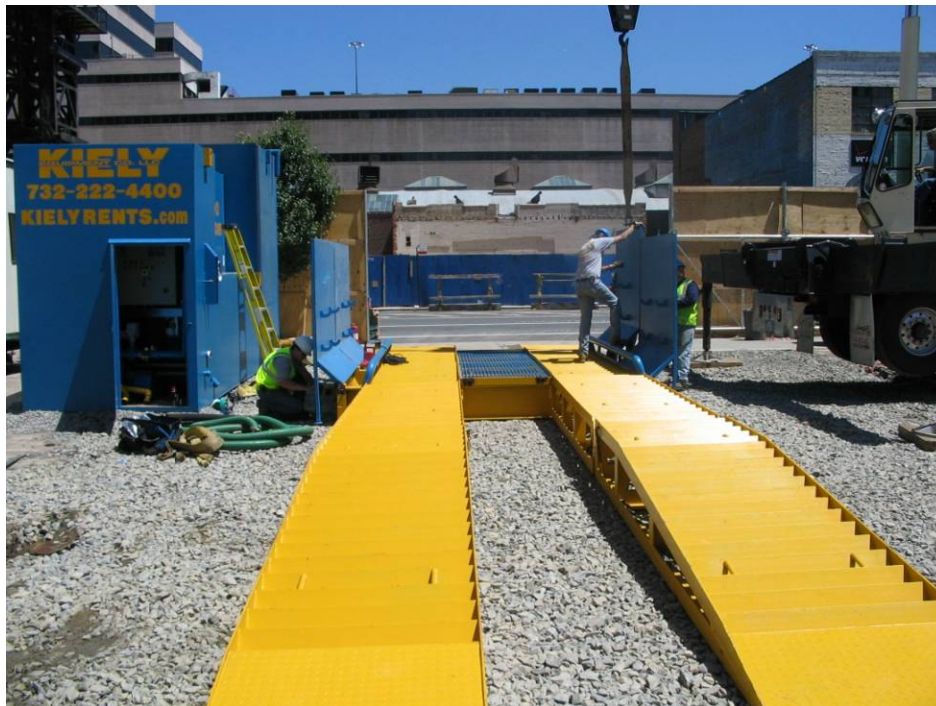
**Photograph No. 8: June 2005 - Assembling the truck wash (view north onto West 42<sup>nd</sup> Street).**

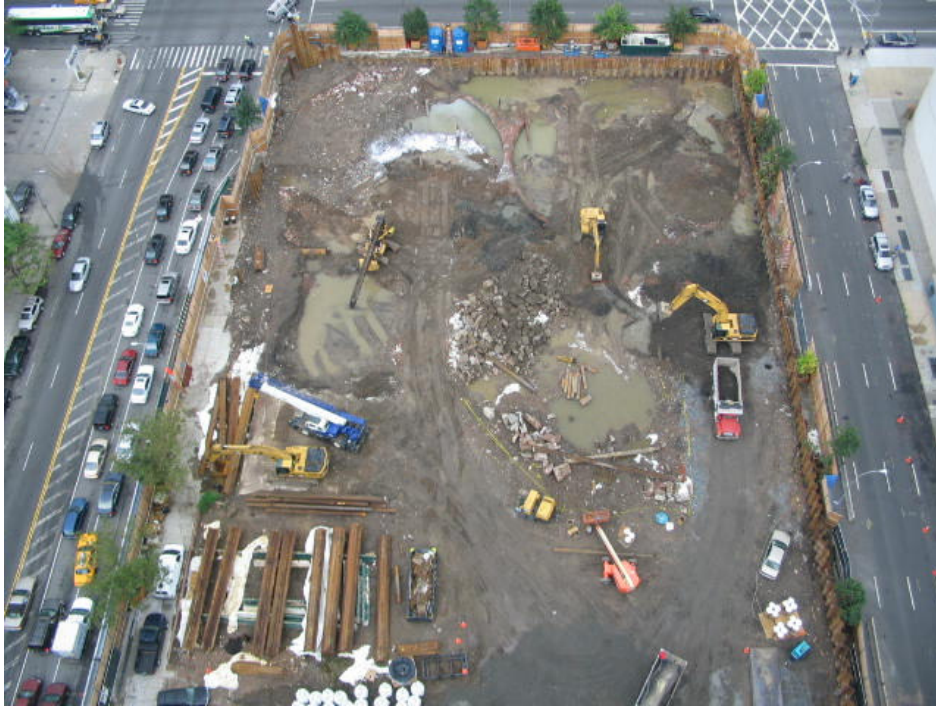
**Photograph No. 21: August 15, 2005 - Aerial view of site (view east) from RiverPlace I 32<sup>nd</sup> floor observation deck. Note the tops of the northeast and southeast MGP holder walls are visible where the two holders are conjoined.**

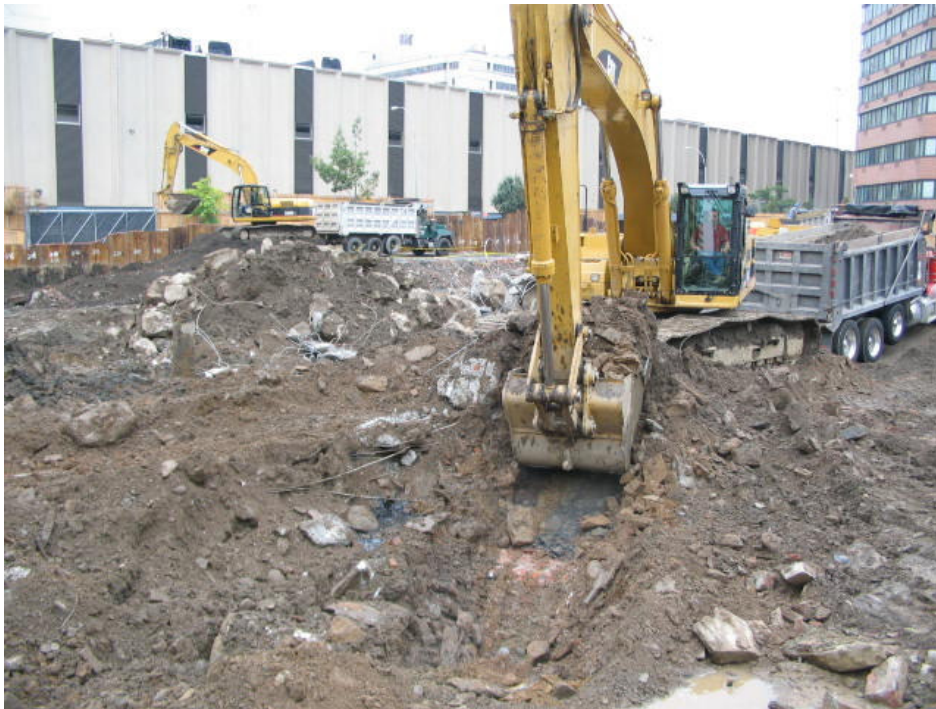
**Photograph No. 22: August 2005 - Typical view of material load-out operations (view towards southwest).**

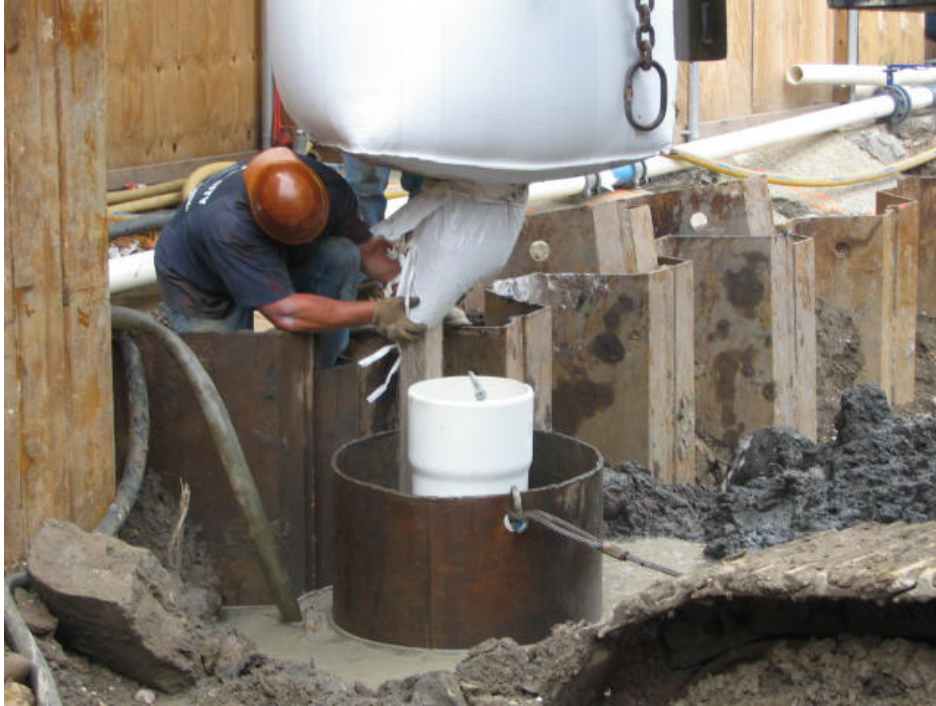
**Photograph No. 23: August 16, 2005 - No. 2 filter sand being placed around screened interval of dewatering well during well installation.**

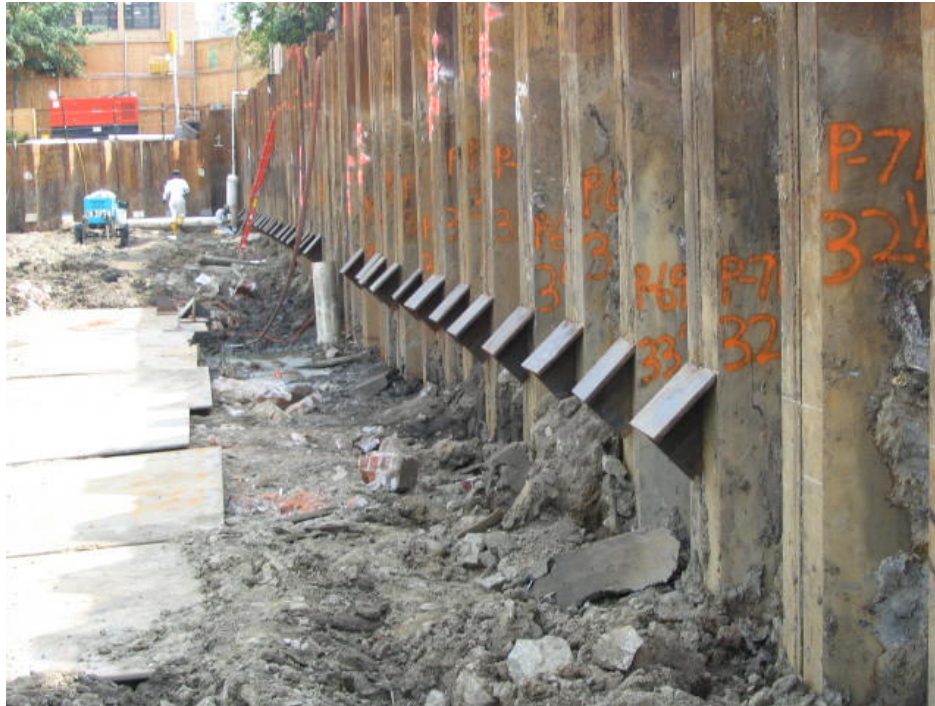
**Photograph No. 29: August 29, 2005 - View of seats for waler installation along southern sheeting line (view east).**

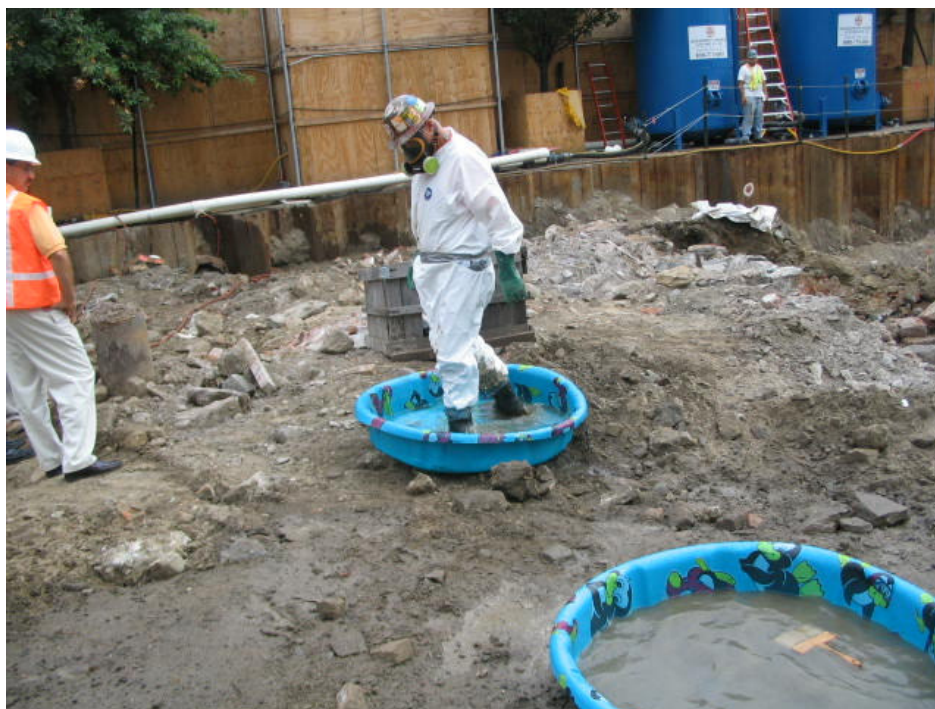
**Photograph No. 30: August 31, 2005 - Workers decontaminating PPE (boots) in decon pools.**

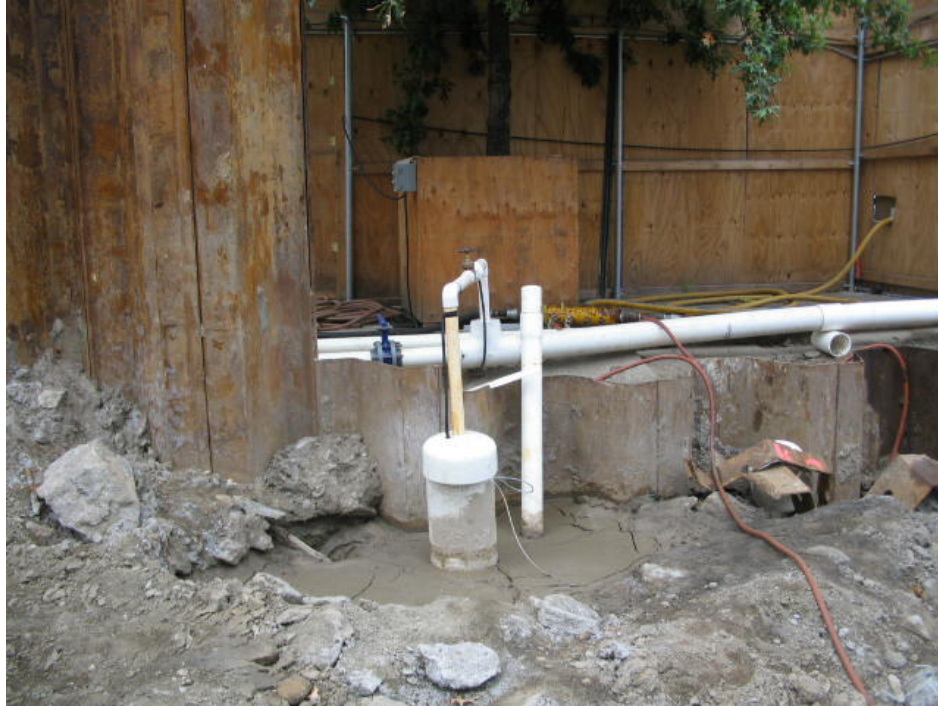
**Photograph No. 31: August 2005 - Typical view of dewatering well assemblage.**

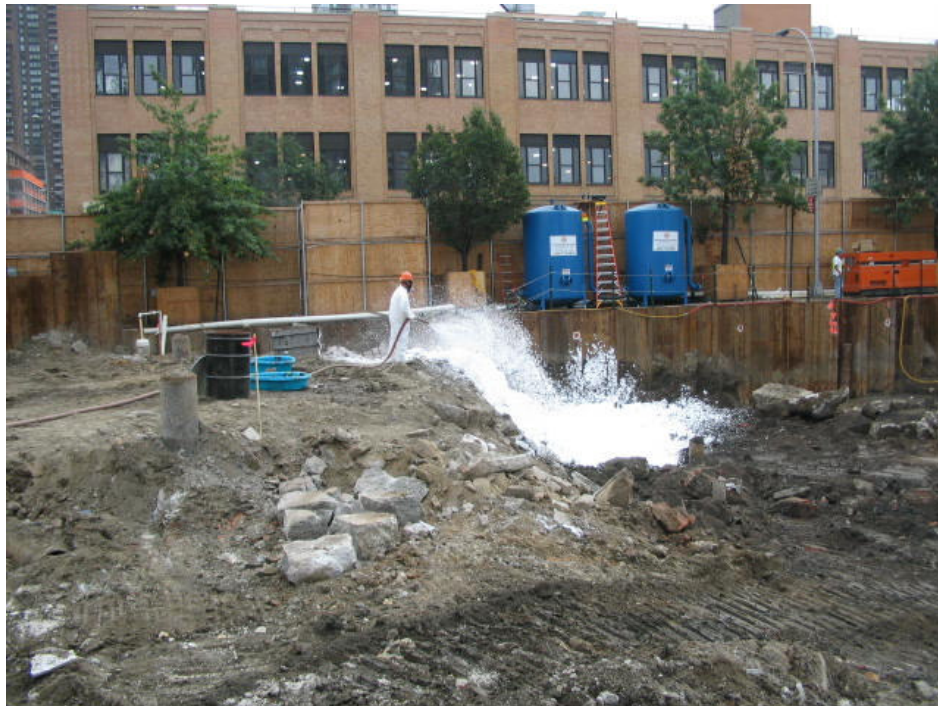
**Photograph No. 32: August 31, 2005 - Worker applying foam odor suppressant to area where USTs were discovered and decommissioned (view east).**

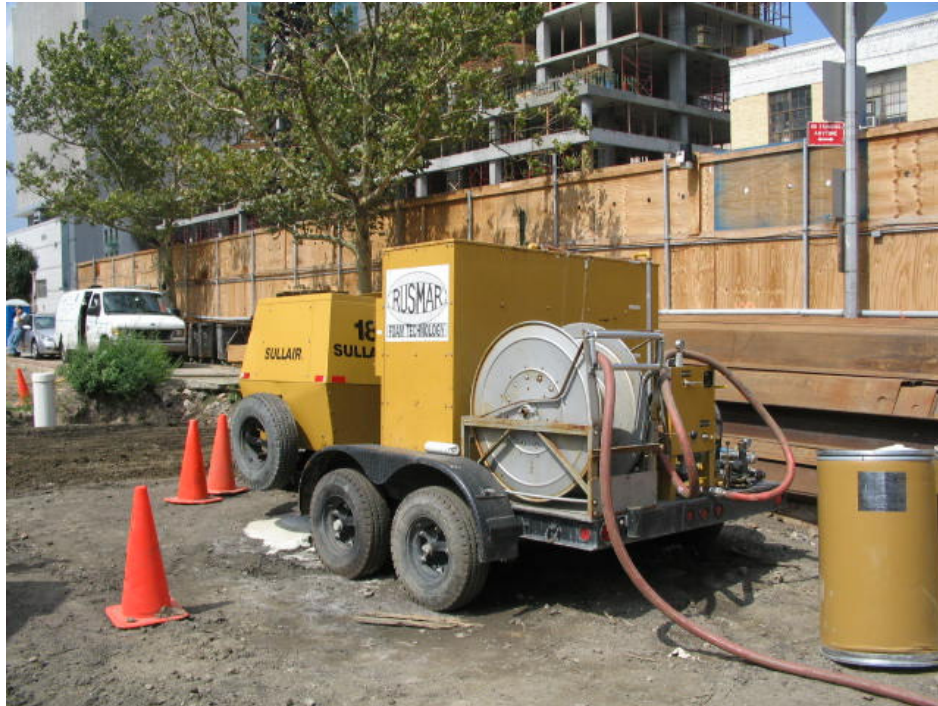
**Photograph No. 33: The foam machine.**

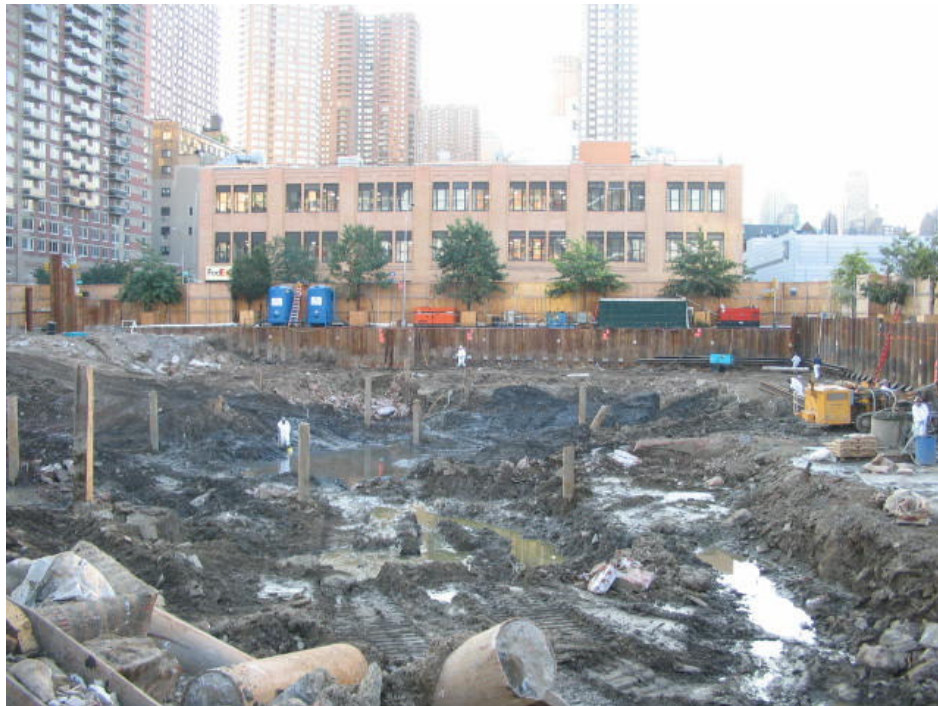
**Photograph No. 34: September 2, 2005 - View of excavation (view west). Note position of foam machine along northern site perimeter.**

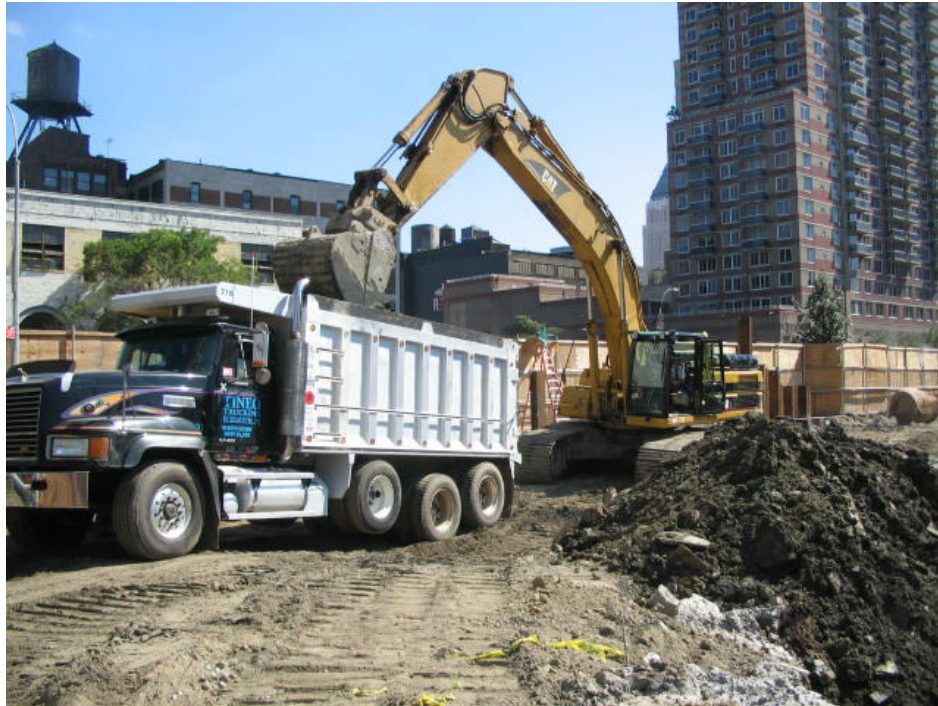
**Photograph No. 35: September 6, 2005 - View of material load-out in progress.**

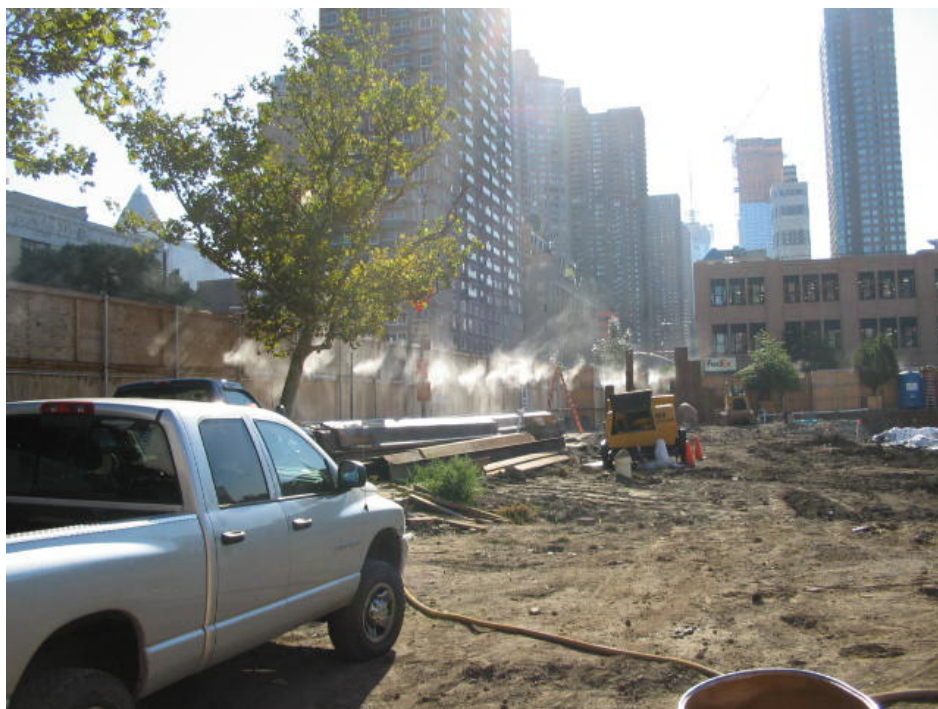
**Photograph No. 36: September 6, 2005 - View of Piaan misting system in action (view east along northern perimeter fencing).**

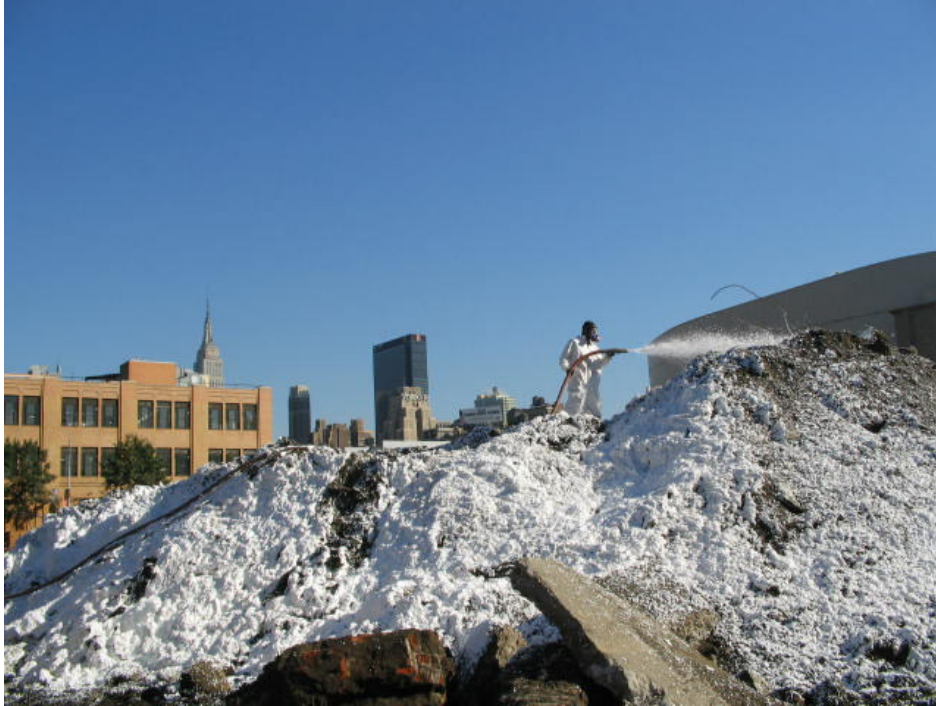
**Photograph No. 37: September 7, 2005 - Worker covering material stockpile with foam.**

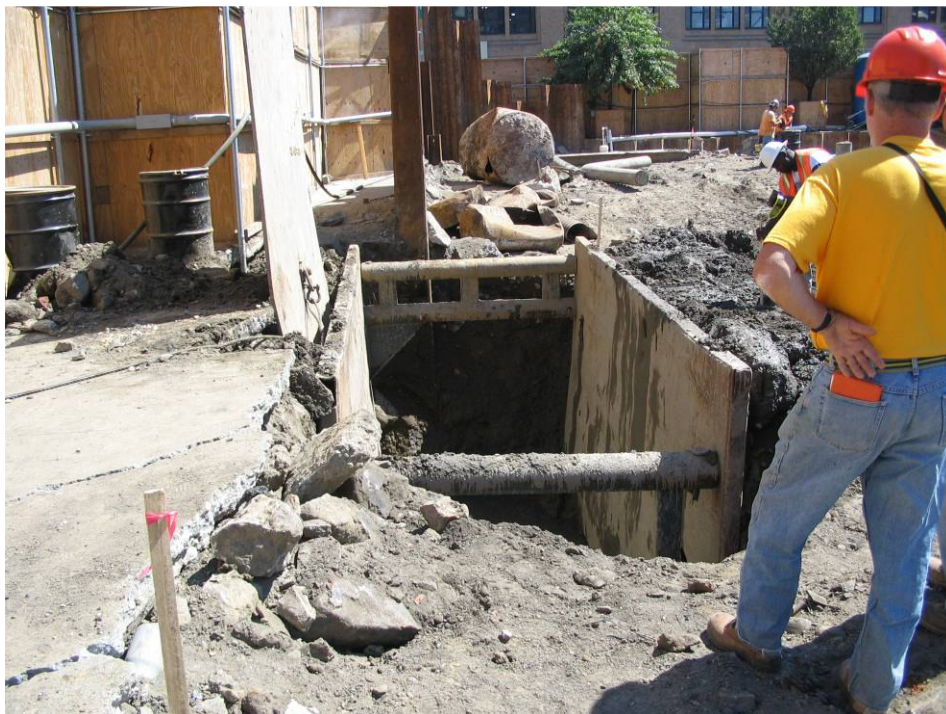
**Photograph No. 40: September 10, 2005 - Another view of the trench box excavation.**

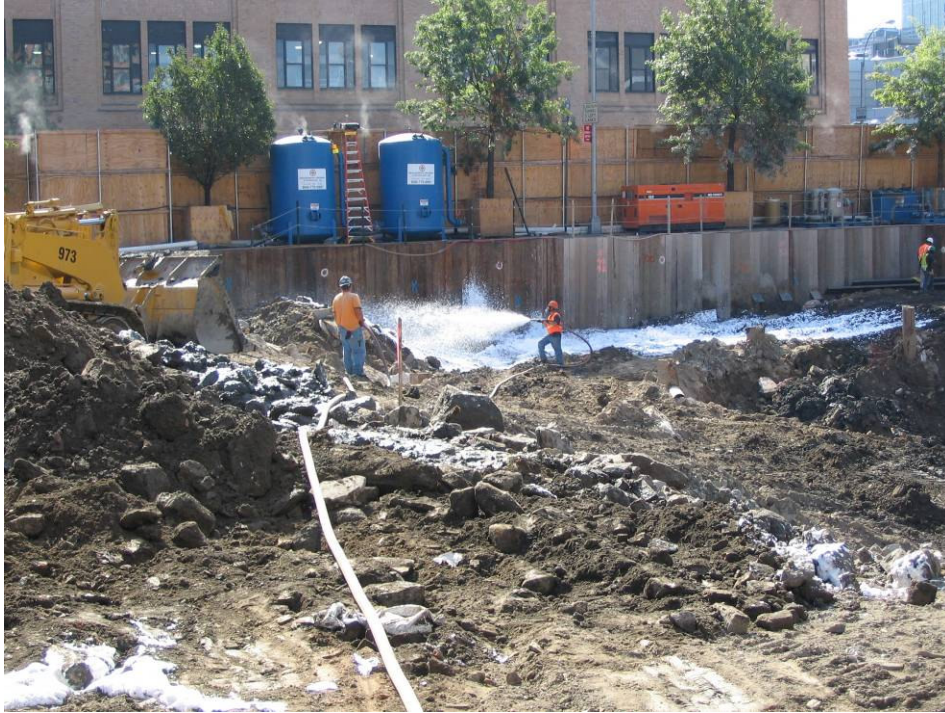
**Photograph No. 41: September 12, 2005 - Workers keeping area along eastern end of Site covered with foam (area where USTs were discovered).**

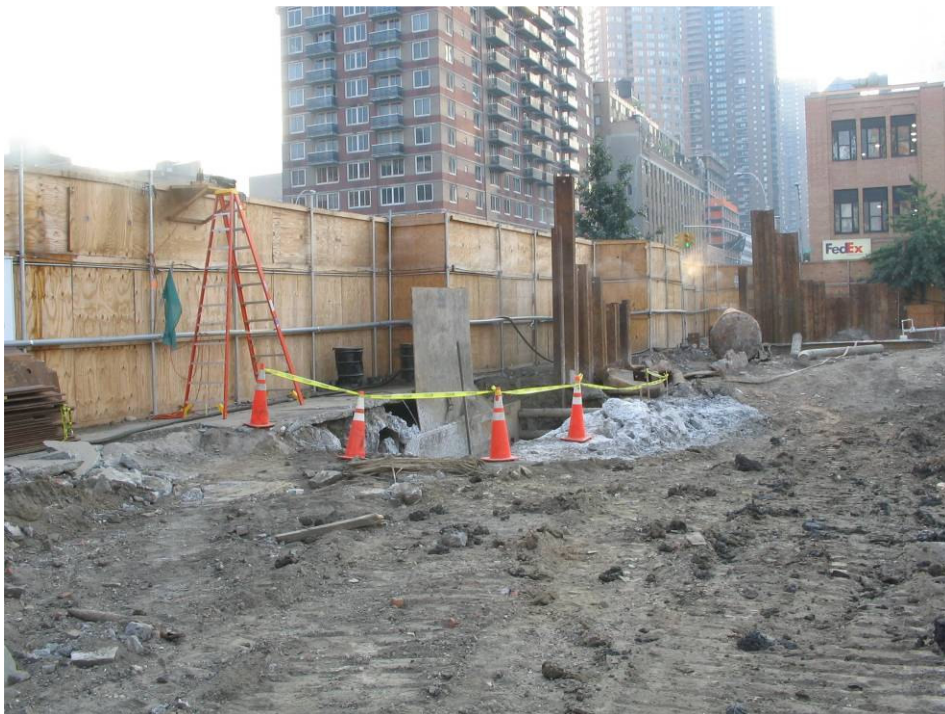
**Photograph No. 42: September 13, 2005 - Trench box secured at conclusion of days activities. Note the section of steel plating used to help reinforce the outside edge of the trench box excavation.**

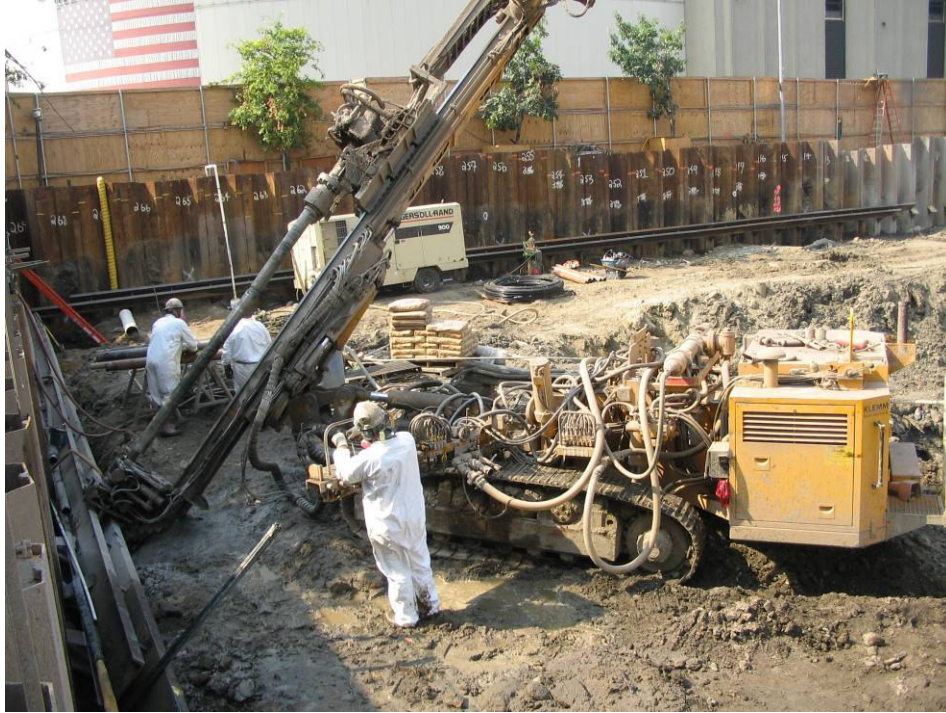
**Photograph No. 43: September 13, 2005 - Moretrench drilling 4-inch diameter angled boreholes (45-degree angle) through sheeting for tie-back installation.**

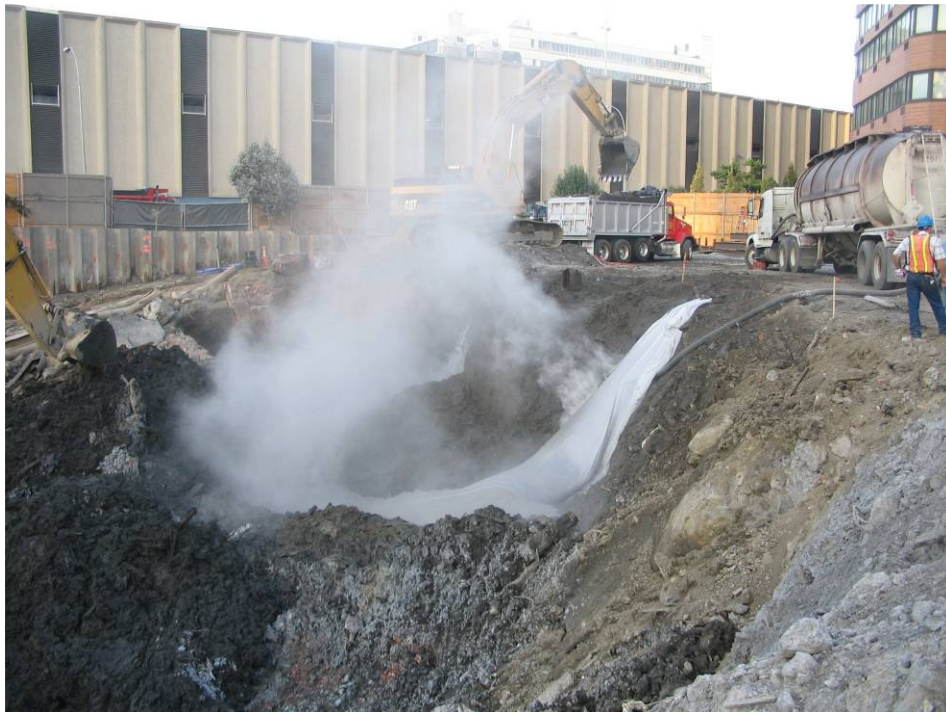
**Photograph No. 44: September 14, 2005 - Dust cloud generated during delivery and offloading of Calciment/kiln dust used for stabilization of excavated material.**

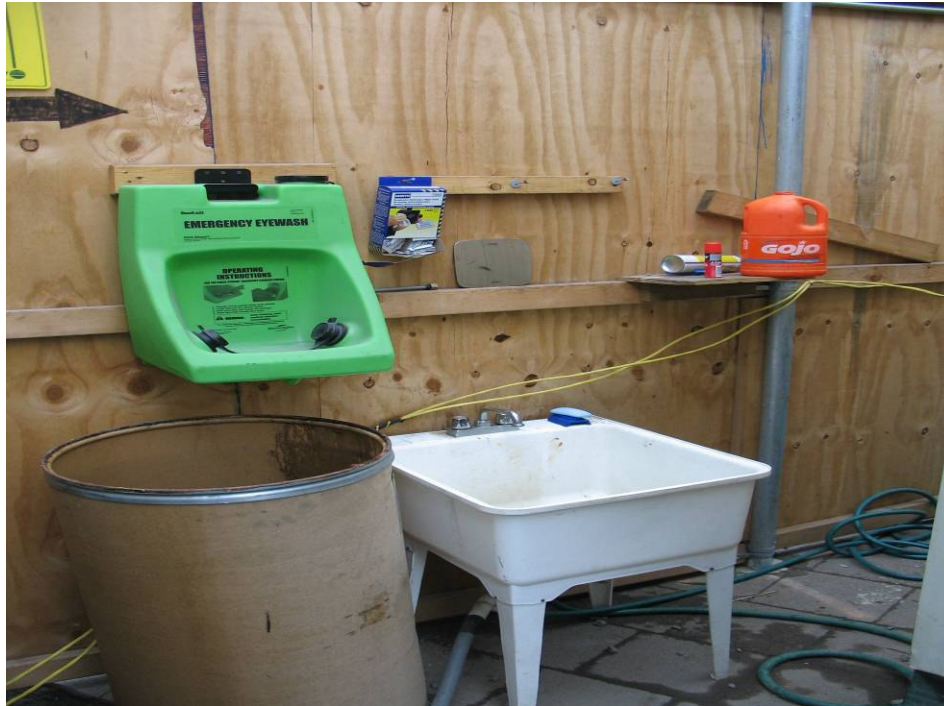
**Photograph No. 45: View of decontamination hand wash and eye wash station.**

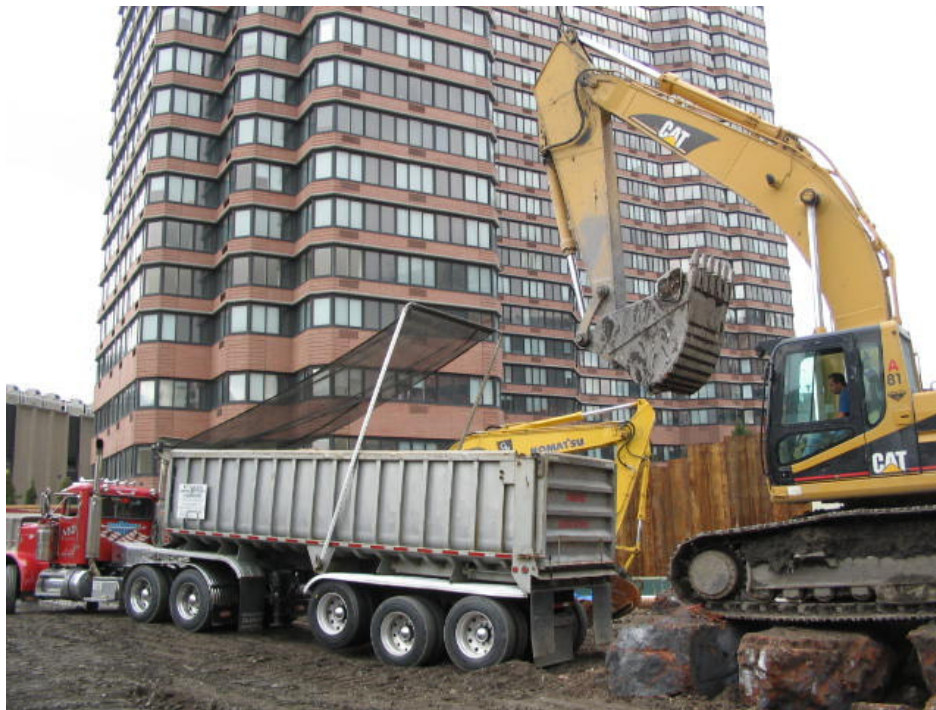
**Photograph No. 46: September 16, 2005 - View showing mesh tarp being installed over top of material load within truck bed. A solid tarp is subsequently installed over the top of the mesh tarp.**

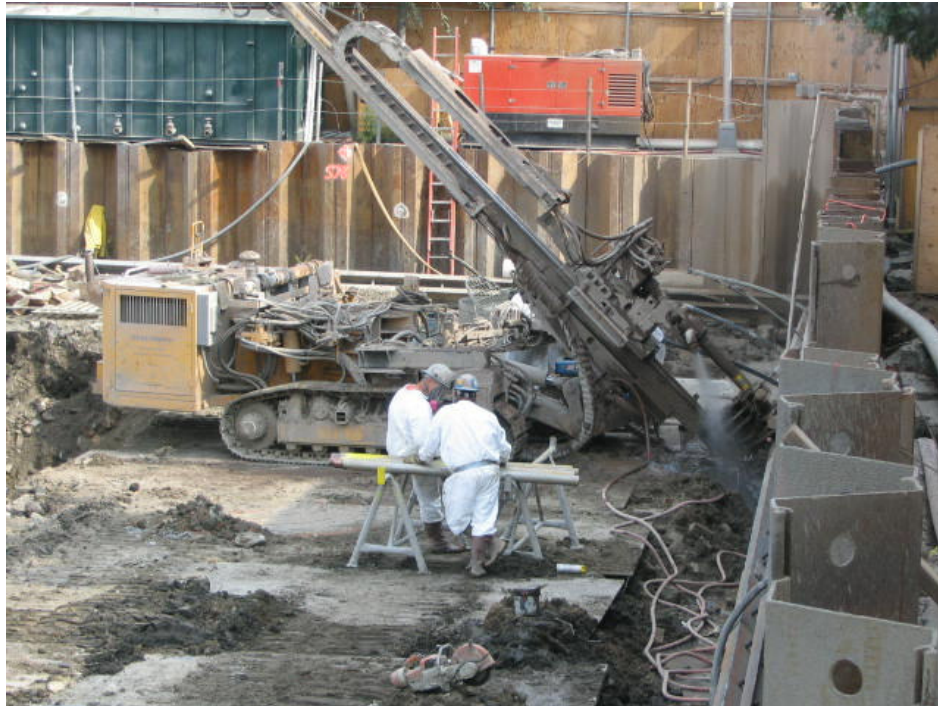
**Photograph No. 47: September 19, 2005 - View showing angled boring for tie-back installation in progress.**

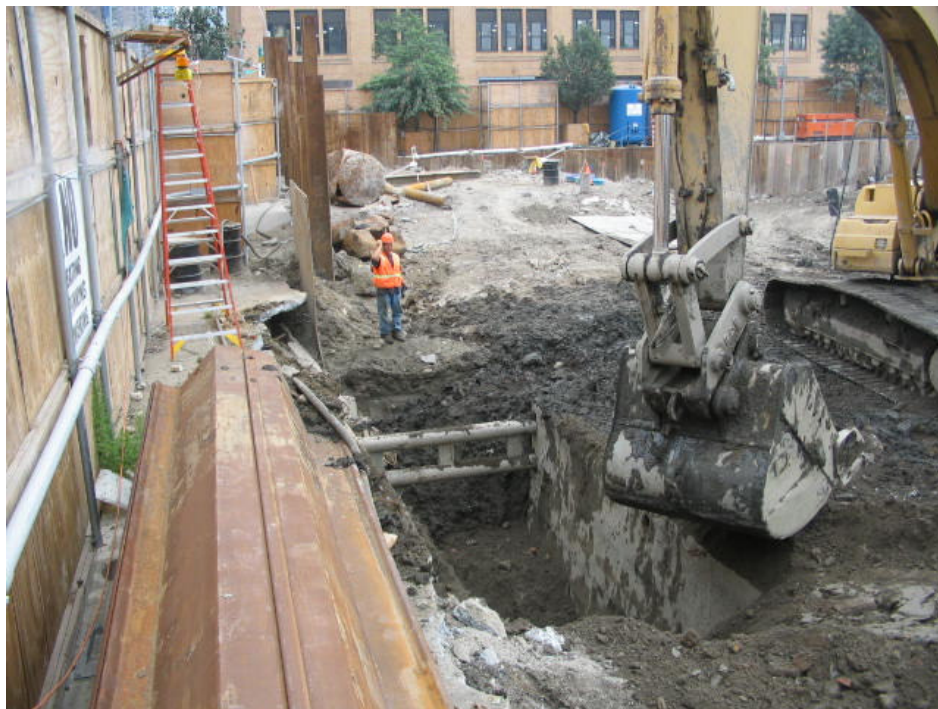
**Photograph No. 48: September 20, 2005 - View showing continued progress with trench box activities.**

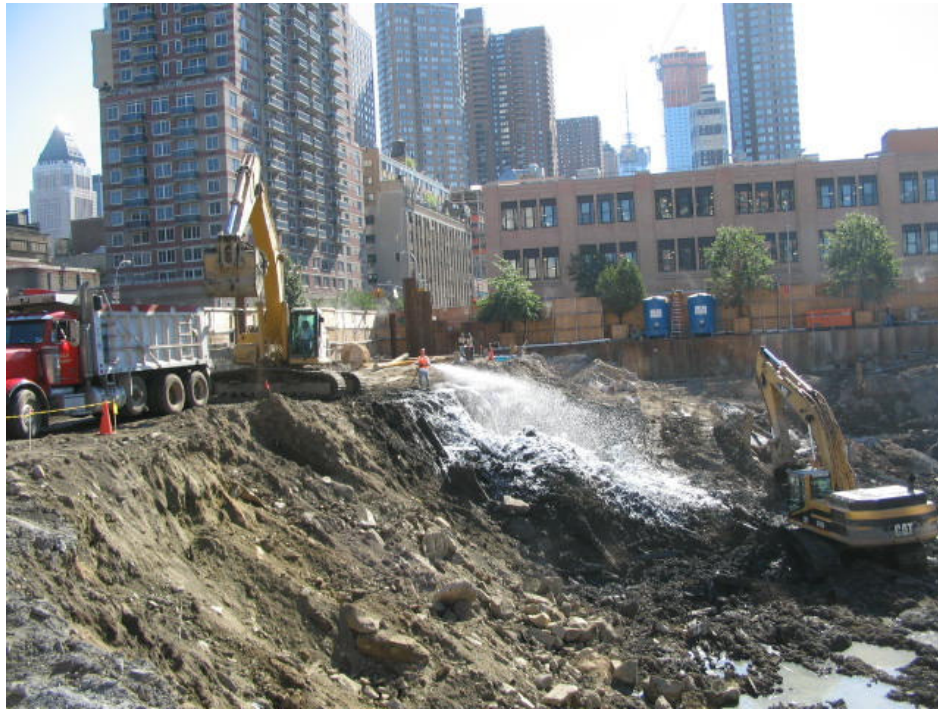
**Photograph No. 49: September 21, 2005 - Workers keeping area covered with foam during excavation activities.**

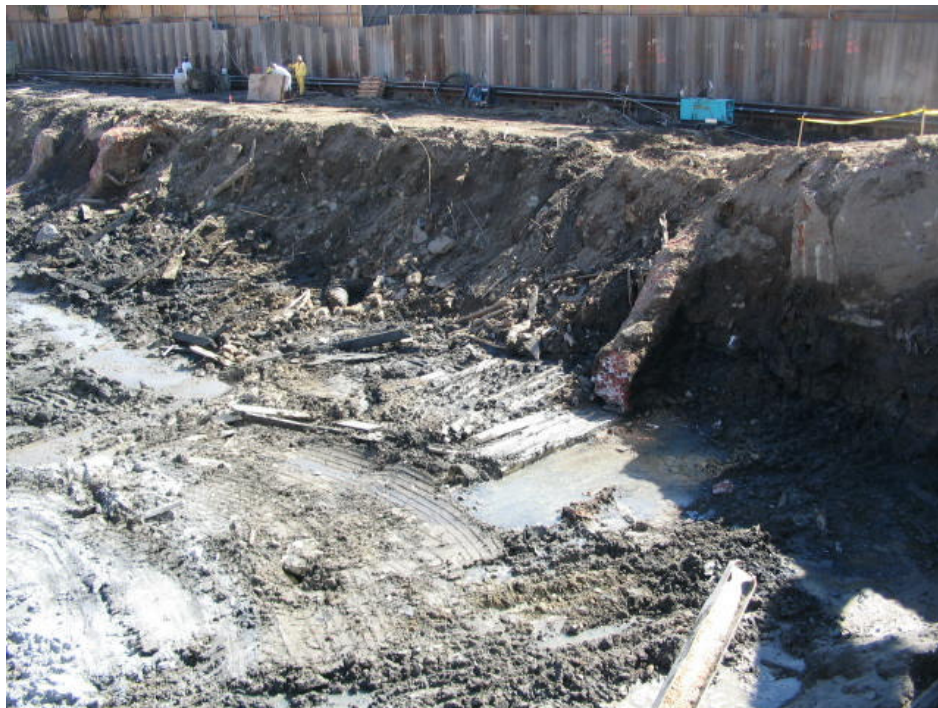
**Photograph No. 50: September 21, 2005 - View showing working platform left in place along sheeting wall allowing work to be done on walers in preparation for installation of tie-backs. Note truncated section of MGP holder wall visible within platform.**

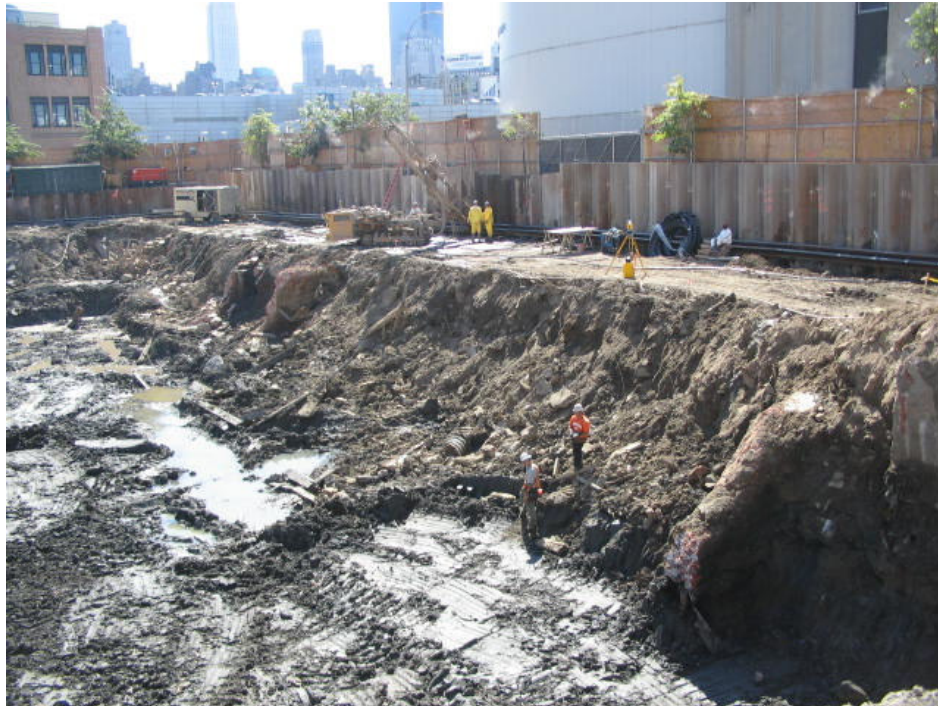
**Photograph No. 51: September 22, 2005 - Another view of working platform temporarily left in place along sheeting line (view towards southeast).**

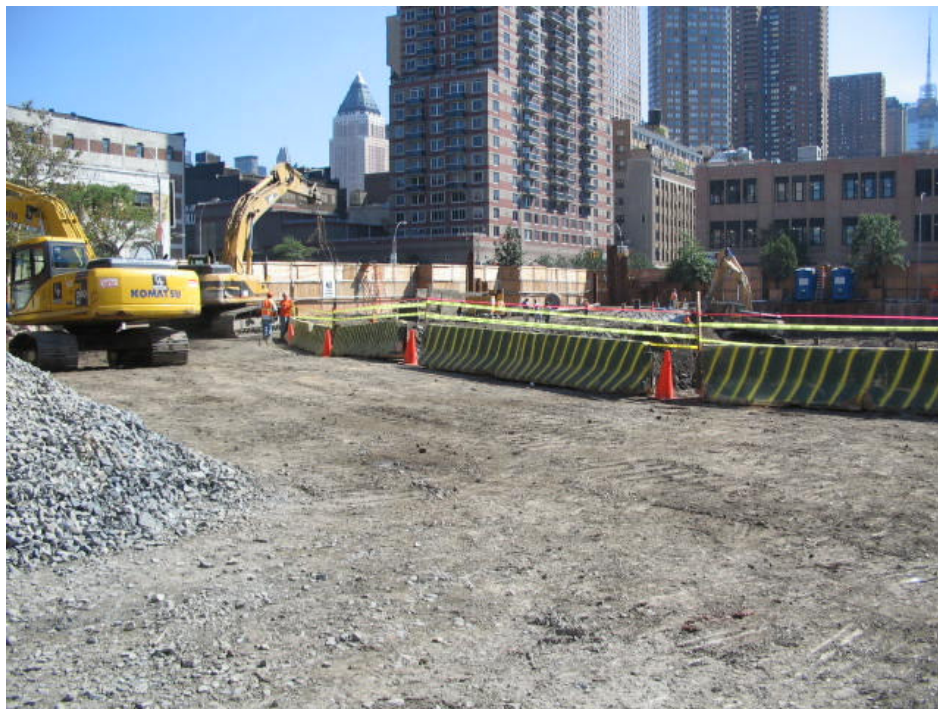
**Photograph No. 52: September 22, 2005 - Improved version of work zone demarcation and safety fencing using concrete Jersey barriers and caution tape.**

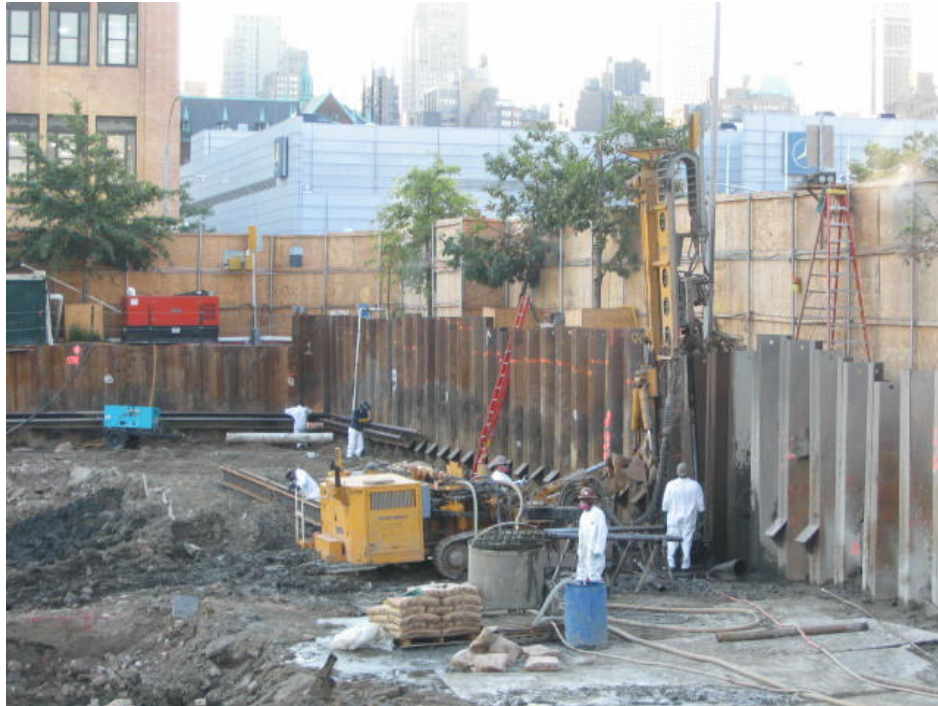
**Photograph No. 53: September 25, 2005 - View of Moretrench performing toe pin installation.**

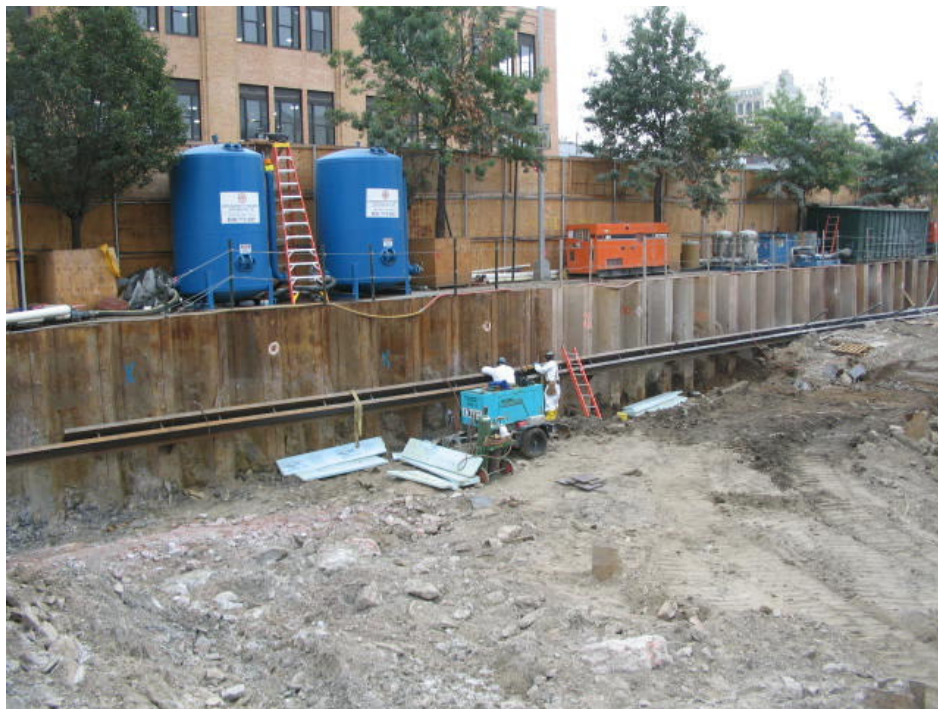
**Photograph No. 54: September 26, 2005 - Welders securing walers. Note dewatering treatment system atop eastern sheeting wall.**
