# **APPENDIX R**

## **PHOTO LOG OF SITE WORK**

1. Photo log of site work from June 2005 to February 2006

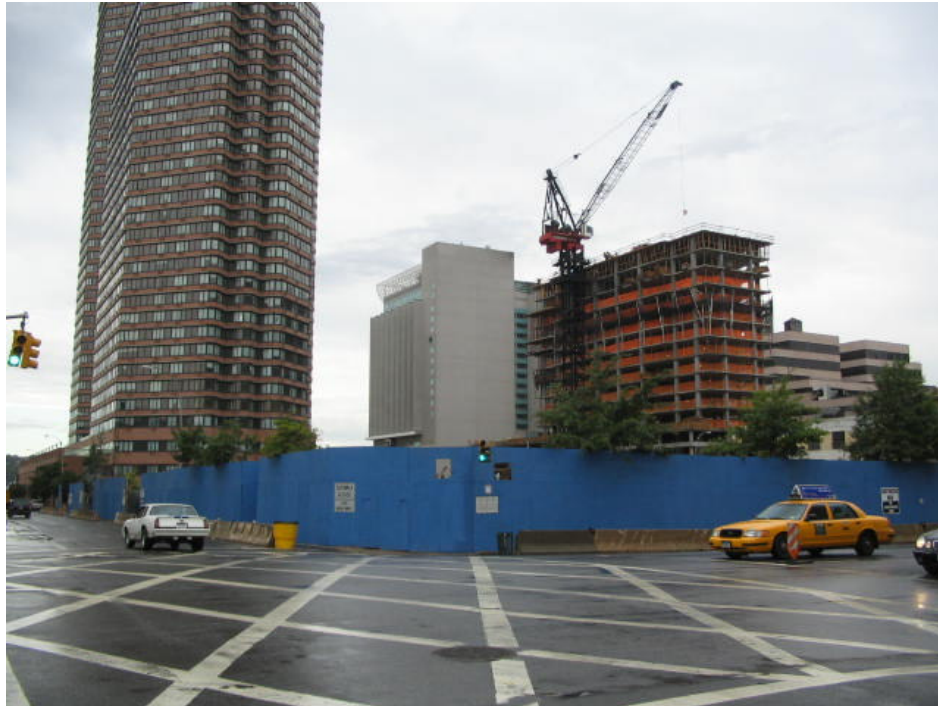
**Photograph No. 55: View of blue fencing surrounding Site perimeter (view towards northwest).**

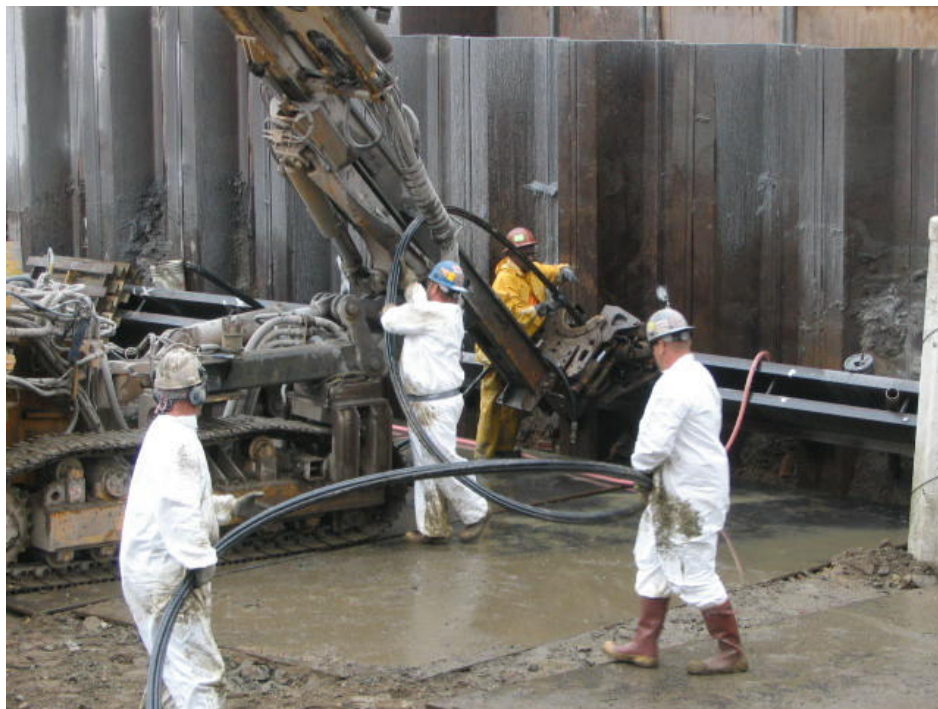
**Photograph No. 56: September 29, 2005 - Tie-back anchor tendon being installed into 45-degree angled borehole.**

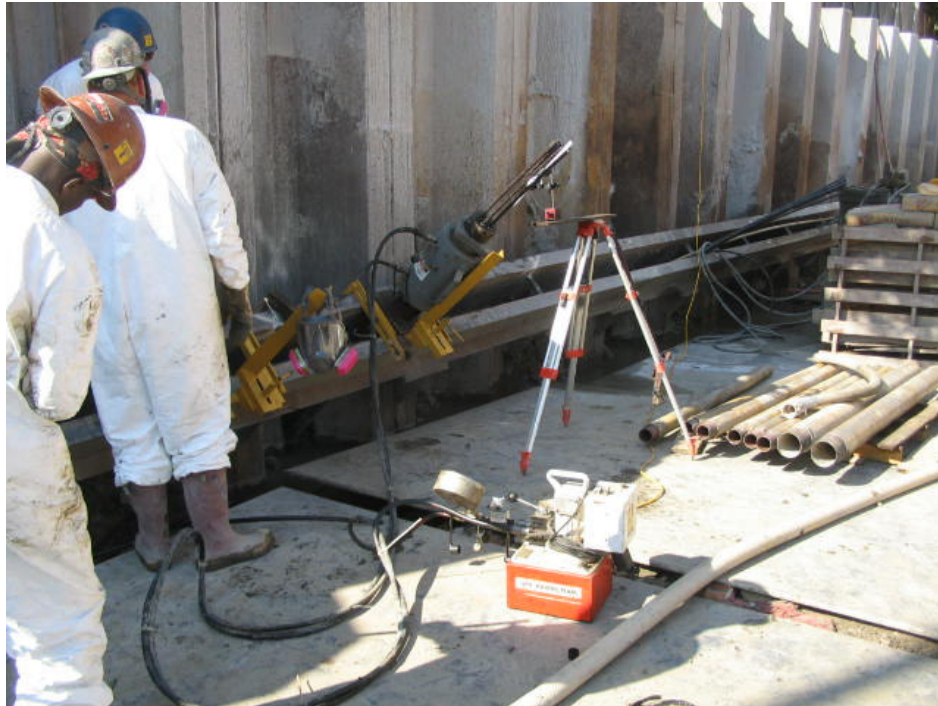
**Photograph No. 57: October 3, 2005 - Testing tie-back installation using hydraulic jack and dial indicator to measure elongation.**

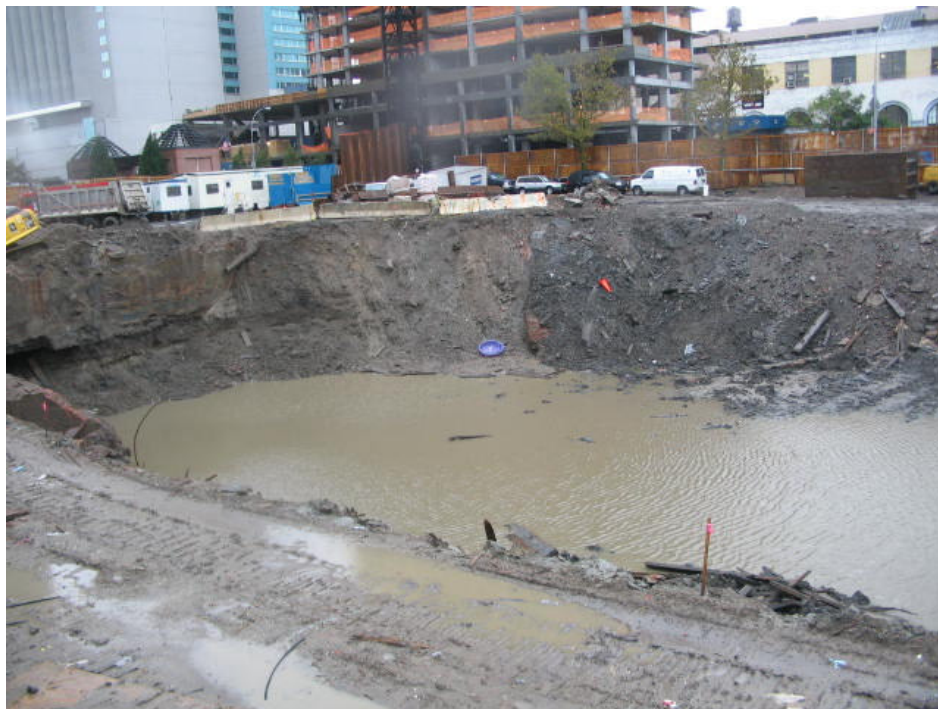
**Photograph No. 58: October 12, 2005 - Surface water accumulation from several days of heavy precipitation (view towards northwest).**

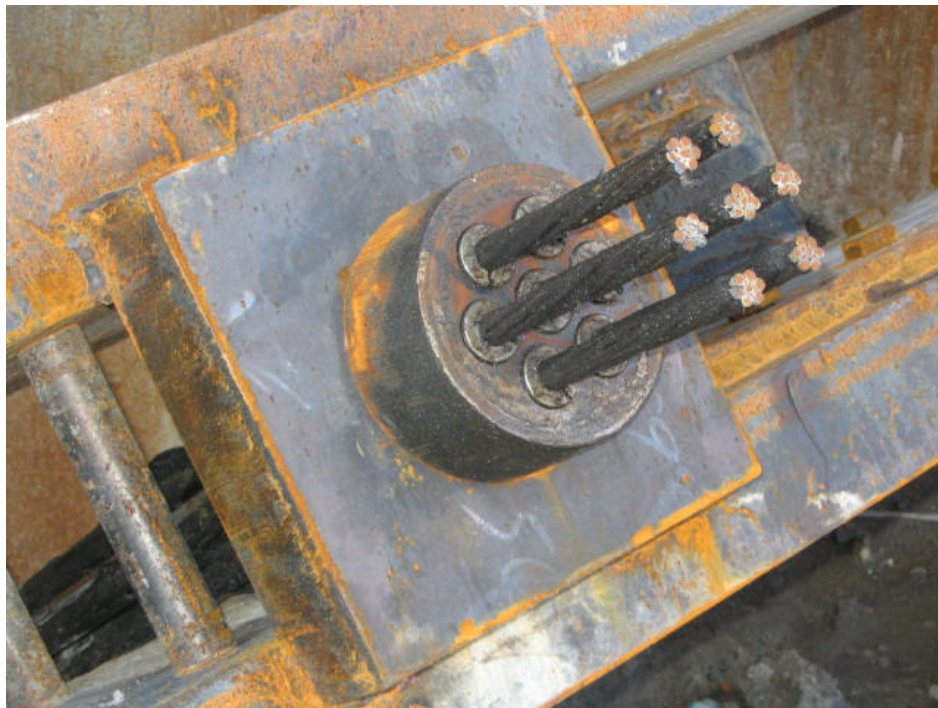
**Photograph No. 60: Close-up view of tie-back locked off and set in place with exposed terminus cut to length.**

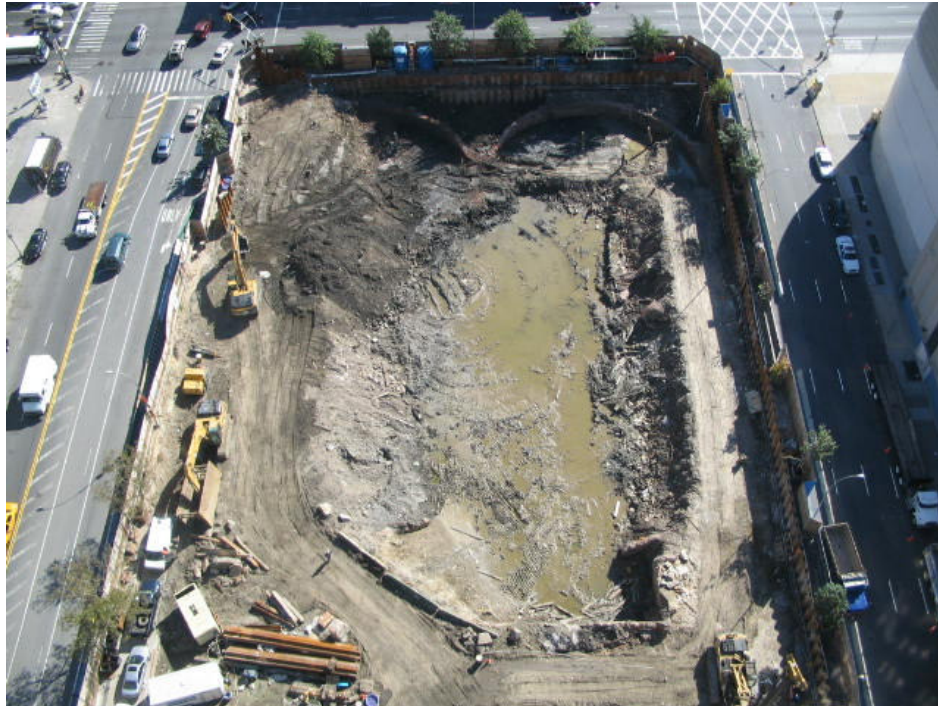
**Photograph No. 61: October 19, 2005 - Aerial view of site (view east) from RiverPlace I 32<sup>nd</sup> floor observation deck.**

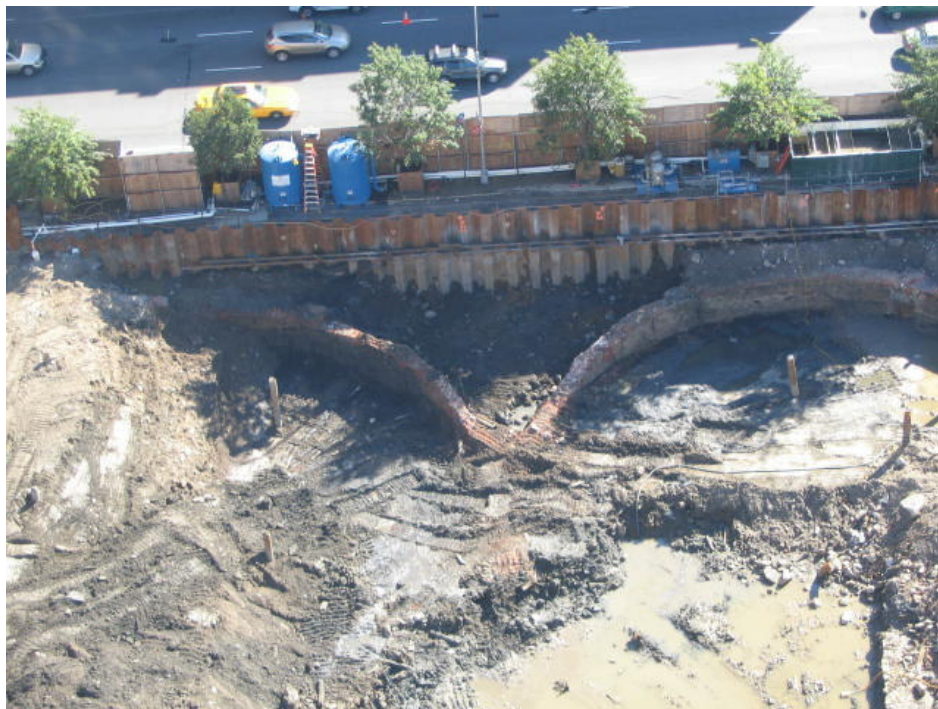
**Photograph No. 62: October 19, 2005 - Aerial view zoomed into to highlight the exposed section of the northeast and southeast MGP holder walls.**

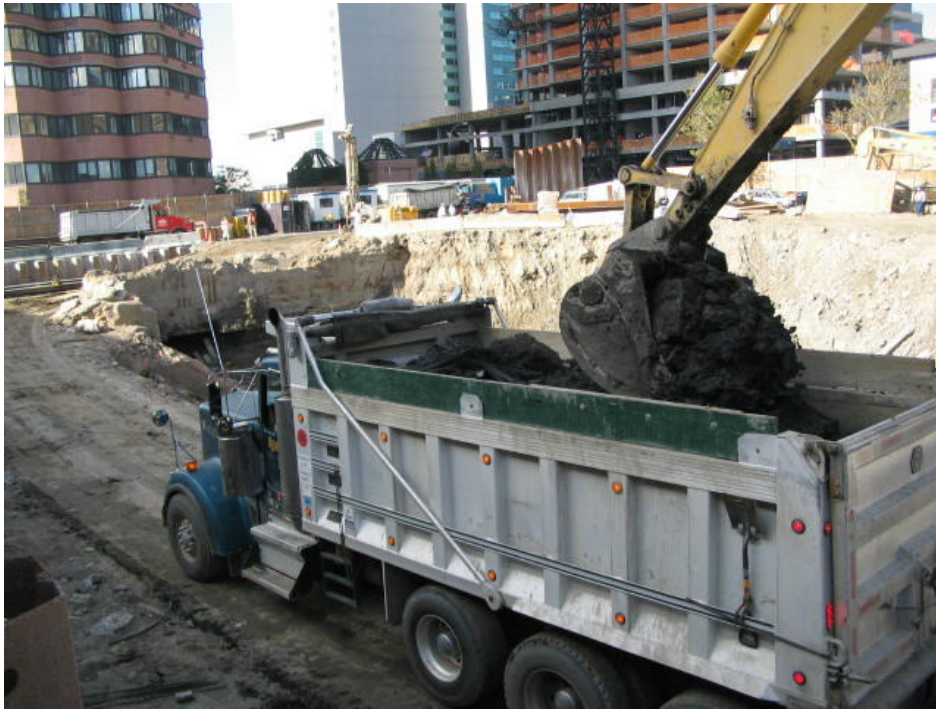
**Photograph No. 63: October 20, 2005 - View of material load-out occurring along the southern perimeter of the Site (view towards northwest).**

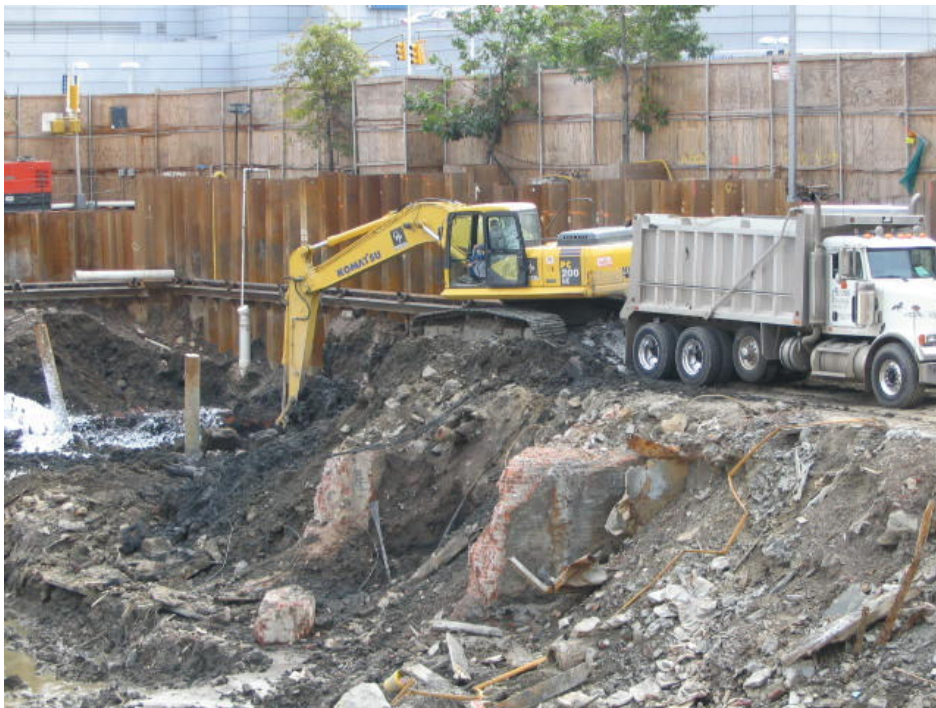
**Photograph No. 64: October 20, 2005 - Material load-out occurring along southern perimeter of Site (view towards southeast). Note southeast dewatering well in background of photo (Well #2).**

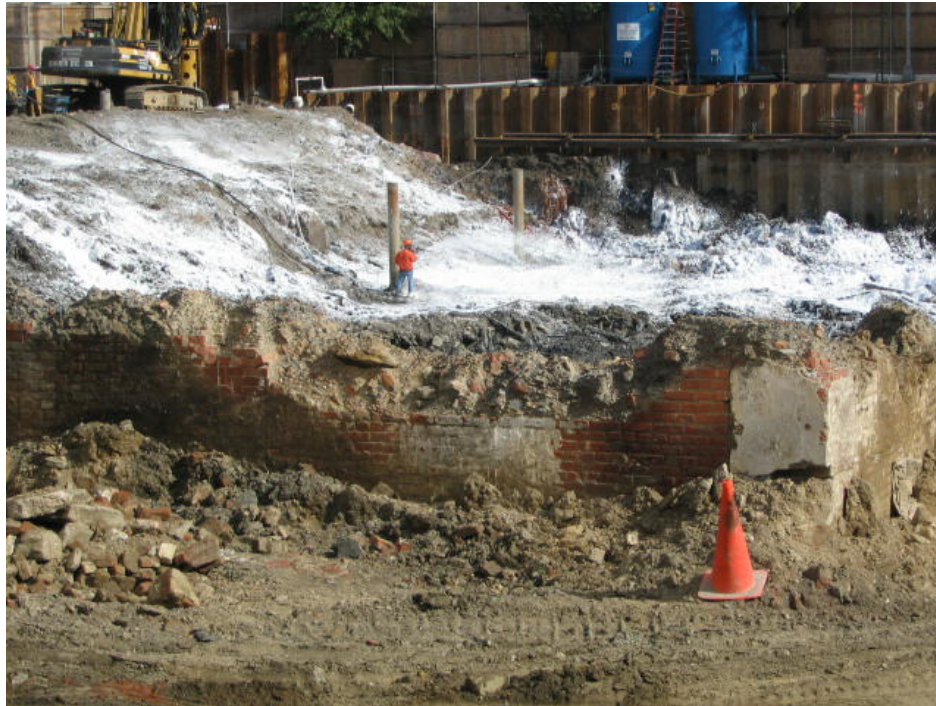
**Photograph No. 65: October 20, 2005 - View showing exposed former MGP-related structure (view towards northeast). Note foam odor suppressant covering area.**

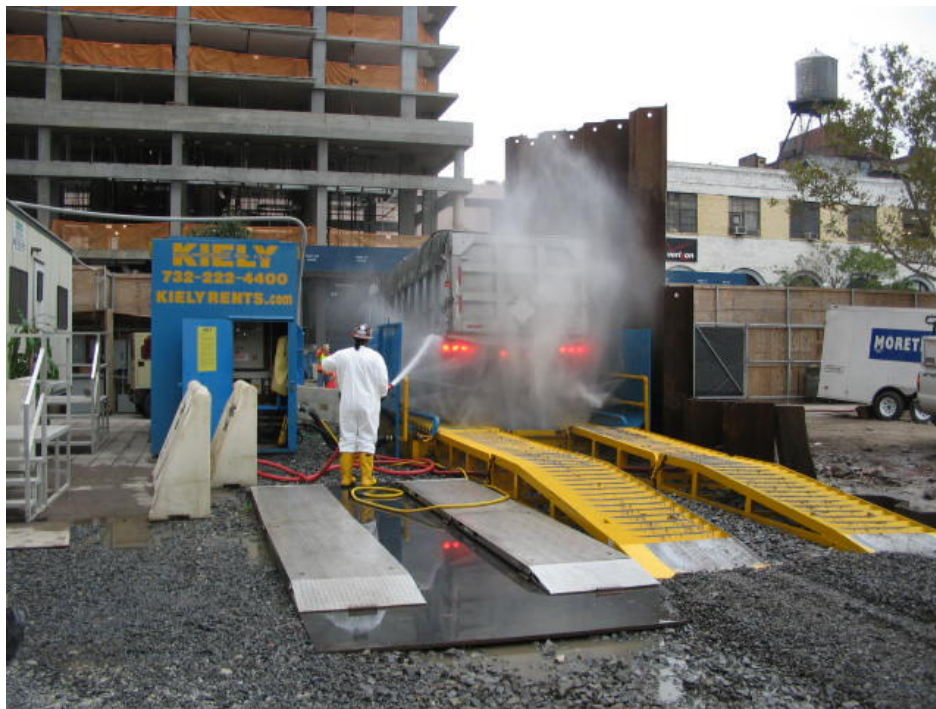
**Photograph No. 66: View of the truck wash in action.**

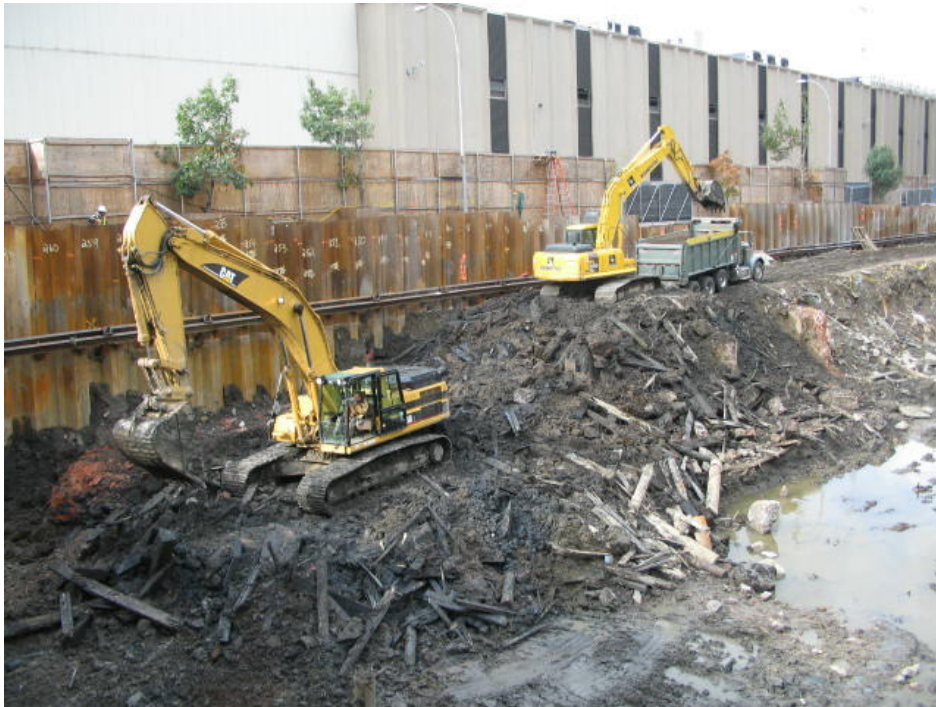
**Photograph No. 67: October 25, 2005 - Excavators working in tandem along southern perimeter of Site. Note presence of wood debris (cribbing and planking).**

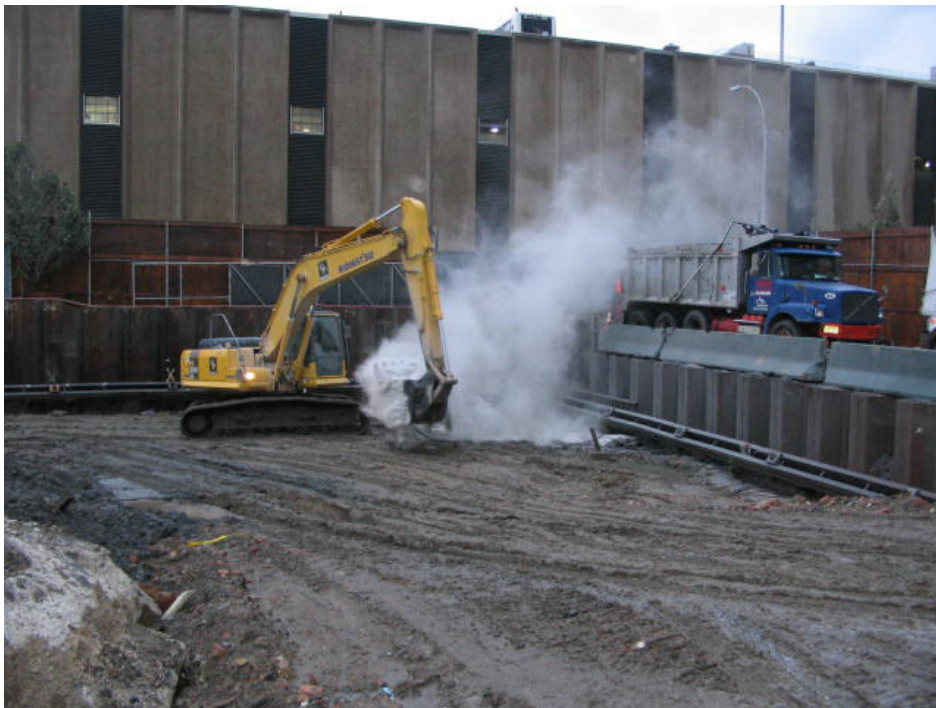
**Photograph No. 68: October 25, 2005 - Typical dust generated by excavator gathering scoop of Calciment/kiln dust for material stabilization.**

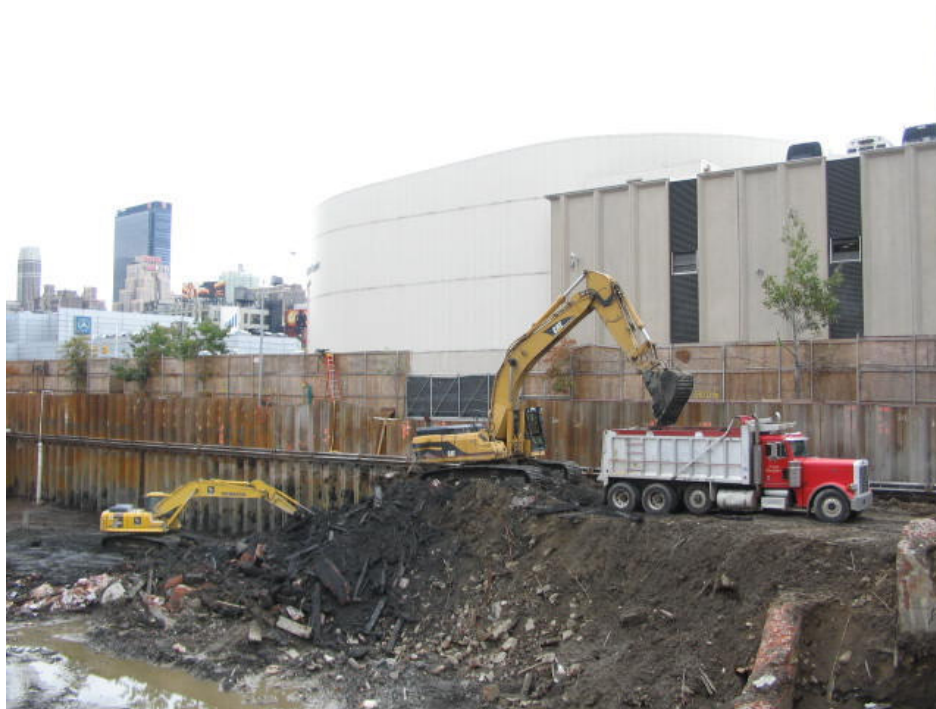
**Photograph No. 69: October 27, 2005 - Another view of material load-out operations occurring along southern perimeter of Site. Note how working platform has been removed progressing towards the west.**

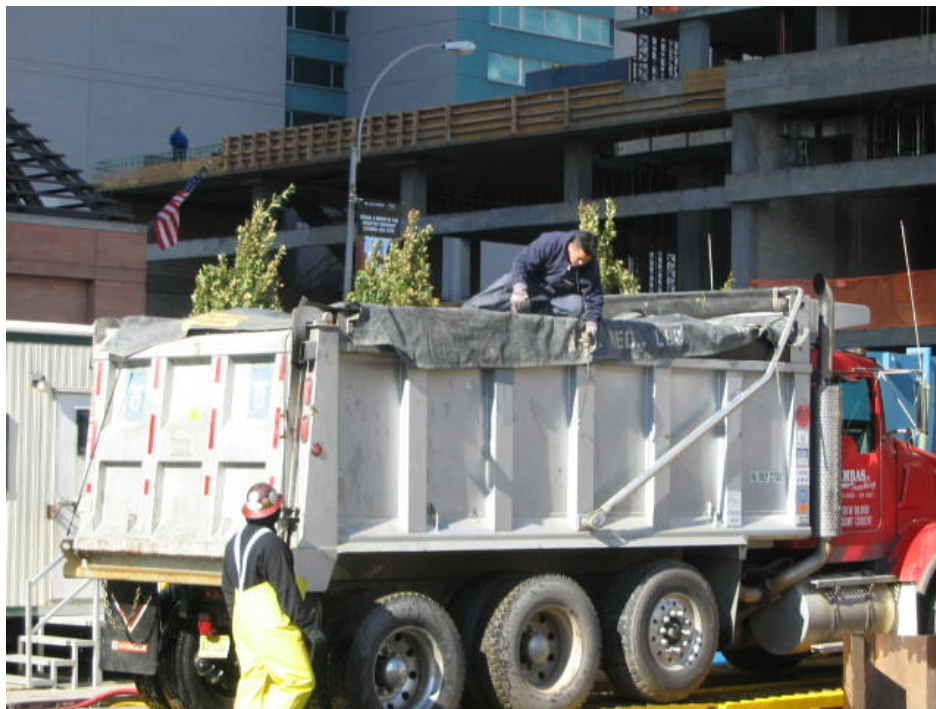
**Photograph No. 70: October 28, 2005 - Trucker installing solid tarp over material load before departing from Site.**

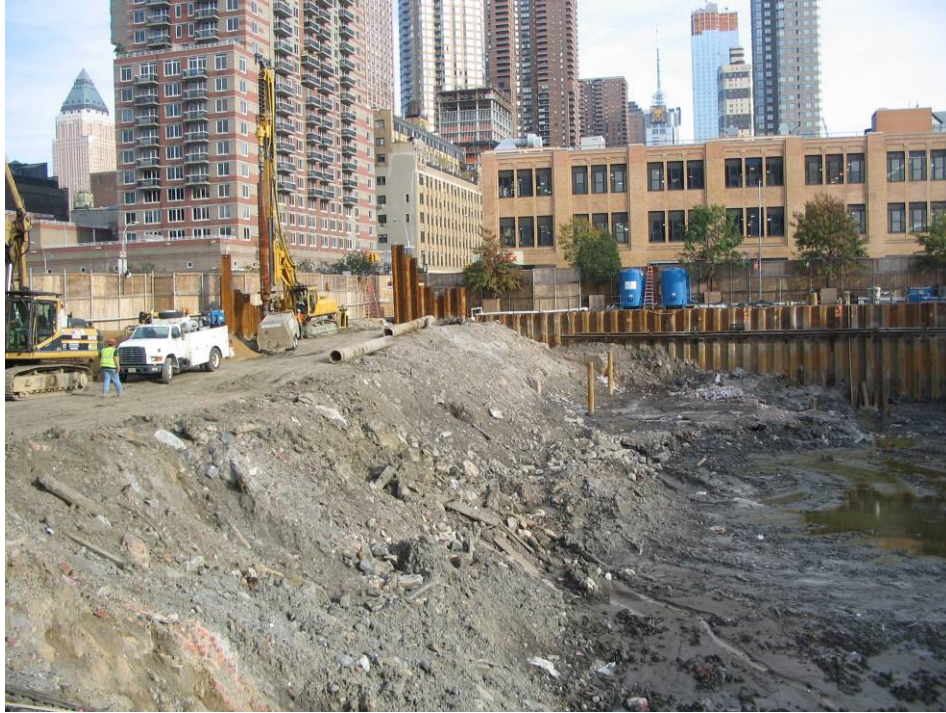
**Photograph No. 71: November 1, 2005 - View of excavation looking northeast. Skanska/Underpinning drill rig can be seen clearing subsurface obstructions along northern perimeter.**

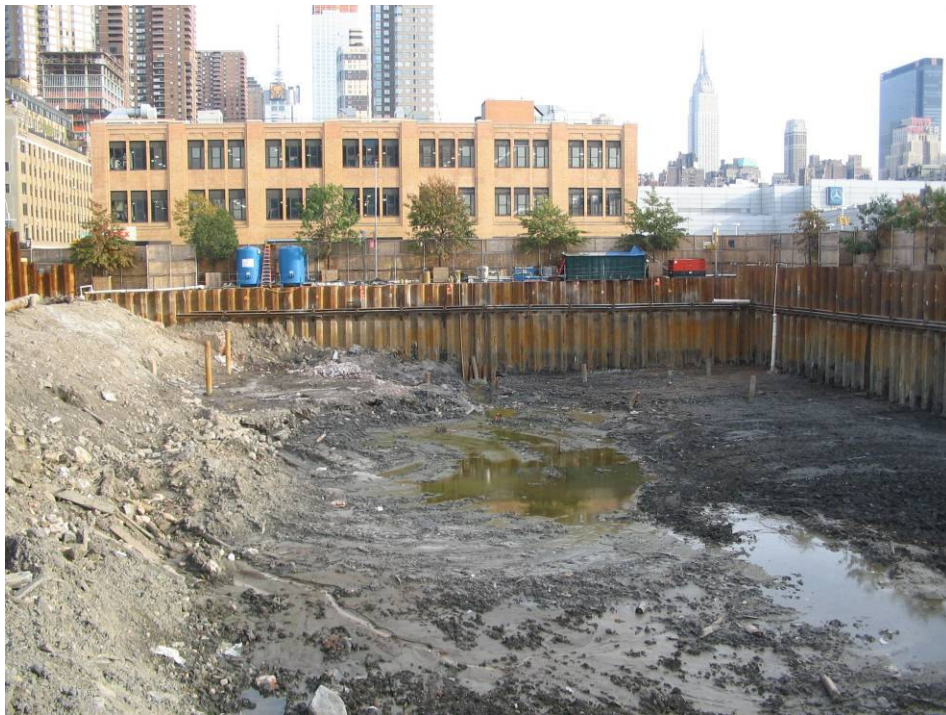
**Photograph No. 72: November 1, 2005 - View of excavation looking east. Note that southernmost area of Site has been excavated to depth. Note surface water accumulation present in center of excavation.**

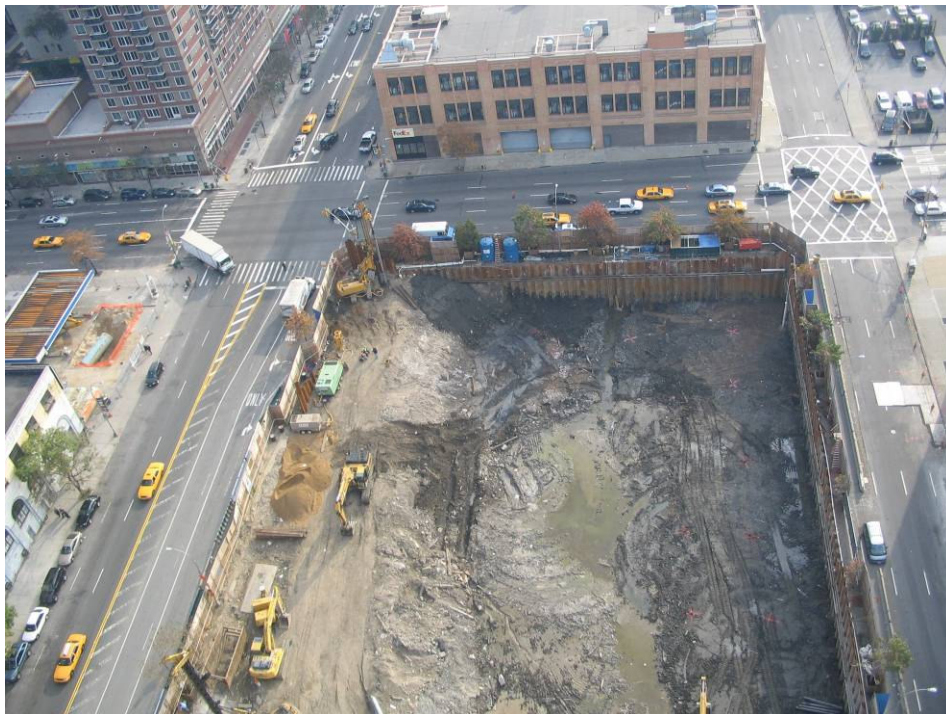
**Photograph No. 74: November 5, 2005 - Aerial view of site (view east) from RiverPlace I 32<sup>nd</sup> floor observation deck.**

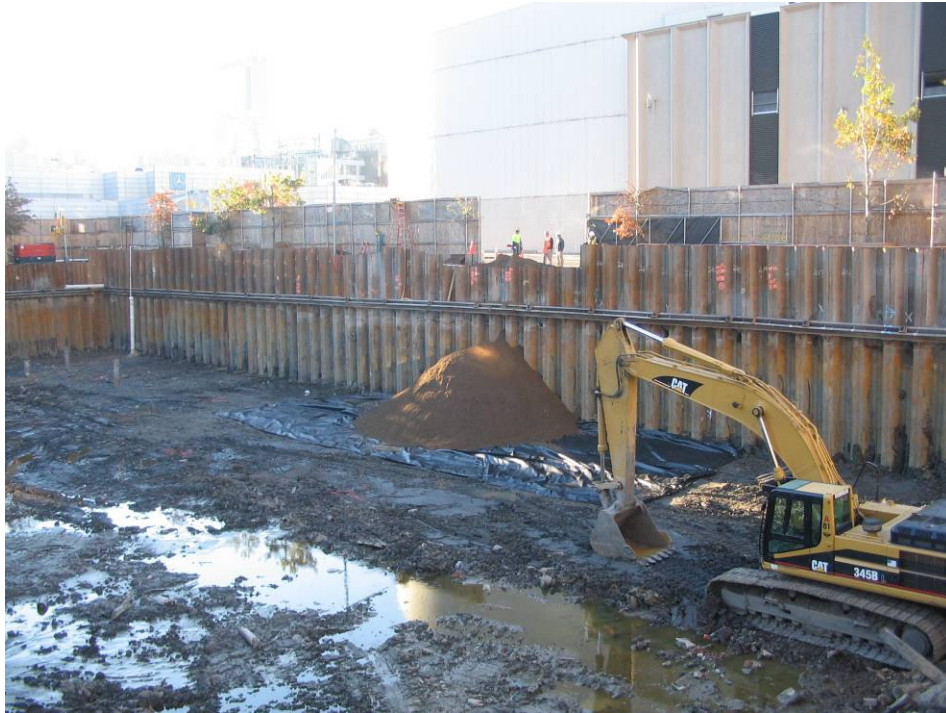
**Photograph No. 75: November 7, 2005 - View of first load of imported RCA material atop section of Mirafi 500 geotextile fabric. RCA delivered through Gate #4.**

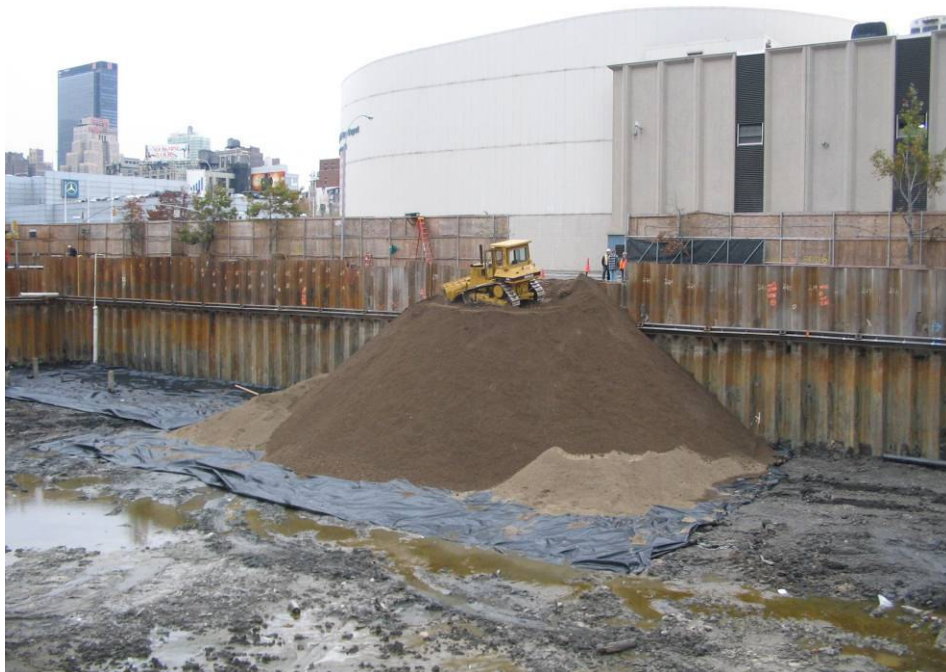
**Photograph No. 76: November 9, 2005 - Continued stockpiling of RCA material. Bulldozer on top of stockpile was used to spread out the RCA material.**

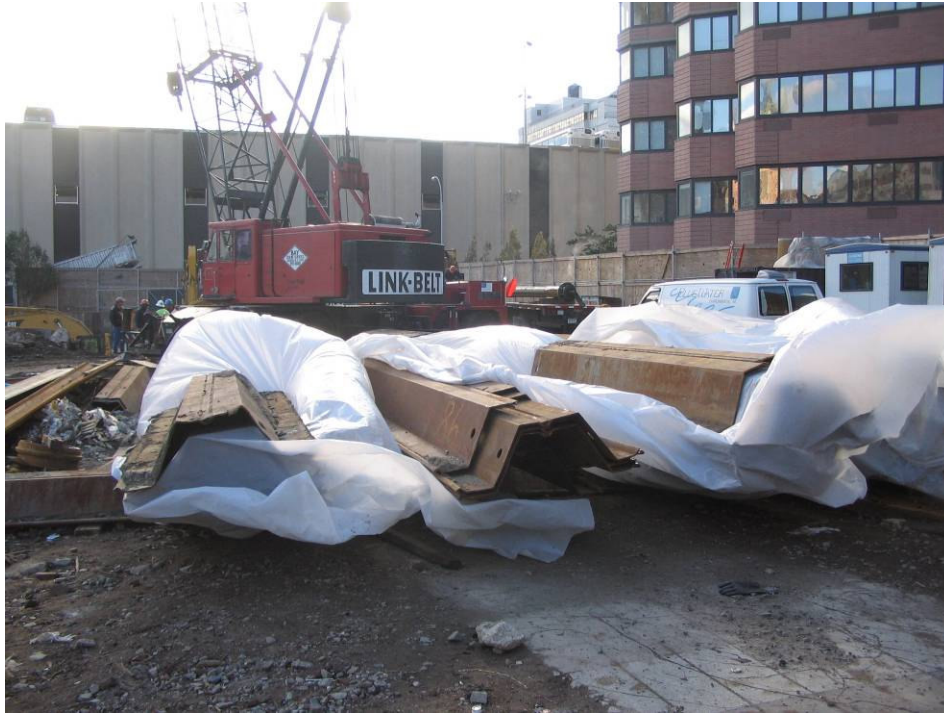
**Photograph No. 77: November 10, 2005 - Sheeting sections (pieces to be installed along northern perimeter) staged for use with plastic sheeting to keep them dry.**

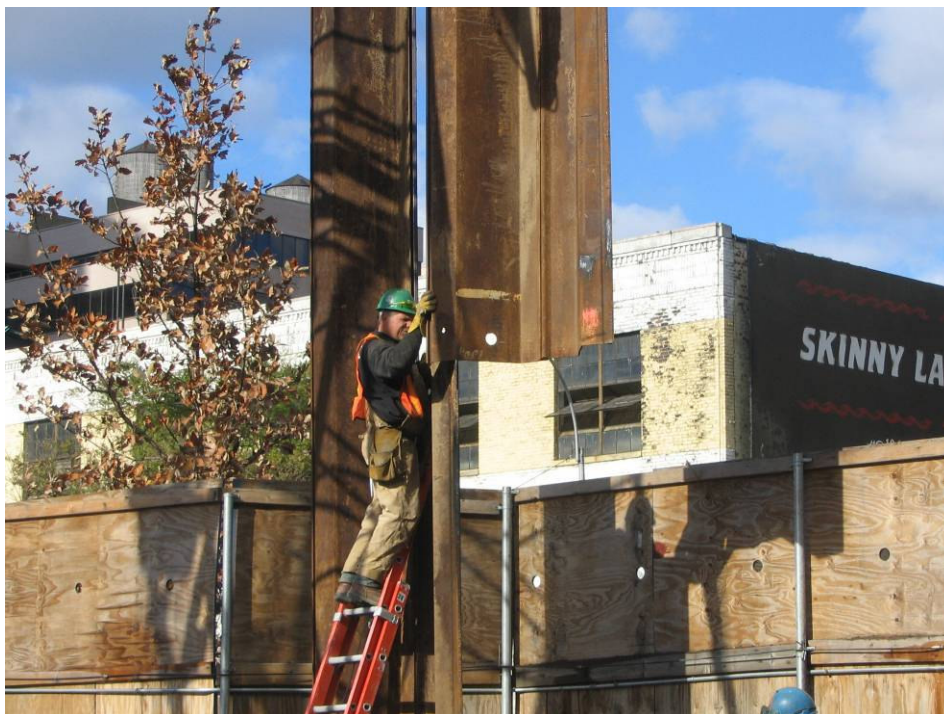
**Photograph No. 78: November 11, 2005 - Worker guiding grooved channels of sheeting sections together during installation.**

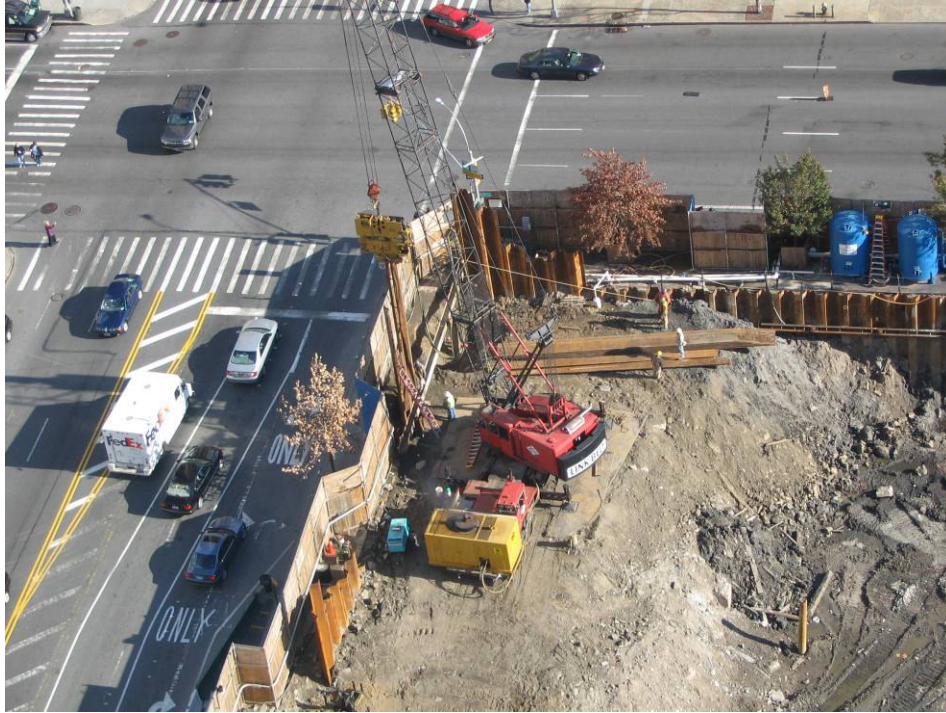
**Photograph No. 79: November 11, 2005 - Close-up aerial view of site (view east) from RiverPlace I 32<sup>nd</sup> floor observation deck. View is of sheeting installation occurring along northern perimeter.**

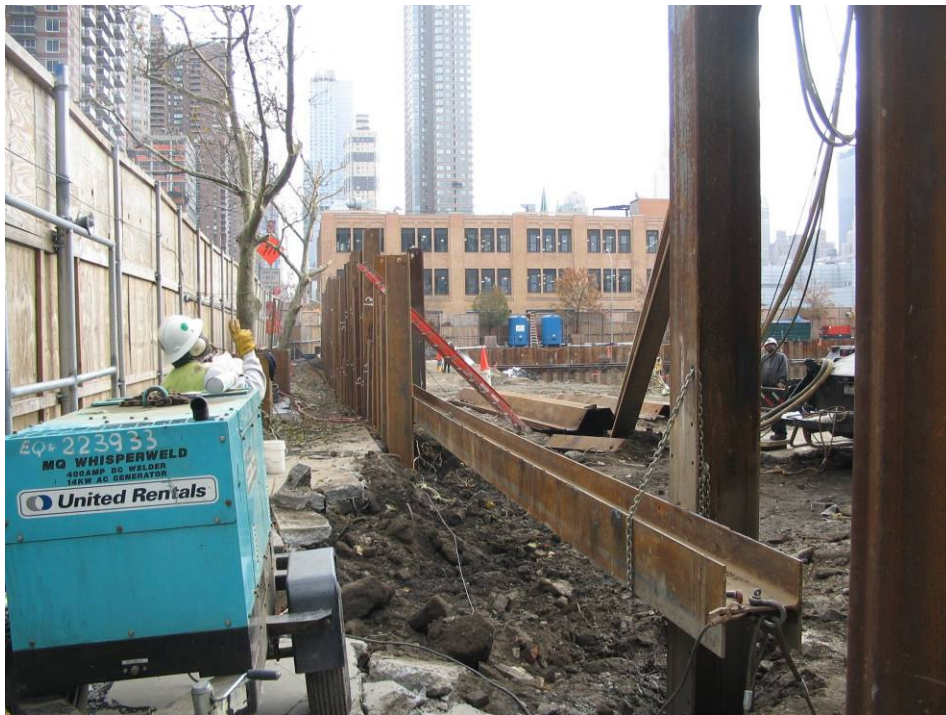
**Photograph No. 80: November 16, 2005 - View of horizontal guide beam used to align sheeting sections during installation (view east).**

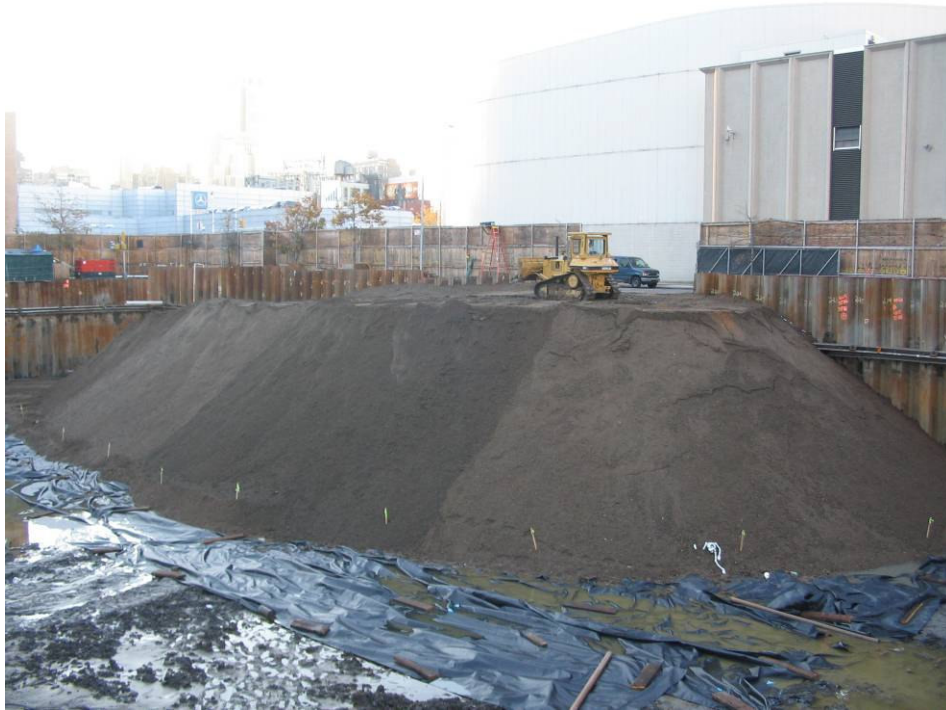
**Photograph No. 81: November 17, 2005 - View of RCA stockpile before beginning to spread material across extent of excavation.**

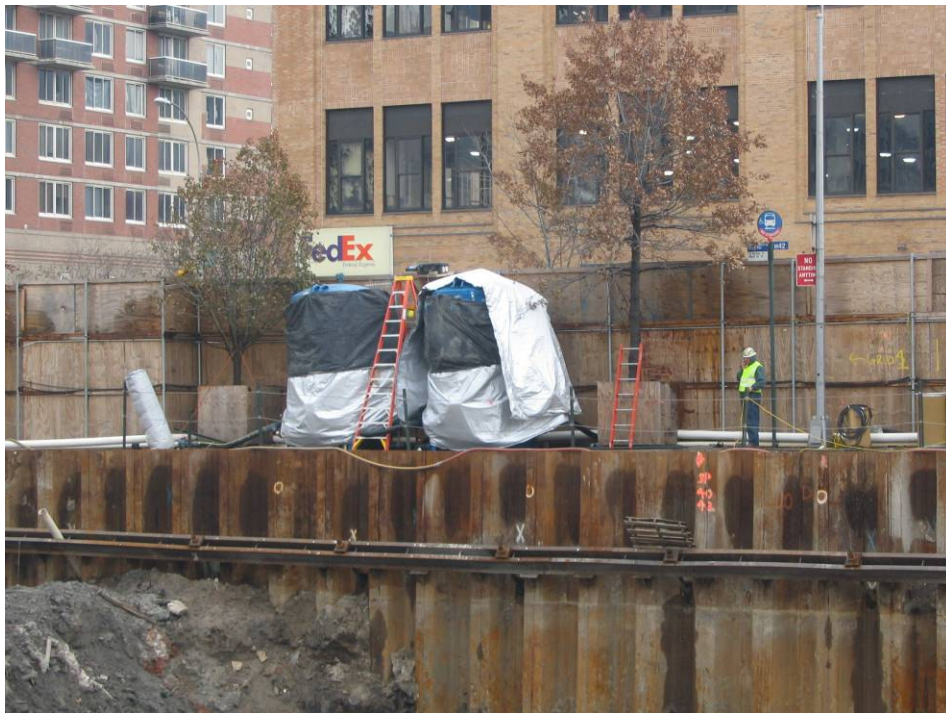
**Photograph No. 82: November 28, 2005 - View of dewatering treatment system carbon vessels prepped for winter with insulated jackets.**

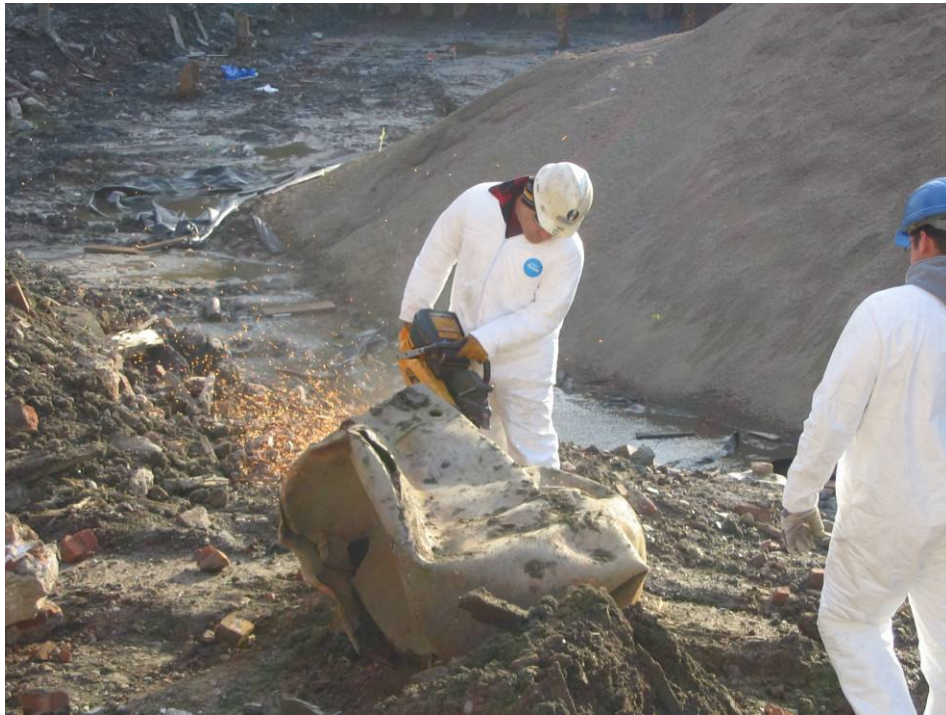
**Photograph No. 83: December 9, 2005 - Workers cutting open the UST discovered on 11/18/05 to clean out any residual contents and decommission.**

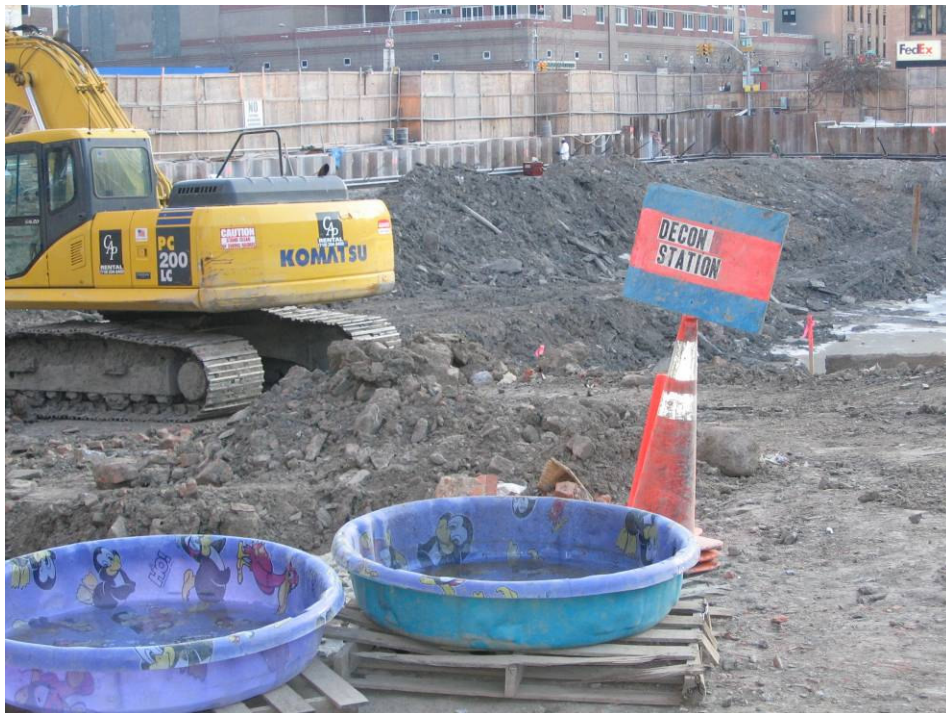
**Photograph No. 84: View of the decontamination station at the exit of the Site exclusion zone.**

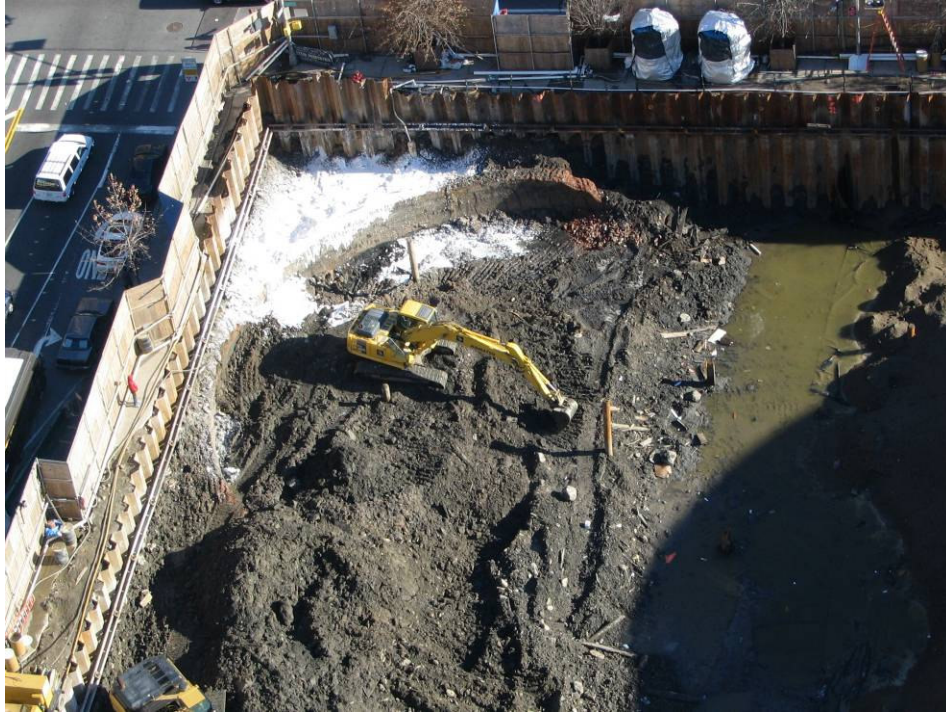
**Photograph No. 85: December 30, 2005 - Close-up aerial view of site (view east) from RiverPlace I 32<sup>nd</sup> floor observation deck. View is of excavation occurring along northern perimeter now that sheeting installation is complete.**

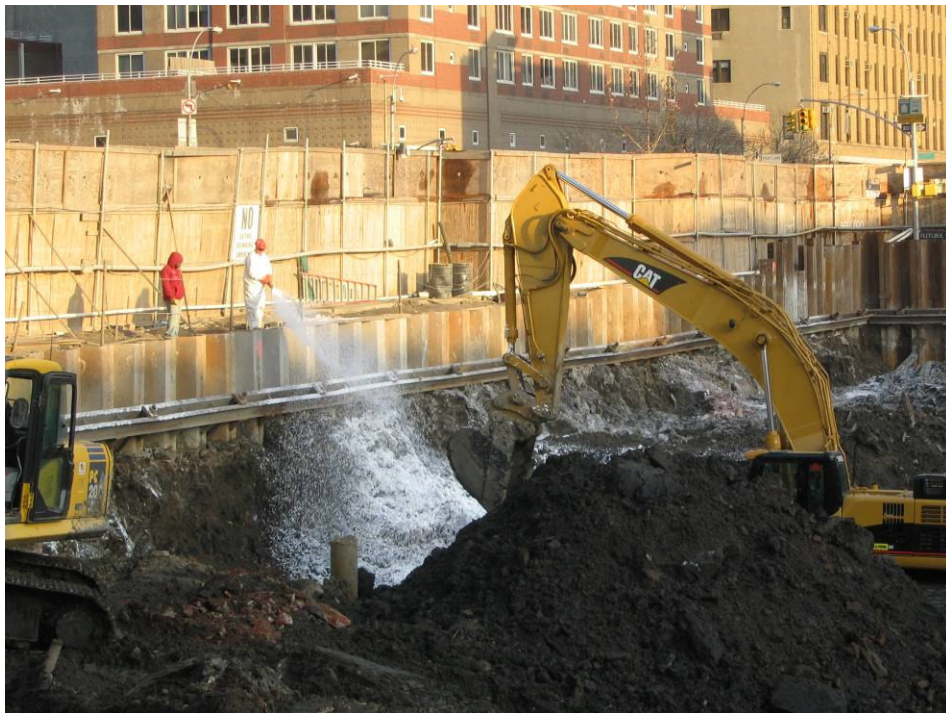
**Photograph No. 86: January 9, 2006 - Foaming during excavation along northern sheeting line.**

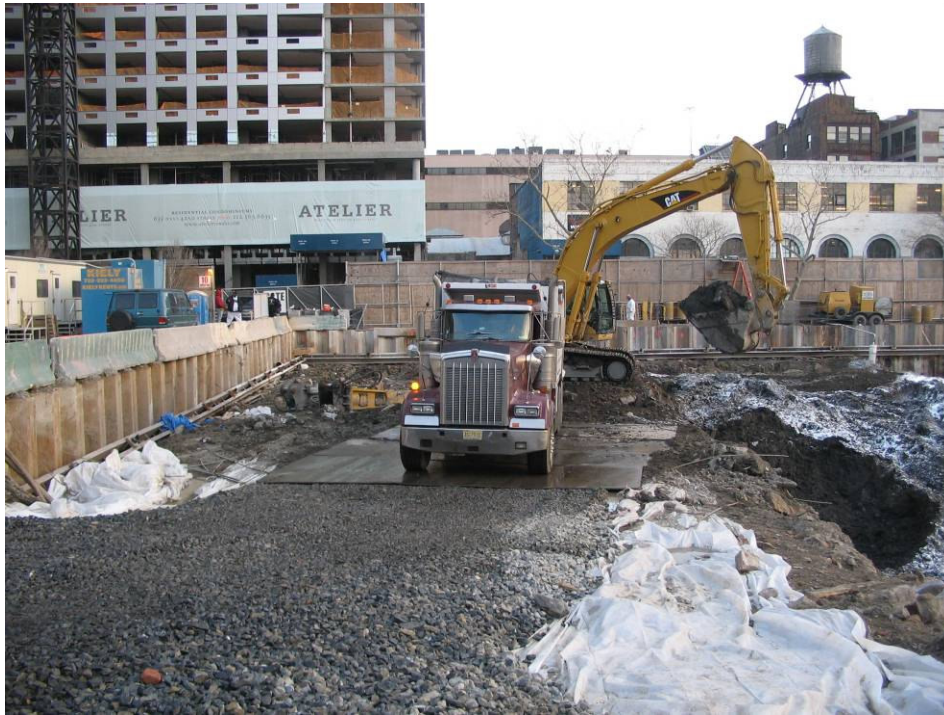
**Photograph No. 87: January 10, 2006 - View of reconfigured material load-out area now that trucks are exiting Site via Gate #2 on West 41<sup>st</sup> Street (view north). Note steel plates positioned under truck.**

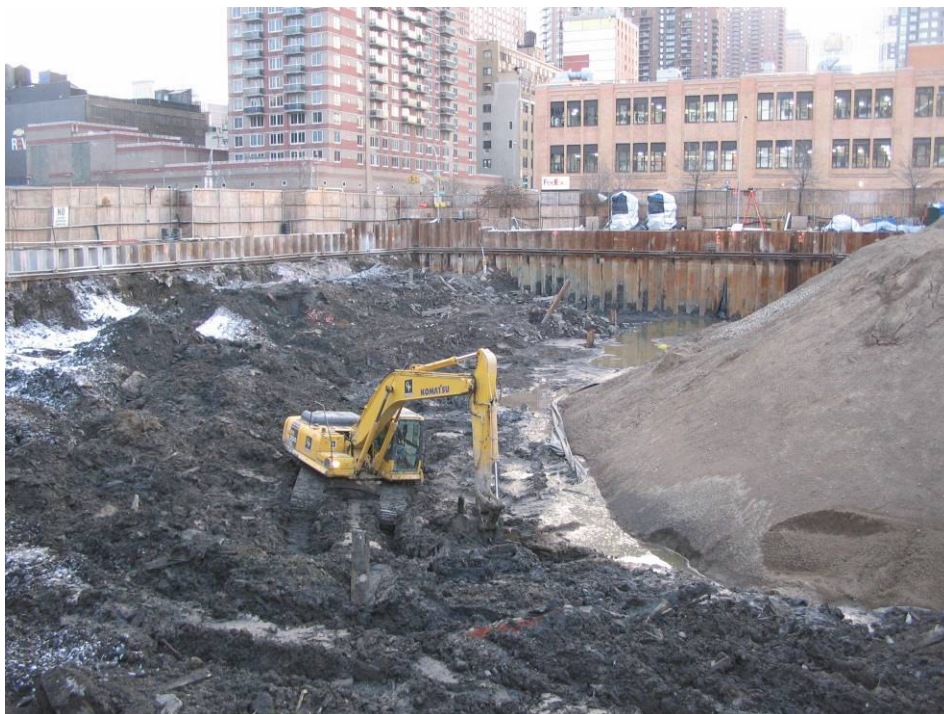
**Photograph No. 88: January 10, 2006 - View of excavator working to keep MGP material segregated from RCA stockpile.**
