# **APPENDIX R**

## **PHOTO LOG OF SITE WORK**

1. Photo log of site work from June 2005 to February 2006

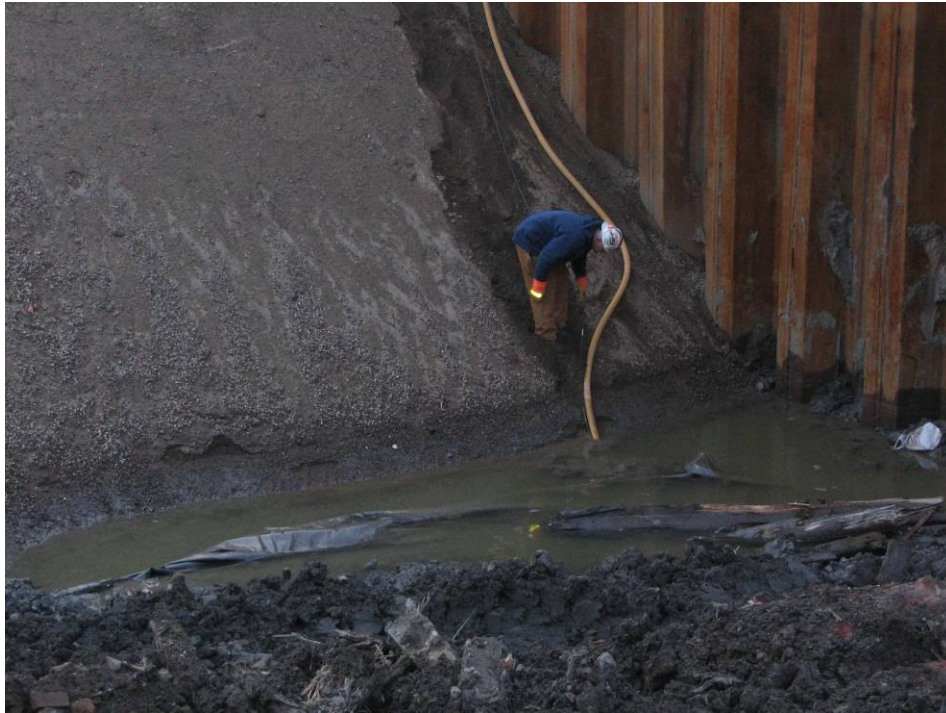
**Photograph No. 89: January 10, 2006 - Moretrench worker moving mobile sumps to area with surface water accumulation during dewatering activities.**

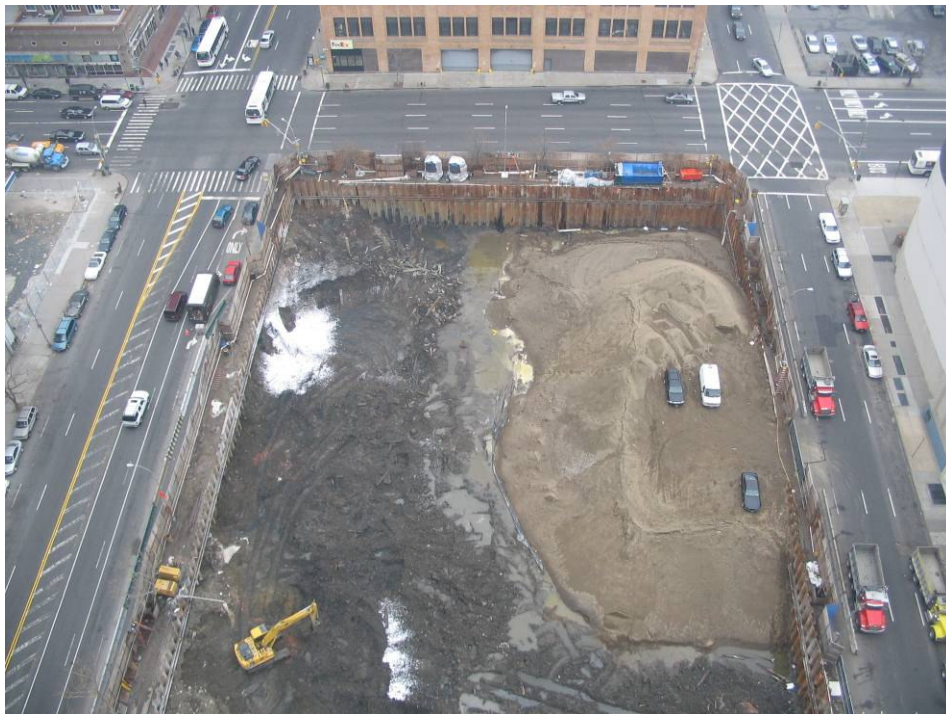
**Photograph No. 90: January 11, 2006 - Aerial view of site (view east) from RiverPlace I 32<sup>nd</sup> floor observation deck. Note RCA stockpile along southern perimeter.**

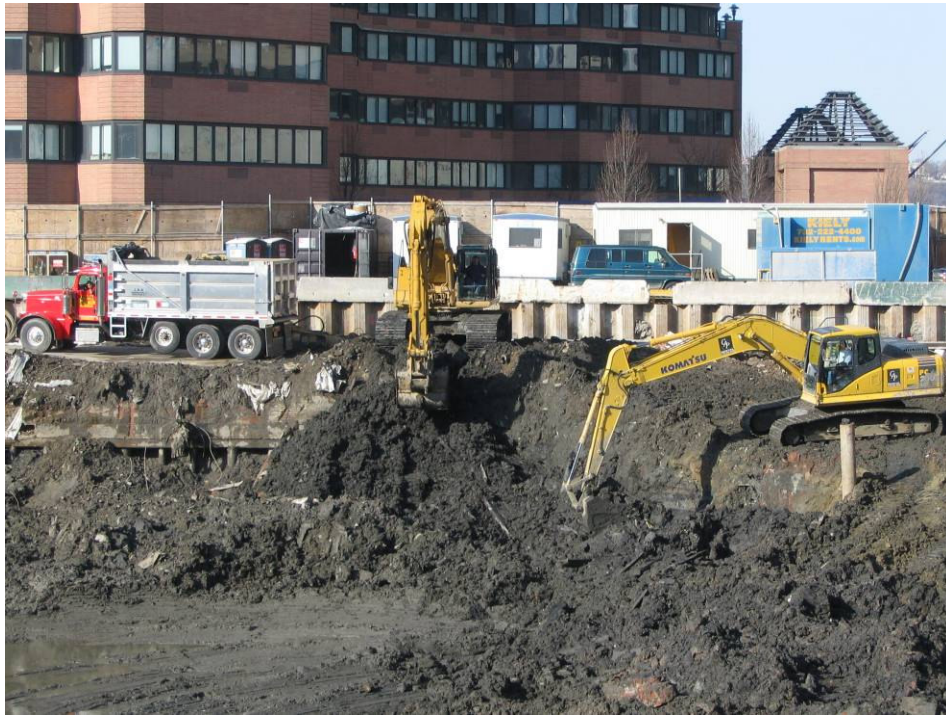
**Photograph No. 91: January 12, 2006 - View of excavators working in tandem to load-out material along northern and western perimeter of Site.**

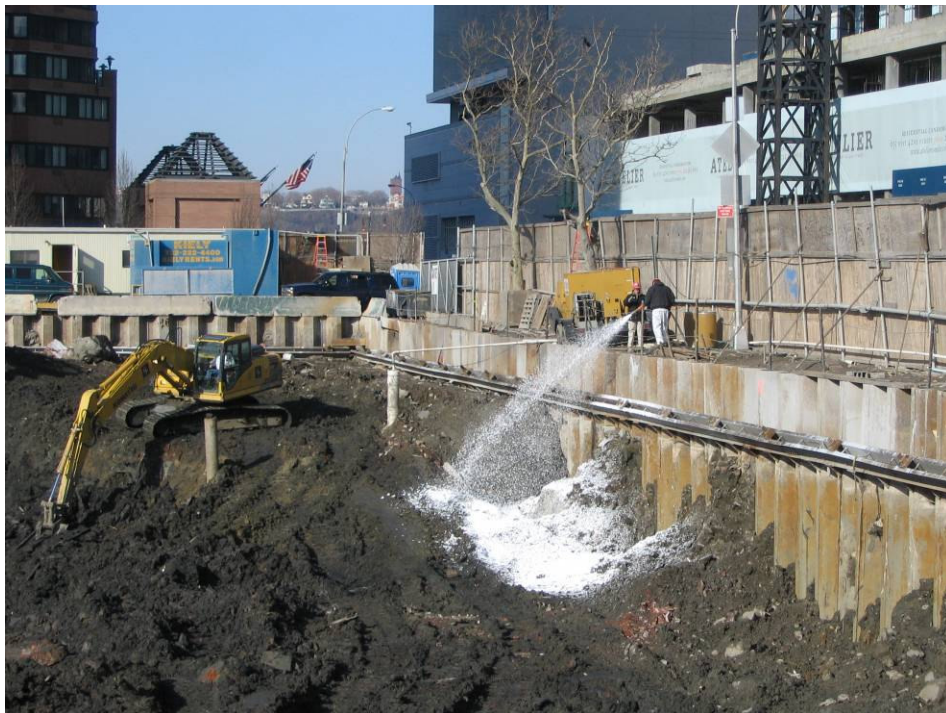
**Photograph No. 92: January 12, 2006 - Foam being applied as excavator works in northwestern corner of Site.**

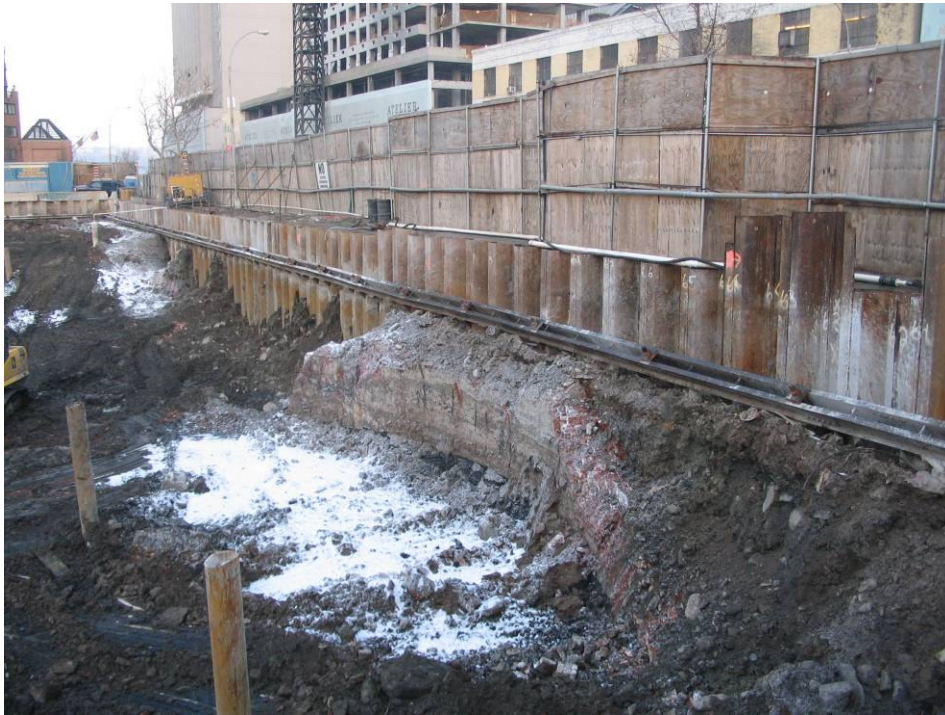
**Photograph No. 93: January 13, 2006 - View of remnant of northeast MGP holder wall (view towards northwest).**

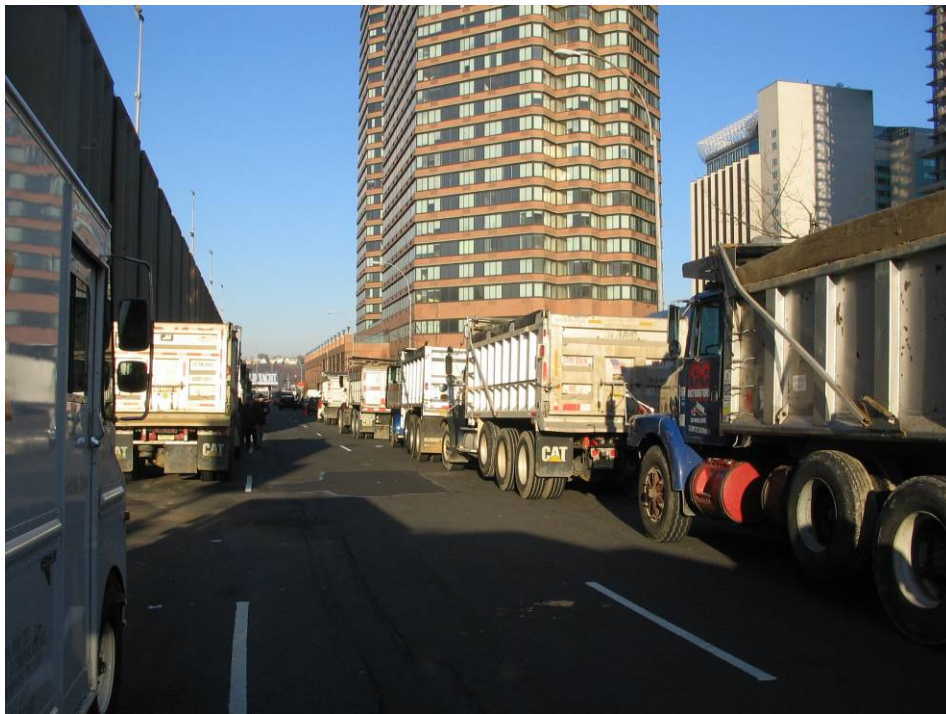
**Photograph No. 96: View of trucks queued along West 41<sup>st</sup> Street (view west).**

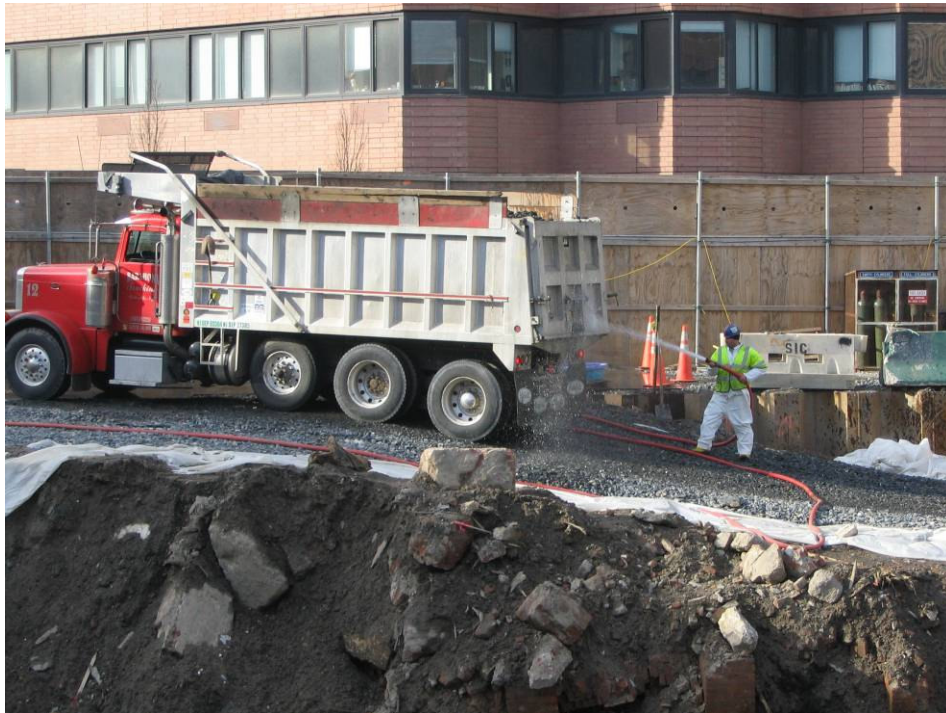
**Photograph No. 97: January 20, 2006 – View of alternate truck wash down operation occurring on stone haul road (trucks are exiting onto West 41<sup>st</sup> Street).**

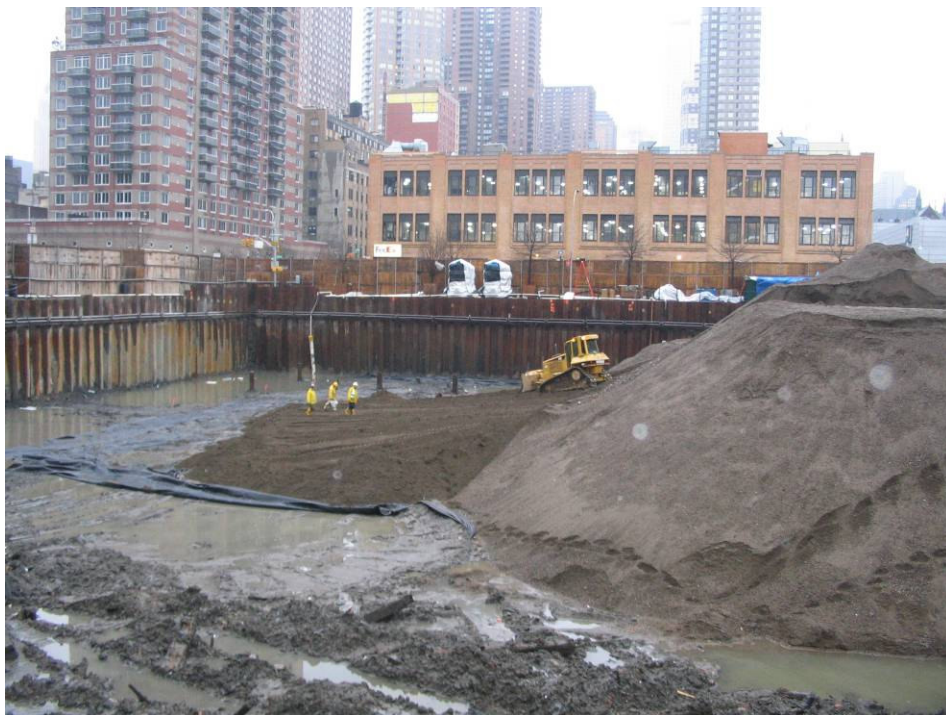
**Photograph No. 98: January 23, 2006 – RCA being spread out over emplaced Mirafi 500 geotextile fabric (view northeast).**

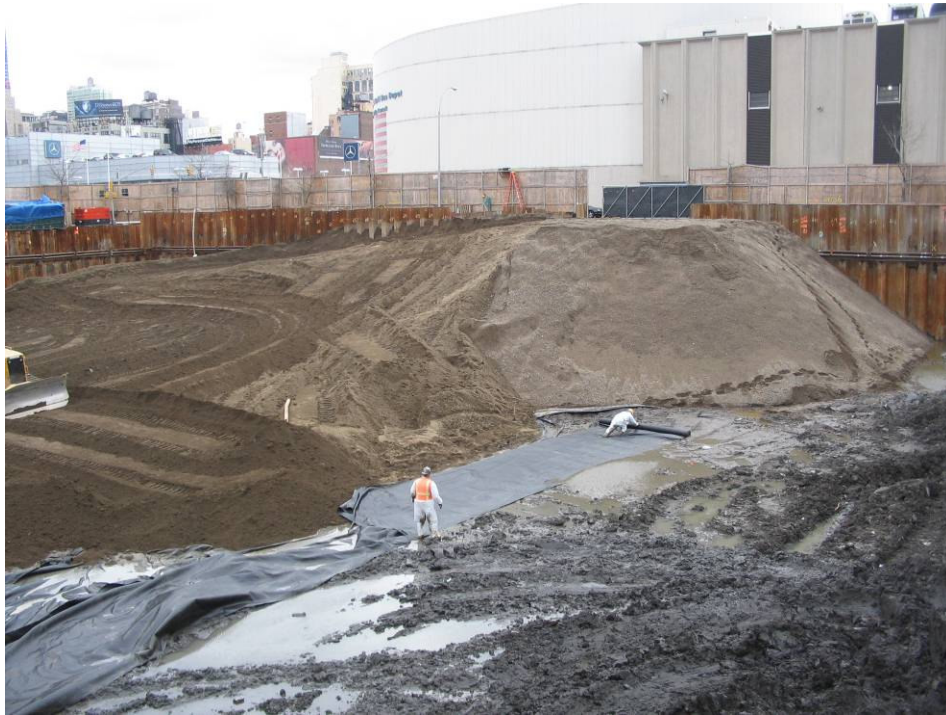
**Photograph No. 99: January 25, 2006 – Workers spreading Mirafi 500 geotextile fabric over bottom of excavation (view south-southeast).**

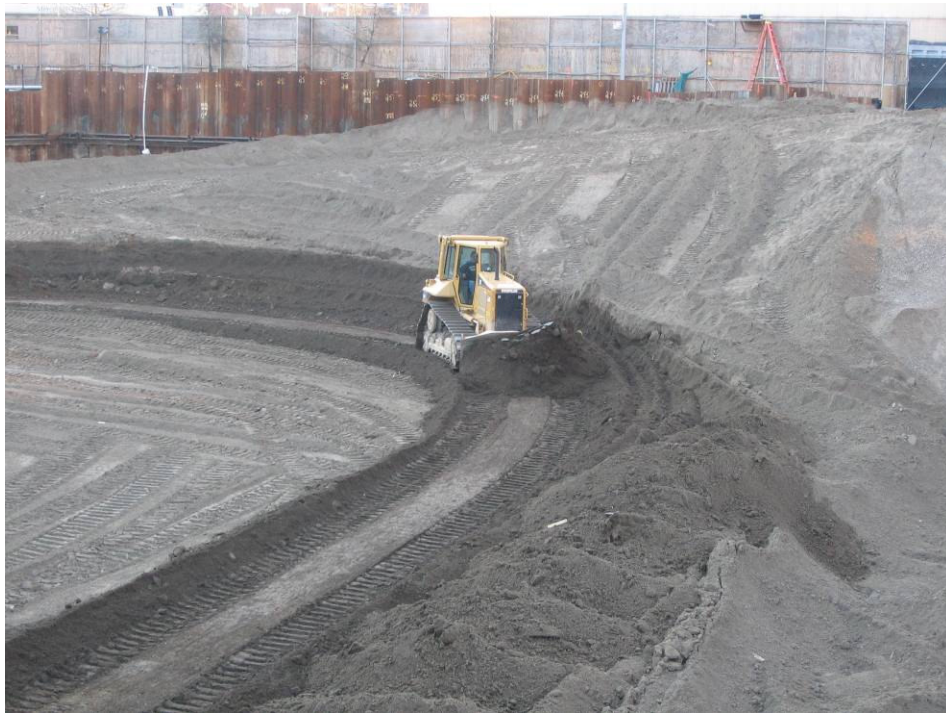
**Photograph No. 100: January 26, 2006 – The bulldozer in action spreading out RCA.**

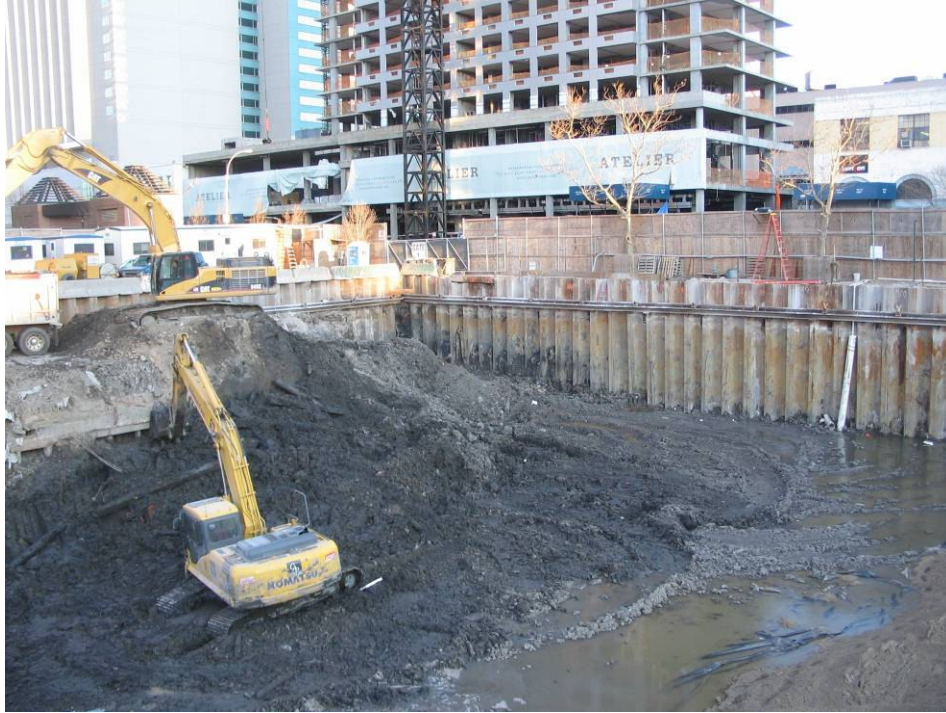
**Photograph No. 101: January 26, 2006 – Material load-out operations occurring along western perimeter (view northwest).**

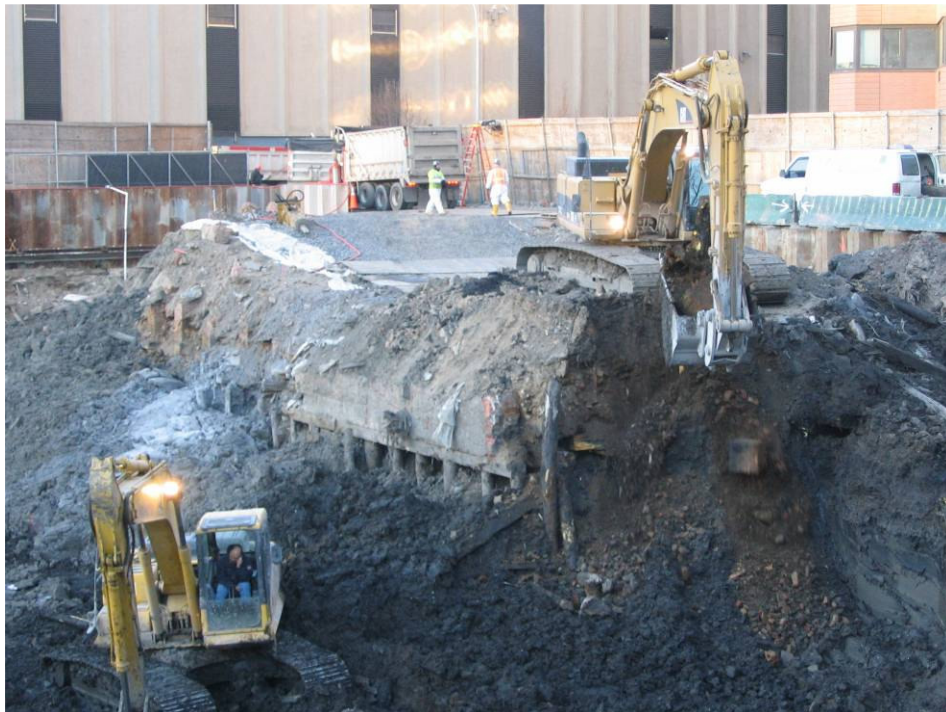
**Photograph No. 102: January 27, 2006 – Excavating the former Purifying House foundation (view south-southwest).**

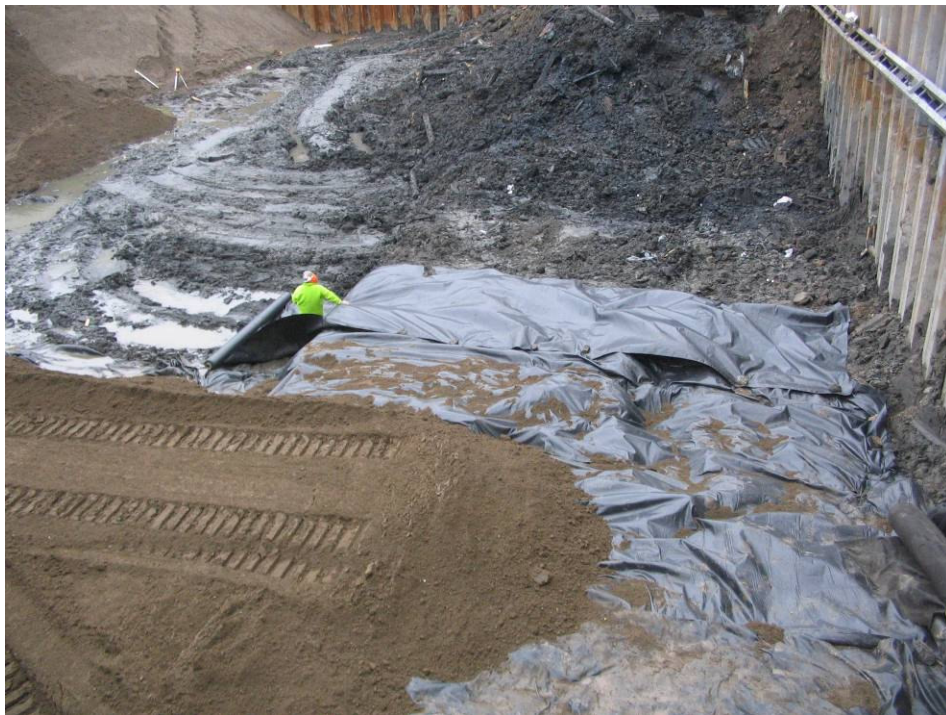
**Photograph No. 104: January 31, 2006 – Worker emplacing Mirafi 500 geotextile fabric atop the westernmost portion of the excavation. Note that this portion of the Site was excavated to approximately el -8.5 (remainder of Site excavated to el -13).**

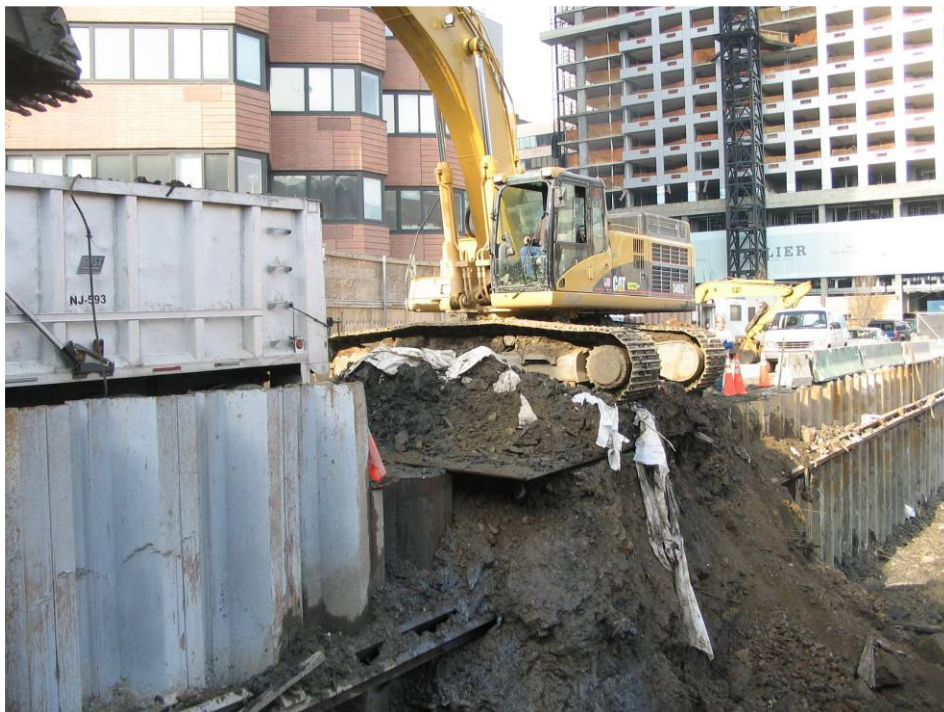
**Photograph No. 106: February 2, 2006 - The last bit of MGP material to be excavated. View is of southwest corner of Site looking towards the northwest.**

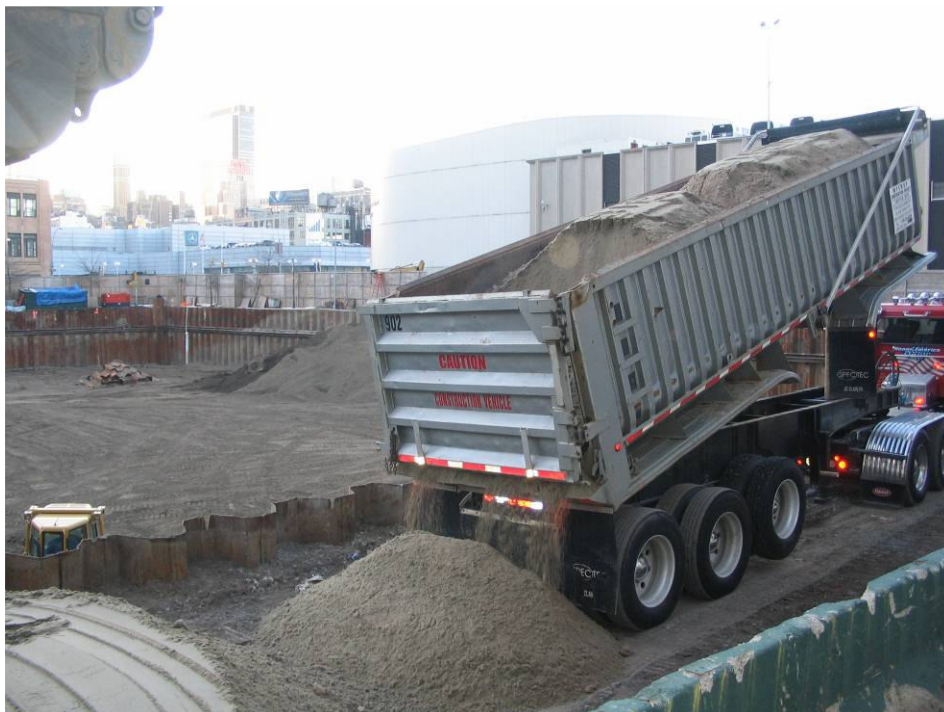
**Photograph No. 108: February 9, 2006 – Delivery of imported sand from New York Sand and Stone to infill roadway from Gate 1 to Gate 2 (view southeast).**

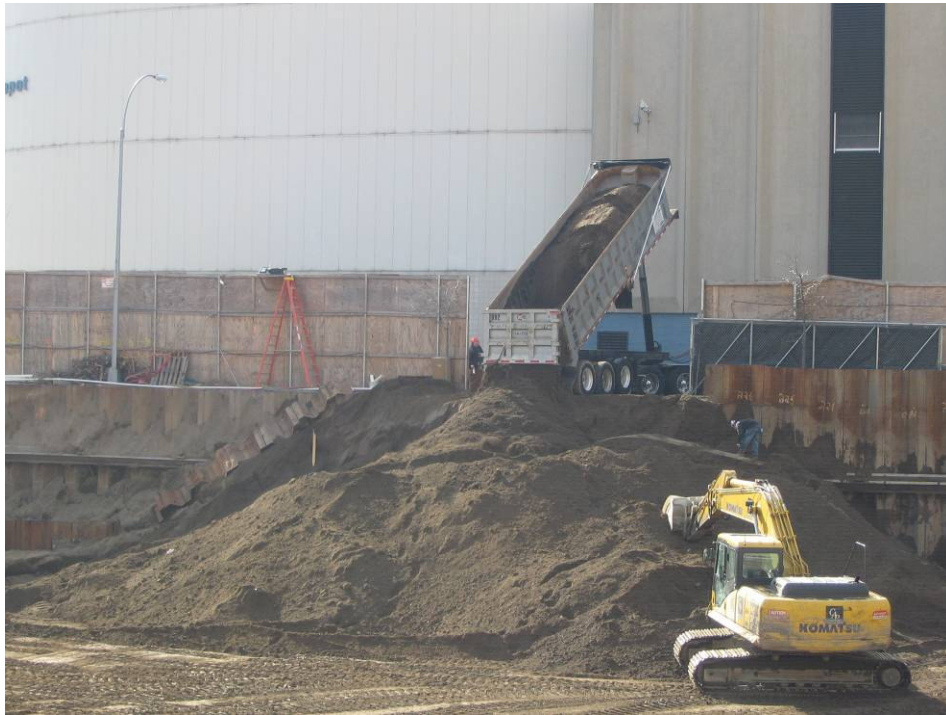
**Photograph No. 109: February 8, 2006 – View of RCA delivery through Gate 4 (view south).**

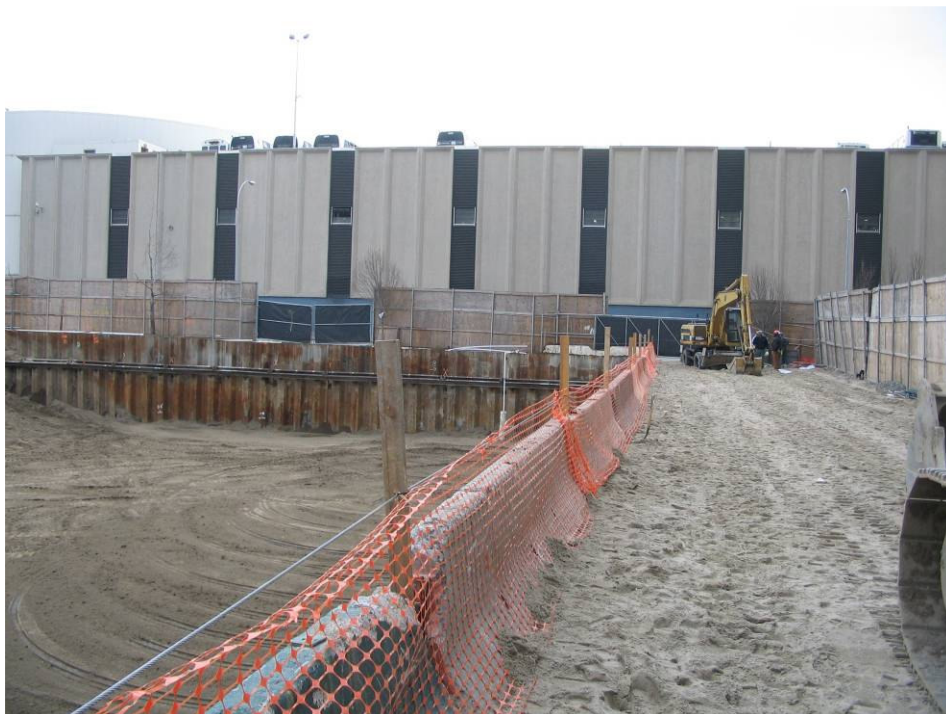
**Photograph No. 110: February 10, 2006 – View of roadway between Gate 1 and Gate 2, with fall protection in place, after import of sand from New York Sand and Stone (view south).**

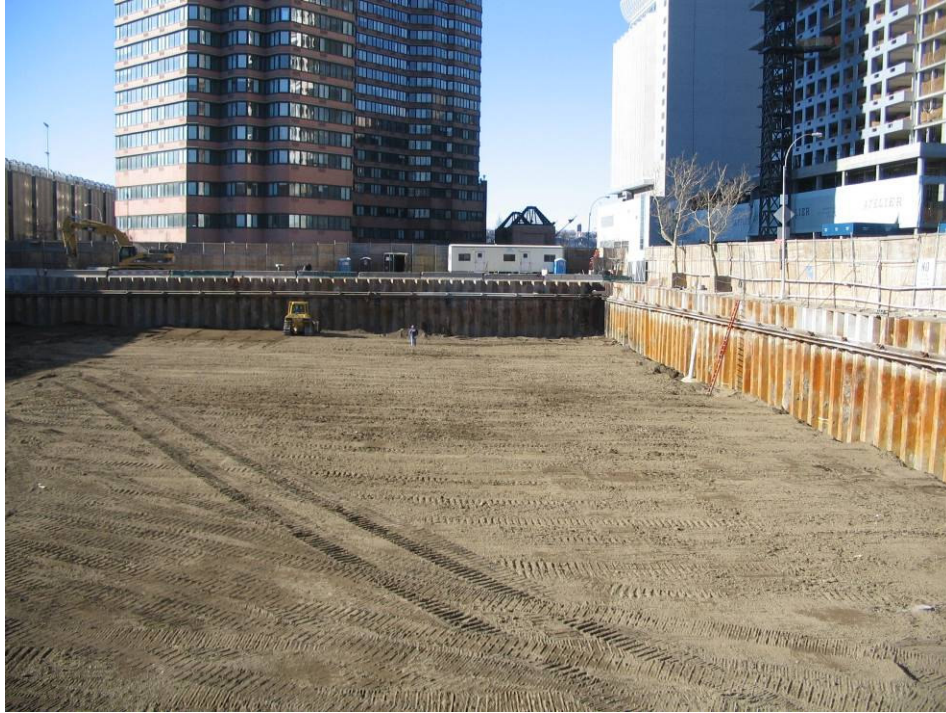
**Photograph No. 111: February 9, 2006 – View of Site at conclusion of field activities (view west).**

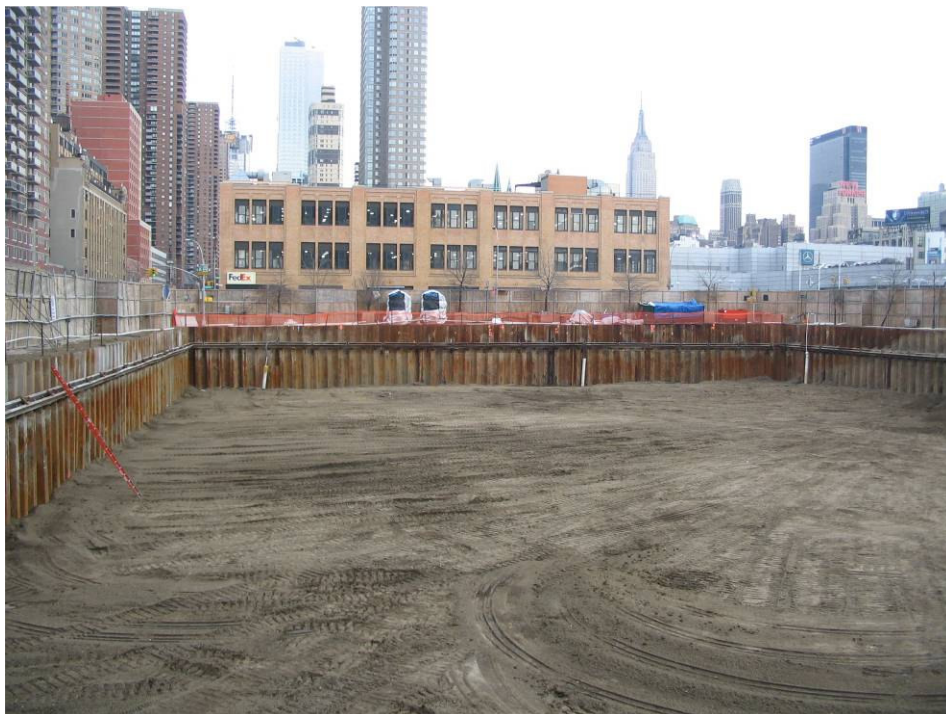
**Photograph No. 112: February 9, 2006 – View of Site at conclusion of field activities (view east).**
