SSDS As-Built Drawings – Building 6

THE SHOPS AT ATLAS PARK **BUILDING 6 SUB-SLAB DEPRESSURIZATION SYSTEM AS-BUILT DRAWINGS QUEENS, NEW YORK**

Re: Atlas Park Sub-Slab Evaluation and Smoke Test Buildings 4 & 6, Glendale, Queens, NY LEA Project #05-323

Re: Atlas Park Sub-Slab Evaluation and Smoke Test Buildings 6 & 7, Glendale, Queens, NY LEA Project #05-323

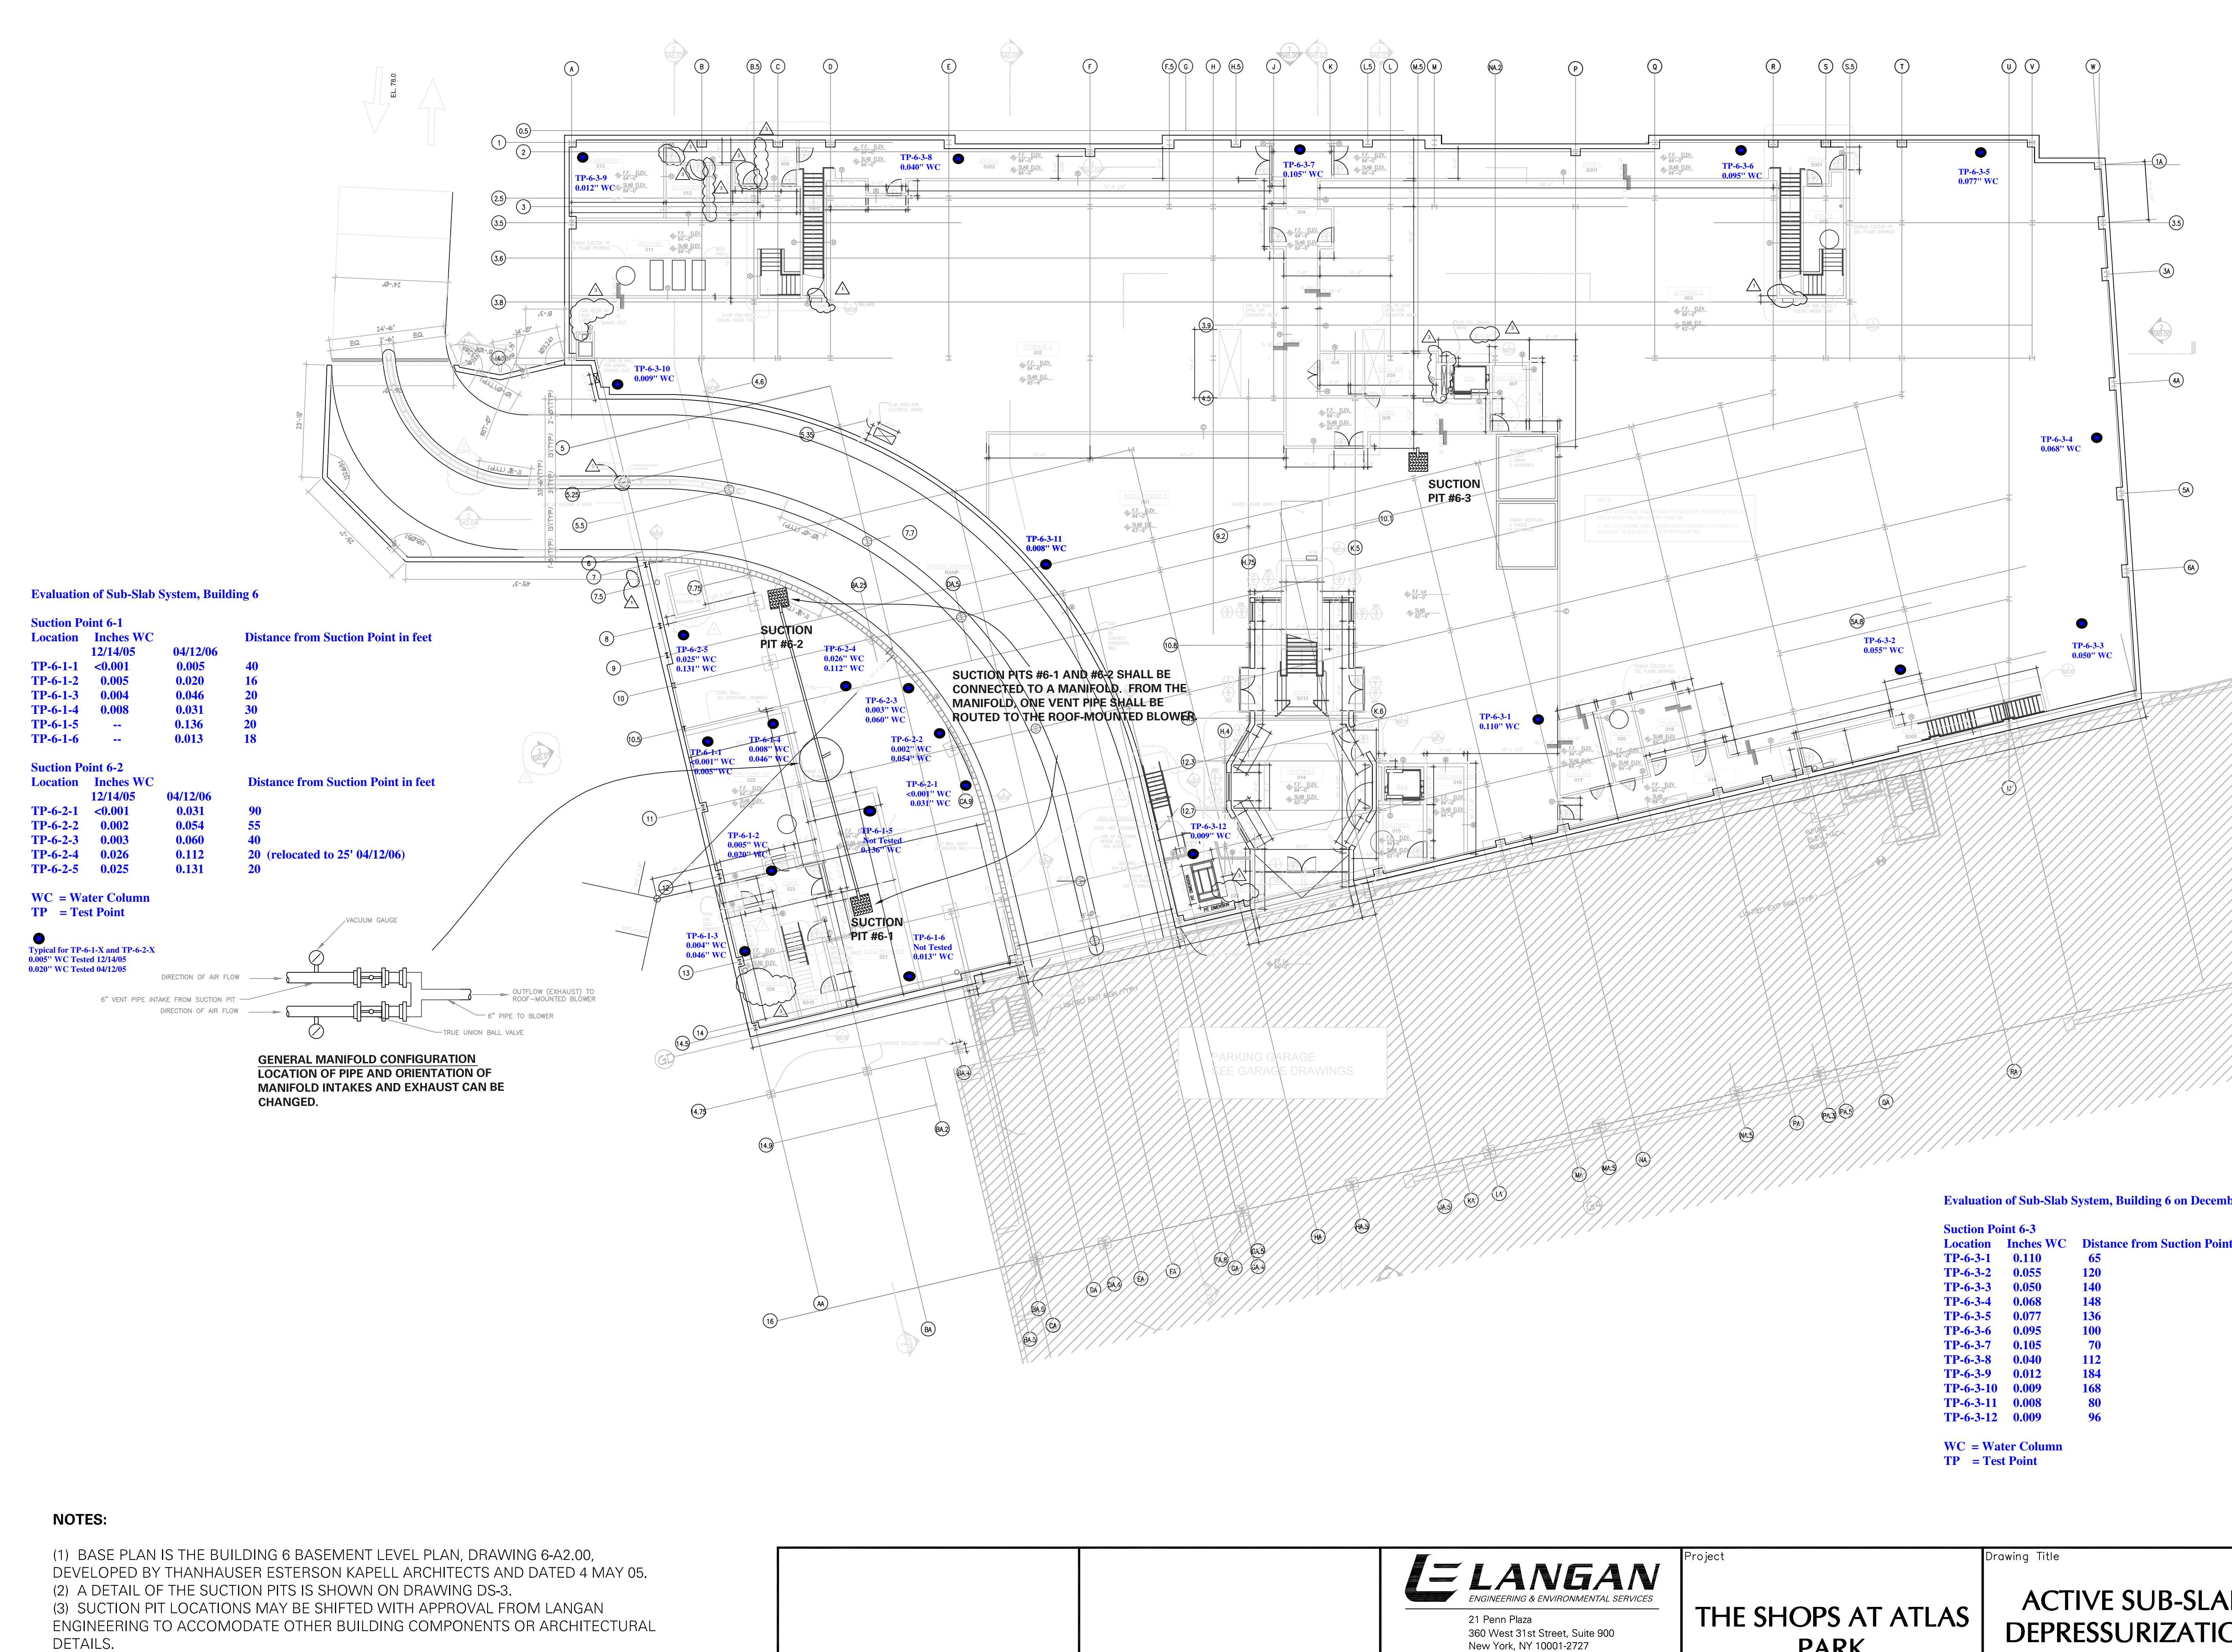
- 1. An inspection of risers and suction pits found all locations complete, with no deficiencies noted.
- 2. A number of deficiencies in the slab were noted near suction pits 6-1 and 6-2. These consisted of non-caulked joints along the parking garage wall in the 6-2 floor and several areas missing a concrete slab in the 6-1 floor. Sewer or drainage sumps noted near 6-1 are not connected with the sub slab, as smoke did not get drawn into openings at grade.
- 3. With the exception of deficiencies noted in the concrete slabs near suction pits 6-1 and 6-2, smoke testing did not observe any drawdown of smoke into the slab along expansion joints, cracks, piping protrusions and other likely points of connection to the sub-slab.

4. A quantitative evaluation of the effectiveness sub-slab system to create a measurable negative pressure field that extends throughout the sub-slab(s) of each building found satisfactory negative pressure fields in slabs treated by suction pits 4-1 and 6-3. The slabs serviced by suction pits 6-1 and 6-2 failed the test. Vacuum measured at the pipe leading into suction pit 6-1 was 0.117 inches of water and was similarly low at 6-2. With a vacuum at the blower specified at 35 inches of water, there was an obvious system malfunction. There was no measurable negative pressure field beyond forty feet from suction pit 6-1. There was no measurable negative pressure field and beyond ninety feet from suction pit 6-2.

A re-evaluation of the effectiveness of suction pits 6-1 and 6-2 should be completed after repairs have been made to the system blower, valves and/or slab and joints. The actual date of system evaluation will be based on weather conditions favorable to performance of the tests in an environment open to the weather, e.g. in the absence of heavy winds that could affect the results of the evaluation.
