**Interim Remedial Measures
Construction Completion Report**

**Former Johnny on the Spot Cleaners
152-153 10th Avenue
Whitestone, NY 11357
Brownfield Cleanup Program
Site #C241125**

August 12, 2022

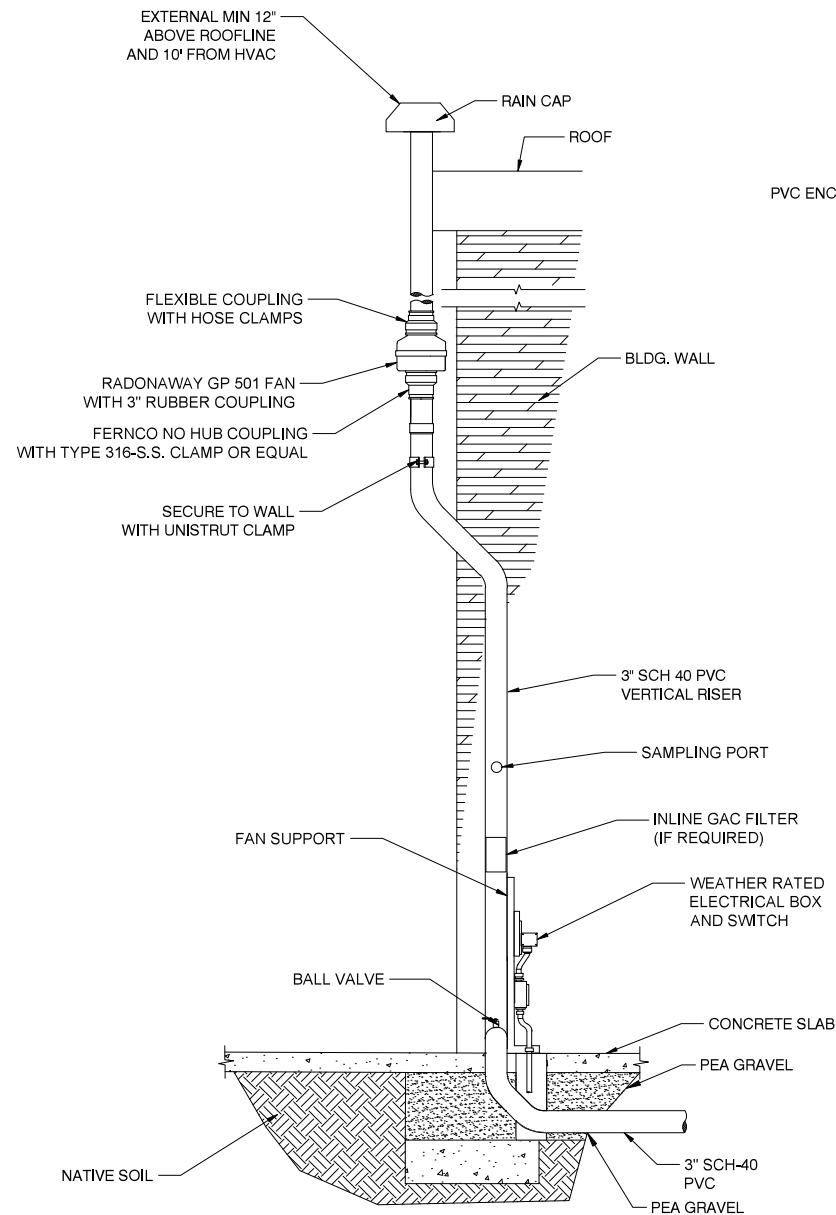
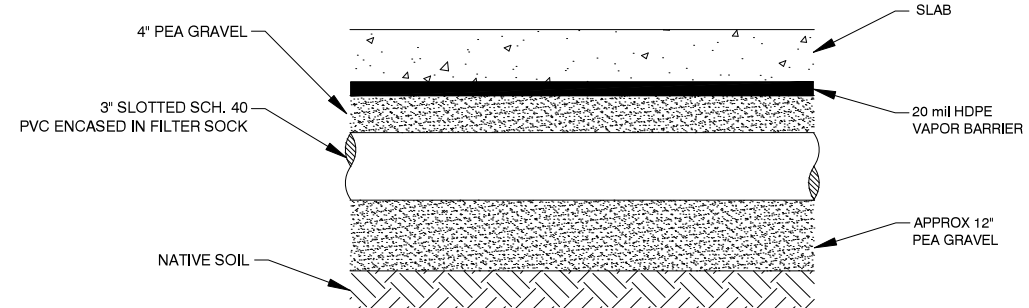
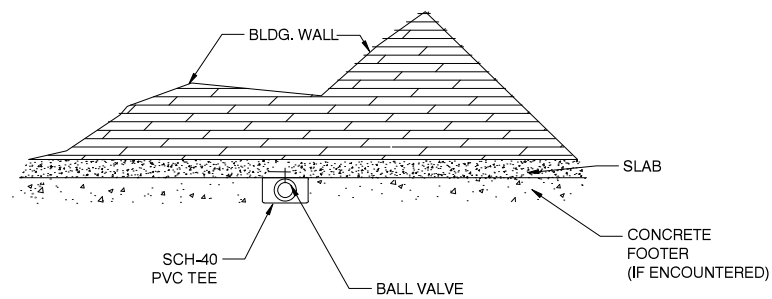
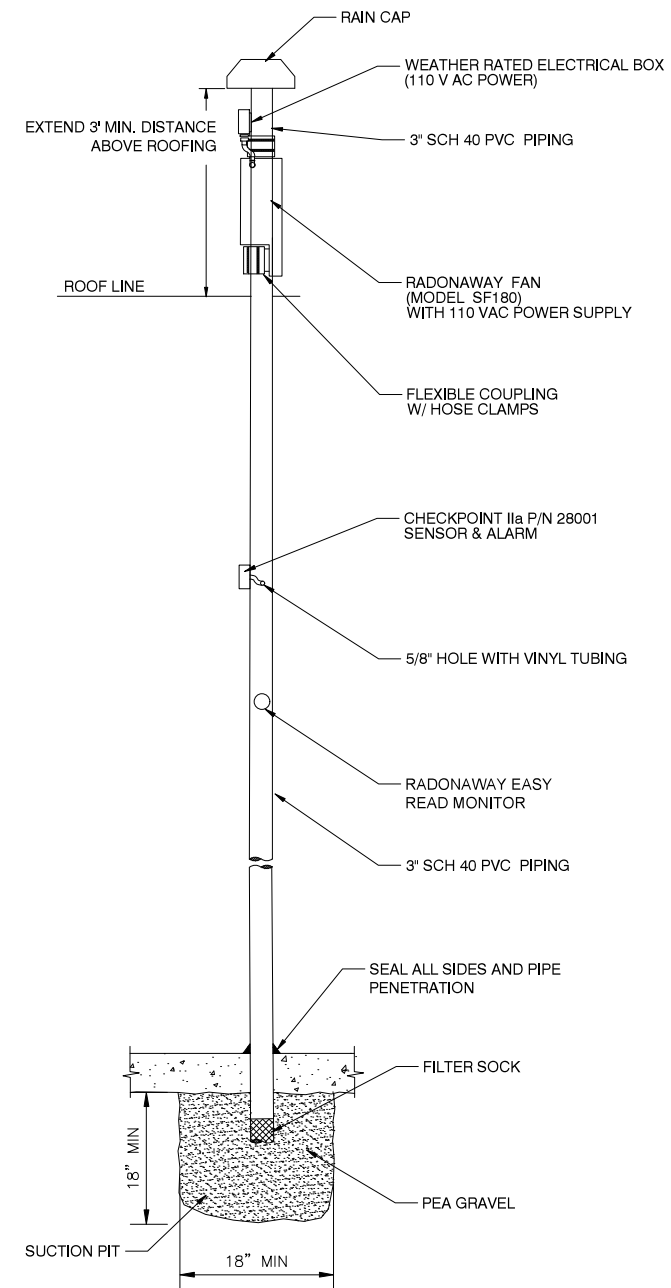
SUBSLAB
DE-PRESURIZATION SYSTEM
DETAILS

- The sections of solid vertical pipe associated with the systems in the former dry cleaner were designed to exit the building below the foundation and then go up the outside wall. However, during the January 2019 work, due to the thickness of the foundation, it was decided to bring the vertical section up along the inside wall, then through, and up the outside wall. Details of this configuration are shown on Figure 5.

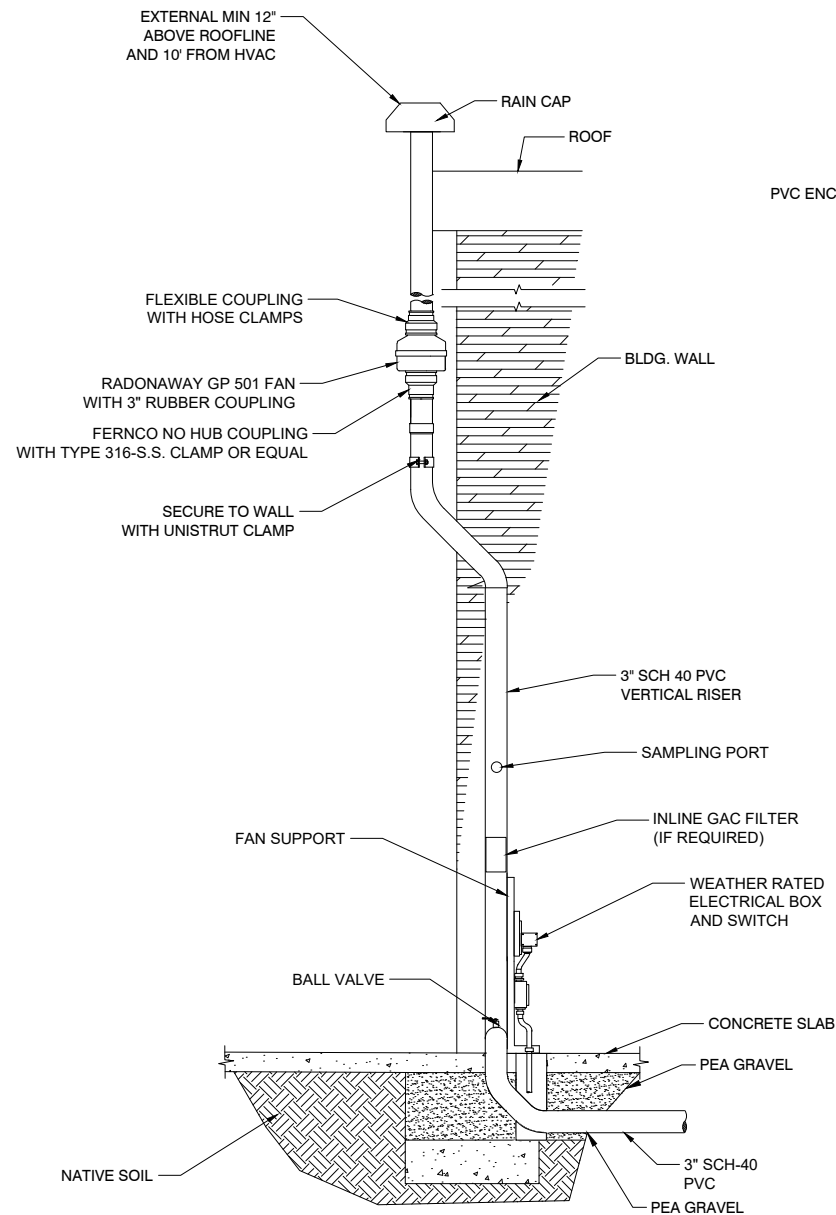
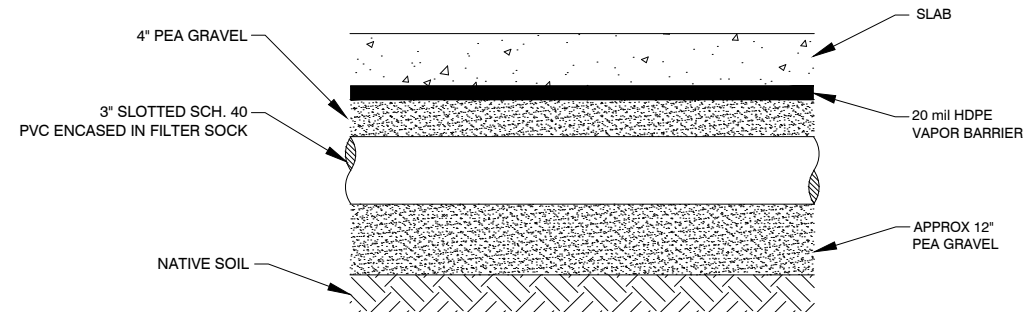
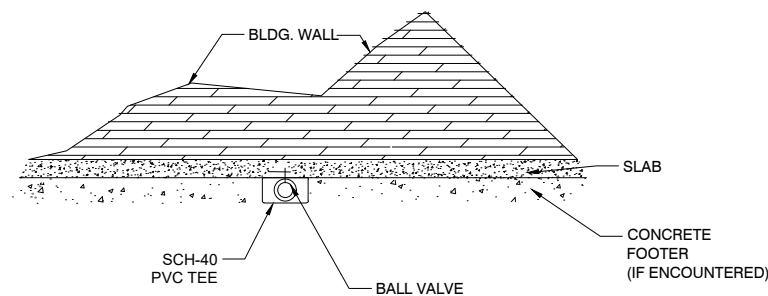
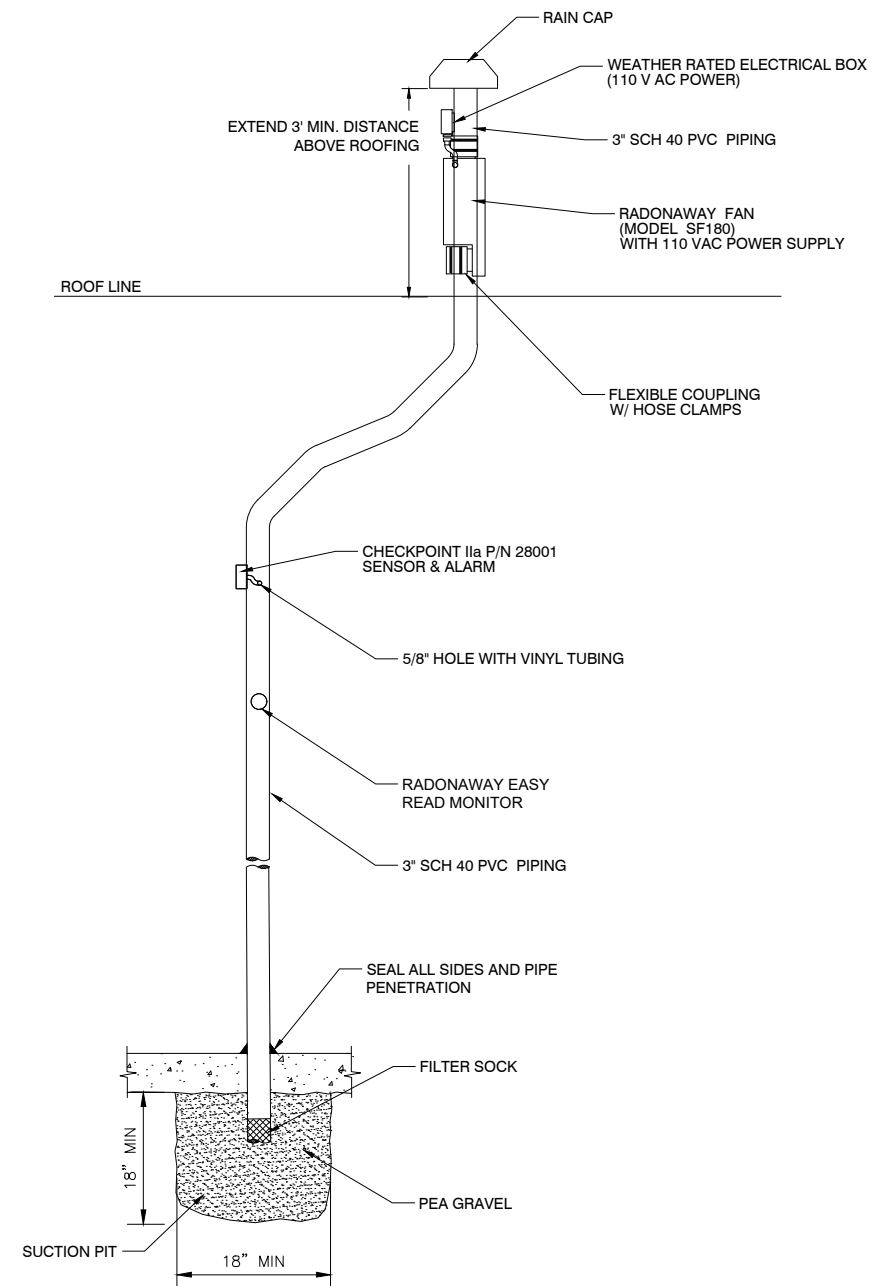
FIGURE:
5A

The tests conducted by Stantec on this relocated System C SSDS indicated that, although it was creating a vacuum under the slab, it did not seem to be running as efficient as the original location. The air flow coming out of the fan on the roof after the re-location has been measured at 5 cubic ft per minute (CFM). This compared to 15 CFM before it was moved (i.e., the original location). Therefore, Stantec and Jam Plumbing returned to the Rehab Center to evaluate the existing piping. The fan was turned off, the piping taken apart both above the floor and below the fan, and a flashlight used to look up and down the pipe. No blockage was observed. So, as the piping was put back together, the current two 90-degree bends at the ceiling were replaced with a series of angled pipes to create a smoother flow. A photo of this new configuration is presented on the Photolog in Appendix E. Details of this configuration are shown on Figure 5a.
