RE: Reiley Building

# Ecosystems Strategies, Inc.

Re: Summary Letter-Report Regarding Environmental Conditions on the Reilly's Garage  
Property Located on Main Street in the Village of Pawling, Dutchess County, New York  
Our File: RP9433.10

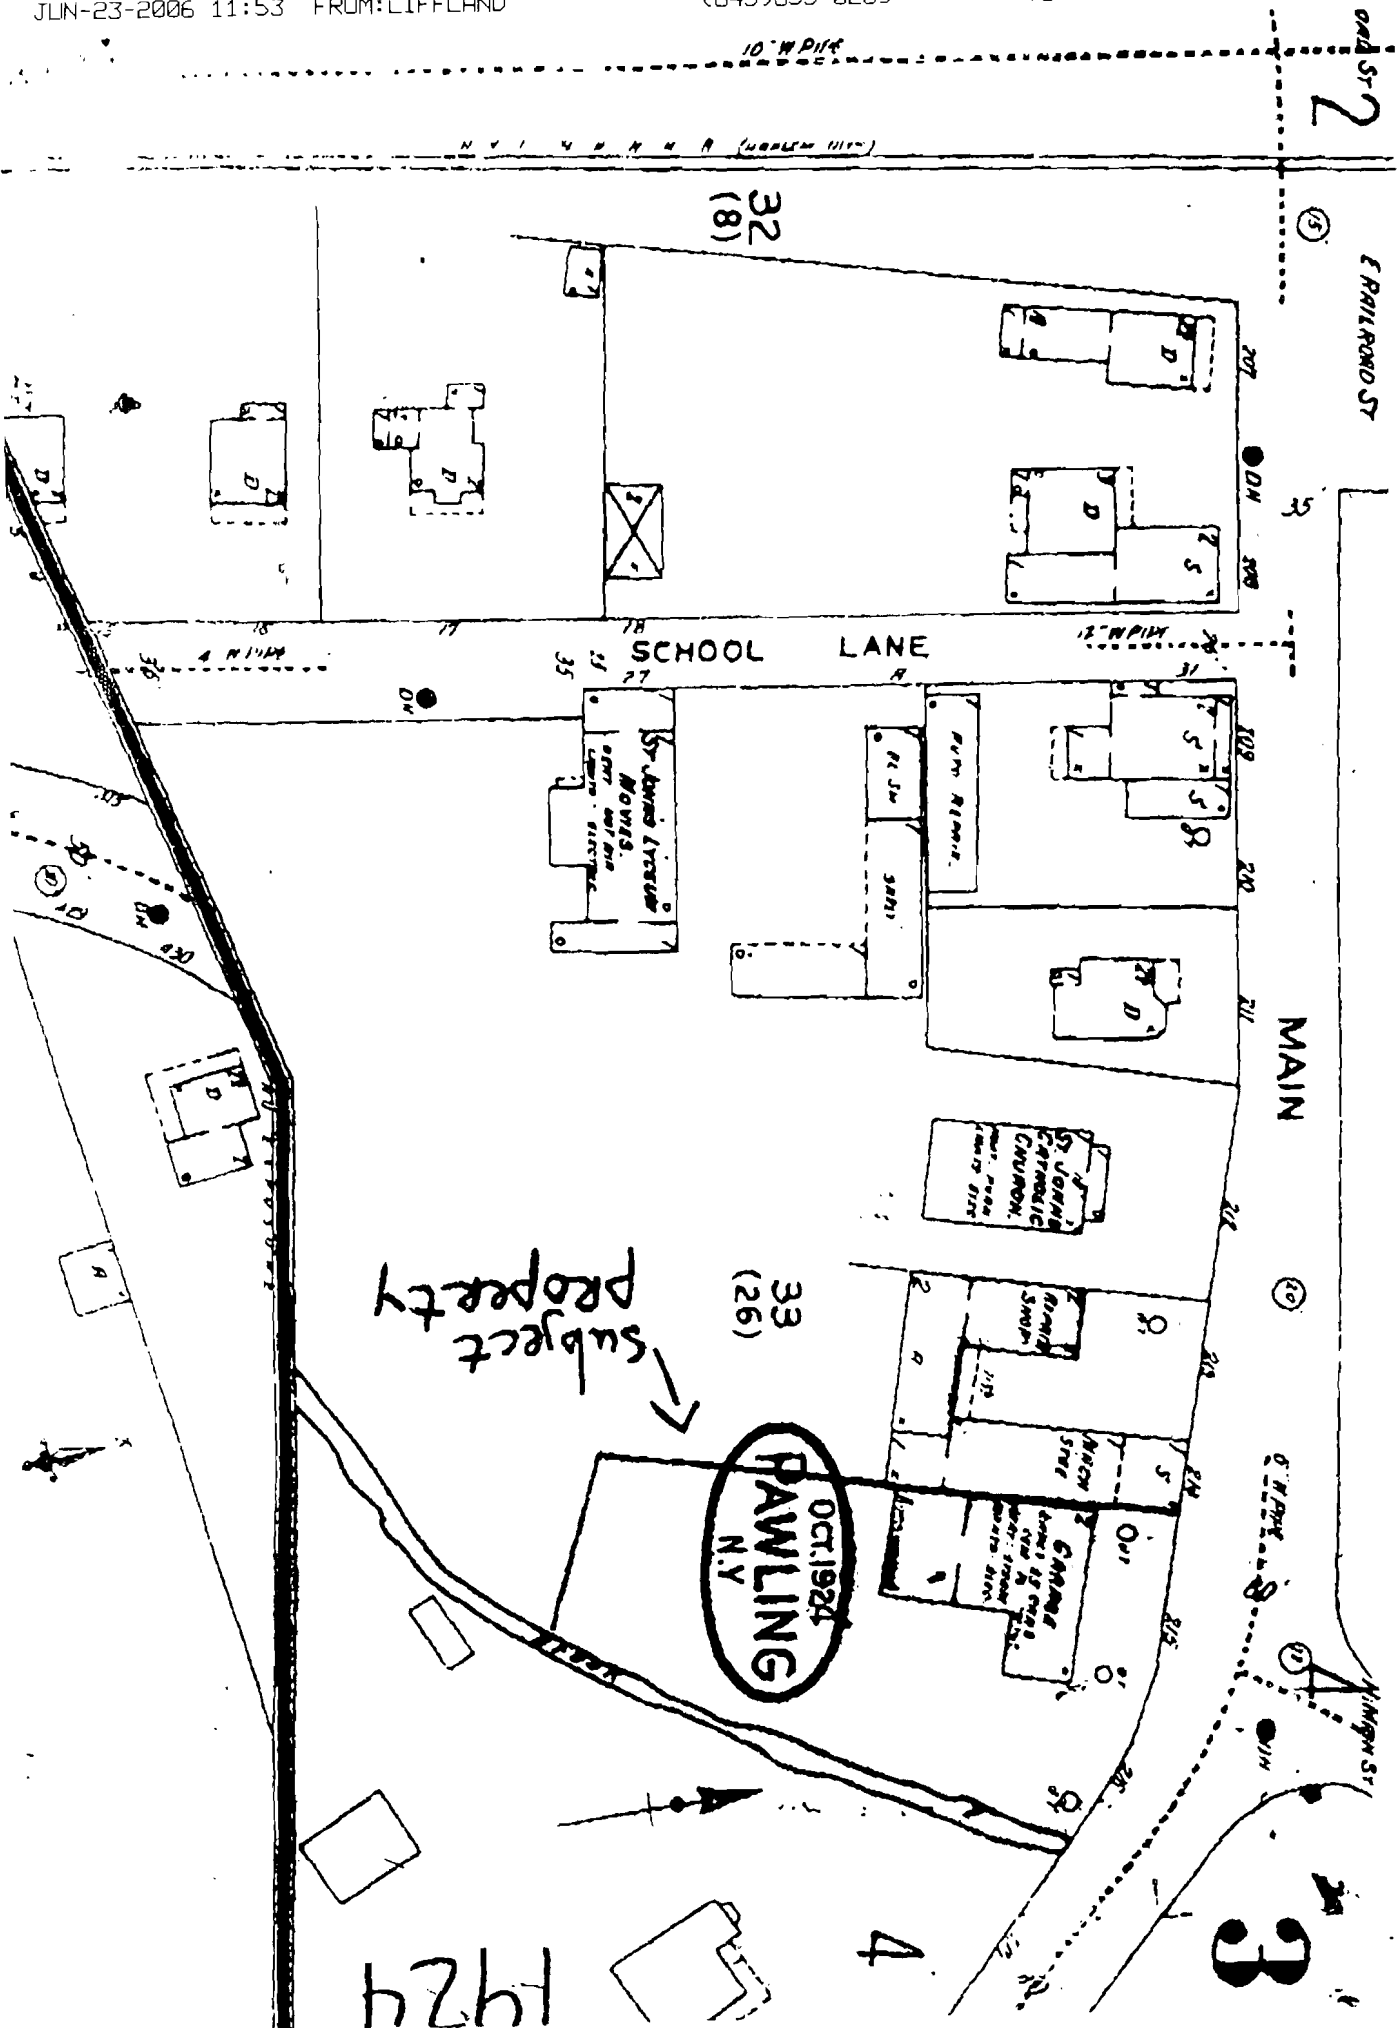
A series of subsurface borings were located on the subject property on June 1, 1994 to document soil conditions. The borings were located in the general vicinity of the known underground gasoline and waste oil tanks.

Based on the laboratory results forwarded to this office, soil in the immediate vicinity of the on-site gasoline tank is significantly contaminated with toluene, ethyl benzene and xylenes. These three compounds are primary constituents of gasoline, suggesting their presence in the soil is a result of a leaking tank. Samples B-1, B-2, B-5 and B-7 showed total xylenes concentrations exceeding 100,000 parts per billion (ppb). Contamination was less extensive at borings B-6 and B-3, which were located further away from the on-site gasoline tank. Existing data indicate that contamination is present at levels warranting immediate action to minimize any on-going migration of contaminants.

- The two known tanks, and the third suspected tank if it is found to exist, should be removed from the subject property. Any saturated soil encountered in the immediate vicinity of the tanks at the time of their removal should be removed at the same time.
