Re: Periodic Review Report | CH - Kingston Gas Works | NYSDEC

Site No. C356017 | Kingston, New York

Engineering Controls Monitoring Checklist - Soil Cover and Sediment Cap Site Management Plan Central Hudson Gas & Electric Corporation

Kingston Former MGP Site, Kingston, New York

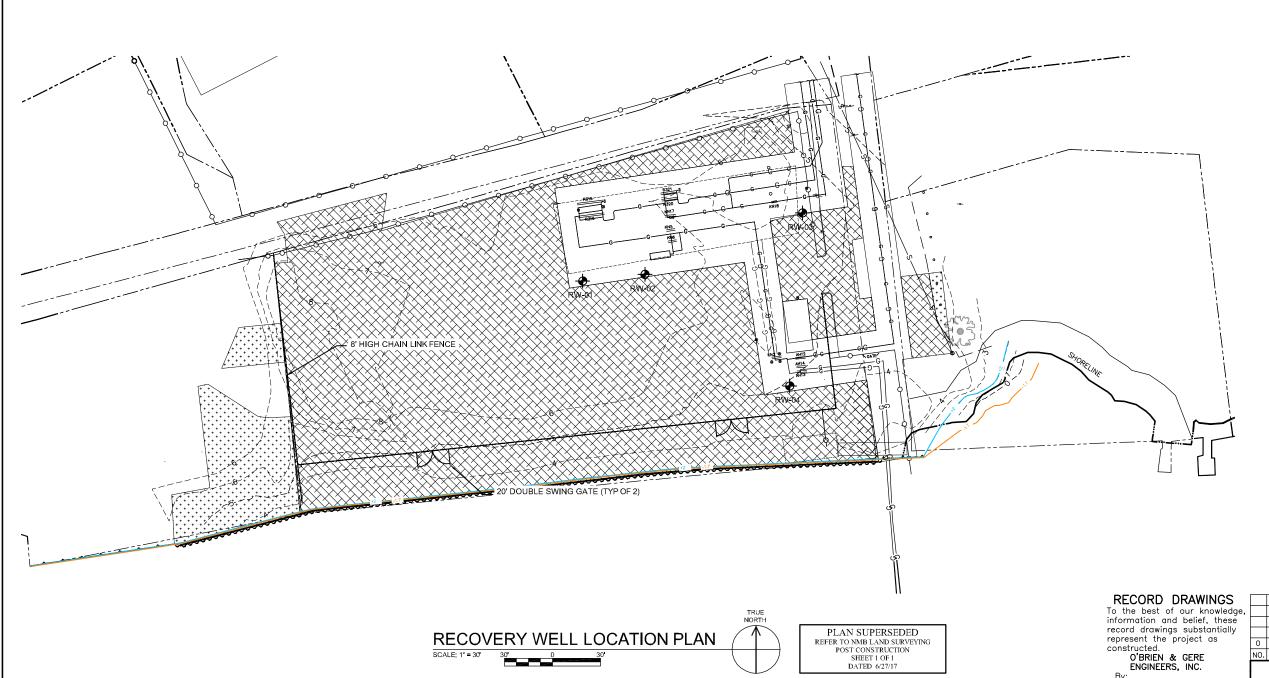
RECOVERY WELL LOCATION PLAN

Depth to water ranged from 4.27 feet below top of casing (fbtoc) to 4.65 fbtoc in monitoring wells RW-2 and RW-1/RW-4, respectively (Table 1). A heavy sheen was observed in RW-1 (approximately 0.10') and a light sheen was observed on the probe tip when gauging RW-2; however, NAPL thickness was not measurable.
