Re: Periodic Review Report | CH – Kingston Gas Works | NYSDEC  
Site No. C356017 | Kingston, New York  
File: 1126476.1940120091

This Periodic Review Report (PRR) was prepared by Ramboll Americas Engineering Solutions, Inc. (Ramboll) at the request of Central Hudson Gas & Electric Corporation (Central Hudson) to document the status of the Engineering Controls (ECs) and Institutional Controls (ICs) established in accordance with the November 2017, updated November 2021, Site Management Plan (SMP) for the Kingston Former Manufactured Gas Plant (MGP) Site (New York State Department of Environmental Conservation (NYSDEC) Site Number: C356017) located in Kingston, New York, and to provide a summary of information generated during the reporting period for the site. The reporting period for this PRR is May 25, 2025 through May 25, 2026. The SMP addressed the means for implementing and periodically inspecting ECs/ICs required by the remedy for the site.

**ATTACHMENT 1**  
**ENGINEERING CONTROLS MONITORING CHECKLIST**

| Engineering Controls Monitoring Checklist – Soil Cover and Sediment Cap Site Management Plan<br>Central Hudson Gas & Electric Corporation<br>Kingston Former MGP Site, Kin

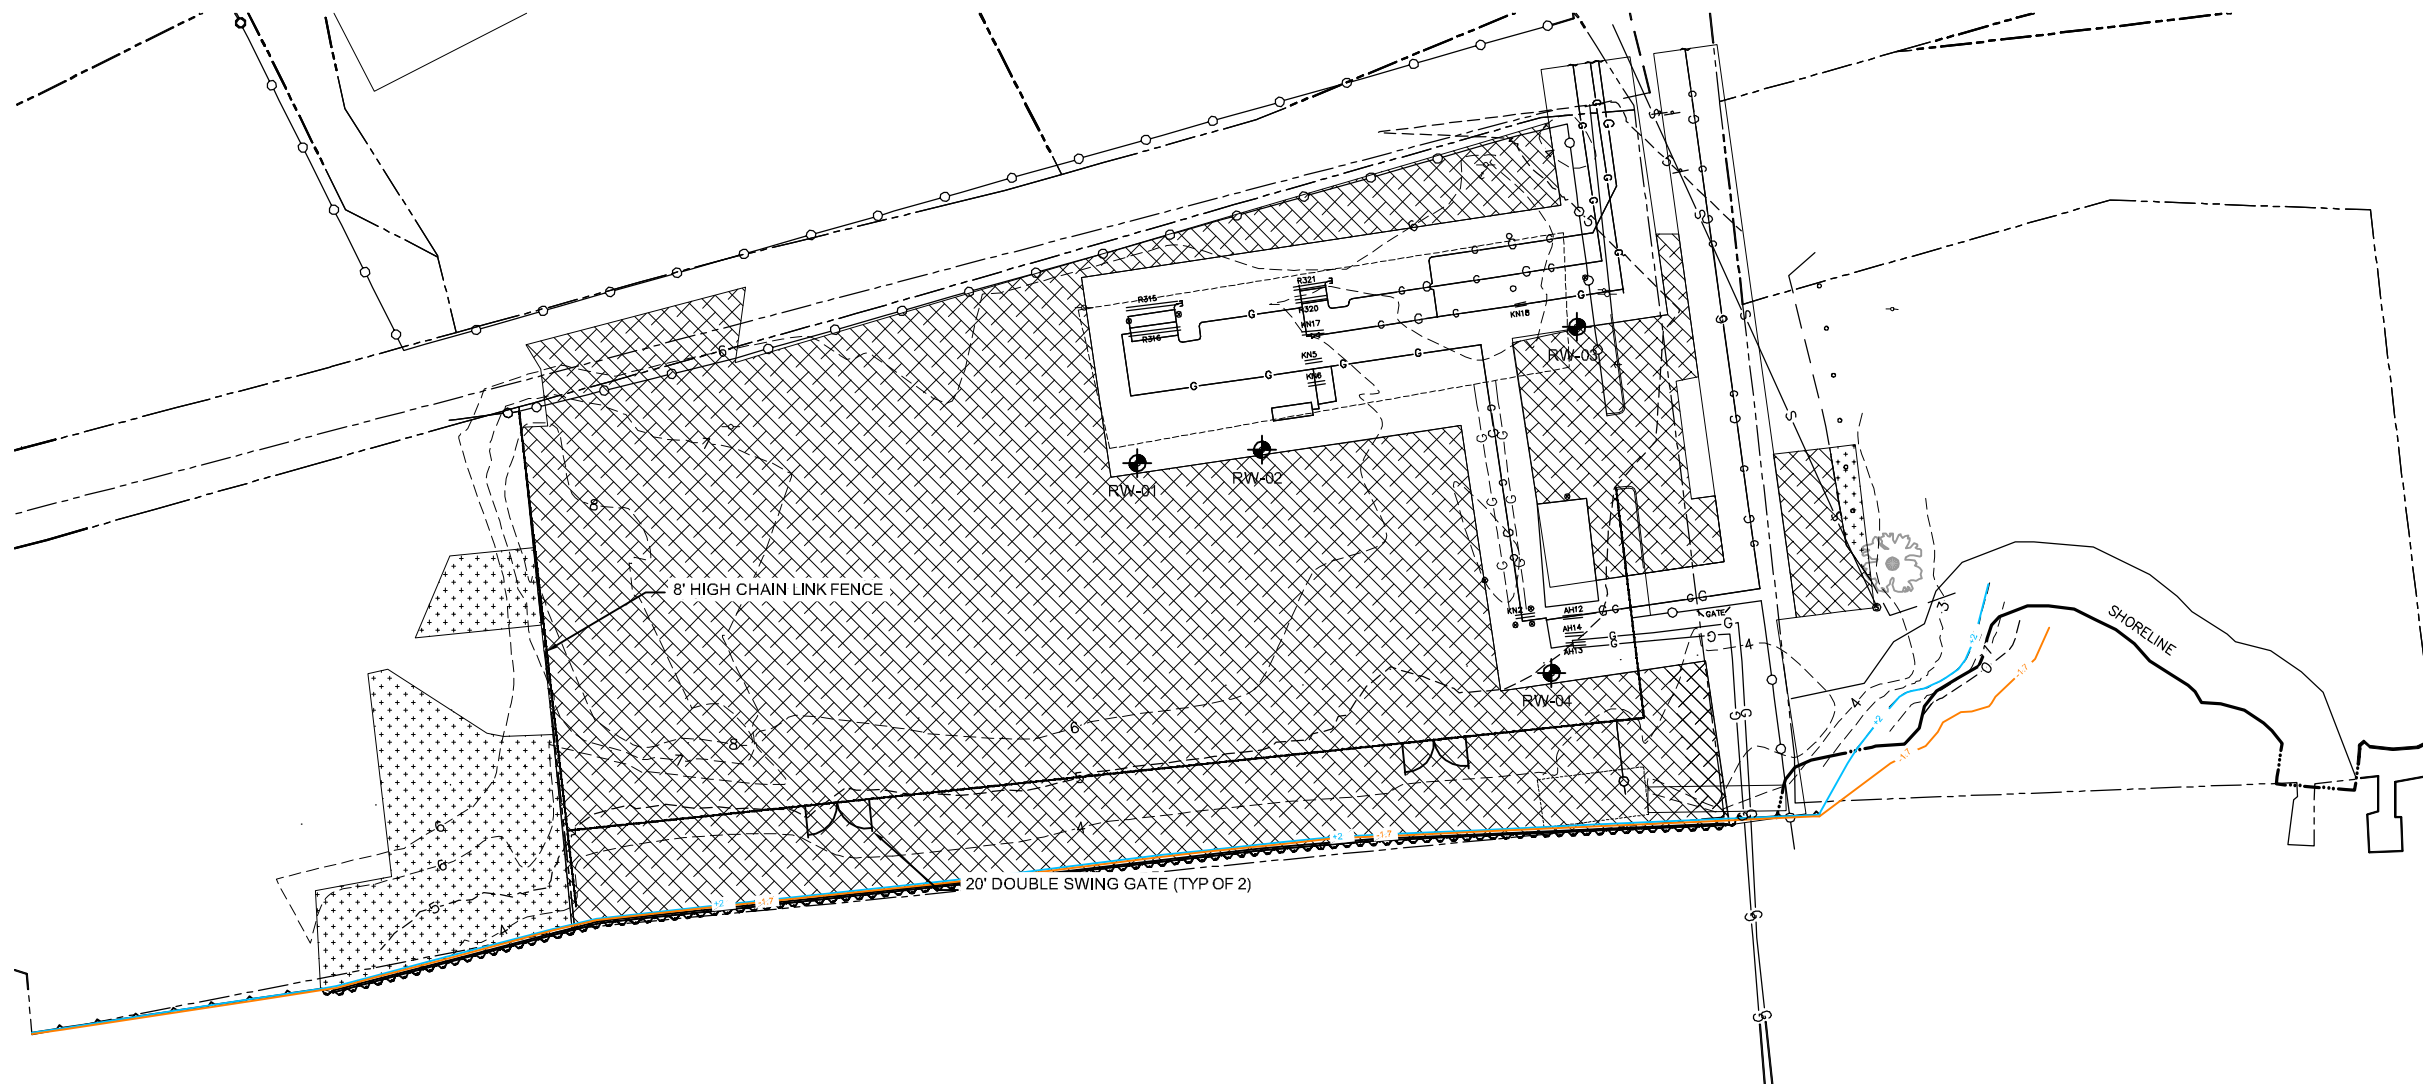
RECOVERY WELL LOCATION PLAN

Depth to water ranged from 4.95 feet below top of casing (fbtoc) to 5.44 fbtoc in monitoring wells RW-2 and RW-1, respectively (Table 1). A heavy sheen was observed in RW-1 (approximately 0.10') and a light sheen was observed on the probe tip when gauging RW-2; however, NAPL thickness was not measurable.
