July 25, 2012

Re: Identification of Petroleum Product in Sump
Flamingo Cleaners, New Rochelle, NY

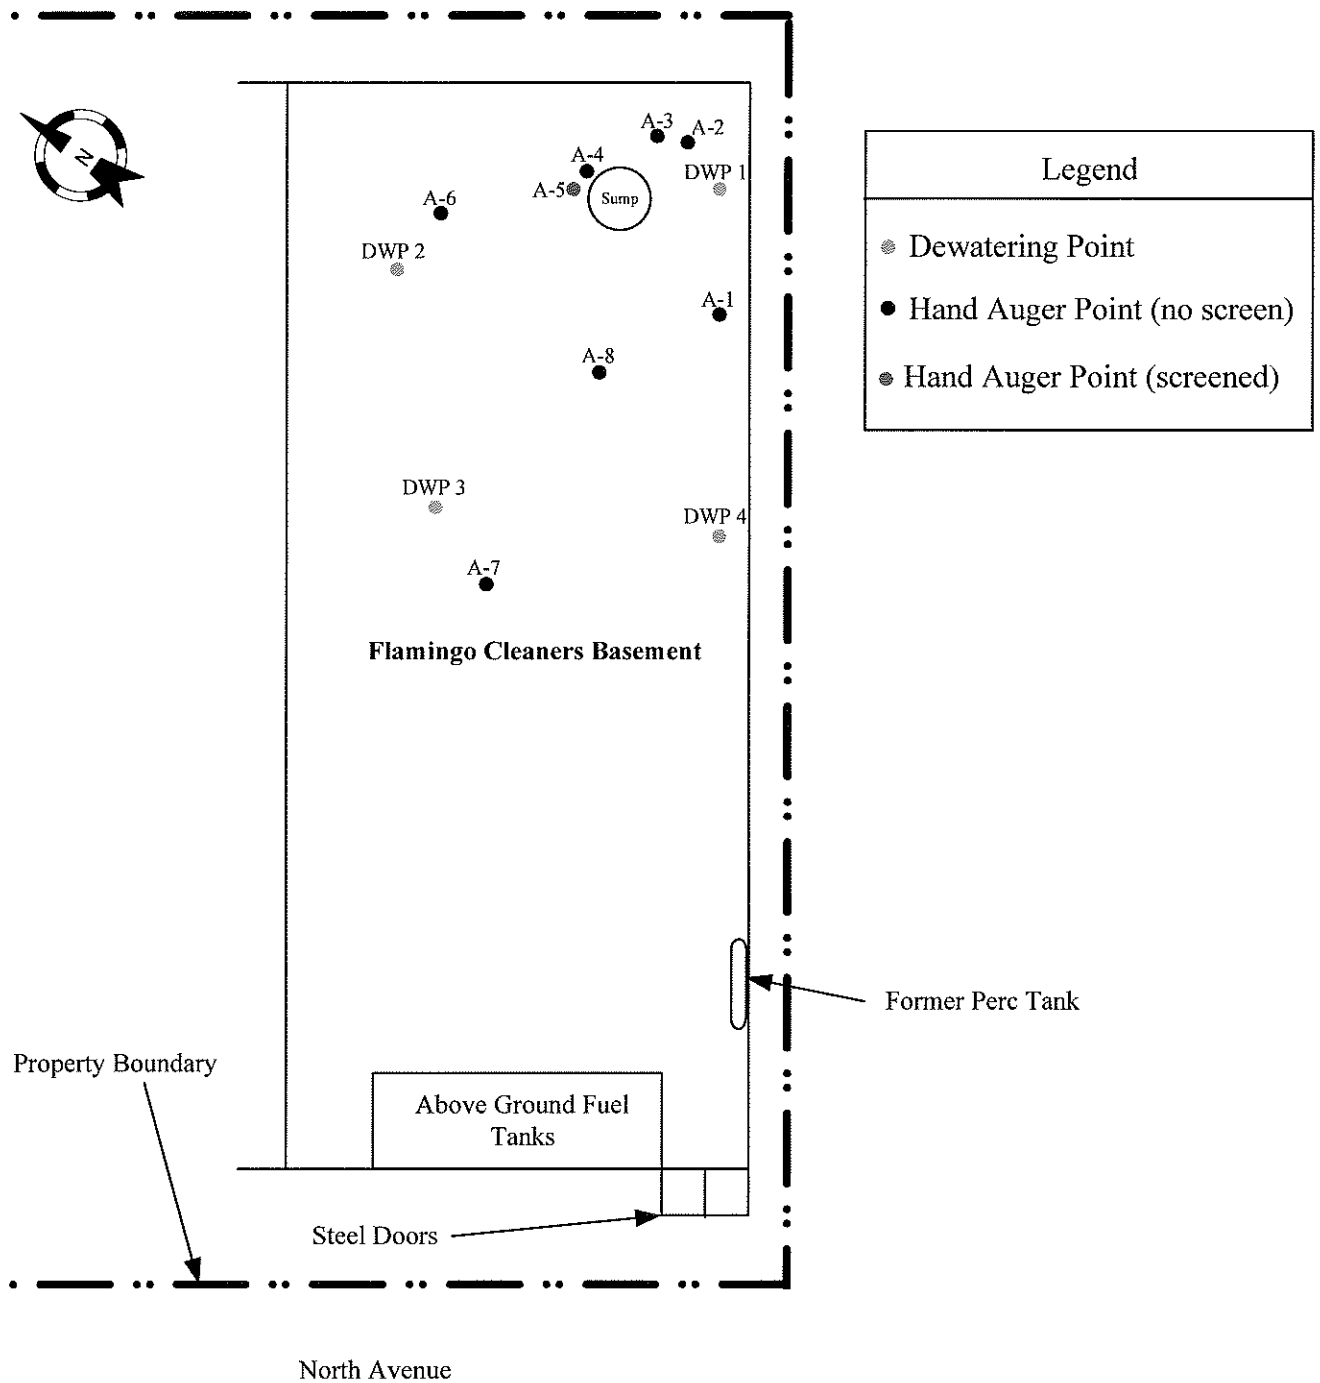
Site Diagram

Dorson advanced a total of eight (8) hand auger assessment holes (“A-1 – A-8”) surrounding the sump area. These holes were advanced to expose the groundwater table in order to evaluate the groundwater conditions to determine if petroleum product existed outside of the sump area. With the exception of A-5, all hand auger locations were advanced to a depth of approximately 2 feet below the basement slab with no PVC well material installed. A PVC well, slotted from grade through the terminus, was installed at the A-5 location to a depth of approximately 4 feet below grade. In addition to the hand auger holes, four (4) of the previously installed dewatering points were also inspected to evaluate groundwater conditions. Please note that the dewatering points were installed for groundwater depression only and are likely not slotted at the depth corresponding to the product layer interface and as such, will not be used as data collection points, however, the findings from the inspection of these points will be provided with regard to groundwater depth.

Groundwater was observed at a depth of approximately 11 inches below basement grade during the inspection of the hand auger holes and dewatering points. Groundwater samples were collected from the eight (8) hand auger locations and visually inspected for the presence of a petroleum product layer. Please note that the samples were not screened for olfactory evidence of contamination as the groundwater in the basement area is known to be contaminated with PCE. No visual evidence of a petroleum product layer was observed in any of the samples collected from the eight (8) hand auger locations. The only evidence of petroleum product that was observed existed on the surface of water within the sump pit.
