# PHASE I ENVIRONMENTAL SITE ASSESSMENT

33 John Street Yonkers, New York 10701

April 10, 2006

ACT File #: 5435-YONY

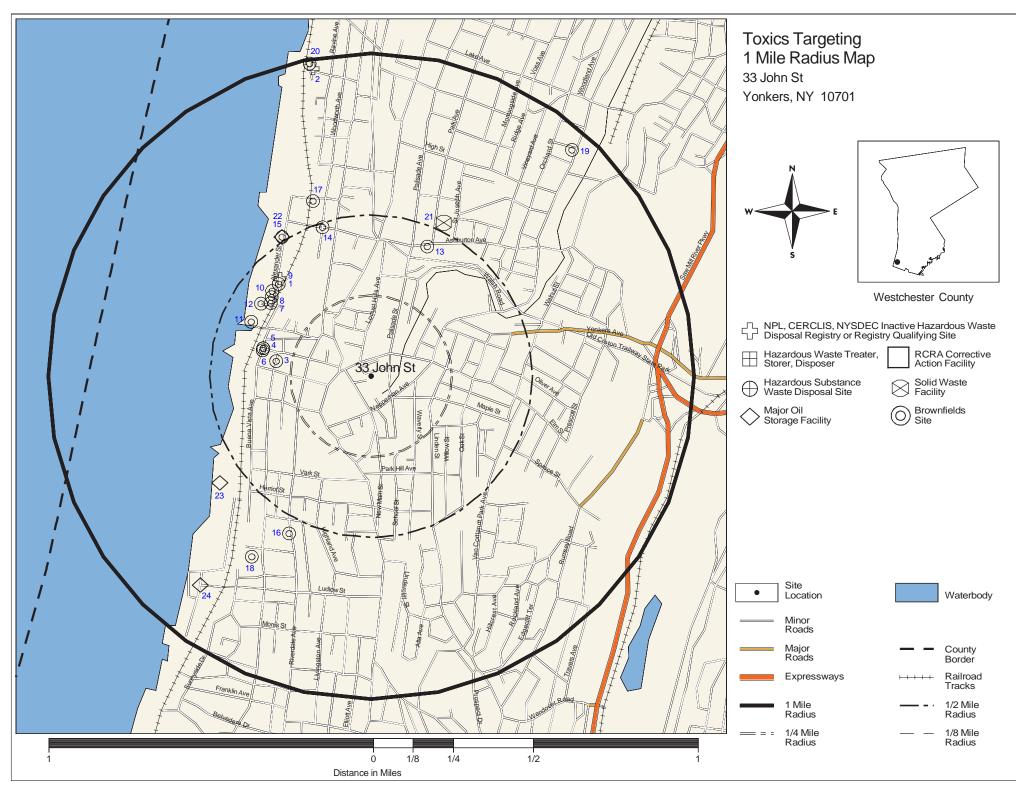
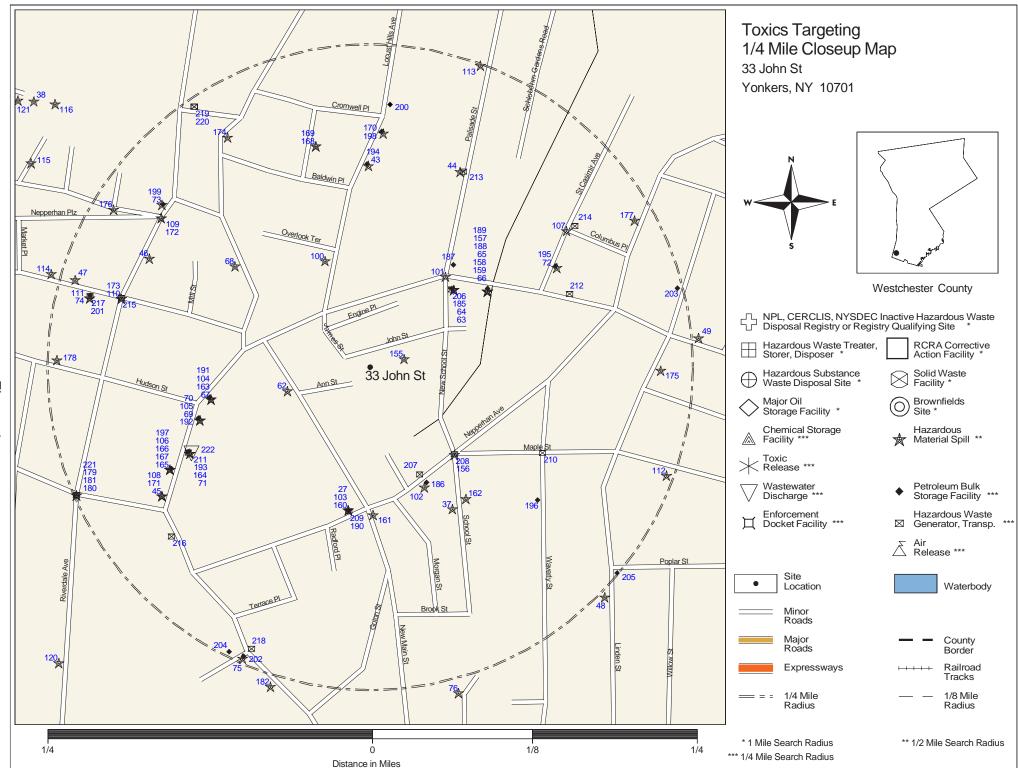
In an effort to determine the potential impact from hazardous waste activities at the subject property and neighboring properties, a review of information on waste sites within one mile of the subject property was conducted. Figures 3 and 4 provide locations of plotted sites. Appendix C contains the results of the database searches. The review included a search of the following Federal data sources:
