FORMER CHATSWORTH COAL AND SUPPLY SITE

**2101 AND 2103 PALMER AVENUE
VILLAGE OF LARCHMONT
WESTCHESTER COUNTY, NEW YORK
NYSDEC SITE #: C360132**

PERIODIC REVIEW REPORT

PERIOD OF 2017 - 2021

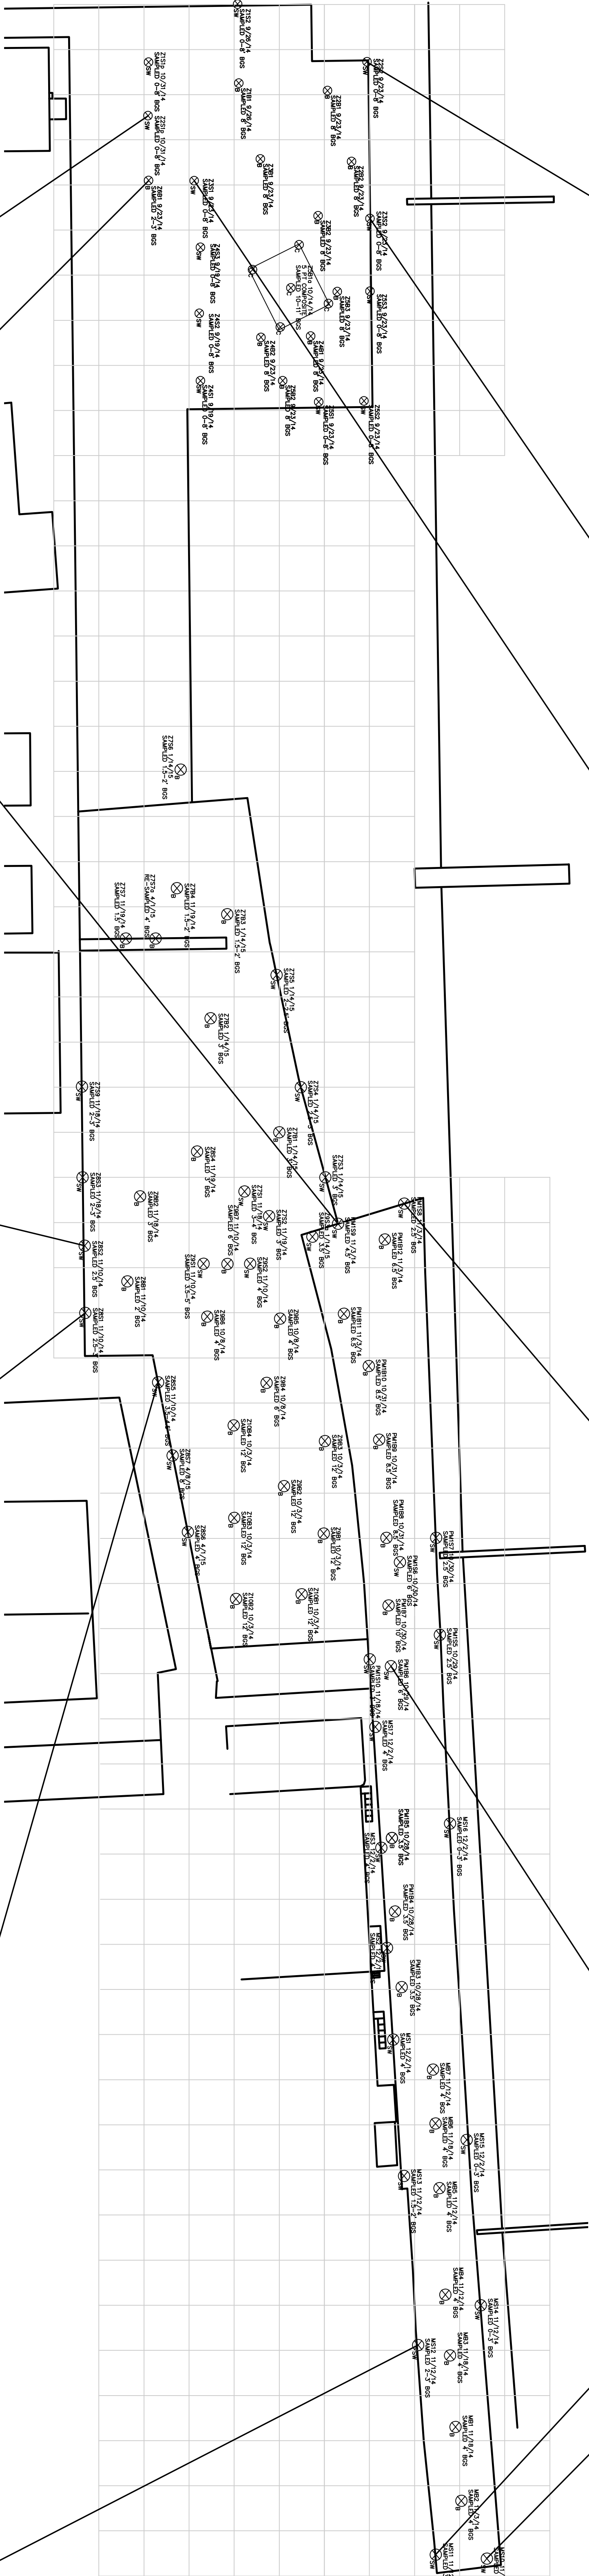
Contaminant	Restricted Residential SCOs (ppm)	Sample MS10 (ppm)
Benzo(a)anthracene	1	1.49
Benzo(a)pyrene	1	1.73
Benzo(b)fluoranthene	1	1.94
Dibenzo(a,h)anthracene	0.33	0.377
Indeno(1,2,3-cd)pyrene	0.5	1.21

Contaminant	Restricted Residential SCOs (ppm)	Sample PM1B6 (ppm)
Copper	270	806

Contaminant	Restricted Residential SCOs (ppm)	Sample Z6B1 (ppm)
Indeno(1,2,3-cd)pyrene	0.5	0.515

Contaminant	Restricted Residential SCOs (ppm)	Sample PM1S9 (ppm)
Arsenic	16	17.9

Contaminant	Restricted Residential SCOs (ppm)	Sample MS12 (ppm)
Benzo(a)anthracene	1	11.5
Benzo(a)pyrene	1	15.6
Benzo(b)fluoranthene	1	16.6
Chrysene	3.9	12.5
Dibenzo(a,h)anthracene	0.33	2.59
Indeno(1,2,3-cd)pyrene	0.5	9.99
Arsenic	16	23.5

Contaminant	Restricted Residential SCOs (ppm)	Sample Z8S2 (ppm)
Benzo(a)anthracene	1	3.62
Benzo(a)pyrene	1	4.46
Benzo(b)fluoranthene	1	5.39
Chrysene	3.9	4
Dibenzo(a,h)anthracene	0.33	0.673
Indeno(1,2,3-cd)pyrene	0.5	3.13

Contaminant	Restricted Residential SCOs (ppm)	Sample Z8S1 (ppm)
Benzo(a)anthracene	1	3.38
Benzo(a)pyrene	1	4.34
Benzo(b)fluoranthene	1	5.21
Chrysene	3.9	4.15
Dibenzo(a,h)anthracene	0.33	0.633
Indeno(1,2,3-cd)pyrene	.5	2.83

SAMPLE IDS Z8B1, Z8S1, AND Z8S1P ARE LOCATED WITHIN THE BOUNDARIES OF THE SITE. CONTAMINATION AT THESE LOCATIONS IS MINIMAL AND HAS BEEN APPROVED BY THE DEPARTMENT AS HAVING MET THE REMEDY.
