**COTTAGE PLACE GARDENS PHASE 5  
PARCEL SITE**

**WESTCHESTER COUNTY, NEW YORK**

**Final Engineering Report**

**NYSDEC Site Number: C360161**

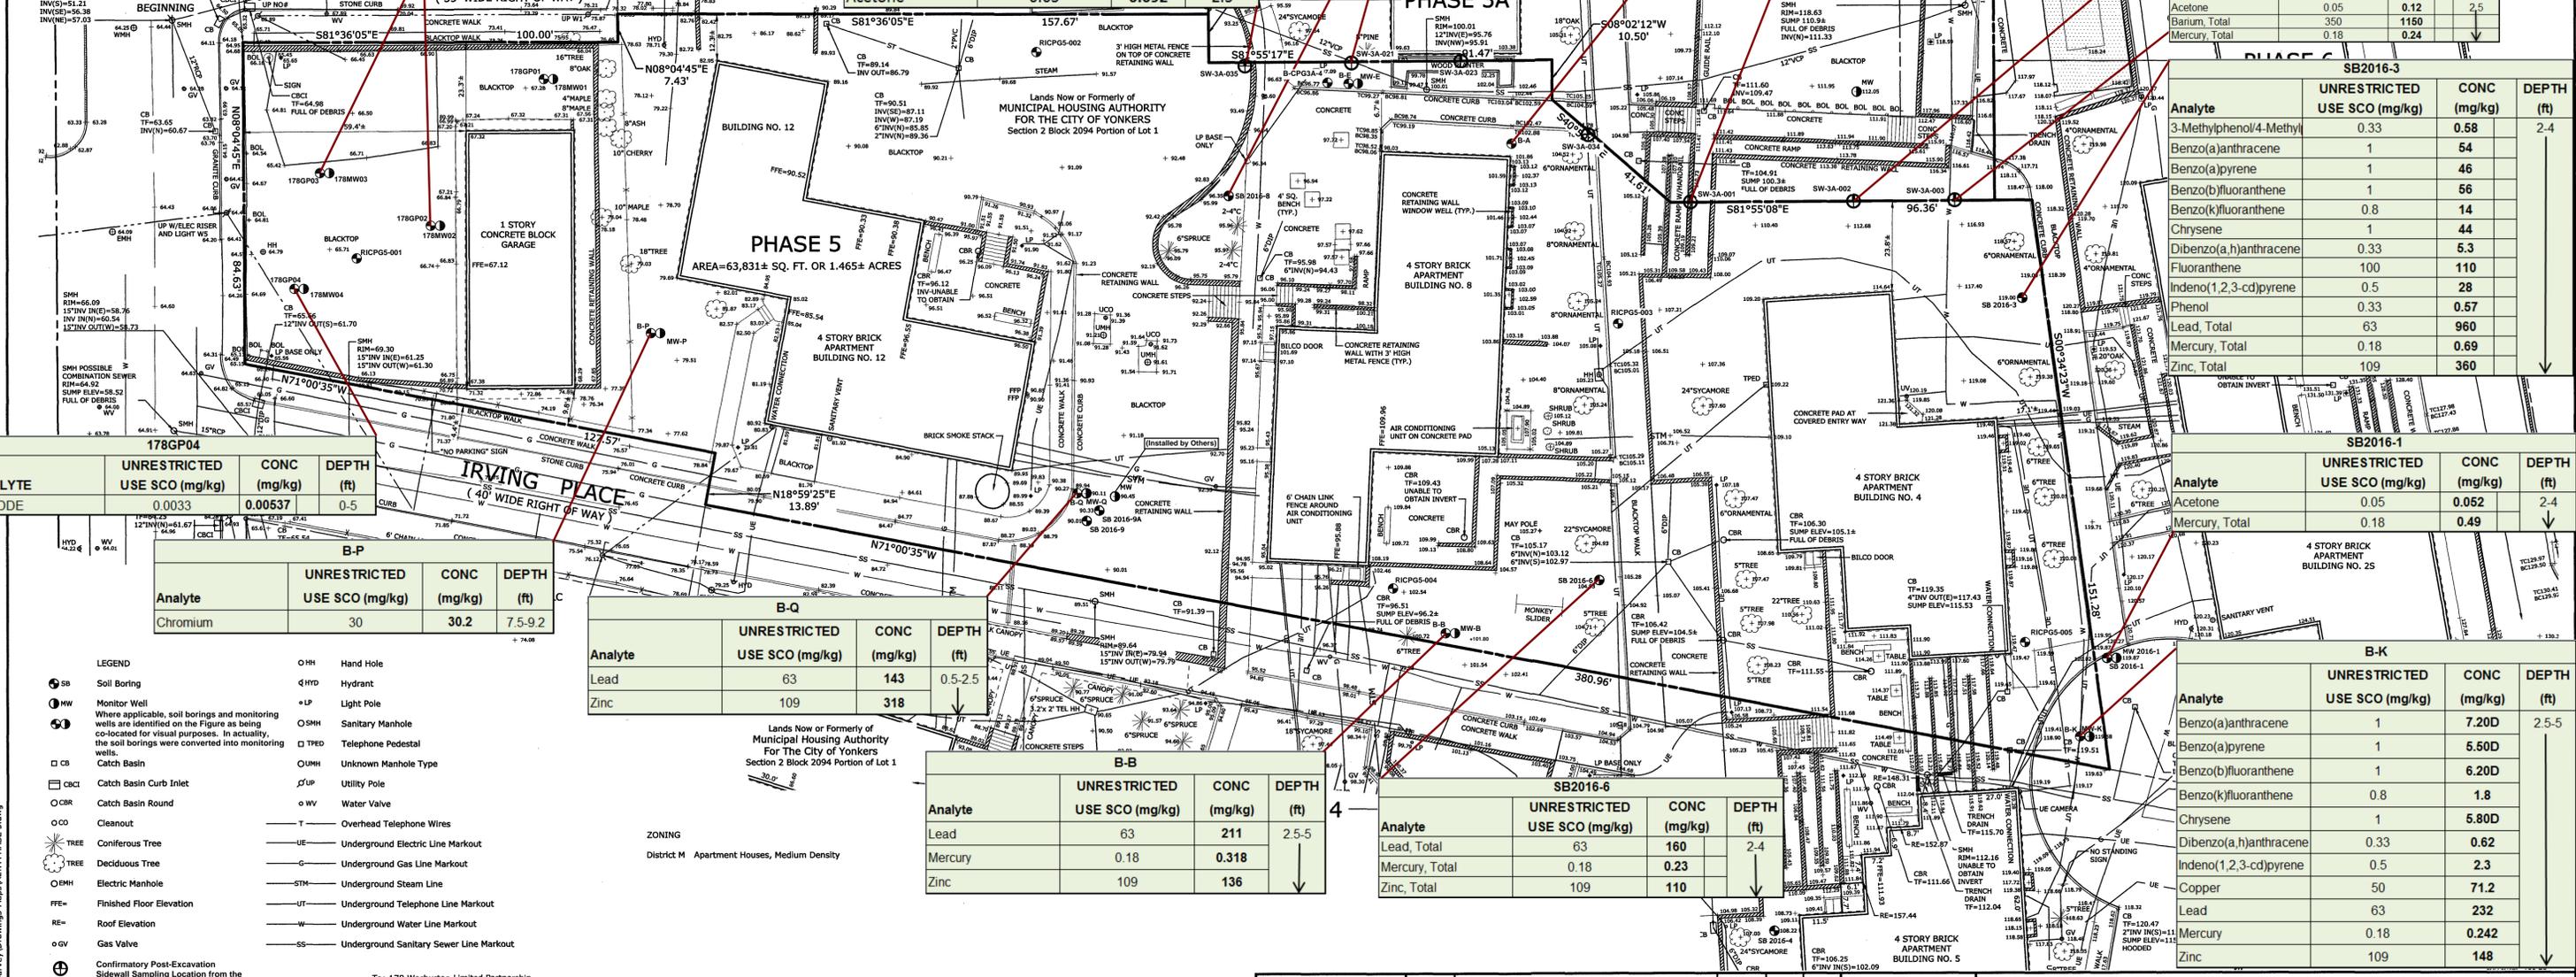
**FIGURE 1A**  
**ANALYTES IN FILL/SOIL EXCEEDING SCGS**  
**PRE-REMEDIATION**  
**COTTAGE PLACE GARDENS PHASE 5 PARCEL SITE**

SB2016-3			
ANALYTE	UNRESTRICTED USE SCO (mg/kg)	CONC (mg/kg)	DEPTH (ft)
3-Methylphenol/4-Methyl	0.33	0.58	2-4
Benzo(a)anthracene	1	54	
Benzo(a)pyrene	1	46	
Benzo(b)fluoranthene	1	56	
Benzo(k)fluoranthene	0.8	14	
Chrysene	1	44	
Dibenzo(a,h)anthracene	0.33	5.3	
Fluoranthene	100	110	
Indeno(1,2,3-cd)pyrene	0.5	28	
Phenol	0.33	0.57	
Lead, Total	63	960	
Mercury, Total	0.18	0.69	
Zinc, Total	109	360

B-K			
ANALYTE	UNRESTRICTED USE SCO (mg/kg)	CONC (mg/kg)	DEPTH (ft)
Benzo(a)anthracene	1	7.20D	2.5-5
Benzo(a)pyrene	1	5.50D	
Benzo(b)fluoranthene	1	6.20D	
Benzo(k)fluoranthene	0.8	1.8	
Chrysene	1	5.80D	
Dibenzo(a,h)anthracene	0.33	0.62	
Indeno(1,2,3-cd)pyrene	0.5	2.3	
Copper	50	71.2	
Lead	63	232	
Mercury	0.18	0.242	
Zinc	109	148

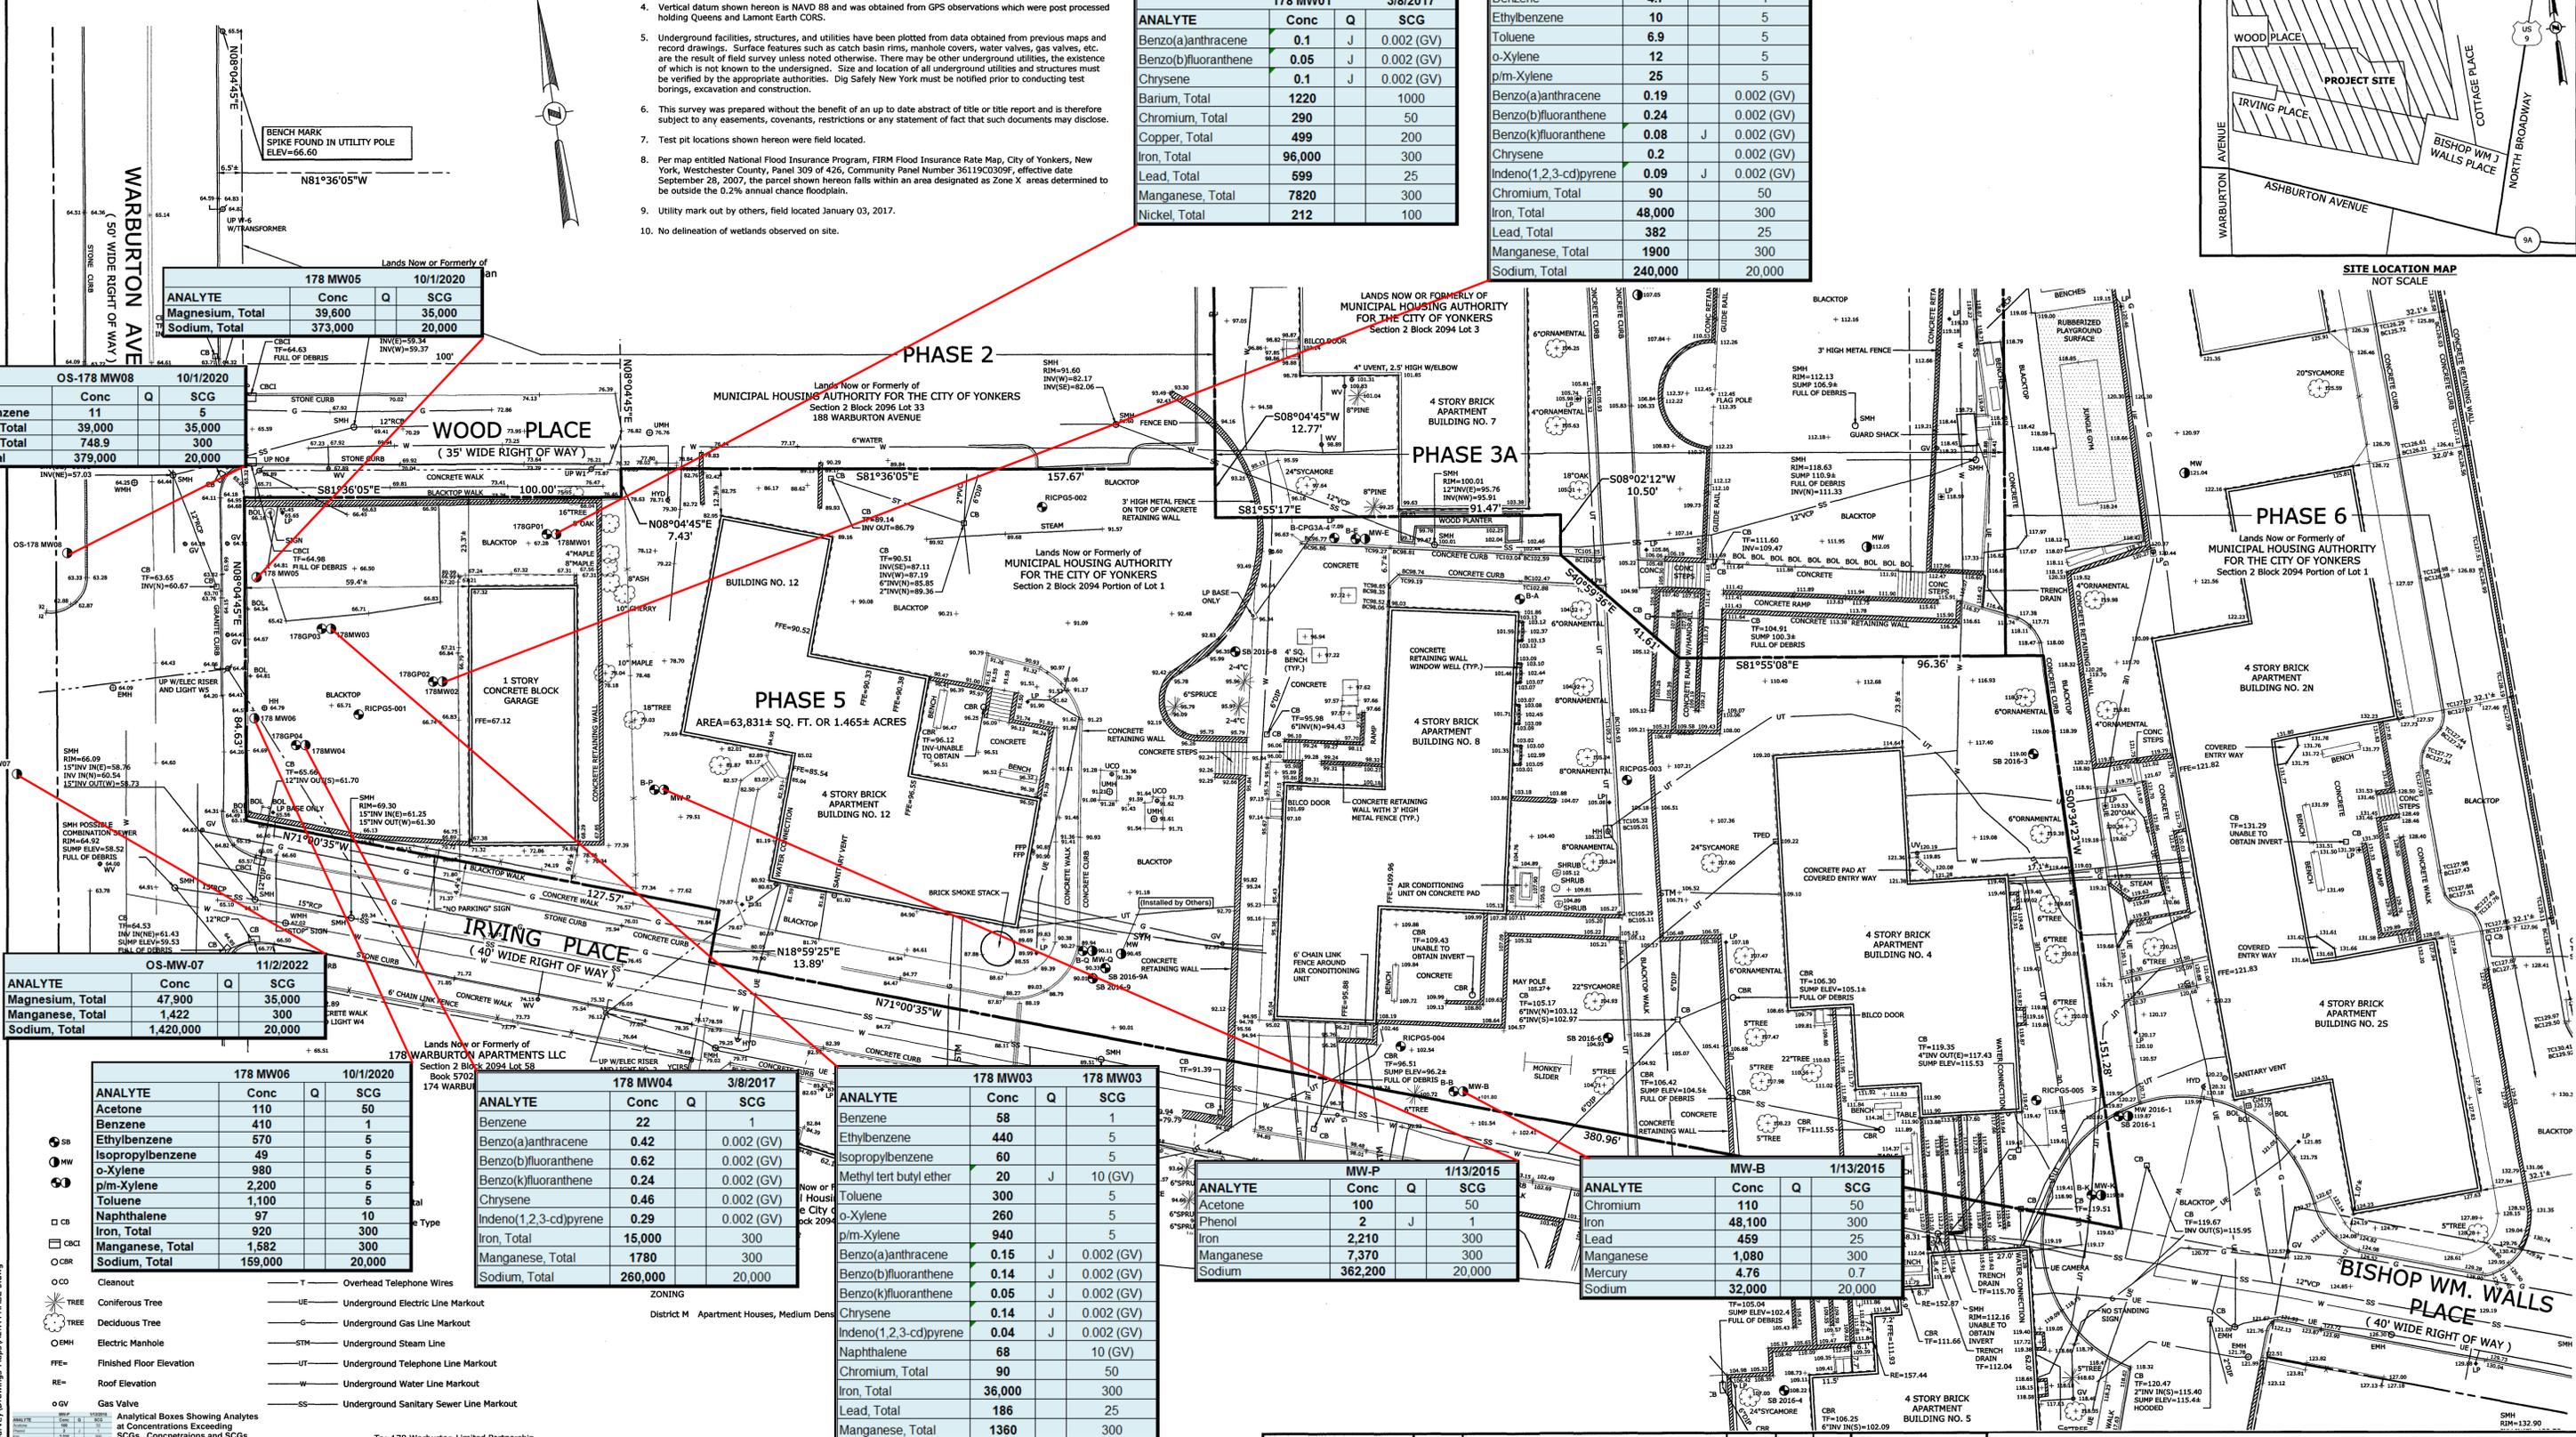
ANALYTE	178 MW01		3/8/2017	
	Conc	Q	SCG	
Benzo(a)anthracene	0.1	J	0.002 (GV)	
Benzo(b)fluoranthene	0.05	J	0.002 (GV)	
Chrysene	0.1	J	0.002 (GV)	
Barium, Total	1220		1000	
Chromium, Total	290		50	
Copper, Total	499		200	
Iron, Total	96,000		300	
Lead, Total	599		25	
Manganese, Total	7820		300	
Nickel, Total	212		100

ANALYTE	178 MW02		3/8/2017	
	Conc	Q	SCG	
Benzene	4.7		1	
Ethylbenzene	10		5	
Toluene	6.9		5	
o-Xylene	12		5	
p/m-Xylene	25		5	
Benzo(a)anthracene	0.19		0.002 (GV)	
Benzo(b)fluoranthene	0.24		0.002 (GV)	
Benzo(k)fluoranthene	0.08	J	0.002 (GV)	
Chrysene	0.2		0.002 (GV)	
Indeno(1,2,3-cd)pyrene	0.09	J	0.002 (GV)	
Chromium, Total	90		50	
Iron, Total	48,000		300	
Lead, Total	382		25	
Manganese, Total	1900		300	
Sodium, Total	240,000		20,000

ANALYTE	178 MW05		10/1/2020	
	Conc	Q	SCG	
Magnesium, Total	39,600		35,000	
Sodium, Total	373,000		20,000

ANALYTE	OS-178 MW08		10/1/2020	
	Conc	Q	SCG	
Isopropylbenzene	11		5	
Magnesium, Total	39,000		35,000	
Manganese, Total	748.9		300	
Sodium, Total	379,000		20,000

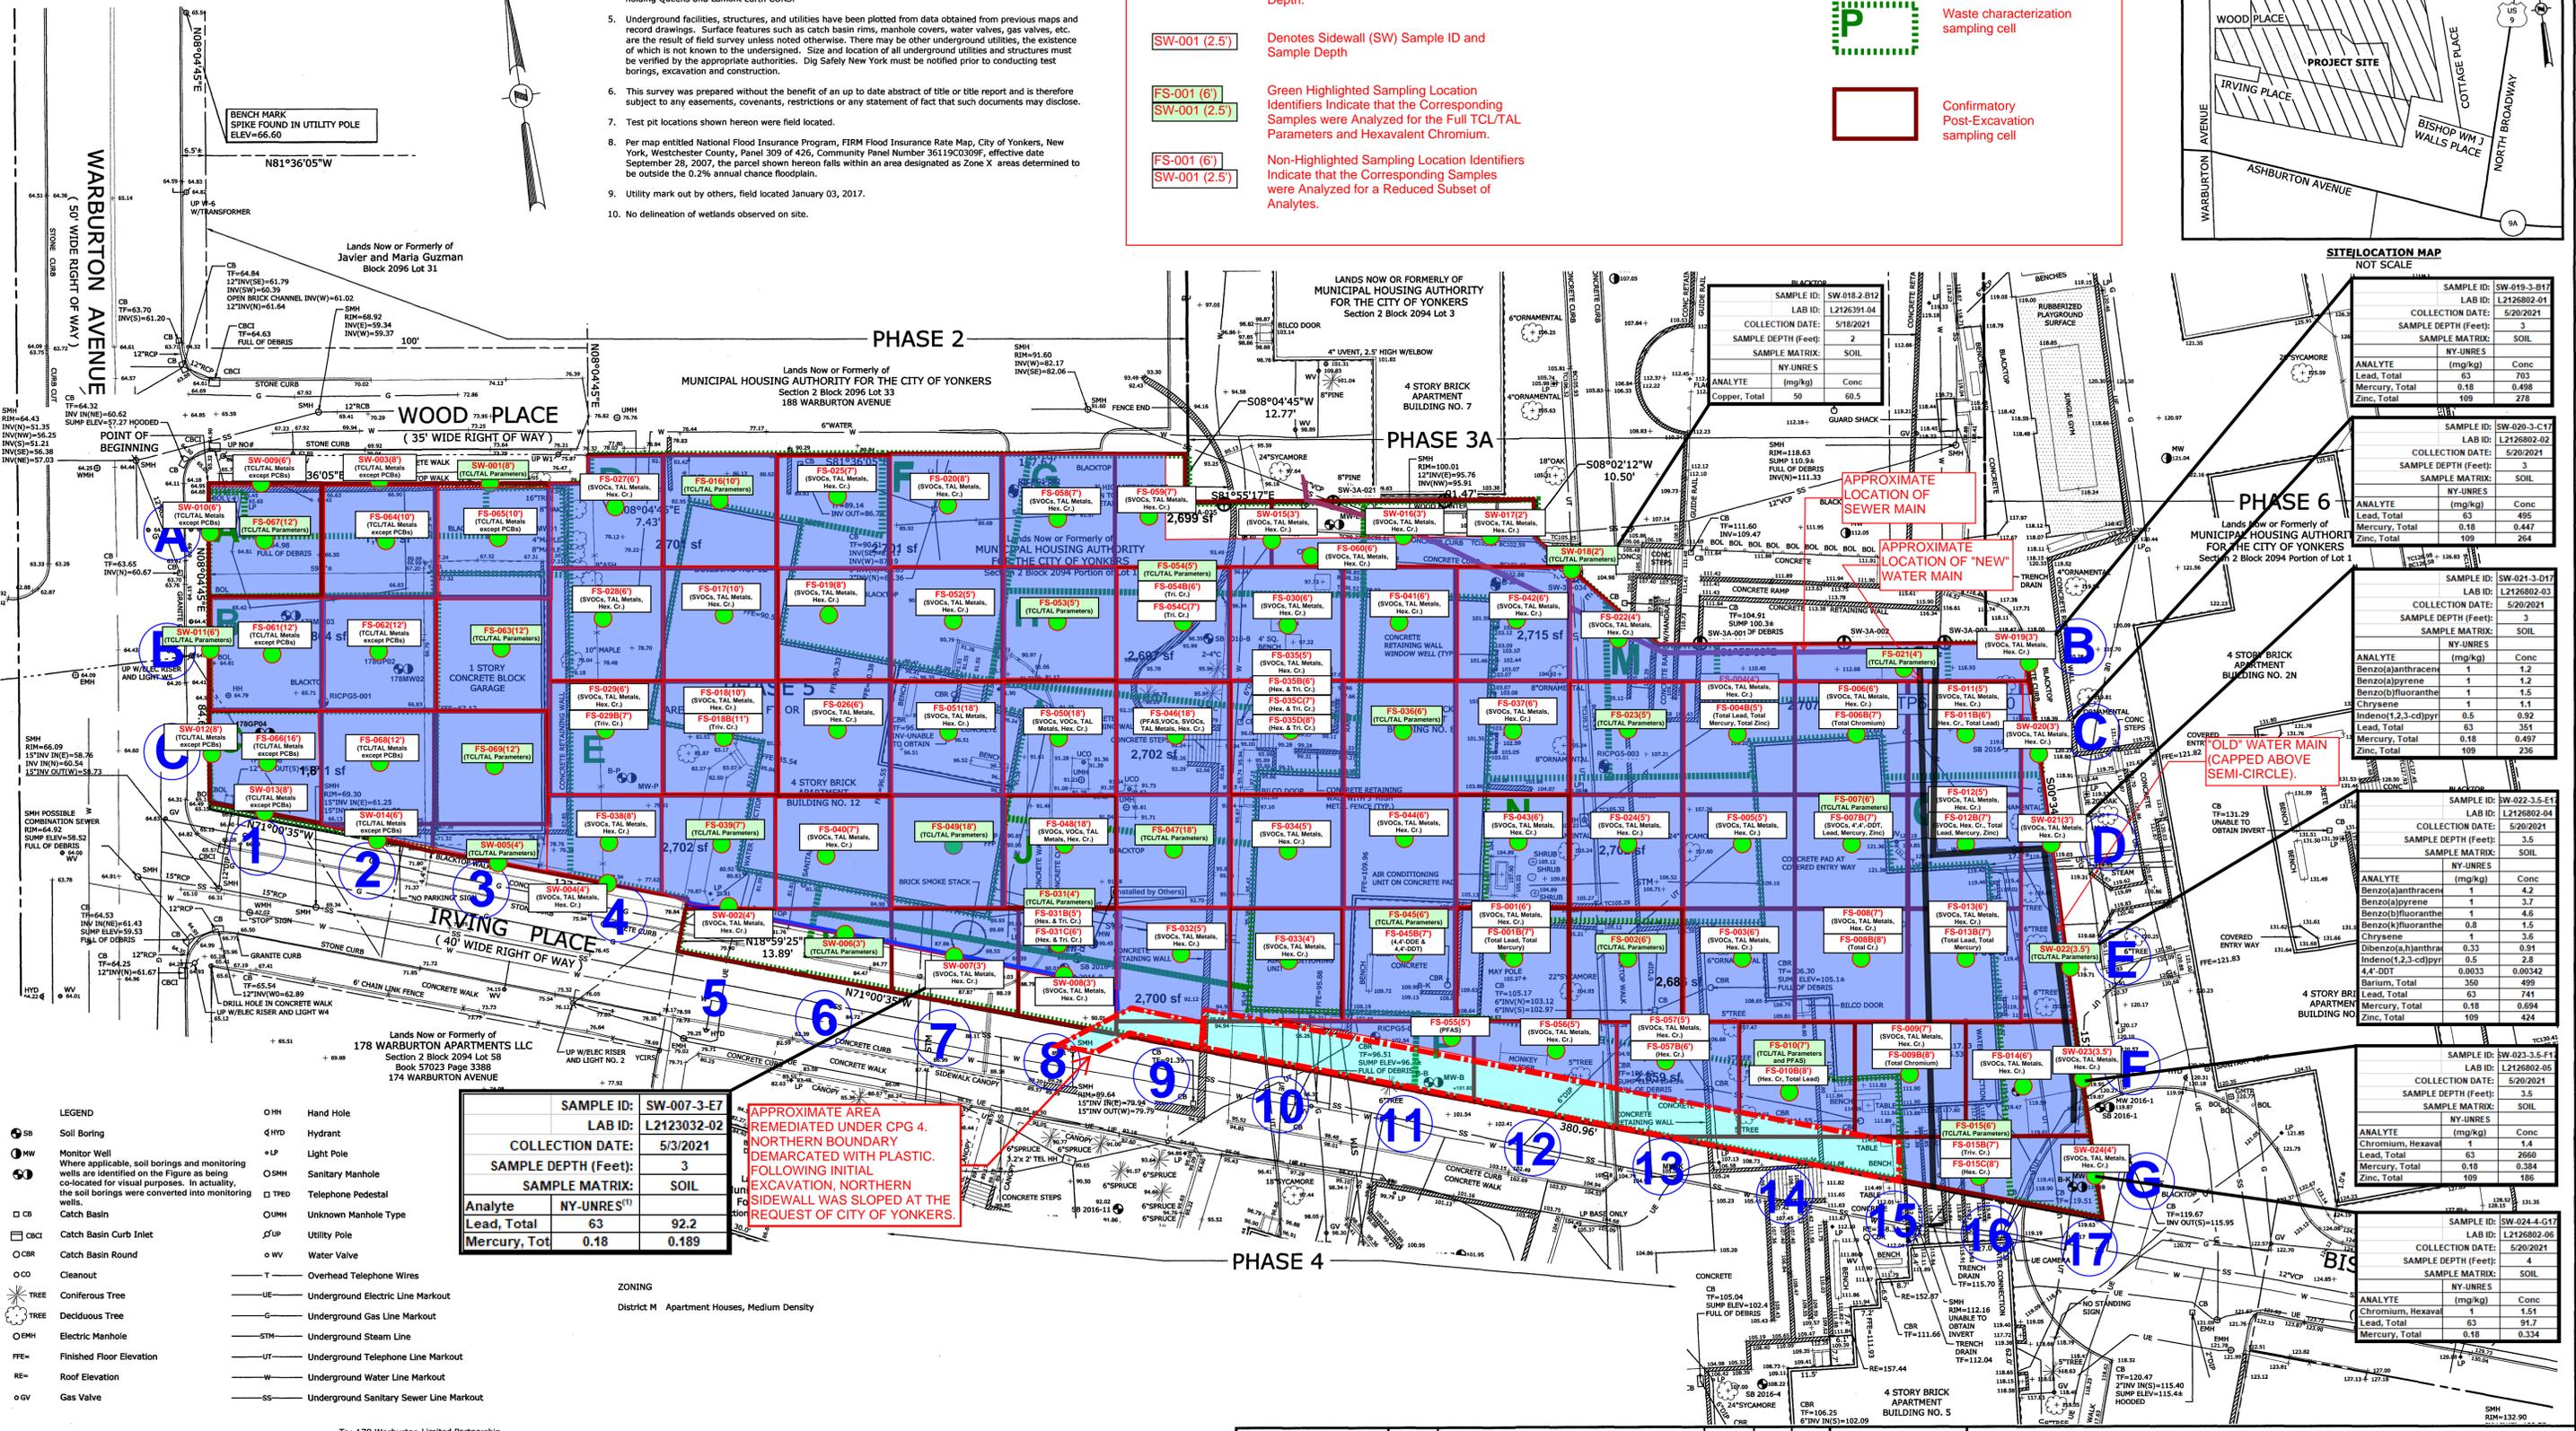
APPROXIMATE AREA REMEDIATED UNDER CPG 4. NORTHERN BOUNDARY DEMARCATED WITH PLASTIC. FOLLOWING INITIAL EXCAVATION, NORTHERN SIDEWALL WAS SLOPED AT THE REQUEST OF CITY OF YONKERS.

SAMPLE ID: SW-018-2-B12  
LAB ID: L2125391-04  
COLLECTION DATE: 5/18/2021  
SAMPLE DEPTH (Feet): 2  
SAMPLE MATRIX: SOIL  
NY-UNRES: 2  
ANALYTE (mg/kg) Conc  
Copper, Total 50 60.5

SAMPLE ID: SW-021-3-D17  
LAB ID: L2126802-03  
COLLECTION DATE: 5/20/2021  
SAMPLE DEPTH (Feet): 3  
SAMPLE MATRIX: SOIL  
NY-UNRES: 1  
ANALYTE (mg/kg) Conc  
Benzol(a)anthracene 1 1.2  
Benzol(a)pyrene 1 1.5  
Benzol(b)fluoranthene 1 1.1  
Chrysene 1 1.5  
Indeno(1,2,3-cd)pyrene 0.5 0.92  
Lead, Total 63 351  
Mercury, Total 0.18 0.497  
Zinc, Total 109 236

SAMPLE ID: SW-022-3-E17  
LAB ID: L2126802-04  
COLLECTION DATE: 5/20/2021  
SAMPLE DEPTH (Feet): 3.5  
SAMPLE MATRIX: SOIL  
NY-UNRES: 1  
ANALYTE (mg/kg) Conc  
Benzol(a)anthracene 1 4.2  
Benzol(a)pyrene 1 3.7  
Benzol(b)fluoranthene 1 4.6  
Benzol(k)fluoranthene 0.8 1.5  
Chrysene 1 3.6  
Dibenzol(a,h)anthracene 0.33 0.91  
Indeno(1,2,3-cd)pyrene 0.5 2.3  
4,4'-DDT 0.0033 0.00342  
Barium, Total 350 499  
Lead, Total 63 741  
Mercury, Total 0.18 0.694  
Zinc, Total 109 424
