**SURVEY OF THE FORMER CANADIAN RADIUM SITE  
MOUNT KISCO, WESTCHESTER COUNTY, NEW YORK**

**NEW YORK STATE DEPARTMENT OF HEALTH  
BUREAU OF ENVIRONMENTAL RADIATION PROTECTION  
OCTOBER, 1993**

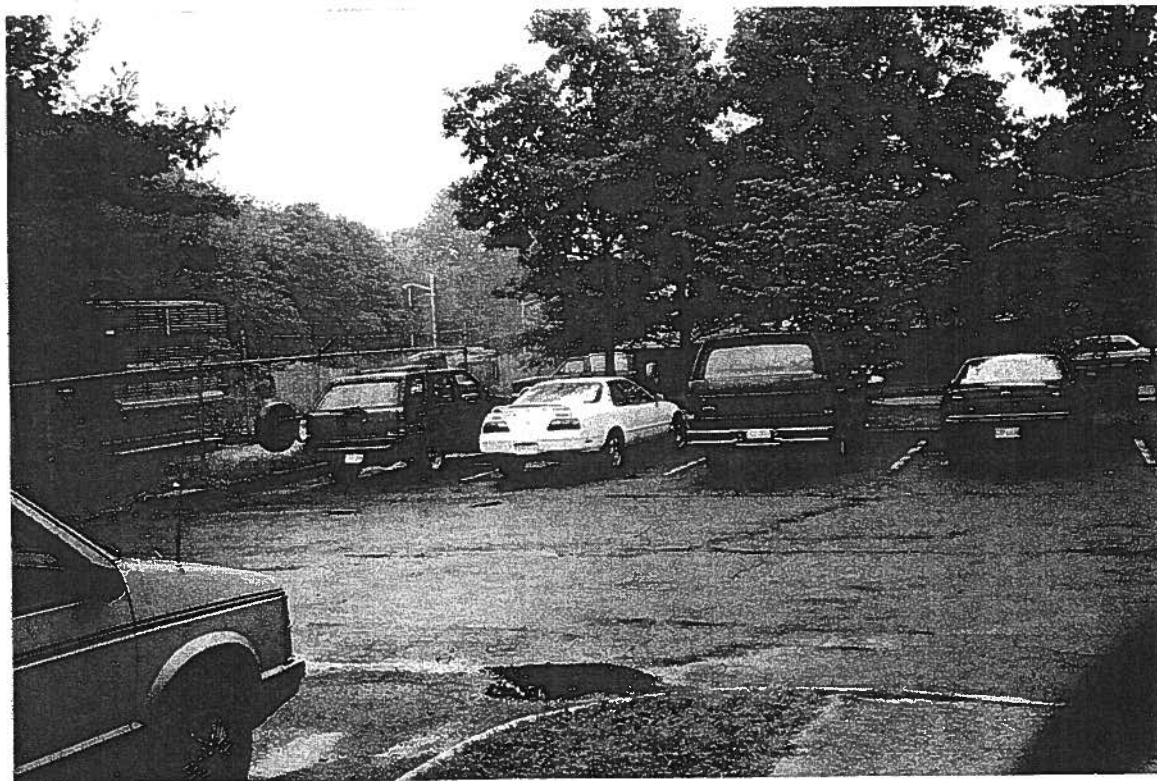
**PHOTO 6** Employee Parking Lot

Figure 4 and Photo 6 show the employee parking lot, which is located at the southern side of the main Richard's building. Readings taken in this area show only a slight increase over typical background levels of 7-12  $\mu\text{R/hr}$ , with the highest readings being 15-16  $\mu\text{R/hr}$  along the south grassy area next to the roadway.

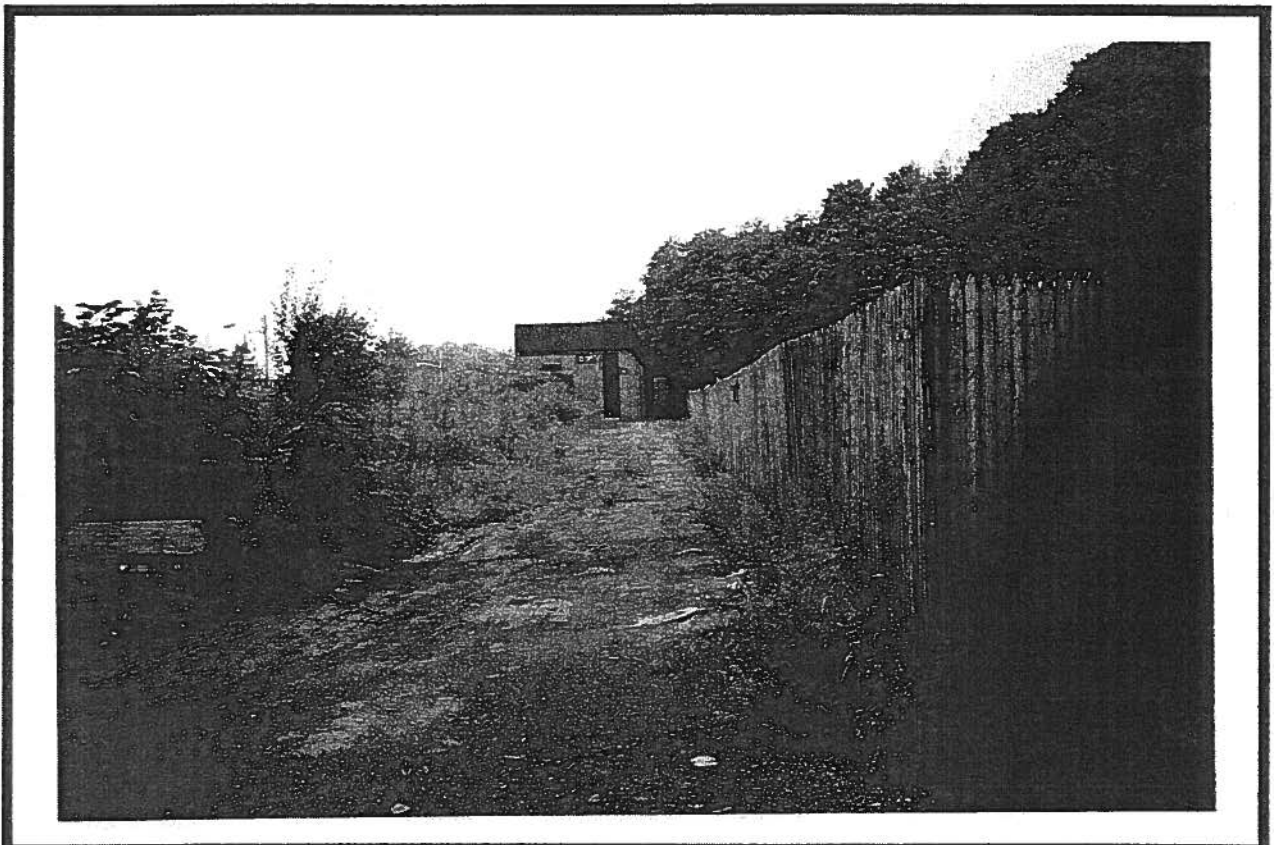
**PHOTO 7 Roadway and Grass Areas Surrounding the Stockade Fenced Area**

Figure 5 and Photos 7 and 8 show the roadway and grassy areas on three sides of the stockade-fenced area. No readings greater than 20  $\mu\text{R/hr}$  above background were found, although levels measured in the northern end are up to 2 times higher than those in the southern portion.

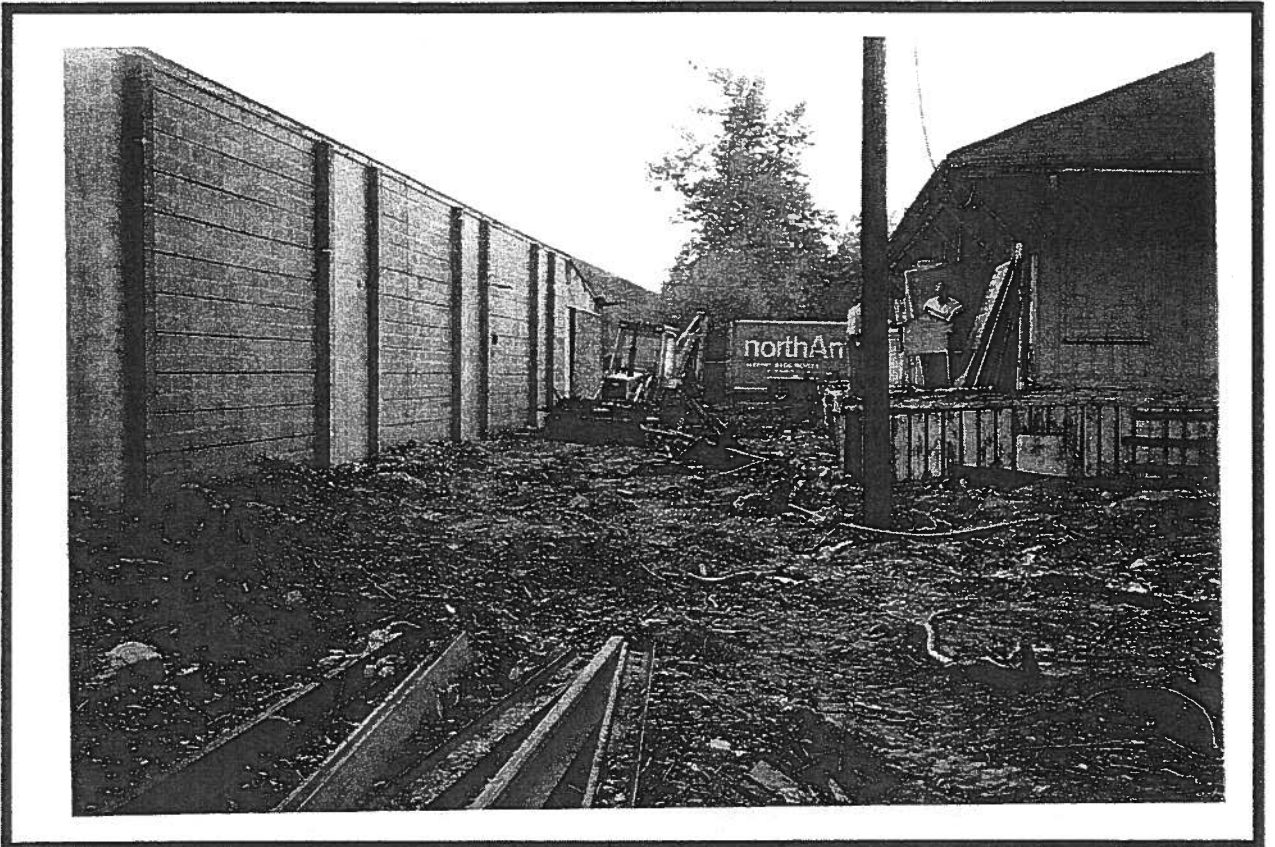
**PHOTO 11** Excavated Old Depot Area

Figure 7 and Photos 4, 5 and 11 depict the formerly fenced old depot area which had been known to contain "hot spots". Ongoing excavation, tree removal and railroad tie/rails removal may have brought additional radium contamination to the surface as well as spread the

contamination over a larger area (Photos 22, 23 and 24). The entire area from the southern fence to the old depot building shows elevated readings, indicated by a box in the survey diagram (Figure 7), ranging from 24-170  $\mu\text{R/hr}$  on the systematic survey. Additional "hot" areas may be found in the excavated area. The highest area found during this survey gave an exposure rate of 240  $\mu\text{R/hr}$ . Photos 25 to 28 show changes at the site since the survey of 9/9/93.

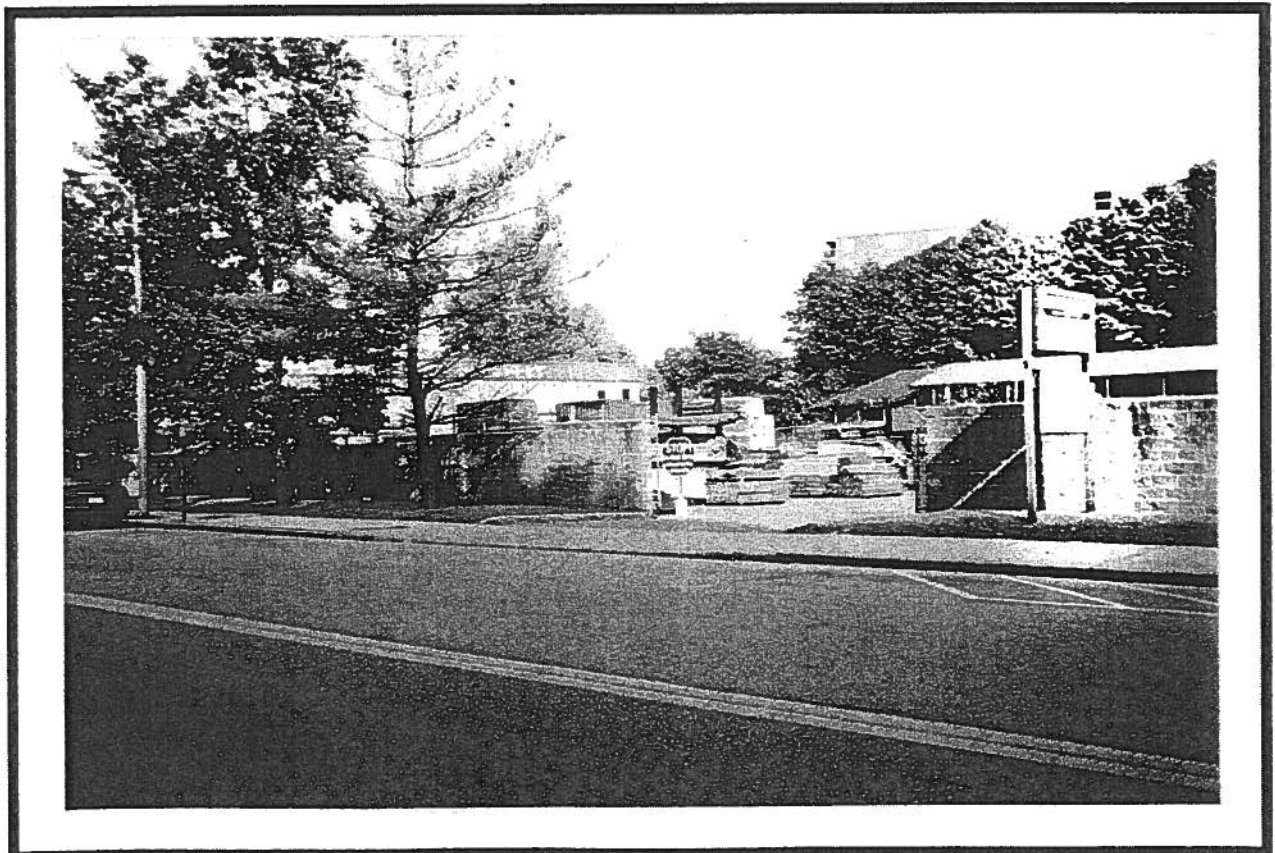
**PHOTO 18 Richard's Main Lumber Yard North Side of Building (Photo 1 of 2)**

Figure 6 and Photos 18 and 19 depict the main lumber yard, storage area and roadway which lies on the east and south sides of the main home improvement building. Three readings were also taken across Kisco Avenue opposite to the building near a rock wall (Photos 20 and 21). These readings ranged from 7-20  $\mu\text{R/hr}$ . The lowest readings (7-8  $\mu\text{R/hr}$ ) were found at the northwest portion of the property. Most of the readings were in the range of 10-14  $\mu\text{R/hr}$ . The two highest readings of 20  $\mu\text{R/hr}$  were found next to a fenced hedgerow which runs from the roadway to the lumber storage shed (not shown, see Figure 8).

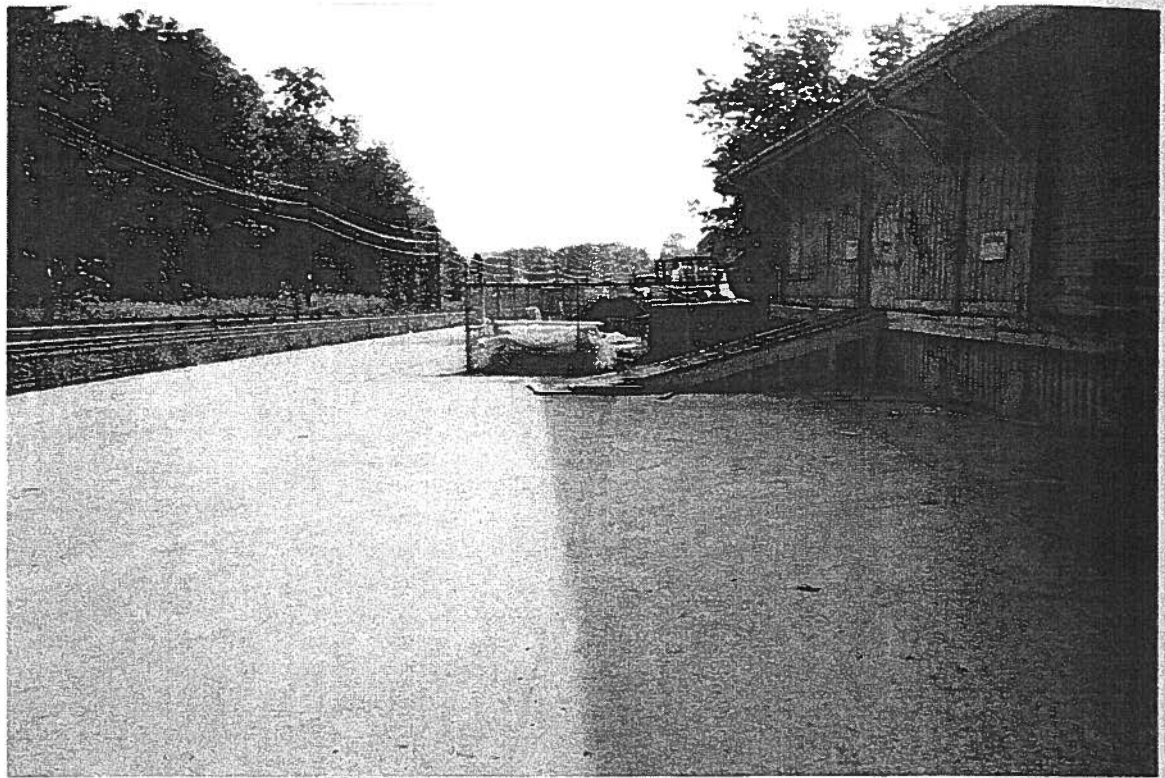
**PHOTO 29 Concrete Pad/Road from New Roadway to Old Depot**

Figure 8 and Photo 29 show the concrete pad/road which extends from the new roadway along the railroad tracks to the area located beyond the old depot. All the measurements appear to be within the normal background range of 7-12  $\mu\text{R/hr}$ . The area on the north side of the depot is unpaved and leads to a fence and building at the extreme northern boundary of the Richard's property. No elevated readings were found in this area.
